# Investigating Corrosion Protection of Offshore Wind Towers

## Part 2: Results of the Site Tests

This article is the second part of a report on a nationally funded project on the performance testing of different corrosion protection methods for offshore wind towers under site and laboratory conditions. Part 1, published in the April 2008 *JPCL*, reported on the rationale behind, and setting up of, the test program. The present article discusses the test results.

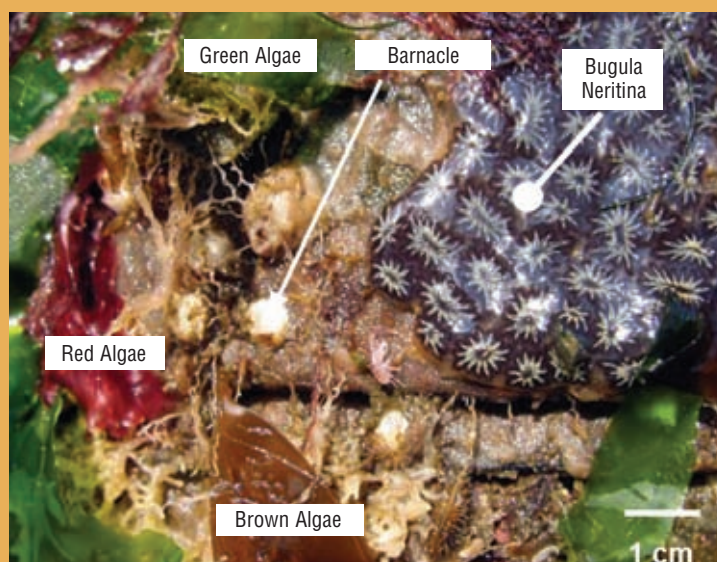
Fig. 1: Fouling at an underwater zone (UZ) specimen  
 Photos and figures courtesy of the authors

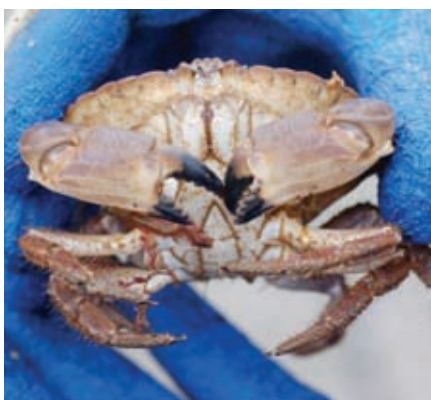
Fig. 2: Great crab, domiciliated in the underwater zone (UZ)

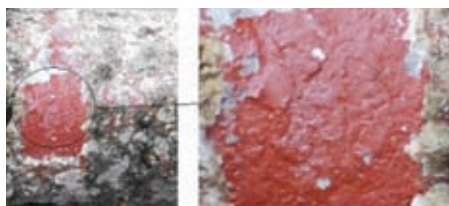
Fig. 3: Coating delamination at System 5 after 36 months of UZ exposure

System 6 exhibited large-scale blistering and severe coating delamination. This sample could not be cleaned properly because high-pressure washing would have removed the deteriorated coating. The sample showed white corrosion products, which were identified as the corrosion product of the metallization. The total system could be removed by scratching it slightly with a fingernail (Fig. 3). Because metallization with adequate sealers (at least Al/Zn metallization) is usually an effective and proven method for protecting offshore steel structures,<sup>10,11,12</sup> the result was surprising. No conclusive explanation can be delivered at the moment, and

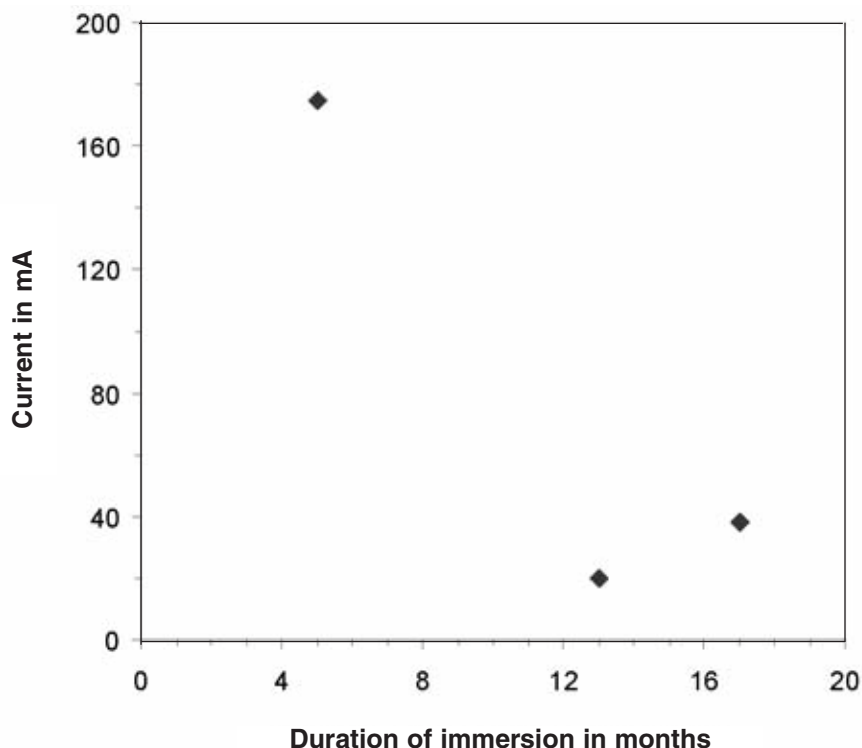
*Fig. 4: Current consumption of cathodic protection of UZ samples*

cathodic protection measurements. During the first months, the sample remained unprotected for technical reasons. The current had rather high values, which may have been caused by initial corrosion of the unprotected samples. After the cathodic protection was introduced, the value for the current dropped, and it seemed to be constant for the entire exposure phase. Coverage by fouling and the precipitate of alkaline earth salts are two probable reasons for the continuously low values for the protective current. Unfortunately,

part of the cathodic protection device was destroyed due to heavy wave load after 17 months, and it did not work properly. Therefore, the cathodic protection failed, and the uncoated sections of the specimens started to corrode.

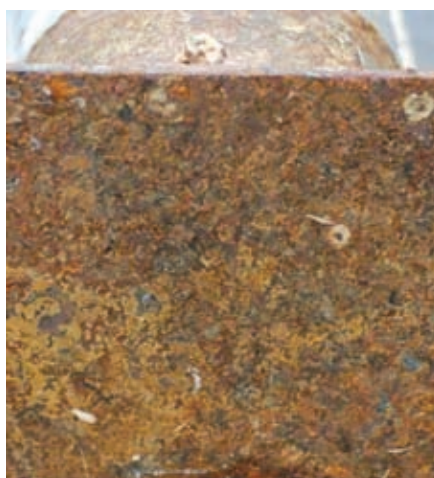
*Fig. 5: Unprotected section of a UZ specimen after 36 months of exposure*

The uncoated sections featured two layers of corrosion products (Fig. 5). The layer next to the steel was a black, loosely adherent layer, which was identified as Fe-oxide, more specifically, Fe-hydroxide with a low oxidation number. The top layer was the typical red rust, also loosely adherent. Figure 6 provides an SEM image and an EDX spectrum taken from the external corroded wall of the uncoated section of an UZ specimen. It can be seen that the rust was already cracked. Crack lengths ranged from 0.25 to 1.5 mm. Rust flakes were partly separated and only loosely adhering to the steel. The honeycomb structure in the far right region of the photograph is residue of fouling, and may be the origin of Si and partly of S and Na, occurring in the

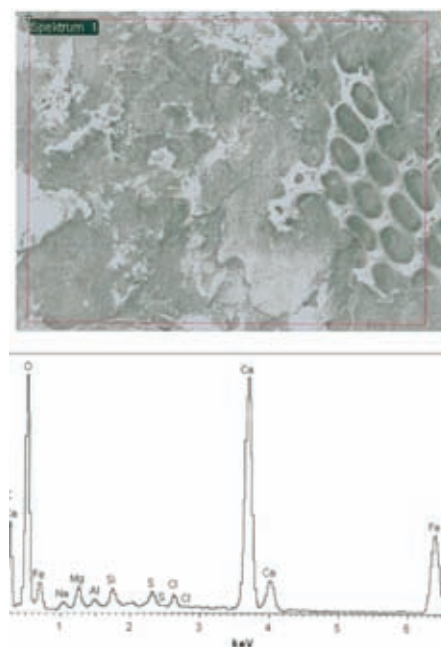
*Fig. 6: SEM image (upper image; image width: 5 mm) and EDX plot (lower diagram) of the corroded external wall of UZ specimen 2 after 36 months exposure*

EDX spectrum. The Fe-peaks in the spectrum originate from the corrosion products formed at the surface. The elements Al, Cl, Ca, Mg, S, and Na are constituents of the seawater.
