# Analysis of paint traces to determine the ship responsible for a collision

H. Lee<sup>✉</sup>, D. Lee & J. M. Seo

Although there have been many instances of ship collision at sea in recent times, not much research has been conducted on the topic. In this study, paint from an actual site of ship collision was collected and analyzed as evidence. The amount of evidence collected from the ships involved in the collision is either small or has inconsistent morphology. In addition, the contaminants and samples are often mixed in this evidence, making its analysis difficult. Paint traces of the damaged ship and the ship suspected to be responsible for the collision were compared through scanning electron microscopy with energy dispersive X-ray spectroscopy (SEM-EDS), attenuated total reflection–Fourier transform infrared spectroscopy (ATR–FTIR), thermogravimetry (TG) and derivative thermogravimetry (DTG), and pyrolysis–gas chromatography/mass spectrometry (Py–GC/MS) analyses. The ship responsible for the collision could be identified by characterization and by performing a comparative analysis of the extracted paint. Among the methods used in this study, Py–GC/MS can sensitively analy

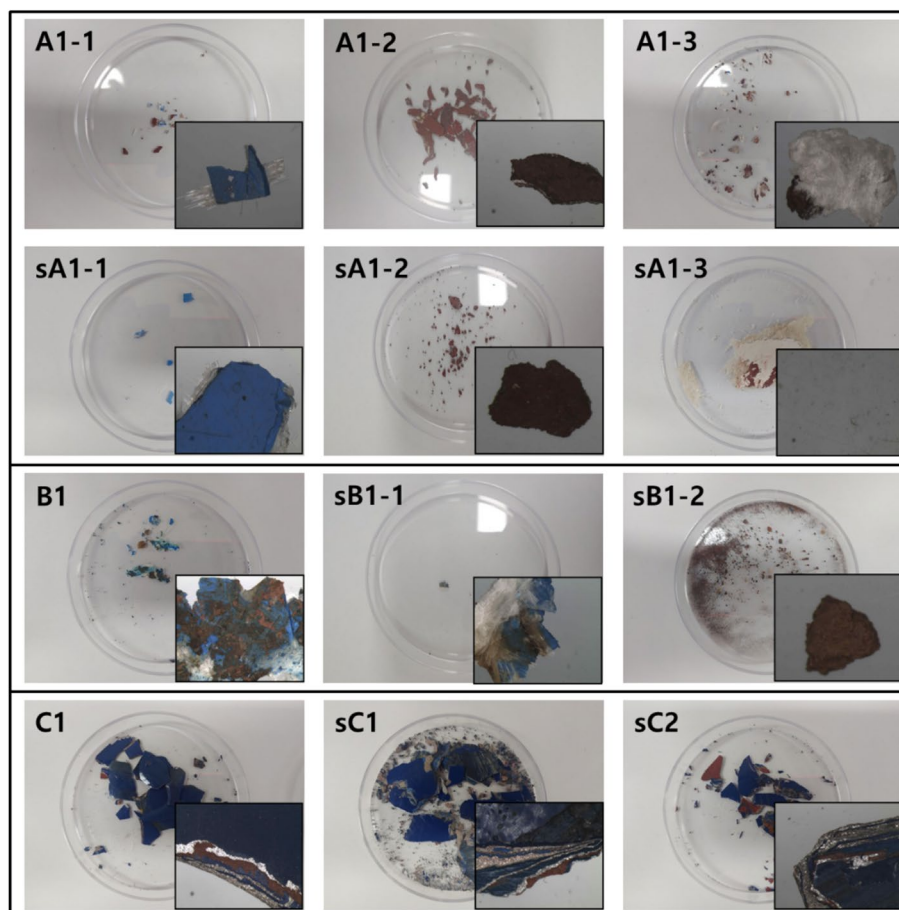
**Sample preparation.** Paint samples were collected from three cases of ship collisions. Evidence samples were collected differently depending on the position and condition of the vessel. The samples were taken from various collision sites, including the deck, guardrails, port-side, and starboard. A representative sample was selected by comparing the paint colors. Table 1 lists information such as the accident date, ship color, and sample name. Figure 1 presents the state of the paint evidence. The bottom right of each image was magnified using an optical microscope. In Case I, the samples were taken from three collision sites of the damaged ship and the ship suspected to be involved in the collision. In Case II, one sample of a mixture of blue and brown paint was taken from the damaged ship and two samples from the suspected ship. In Case III, one sample was collected from the damaged ship and one sample each from the two suspected ships.

**Figure 1.** Paint collected from the actual collision site.

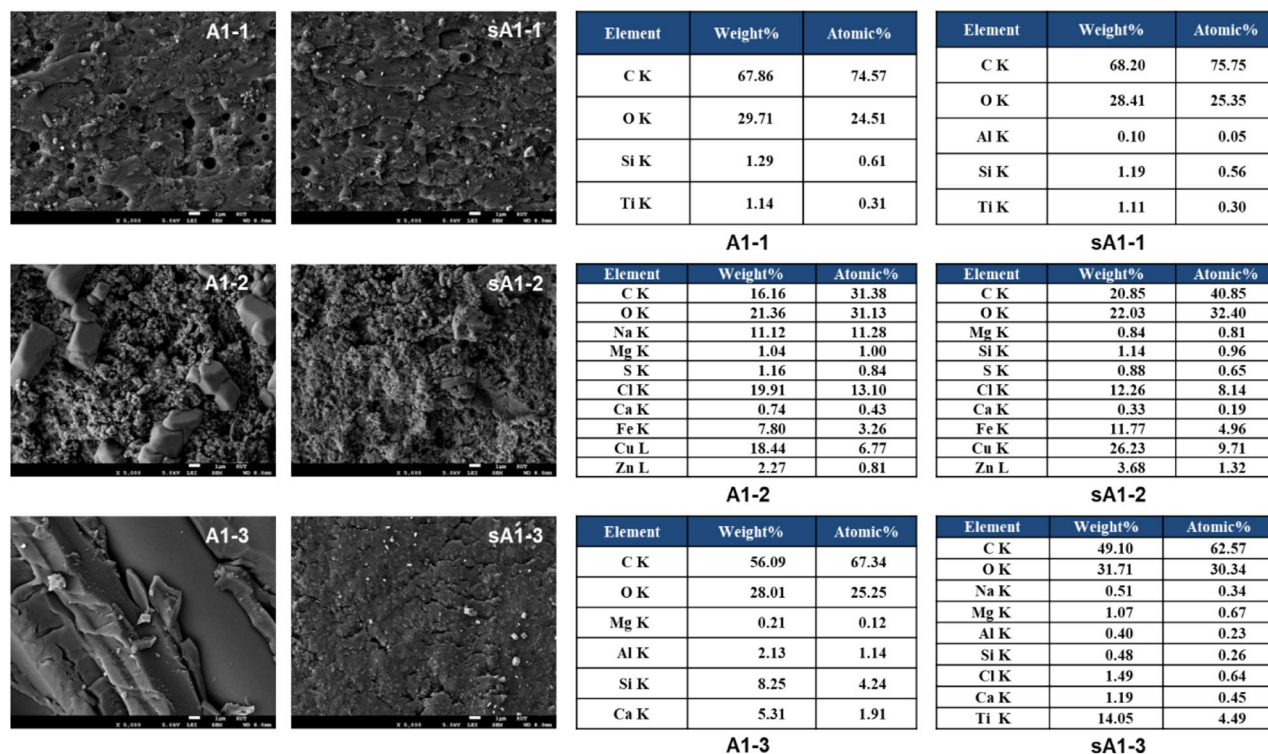
port of the damaged ship (A1-1) and the starboard deck of the suspected ship (sA1-1) are similar to each other (Fig. 2). In addition, the surface images of the brown traces of A1-2 and sA1-2 collected from the backside of the port and the part of the fore deck were similar. However, the surface images of the white paint collected from the port (A1-3) and starboard center (sA1-3) were different. C, O, Si, and Ti were observed in the blue fragments, while C, O, Cl, Fe, and Cu were detected as the main elements in the brown paint samples (EDS images, Fig. 2). However, more atomic elements were distributed in the white paint collected from the suspected ship than that collected from the damaged ship. In the damaged ship sample, C, O, Si, and Ca were detected as the principal elements, while Ti and Cl were also detected in the suspected ship sample. It is not possible to accurately determine why the analysis results of the white paint samples of the damaged ship and the offending ship are different. The analysis results may differ because of the contaminants or other traces. Optical microscopy and SEM analysis results are shown in Figs. 1 and 2, respectively. A fibrous material was observed in the white paint layer and a smooth long shape was observed in the surface morphology, suggesting that the paint may contain the fibrous material. Parks et al. and Soroldoni et al. reported the presence of C, O, Mg, Al, Si, S, K, Ca, Fe, Ti, Ba, and Mn, depending on the paint type<sup>19,20</sup>.

**Figure 2.** SEM-EDS image of Case I evidence.

The SEM-EDS analysis of the white paint traces taken from the damaged and suspected ships did not match. However, the surface elements of the other samples were similar, and the pyrogram patterns and compounds of Py-GC/MS were also consistent. It is not easy to match all the evidence collected from the site of maritime accidents, because the surface of the ship contains various contaminants and sampling is not easy. The surface morphology of the white paint did not match, but the blue and brown paint samples taken together perfectly matched. Therefore, it can be concluded that the suspect ship was the dominant offender.

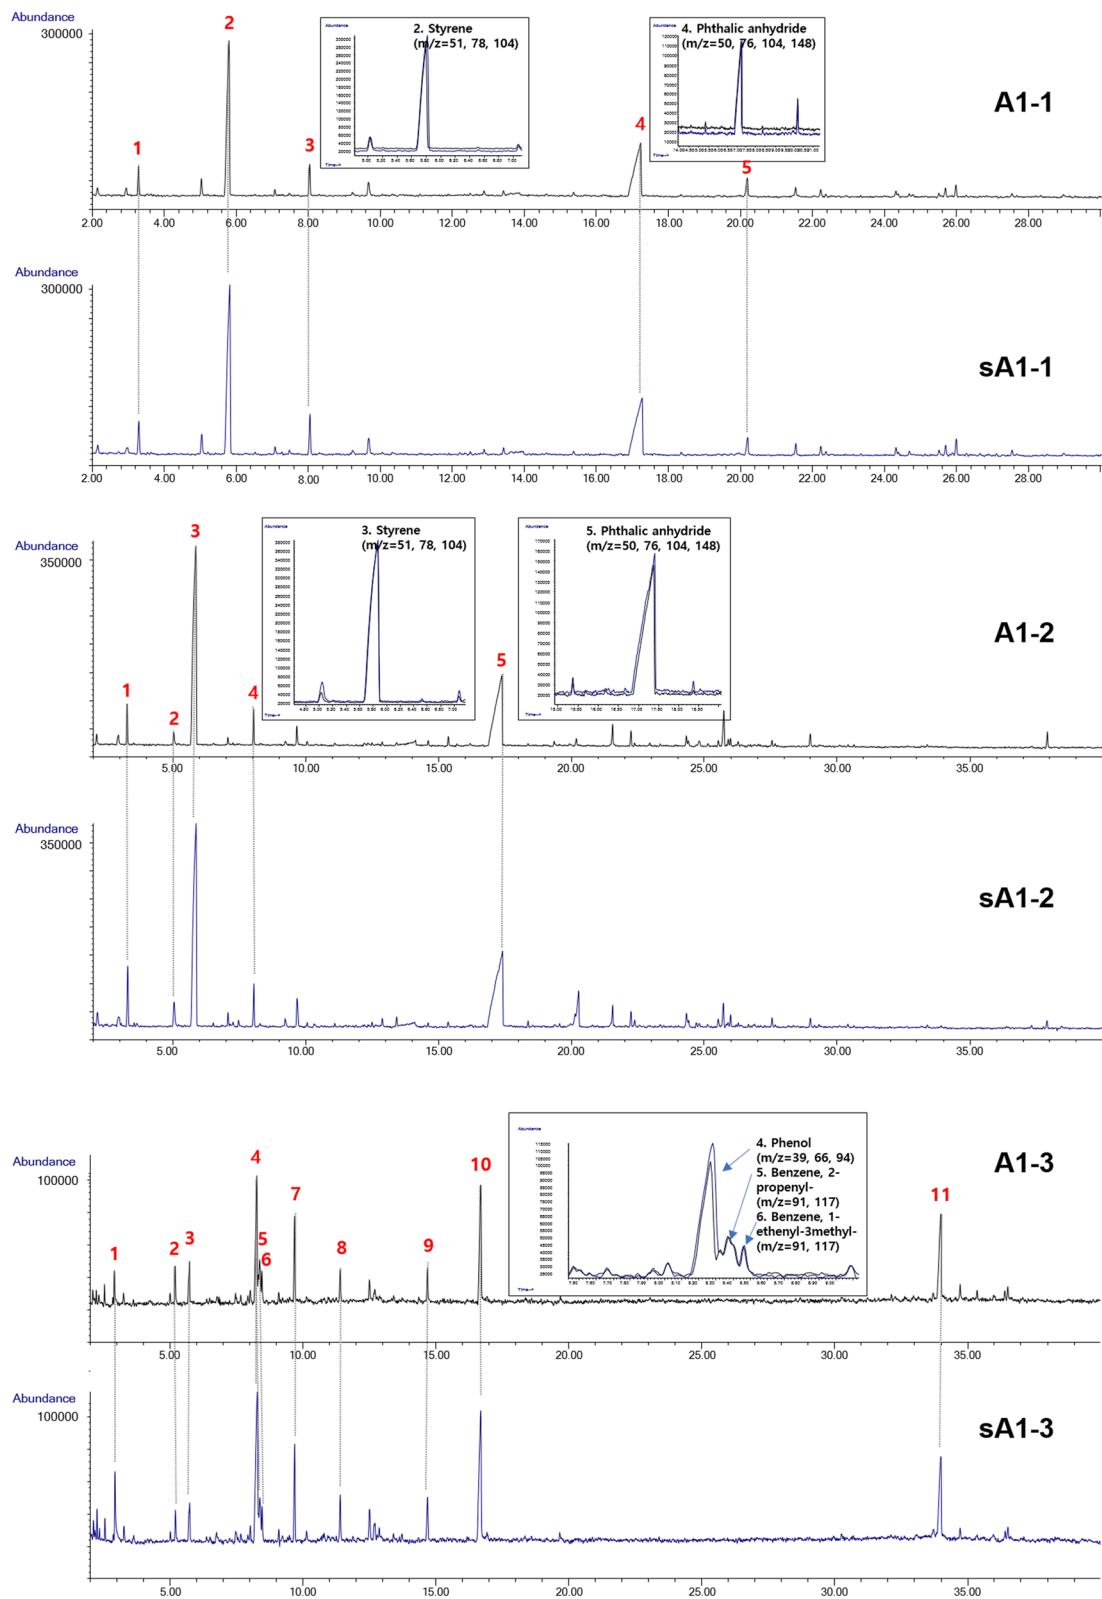
Figure 3 shows the chromatogram obtained from Py-GC/MS. The pyrolysis patterns of the blue, white, and brown samples of the damaged and suspected ships were similar. The major compounds of the blue samples were (1) toluene, (2) styrene, (3)  $\alpha$ -methylstyrene, (4) phthalic anhydride, and (5) dimethyl phthalate. In the white paint sample, (1) toluene, (2) ethylbenzene, (3) styrene, (4)  $\alpha$ -methylstyrene, and (5) phthalic anhydride were detected. In the brown samples, (1) toluene, (2) ethylbenzene, (3) styrene, (4)  $\alpha$ -methylstyrene, (5) phthalic anhydride (1) pyridine, (2) p-xylene, (3) p-xylene, (4) phenol, (5) benzene, 2-propenyl, (6) benzene, 1-ethenyl-3-methyl-, (7) indene, (8) triisopropylsilanol, (9) phenol, 4-(1-methylethyl)-, (10) p-isopropenylphenol, and (11) phenol, 4,4'-(1-methylethylidene)bis- were identified. Styrene and phthalic anhydride were the most prominent components. Phthalic anhydride is known to be dominant in alkyd formulations<sup>21,22</sup>. Poly(acrylate/styrene) is an unsaturated polyester widely used in emulsion-based paints<sup>23–25</sup>. Song et al. indicated that alkyds and poly(acrylate/styrene) derived from marine paint resins in microplastics dominate the sea surrounding Korea<sup>23</sup>. Pyridine and triisopropylsilanol were the characteristic compounds in the brown paint traces. These chemicals are used in antifouling paints for ships because they inhibit the growth of marine bacteria<sup>26</sup>. In addition, common ship surface-coating materials such as toluene, ethylbenzene, and xylene were identified.

**Figure 3.** Py-GC/MS spectra of Case I evidence.

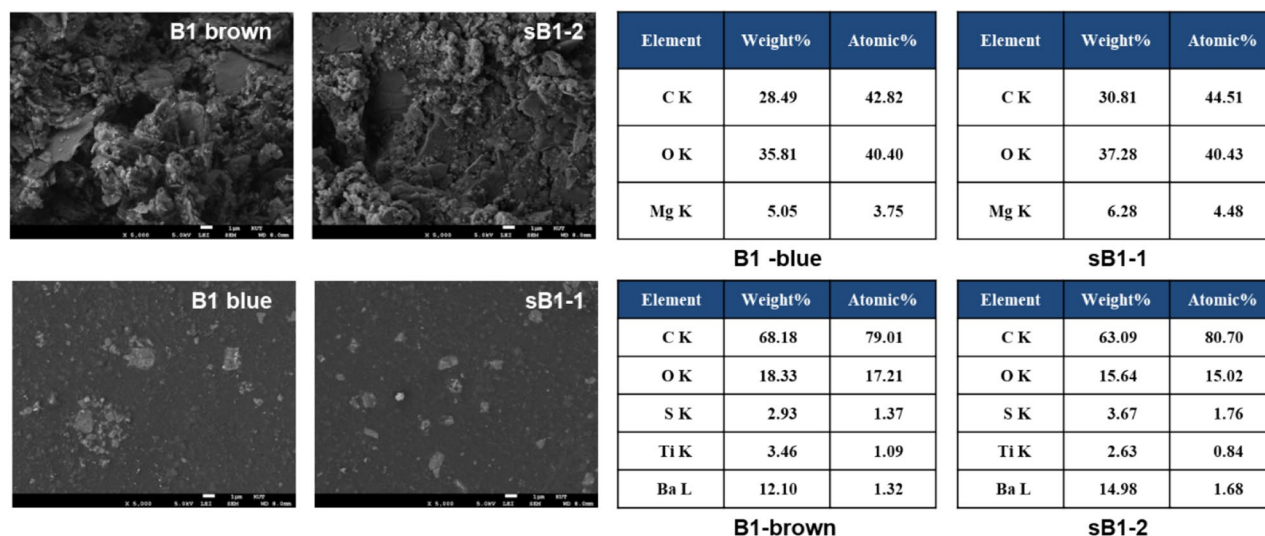
**Case II: Ship collision in March 2020.** Five paint traces were collected from the collision site, the paint color was visually checked, and then three representative samples were selected for this study. The traces were not large, and some samples were collected by scraping the ship guardrail, causing the paint traces to shred like powder. In addition, in some of the samples, the paint traces of both the damaged and suspected ships were mixed; therefore, it is necessary to check the paint colors carefully and separate them using an optical microscope. The brown and blue parts of the B1 sample were compared with the sB1-1 (blue) and sB1-2 (brown) samples, and it was observed that these samples had similar surface morphology (Fig. 4). The blue traces had a relatively smooth surface, while the brown samples had amorphous particles on the surface. C, O, and Mg in the blue samples and C, O, S, Ti, and Ba in the brown samples were detected by EDS analysis (Fig. 4).

**Figure 4.** SEM-EDS image of Case II evidence.

The SEM-EDS analysis results of the damaged and suspected ships were similar, and the peak patterns and composition of Py-GC/MS the brown sample did not match. The suspected ship was determined to be the major offending ship based on the analysis of the blue samples collected from the same ship.

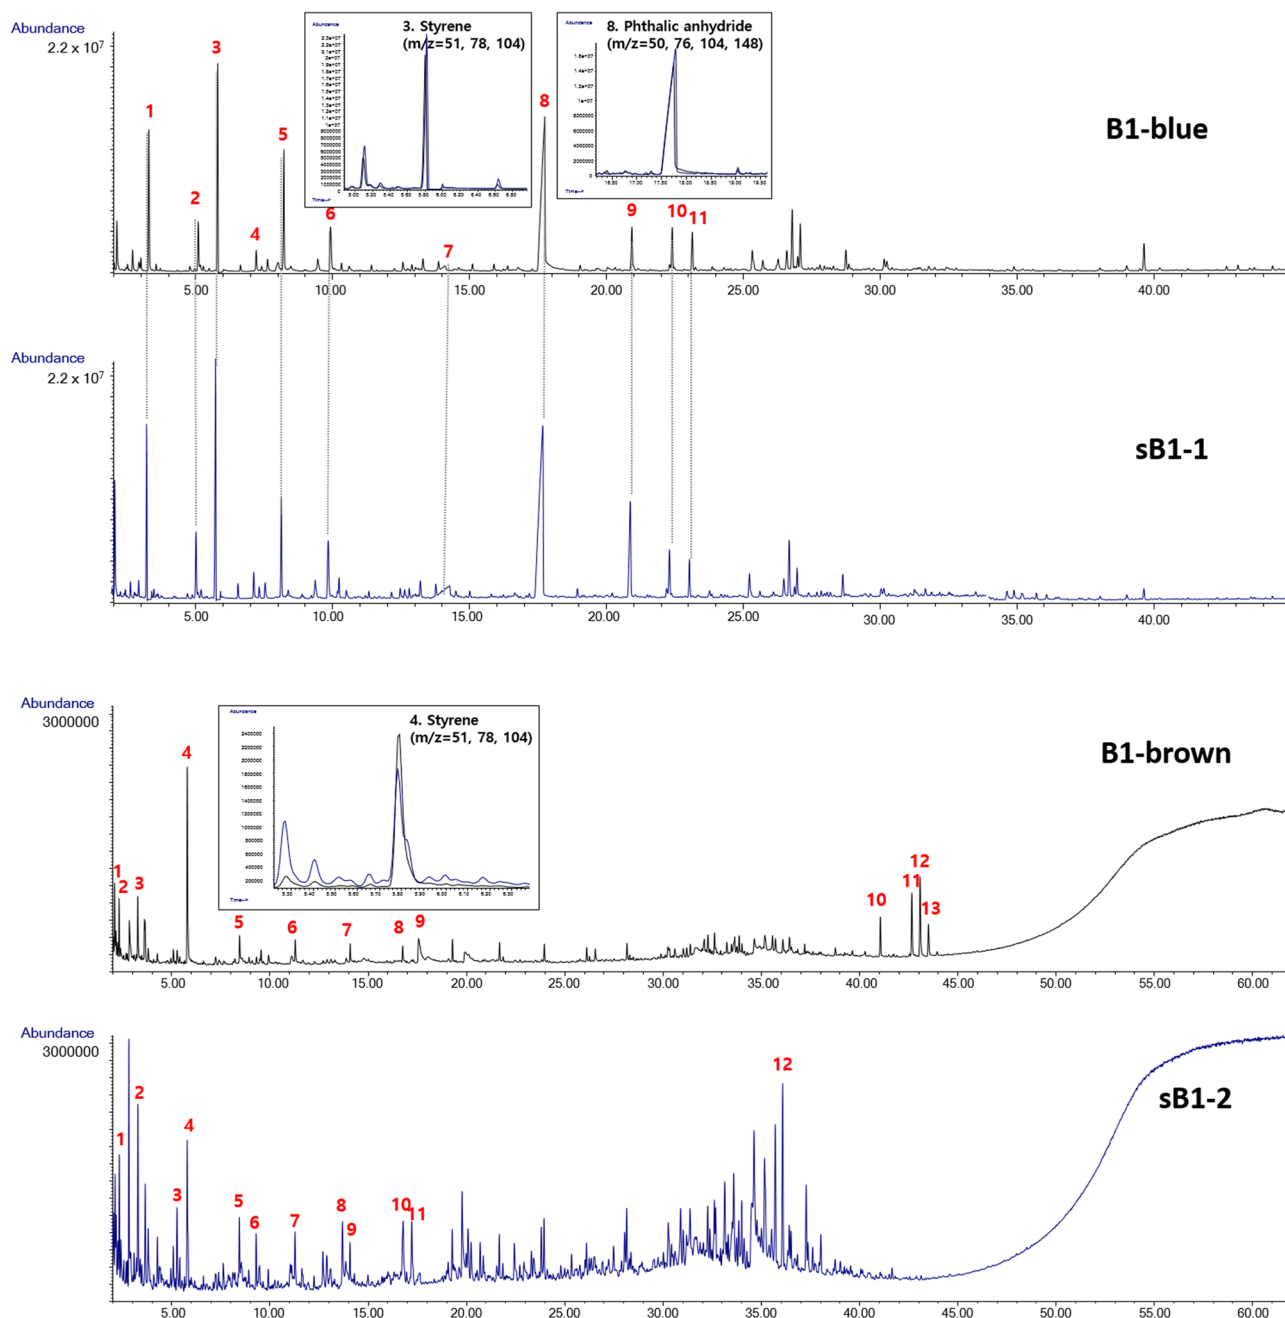
Figure 5 presents the Py-GC/MS results. The chromatograms of the blue samples, B1 and sB1-1, were similar. However, the brown samples of the damaged and suspected ships showed different patterns. The main components of the blue sample were (1) toluene, (2) ethylbenzene, (3) styrene, (4) 2-propenoic acid, 2-methyl-, 2-methylpropyl ester, (5)  $\alpha$ -methylstyrene, (6) benzene, (1-methylenepropyl)-, (7) benzenecarboxylic acid, (8) phthalic anhydride, (9) dimethyl phthalate, (10) benzene, 1,1'-(1,2-ethanediyl)bis-, and (11) benzene, 1,1'-(1,2-ethanediyl) bis-. (1) benzene, (2) 1-heptene, (3) toluene, (4) styrene, (5) 1-decene, (6) 1-dodecene, (7) 1-dodecene, (8) 1-tridecene, (9) phthalic anhydride, (10) bis(2-ethylhexyl) phthalate, (11) phosphoric acid, tris(3-methylphenyl) ester, (12) phosphoric acid, tris(3-methylphenyl) ester, and (13) phosphoric acid, tris(3-methylphenyl) ester were identified in the B1 sample, and (1) benzene, (2) toluene, (3) o-xylene, (4) styrene (5) 1-decene, (6) benzene, 1-methyl-3-(1-methylethyl)-, (7) 1-dodecene, (8) naphthalene, (9) 1-dodecene, (10) naphthalene, 1-methyl-, (11) naphthalene, 1-methyl-, and (12) phenanthrene, 1-methyl-7-(1-methylethyl)- were detected in the sB1-2 sample. In the blue sample (B1 and sB1-1) as in Case I, phthalic anhydride, the main component of the alkyd paint, and styrene were observed. As shown in Fig. 5, the two samples showed similar peaks. Phosphoric acid, tris(3-methylphenyl) ester—a characteristic component of brown paint—was detected in B1, while naphthalene compounds such as (1) naphthalene, (2) naphthalene, 1-methyl-, and (3) phenanthrene, 1-methyl-7-(1-methylethyl)- were identified in sB1-2. The brown part was collected in a powder form from the ship guardrail, making it difficult to distinguish between the paint and the contaminants. In fact, it was difficult to identify the composition of a part of the sample because of the overall low intensity of the chromatogram.

**Figure 5.** Py-GC/MS spectra of Case II evidence.

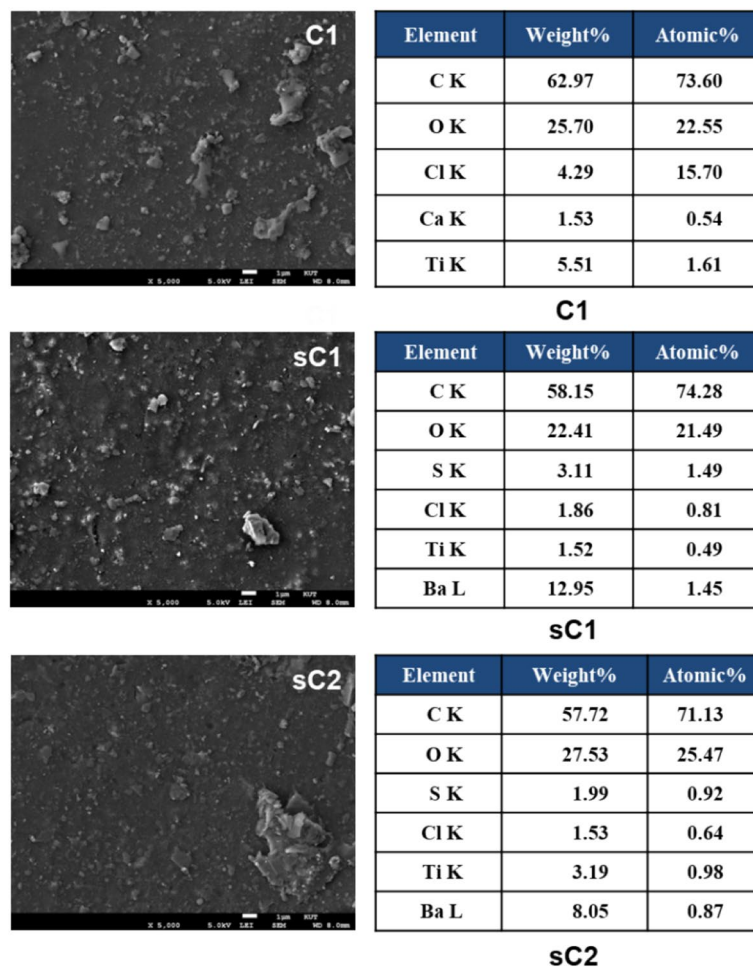
**Case III: Ship collision in March 2020.** Three samples were collected from the collision site. Two suspected ships were identified after investigating the damage. The damaged ship sample C1 and the suspected ship samples sC1 and sC2 had similar surface textures. However, the elemental analysis of the suspected ship samples conducted using EDS was not consistent with that of the damaged ship (Fig. 6). C, O, Ti, Cl, and Ca elements were detected in the damaged ship sample; S and Ba were also identified in the paint traces obtained from the two suspected ships.

**Figure 6.** SEM-EDS image of Case III evidence.

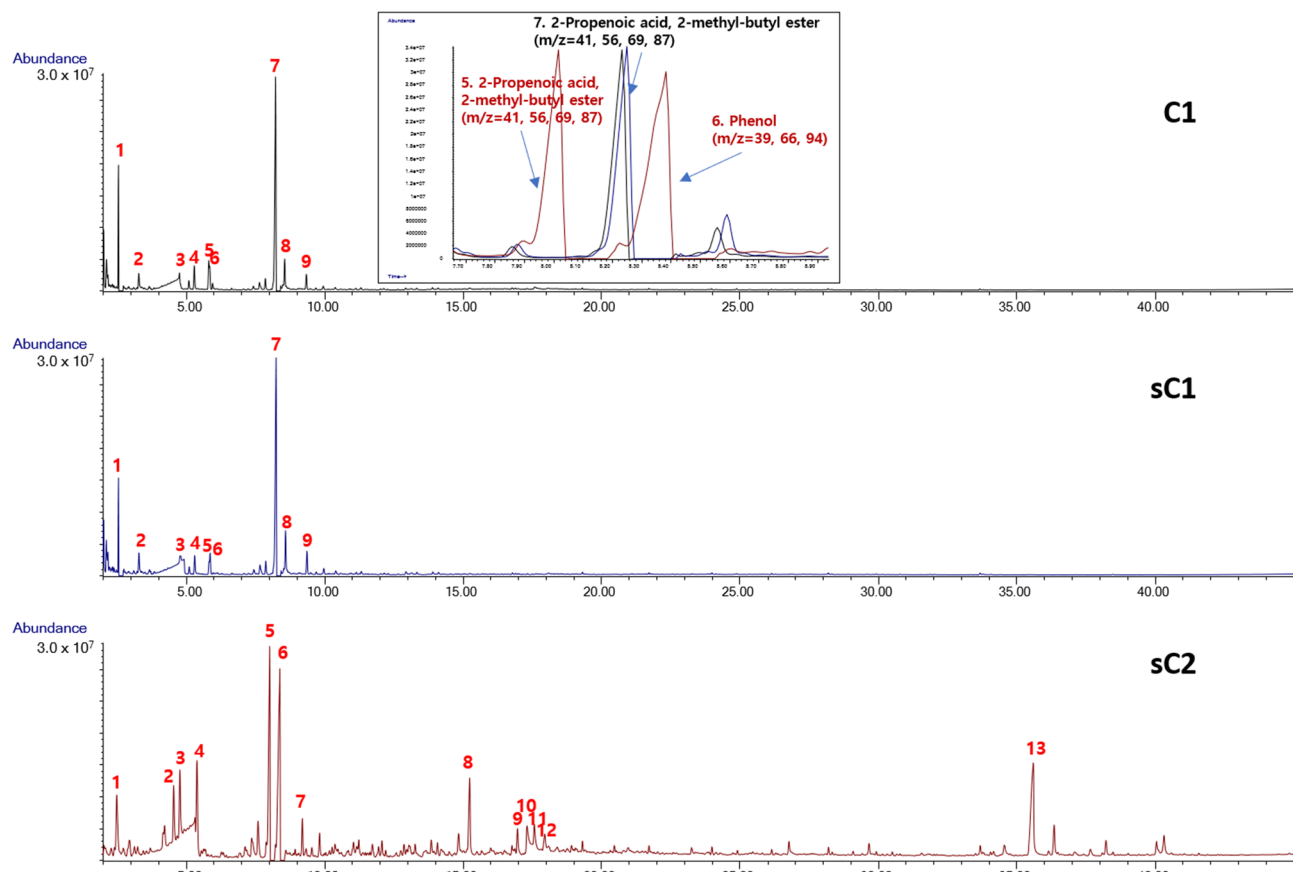
The chromatogram results of C1, sC1, and sC2 samples are shown in Fig. 7. C1 and sC1 showed similar chromatogram patterns, while sC2 showed a different profile. The following were the major compounds of C1 and sC1 samples: (1) 2-propenoic acid, 2-methyl-, methyl ester, (2) toluene, (3) 2-propenoic acid, 2-methyl-, (4) p-xylene, (5) styrene, (6) o-xylene, (7) 2-propenoic acid, 2-methyl-, butyl ester, (8) benzene, 1,2,3-trimethyl-, and (9) benzene, 1,2,3-trimethyl-. For the sC2 fragments, the major elements were (1) toluene, (2) ethylbenzene, (3) p-xylene, (4) p-xylene, (5) 2-propenoic acid, 2-methyl-, butyl ester, (6) phenol, (7) benzene, 1,2,3-trimethyl-, (8) phenol, 4-(1-methylethyl)-, (9) phenol, p-tert-butyl-, (10) p-isopropenylphenol, (11) phthalic anhydride, (12) 1,3-benzenedicarbonitrile, and (13) phenol, 4,4'-(1-methylethylidene)bis-. Hydrocarbons such as toluene and xylene were mainly detected in the C1 and sC1 samples. In the sC2 sample, in addition to hydrocarbons, O-compounds such as 2-propenoic acid, 2-methyl-, butyl ester, phenol, 4-(1-methylethyl)-, benzaldehyde, 3-methyl-, and N-compounds of 1,3-benzenedicarbonitrile were detected.

**Figure 7.** Py-GC/MS spectra of Case III evidence.

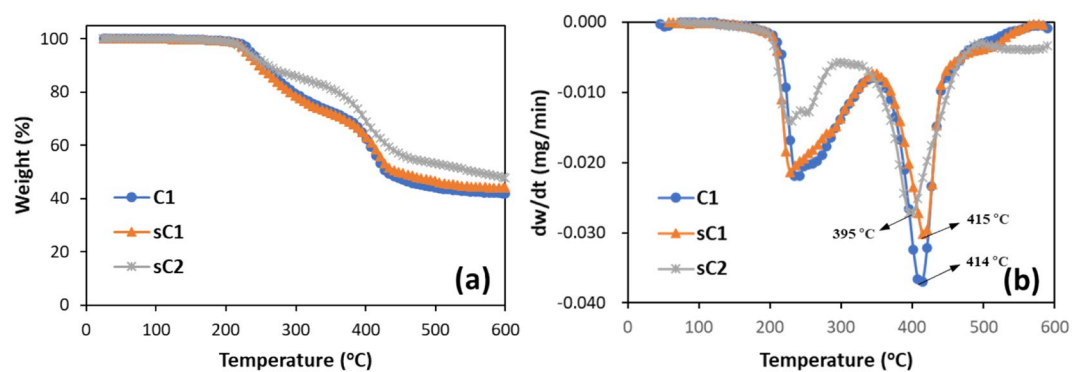
Figure 8 shows the TG and DTG curves of the Case III evidence. All three samples present two decomposition stages in the TG and DTG curves. The first stage was from 200 to 350 °C, and the second stage was from 350 to 500 °C. The C1 and sC1 samples presented similar behavior; in contrast, sC2 showed less weight loss compared to the other samples. The weight losses of C1, sC1, and sC2 were 27%, 28%, and 19% at 350 °C, respectively, and 56%, 53%, and 47% at 500 °C, respectively. Because of the presence of phenolic compounds such as phenol, 4-(1-methylethyl)-, phenol, p-tert-butyl-, p-isopropenylphenol, phenol, 4,4'-(1-methylethylidene)bis in the sC2 sample, the weight loss was estimated to be less in the TG-DTG curve measured from room temperature to 600 °C. Zhou et al. and Souza et al. reported the thermal decomposition of a phenolic resin converted to an amorphous carbon at 700 °C, and showed that the thermogravimetric loss rate of pure phenolic resin reached a maximum at 550 °C<sup>27,28</sup>.

**Figure 8.** TG-DTG curves of Case III evidence.

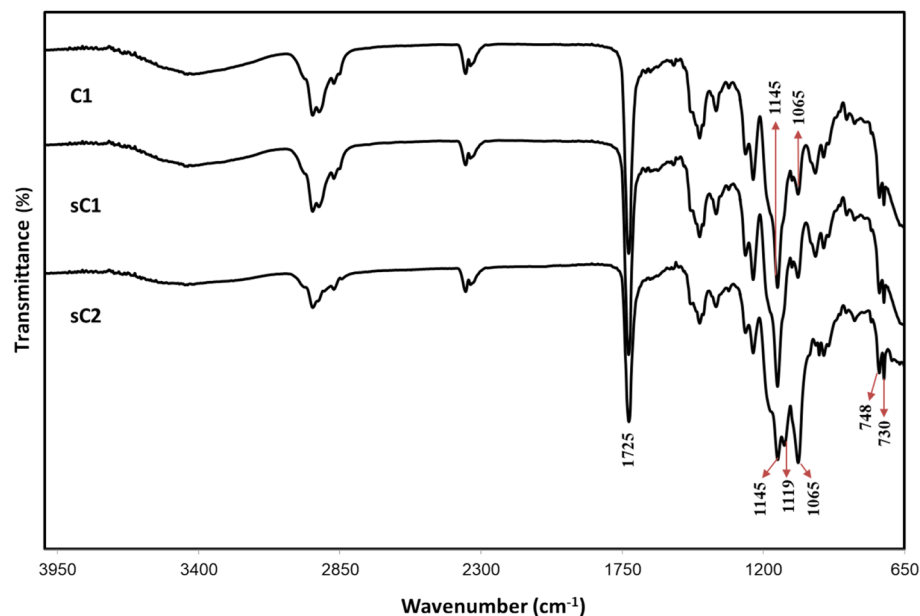
The infrared spectra of the Case III evidence are shown in Fig. 9. The ATR-FTIR spectra of C1, sC1, and sC2 showed similar absorption bands. In particular, the peak position and intensity of C1 were similar to those of sC1. An investigation of the paint evidence based on the spectra obtained from the FTIR polymer library at OMNIC (Thermo Nicolet Corporation, Sprouse Polymer by ATR Library) showed that the spectra matched well with that of poly(butyl methacrylate). A comparison of the paint evidence spectra with the Py-GC/MS results showed the presence of 2-propenoic acid, 2-methyl-, butyl ester (=butyl methacrylate), which showed the highest intensity in the chromatogram. These spectra are similar to those obtained for the alkyd resin, as reported by Hayes et al. and Burns et al. using ATR-FTIR. The spectral regions of the alkyd resin were identified as 1680–1770, 1000–1360,

and  $630\text{--}800\text{ cm}^{-1}$  for ester  $\text{C}=\text{O}$ , ester  $\text{C}-\text{O}-\text{C}$ , aromatic  $\text{C}-\text{H}$  and aromatic ring bending, respectively<sup>21,22</sup>. Although the spectra of the sC2 sample were similar to those of the damaged ship sample, different peaks were observed in the  $1119$  and  $1065\text{ cm}^{-1}$  regions. He et al. analyzed the ship deck paint and reported peaks at  $1120$ ,  $1070$ ,  $830$ , and  $740\text{ cm}^{-1}$ , indicating the presence of nitrocellulose and alkyd resins<sup>5</sup>.

**Figure 9.** ATR-FTIR spectra of Case III evidence.
