The Var River in Southern France

The 1994 flood & inundation

The collapse of sills 2 & 3

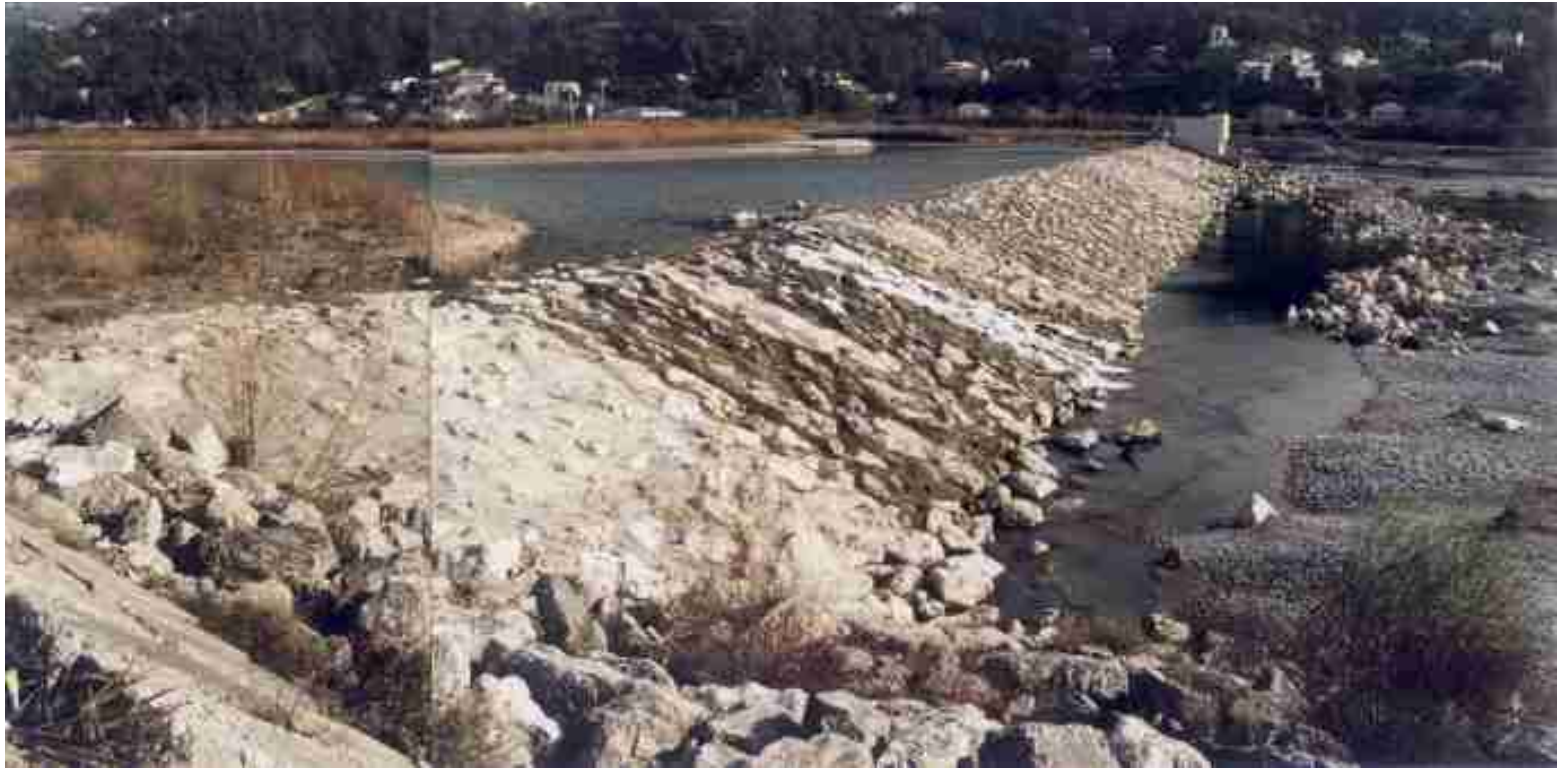
- First sill halted the transit of coarse sediment, so that fine-grained silt deposited in between the next sills (process similar as for land reclamation)

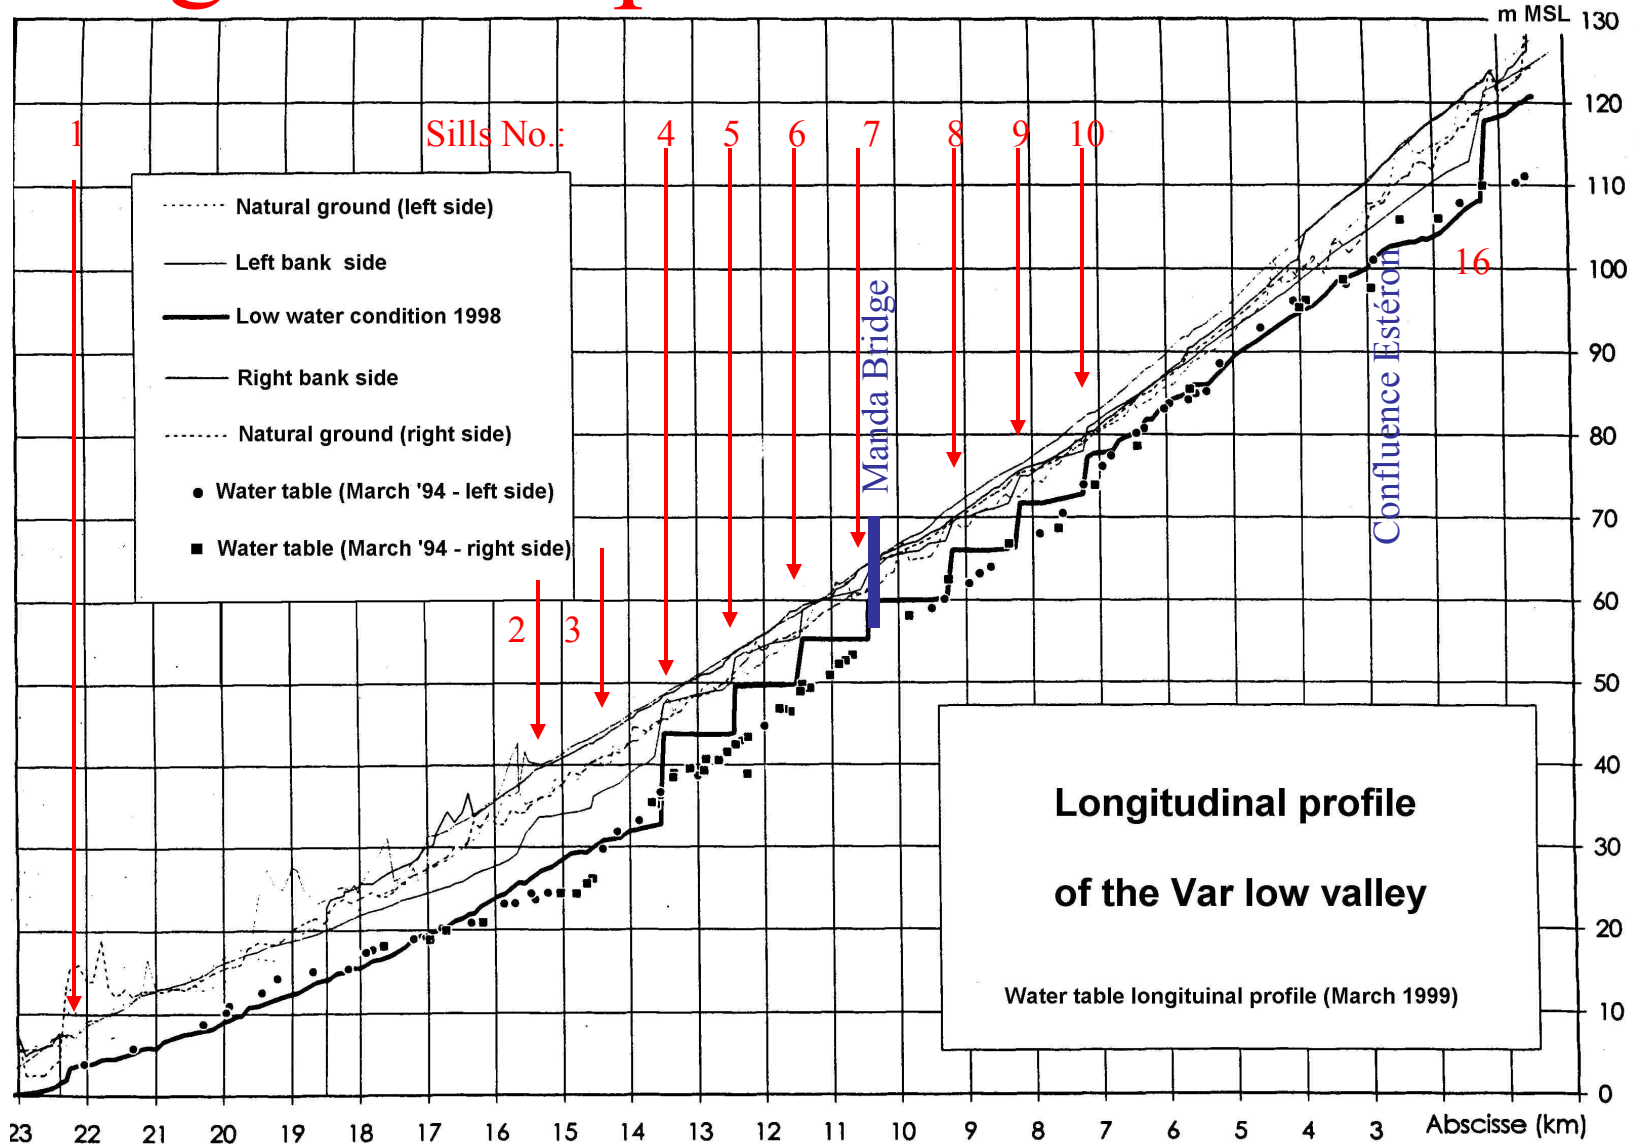
Longitudinal profile 1998

- The storage of coarse river sediment upstream the dams made the riverbed drop at the foot of last dam, the head passing from 6 to 12 m in 12 years
- On 5 November 1994, an extreme flood event produced the collapsing of the lowest and the second-lowest dam, the flood wave inundating Nice's international airport.

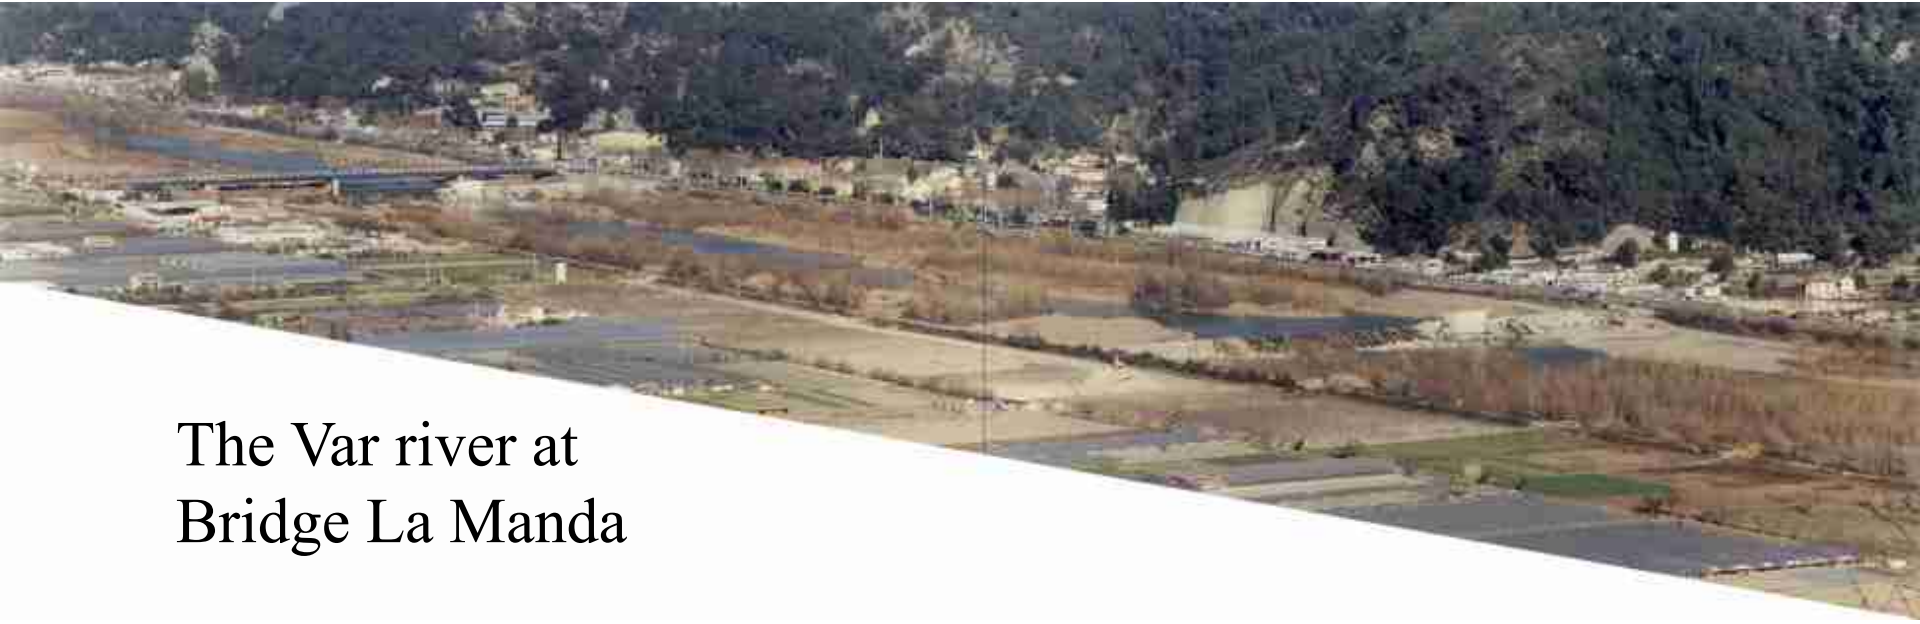
The Var river at
Bridge La Manda

Impact on transit of sediment

- Only fine material passed the sills after these were constructed.
- Deficit in sediment created scouring downstream of lowest sill (Nr. 2), which head passed from 6 to 12 m.

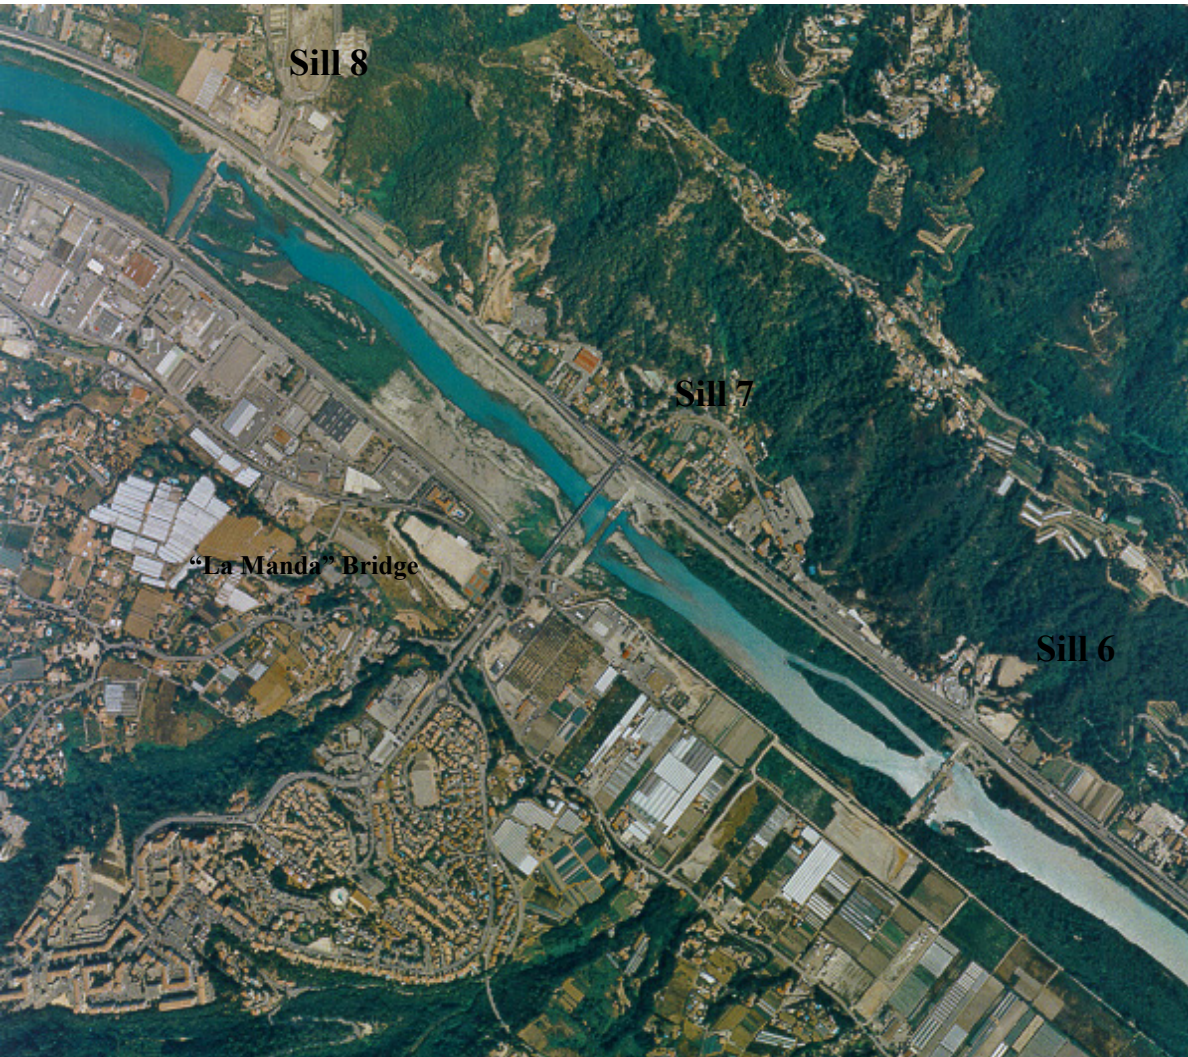
Morphological impact of the sills

- Fine silt deposits changed the river environment: narrow channels bordered with lateral terraces.
- Dense vegetation grew on terraces in between sills, changing the flow resistance.

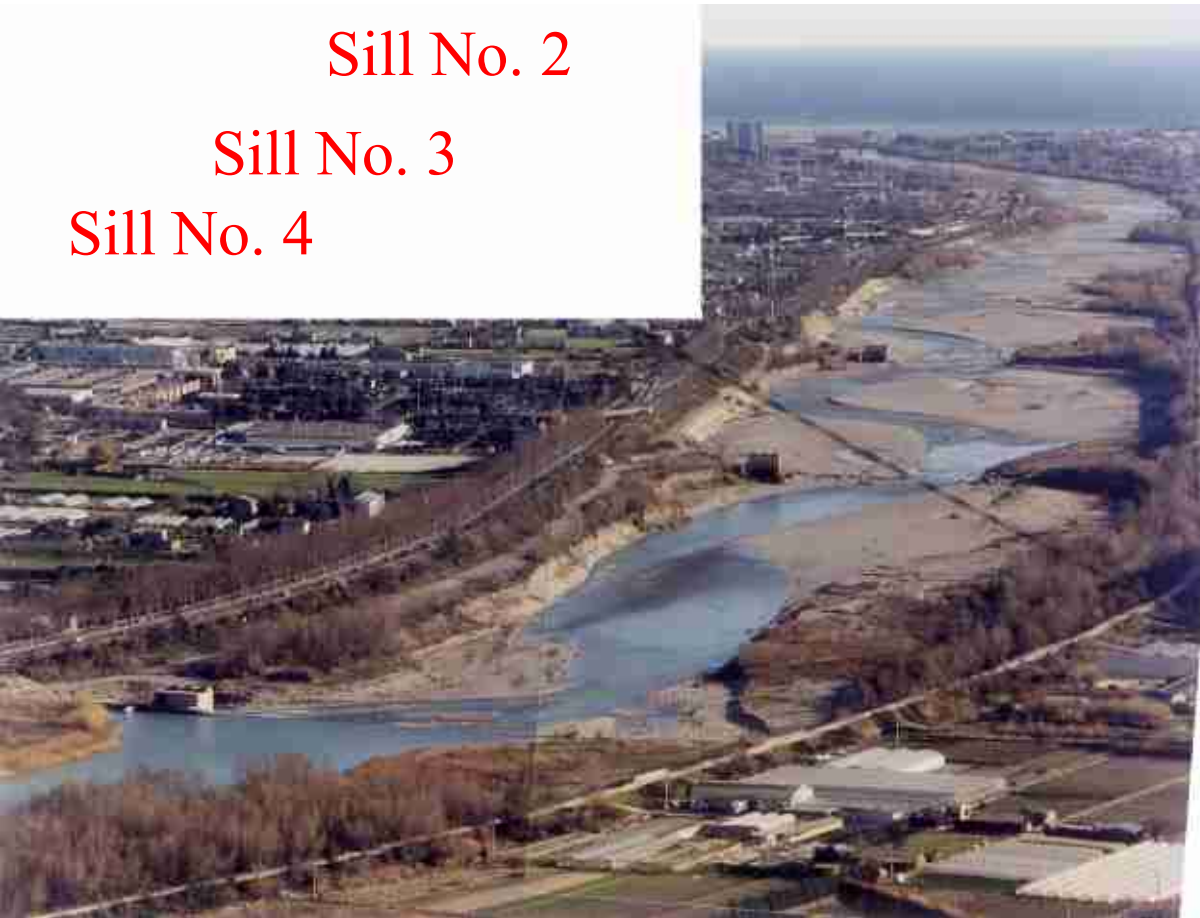
Sill No. 2

Sill No. 3

Sill No. 4

- During the flood event of 5/11/94, sills 2 & 3 collapsed and the flood wave inundated part of the city and airport.
- Sill 4 is in danger of collapsing because of high head.

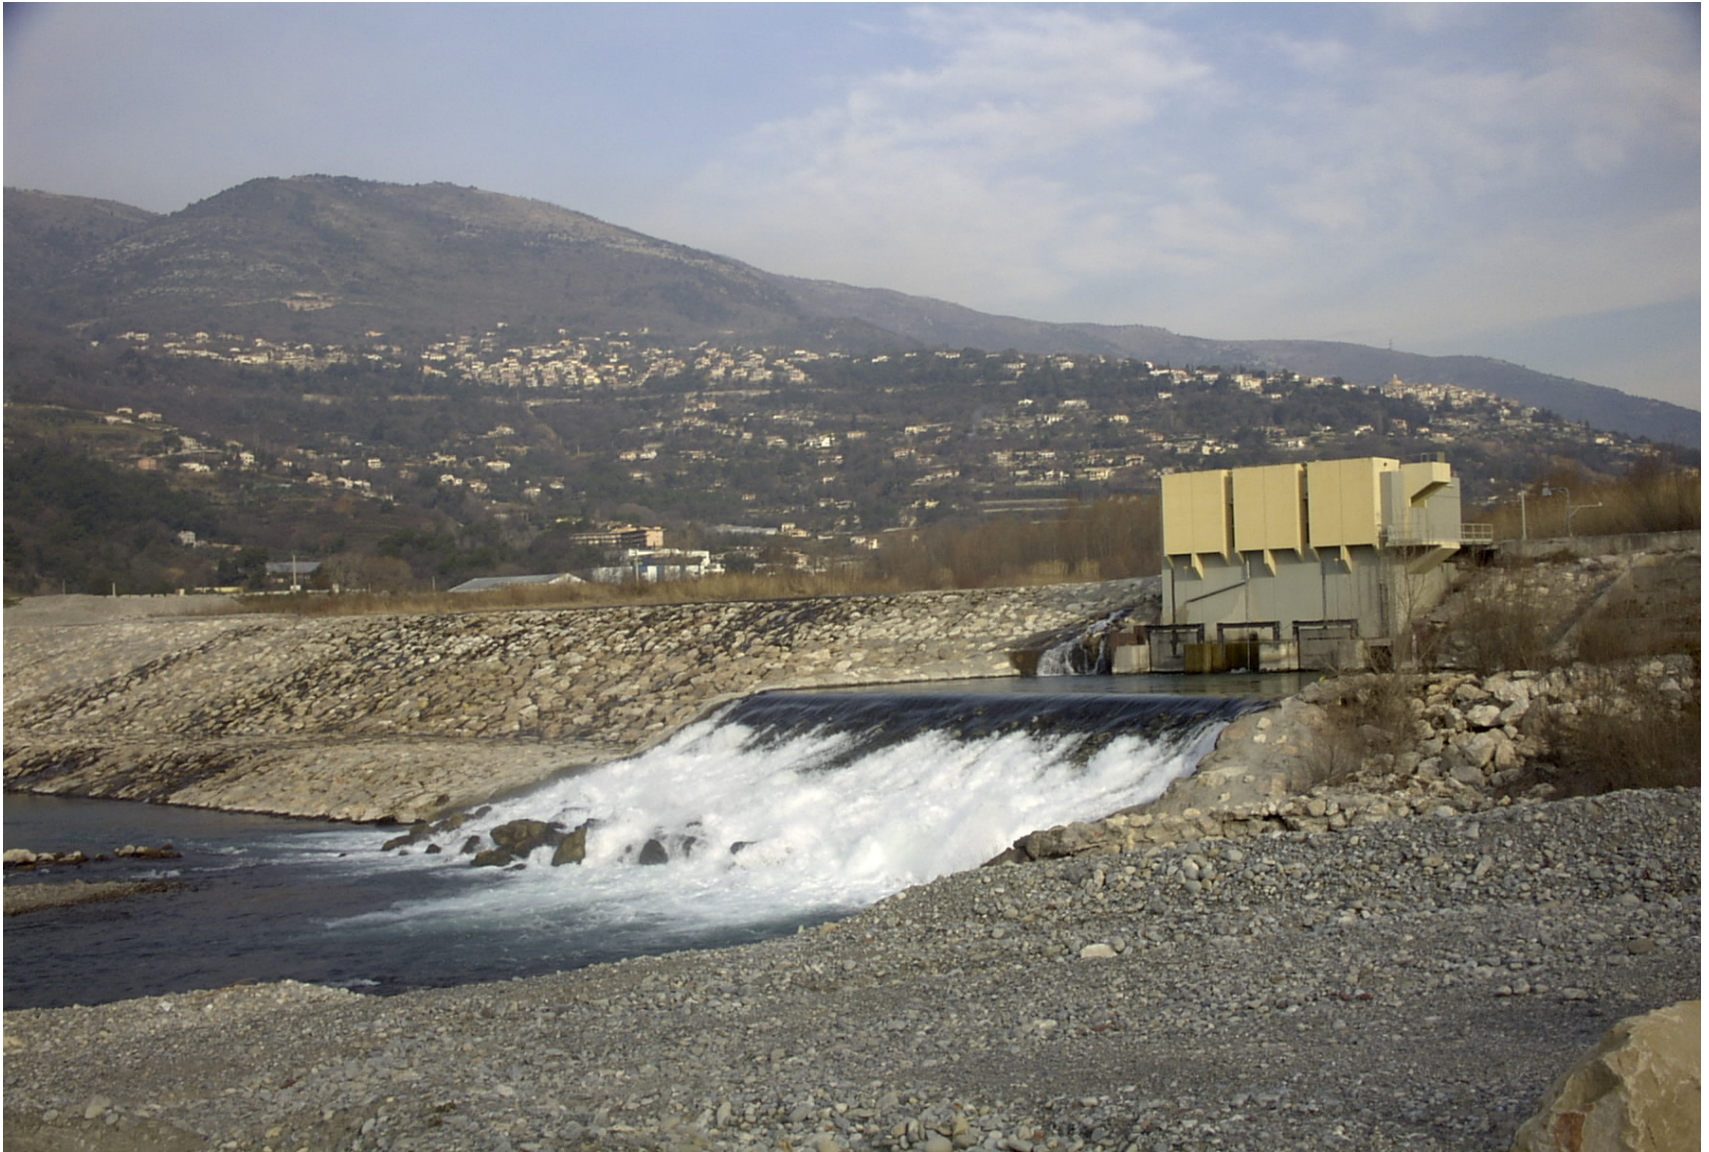
Downstream: Sill 4 in great danger

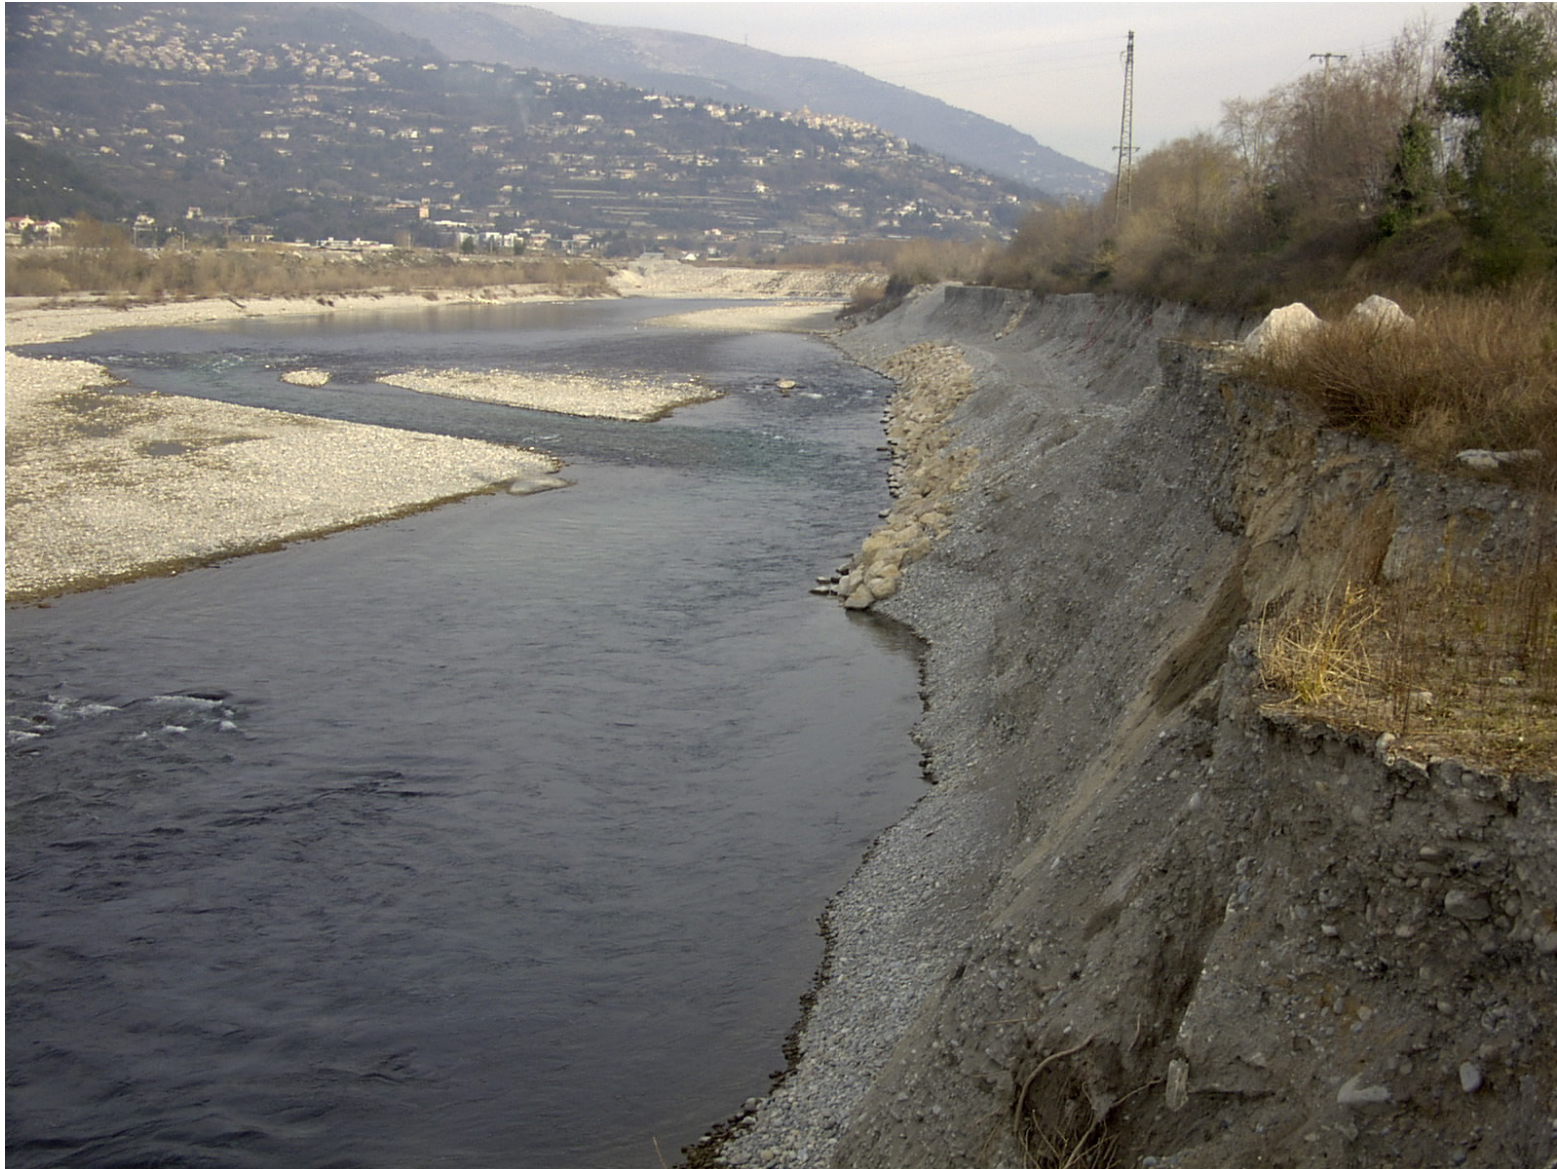
Still sediment deficit below sill 4

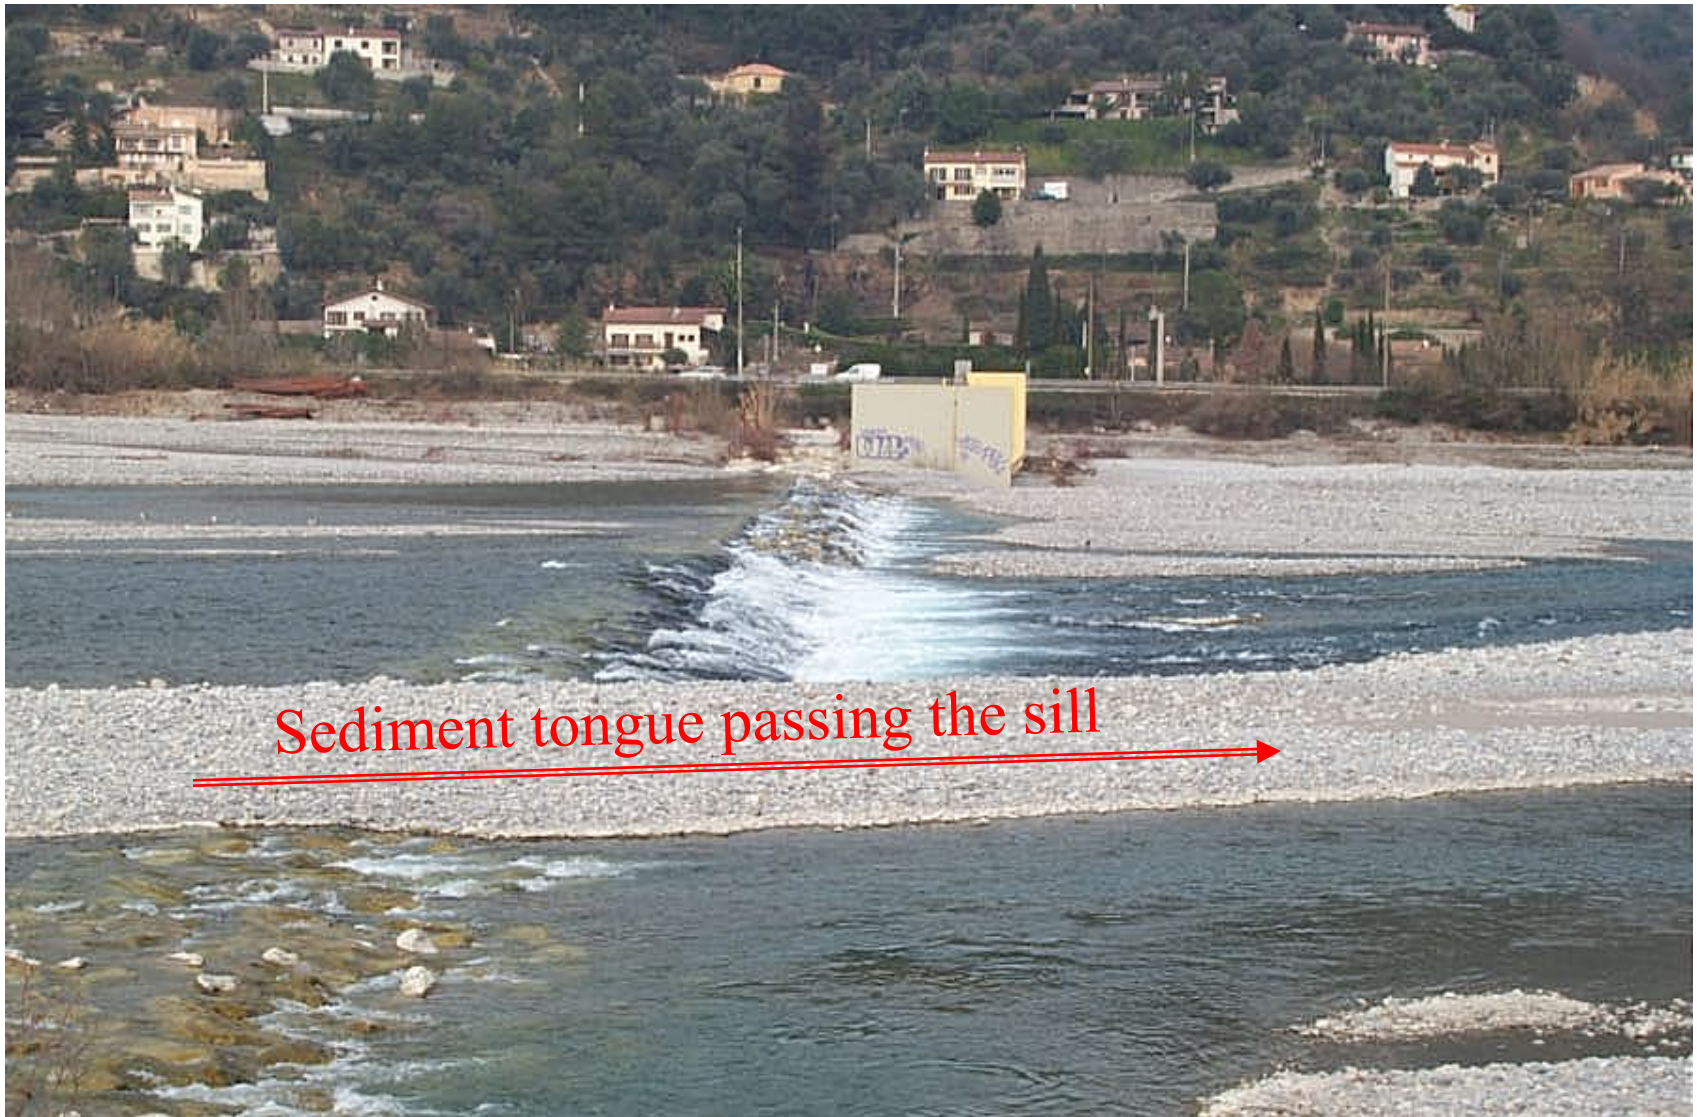
Upstream: Sill No 10 in 2002

Sediment tongue passing the sill
