Overflow Tests on Grass-Covered Embankments at the Living Lab Hedwige-Prosperpolder: An Overview

Citation: Koelewijn, A.R.; Rikkert, S.J.H.; Peeters, P.; Depreiter, D.; van Damme, M.; Zomer, W. Overflow Tests on Grass-Covered Embankments at the Living Lab Hedwige-Prosperpolder: An Overview. *Water* **2022**, *14*, 2859. <https://doi.org/10.3390/w14182859>

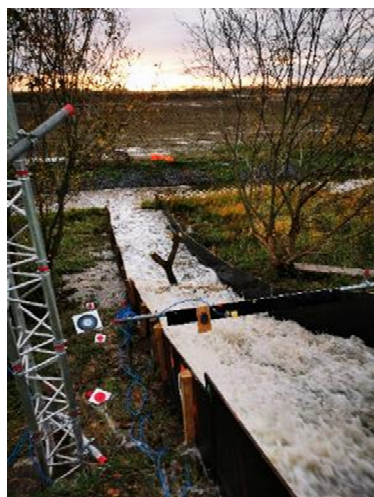
Figure 4. Anomaly test section with a tree trunk at the toe of the dike.

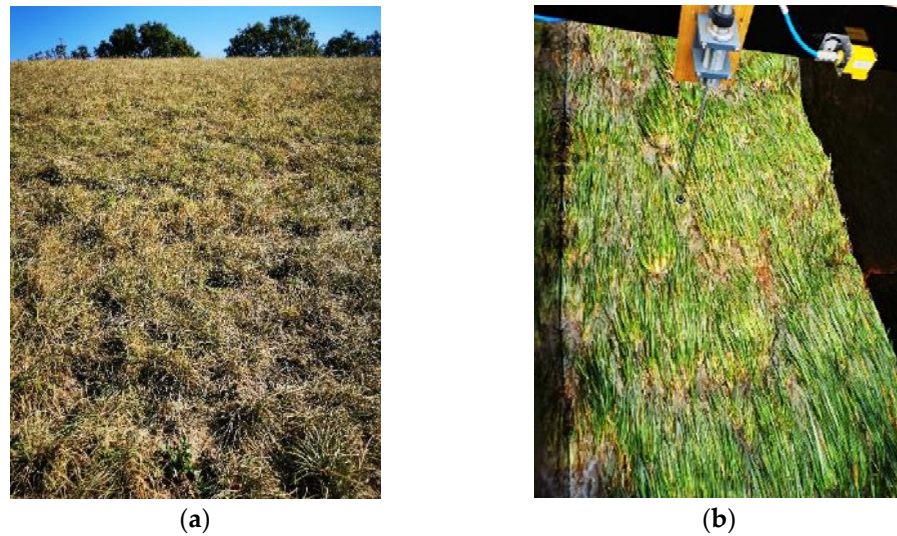
The reference tests carried out on a Belgian dike (see for an impression Figure 7a) showed a similar development. The clay cover of a Belgian dike is typically thinner (~40 cm) compared to a Dutch dike (~80 cm), but this did not affect the result of these reference tests. Figure 7b shows a typical view of the exposed grass roots after multiple hours of overflow. Only in test B-10, erosion of the high-quality grass sod and the underlying clay layer occurred, leading to failure. Note that on the Dutch side, under similar conditions this did not occur (test N-02).

Figure 7. (a) Belgian reference test section (September 2020); (b) Typical view of exposed grass roots after multiple hours of overflow.

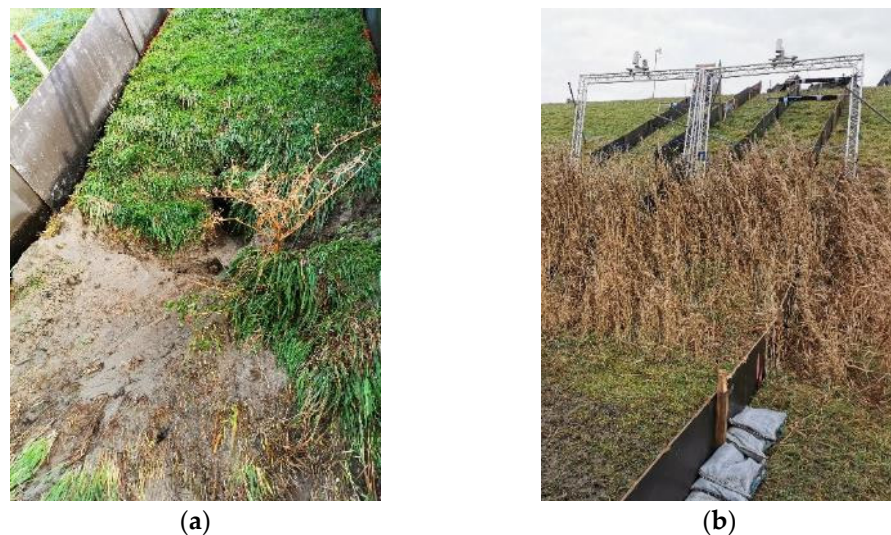
Figure 8. (a) Burrow entrance halfway the landside slope on a Dutch dike; (b) Sections with softened, saturated soil and reed overgrowth on a Dutch dike.

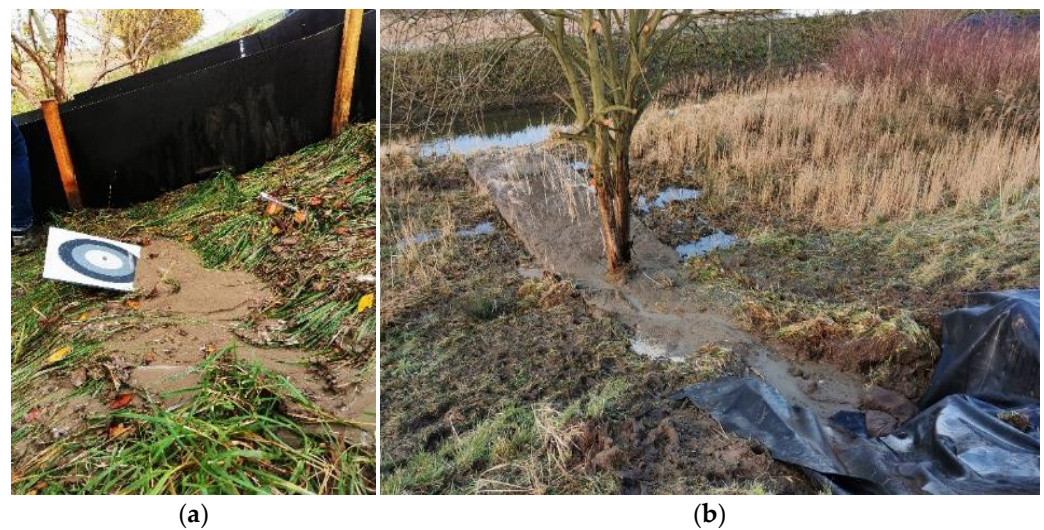
It was observed in several cases that burrows at or near the dike toe expelled sediment coming from the dike core. This transport of sand undermined the dike clay cover up to the point that it caused the cover layer to collapse. From that point onwards, the outflow of water saturated sands from the dike core, and the overflowing water would quickly transport the exposed sands and further support fast backward headcut erosion, in the order of several meters within minutes. Figure 9a shows outflow of sand next to the test section and the failure induced by animal burrow in a test section that was initially focusing on the effect of the presence of vegetation during overflow (Figure 9b). These observations instigated additional research [16,17].

Figure 9. The role of burrows and the outcome of dike cover collapse at the second test with a tree: (a) puddle of sand flowing out at burrows near the dike toe; (b) the aftermath of a collapsed dike slope after sand outflow at the toe. Note that the tree itself is in place and did not appear to influence the process.

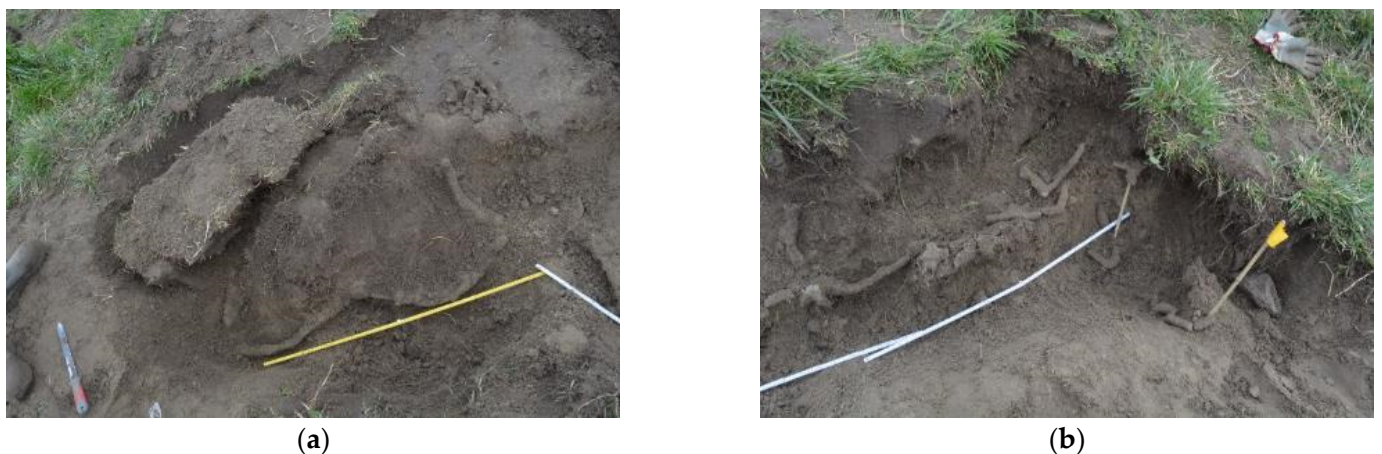
To learn more about the structure, dimensions and depth of animal burrows, some burrow systems were filled with grout and exposed (Figure 10). These activities led to an increased understanding of the processes at hand [16,18]. The critical factor in the damage to develop appears to be whether the burrows are in contact with the sand core and whether sand can be mobilized from within the core and exported to the outside of the dike. The requirements for this seems to be (1) a burrow system that is connected over meters to decameters distances; (2) a burrow system that reaches deep enough so that the dike clay cover is pierced and contact with the sand is made; (3) a flow of water through the burrow system is generated by the overflow process so that core sands are mobilized. Surprisingly, the artificially made holes, supposed to resemble animal burrows, were generally better resistant to flow, even if they were clearly connected to the sand core, with both an entry pipe and an exit pipe. In test B-11 for instance, the artificial hole was the very last part to collapse.

Figure 10. (a,b) Examples of excavated grouted animal burrows.

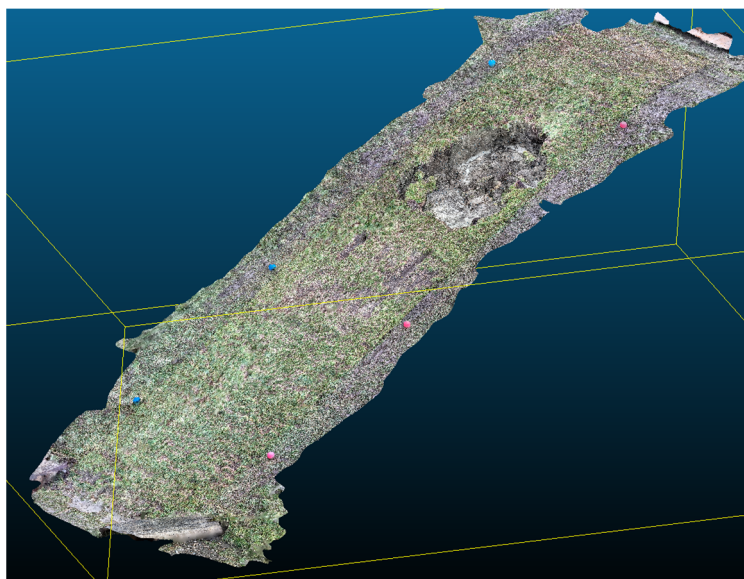
Figure 11. Example of a 3D view of the Handheld Lidar point cloud data of a damaged section.
