Integrated assessment of the buried wreck site of the Dutch East Indiaman 't Vliegende Hart

Tine Missiaen¹, Ine Demerre² & Valentine Verrijken³

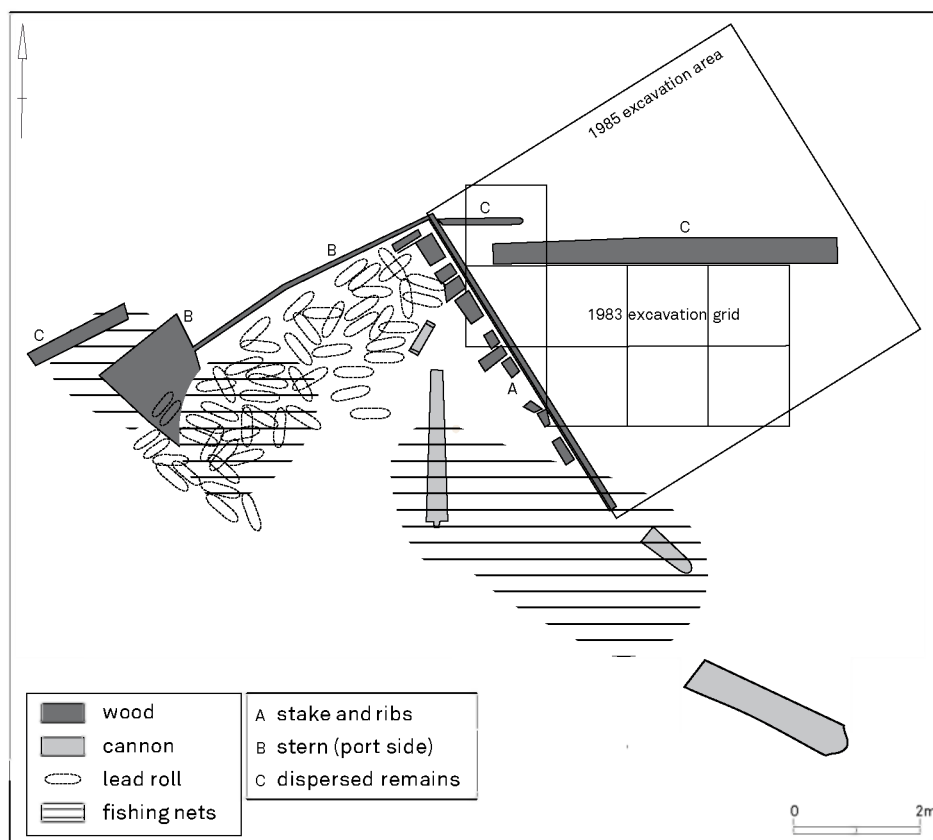
Structural fragments found in 1983 included remains of the stern and hull on the port side (fig. 5). They can most likely be linked to the lower hold of the ship. The fragments indicate that the stern lays inclined to the port side at an angle of 55 degrees⁴⁰. Further to the southeast three cannons, various lead rolls and fishing nets were found (fig. 5). The western side of the wreck site showed an abrupt slope, while towards the east the slope was more gentle⁴¹.

FIG. 5 Remains of *t Vliegende Hart* wreck site observed during diving investigations in 1983 (after Gawronski & Kist 1984). Structural fragments include a.o. wooden fragments of the stern (B) and hull (A). Nearby also several cannons and a large number of lead rolls were found, partly covered by fishing nets. The 1985 excavation area is also shown on the right (after Sills Consortium Recoveries Ltd 1985). *Overblijfselen van het wrak van 't Vliegende Hart zoals blootgelegd tijdens het duikonderzoek in 1983 (naar Gawronski & Kist 1984). Houten fragmenten van de opbouw zijn o.a. afkomstig van de achtersteven (B) en de scheepsrump (A). Vlakbij werden ook een paar kanonnen en een groot aantal loden ballastrollen gevonden, gedeeltelijk bedekt door vissersnetten. Het opgravingsgebied uit 1985 is ook aangeduid rechts (naar Sills Consortium Recoveries Ltd 1985).*

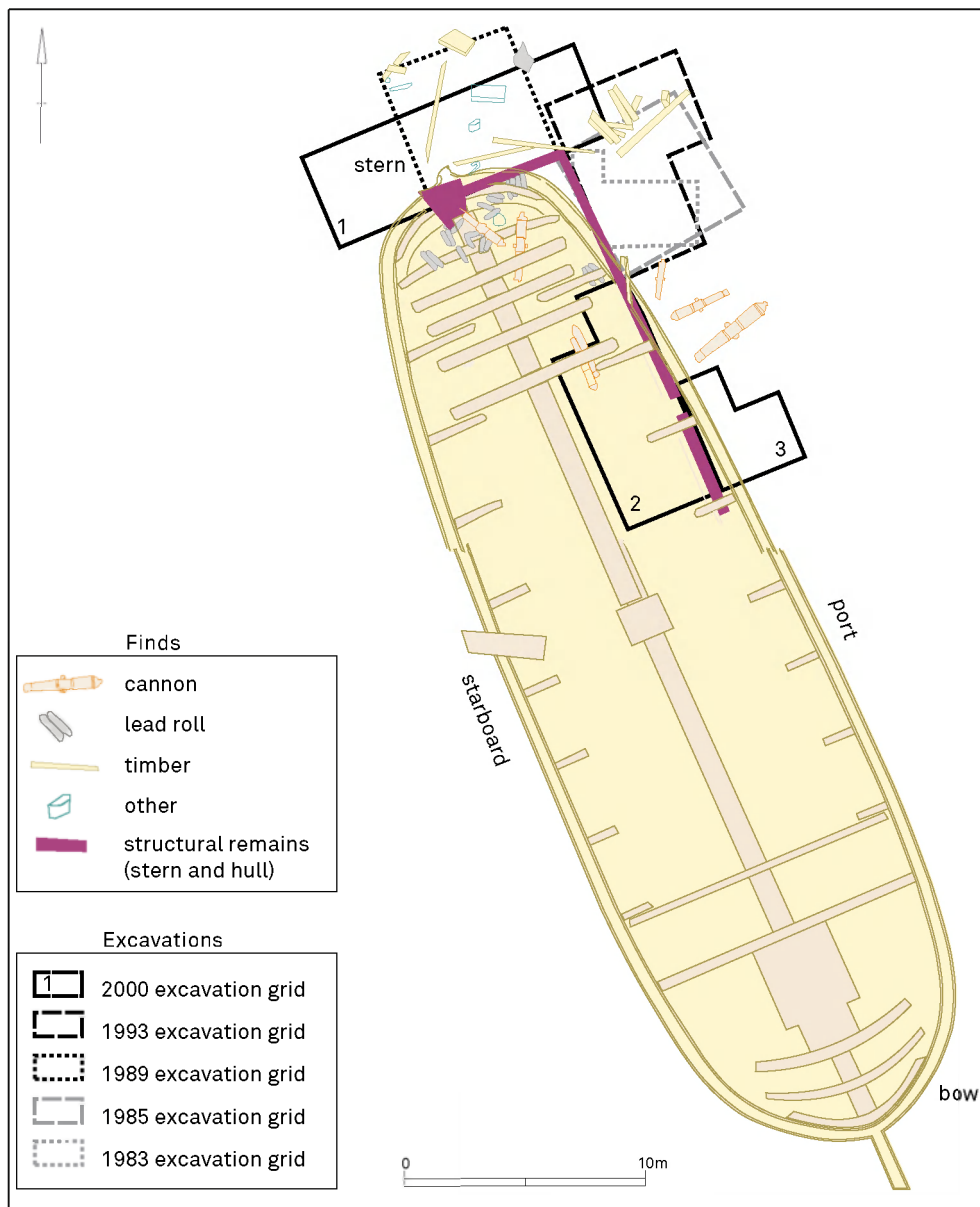
In 2000 three extra trenches were excavated near the sternpost and on the port side of the wreck (see fig. 6)⁵¹. The excavated areas were located both inside and outside of the wreck structure. The results confirm that the main stern remains are located between the sternpost and the port side. There seems to be no indication of a collapse of the port side to the east. The inclined sternpost protruded roughly 0.5 m above the surrounding seabed. Fishing nets, chains and ropes were found tangled around the sternpost. The structural remains of the hull confirmed the large gap roughly 12 m south of the stern⁵².

FIG. 6 Schematic drawing of the wreck based on historical drawings and excavation works in 1988-1993 (after 3H Consulting Ltd 2005). Different finds are indicated. Black and grey rectangles mark the trenches excavated in 1983, 1985, 1989, 1993 and 2000 (trench 1, 2 and 3). The structural remains of the stern and hull are marked in purple.

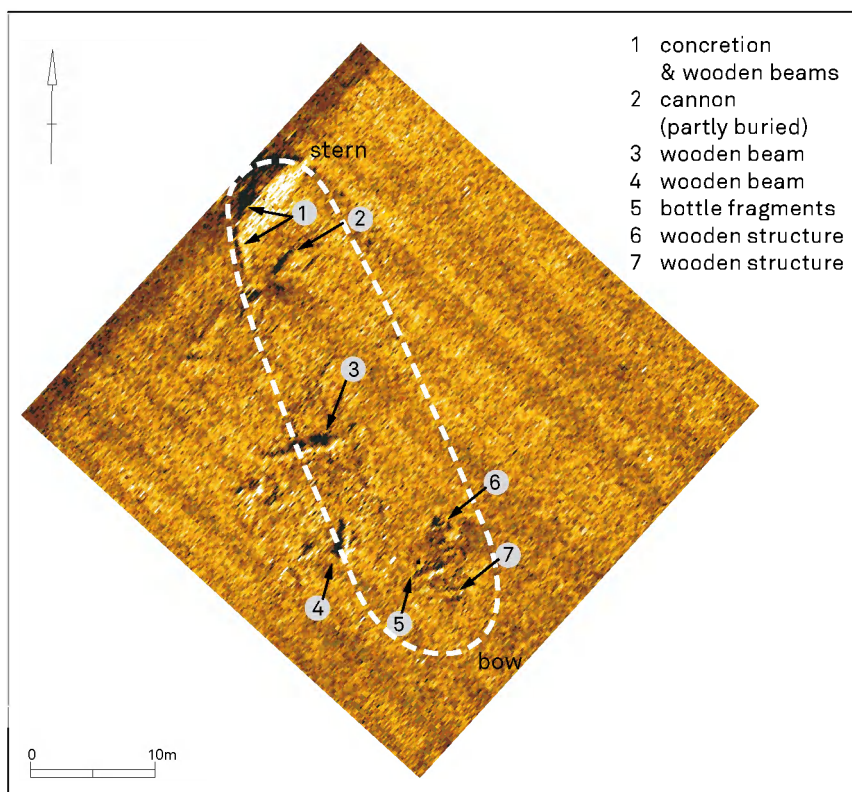
FIG. 7 Side-scan sonar image obtained in 2009 from the 't Vliegende Hart wreck site (courtesy by RCMG). The dotted line marks the (supposed) outline of the ship based on 1993 data (see fig. 6). The stern remains stand out clearly at the top. Different smaller fragments protruding from the seabed are observed near the bow. Elongated features are most likely due to wooden beams or cannons. Numbered arrows refer to some of the wreck remnants observed in 2010 (see fig. 9).

Many of the wreck remains observed on the seabed in 2010 correspond well with prominent features on the side-scan and multibeam data from 2009 (see numbered arrows in figs. 7 and 8), but in some cases no match was found. The diving surveys in August and September 2010 also revealed larger parts of timber than in June. This further confirms the fact that the site is sub-

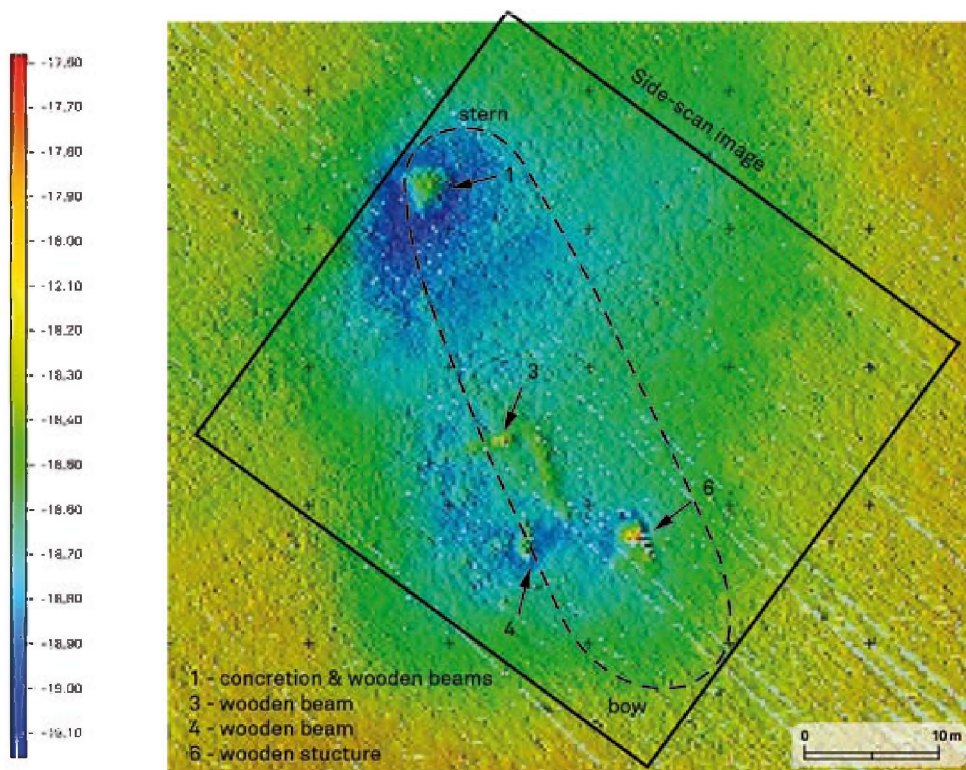
FIG. 8 Multibeam image obtained in 2009 from the 't Vliegent Hart wreck site (courtesy by MDK - Afdeling Kust - Vlaamse Hydrografie). Depth in m MLLWS (Mean Lowest Low Water level at Spring tide). The dotted line marks the (supposed) outline of the ship based on 1993 data (see fig. 6). Only few protruding wreck fragments are observed. Elongated features are most likely due to wooden beams or cannons. The stern remains stand out clearly. Numbered arrows refer to some of the wreck remnants observed in 2010 (see also fig. 9).

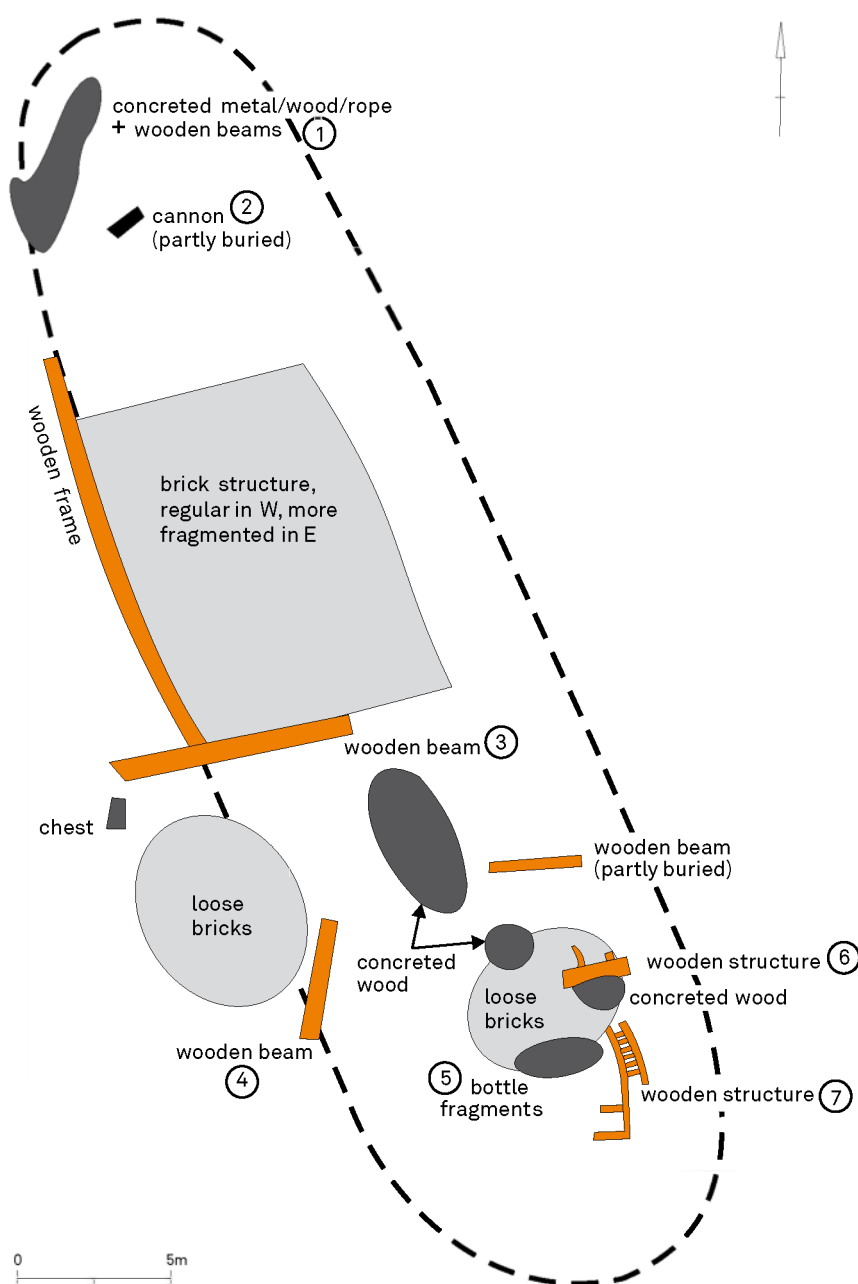
The results indicate the presence of a number of scattered wreck remains on the seabed over a length of 37 m. A schematic overview of the exposed wreck remains observed in 2010 is presented in figure 9. In the northwest a partly buried cannon was observed adjacent to a large elevation (also clearly visible on side-scan and multibeam data) with metal concretions but also wood, rope (presumably remains of old fishing nets) and sediment. This concretion is bound on the northwest side by two sloping wooden timbers. Most likely the timber could be related to part of the stern. These results are consistent with previous diving observations (1983, 2000) revealing wood constructions, fishing nets, ropes and concretions in this area as well as several cannons⁵⁶. However this time no structural remains of the sternpost and adjoining hull were observed on the port side. This is not so surprising since these remains were chiefly found below the seabed after careful excavation.

More importantly, the 2010 diving investigations also revealed structural remains of timber and large beams in the southeast, towards the bow. The most northern feature in that area is part of a large wooden beam, concreted together with smaller wooden fragments and with an elevation of up to 0.5 m above the sea floor. It matches well with the sharp protruding feature (nr. 6) observed on the multibeam images (fig. 8) and the side-scan data (fig. 7). This feature could not yet be identified. Its size might however suggest it is part of a crossbeam of the ship. The most southern wooden structure consists of two long wooden beams following the length of the interpreted wreck orientation. In between is a series of wooden planking, superimposing the western beam and underlying the eastern beam and lined up very close to one another. The latter seems to suggest that we are dealing with hull or ceiling planking, nearing the end of the hull structure, either near the keel or the bow of the ship. The other two beams might be part of floor timbers.

FIG. 9 Schematic drawing of the wreck and structural remains exposed during diving investigations in 2010. The dotted line marks the (supposed) outline of the ship based on 1993 data (see fig. 6). Numbers refer to marked features observed on the 2009 side-scan and multibeam data (see figs. 7-8).

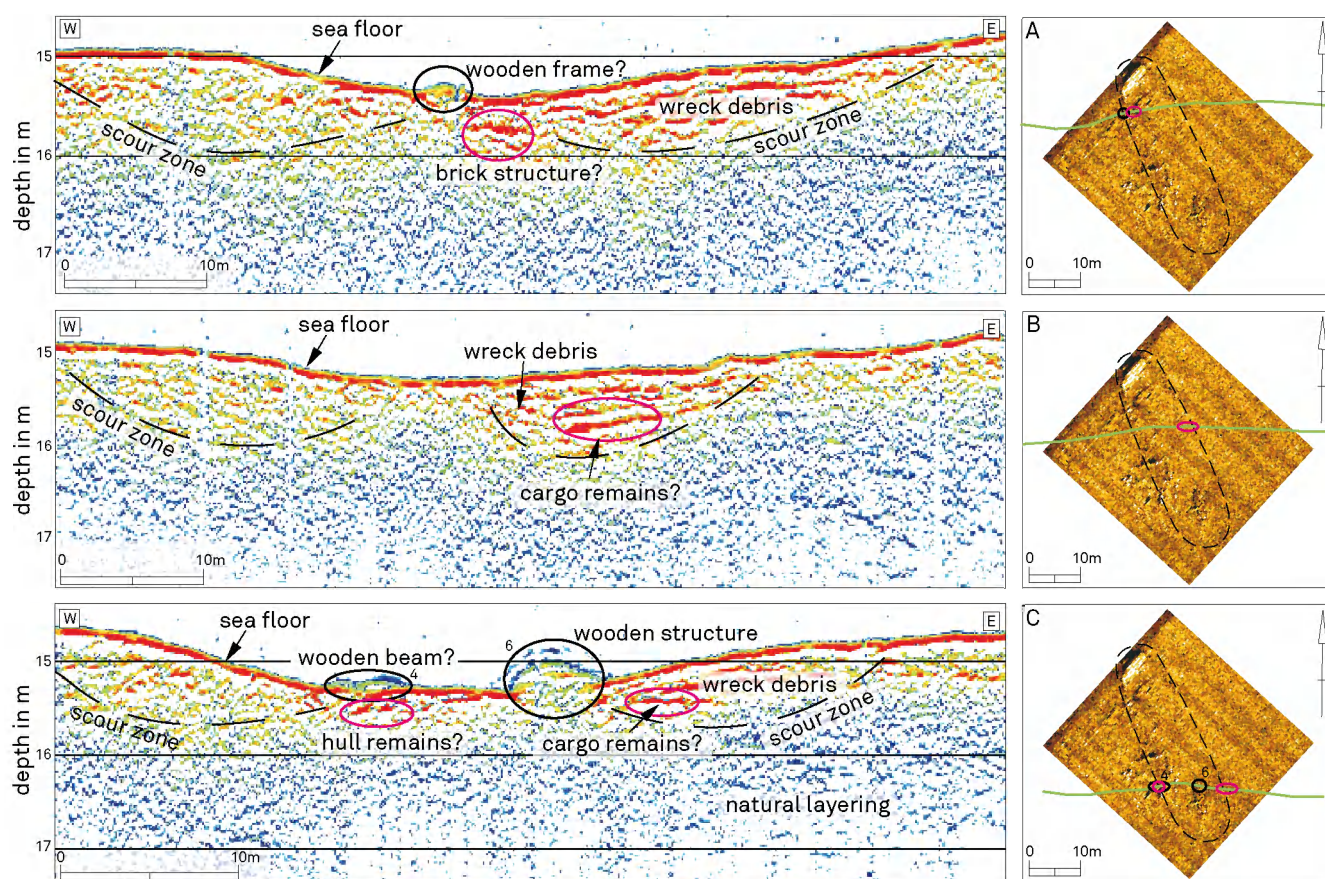
FIG. 11 Seismic profiles crossing the wreck site roughly W-E. Black circles = exposed objects; red circles = buried wreck remains (numbers refer to fig. 9). Two scour fill zones, west (starboard) and east (port) of the wreck, can be observed. Discontinuous shallow reflectors on the east are most likely related to scattered wreck debris. The high-amplitude reflectors on the port side are probably related to the brick cargo (profiles B & C). Possible small hull remnants are observed on the starboard side (profiles A & C). Exposed objects are seen either as large diffractions (profile C) or as small side-reflections (profiles A & C).

East of the port side the shallow geology is marked by an infilling stratigraphy with discontinuous reflectors (fig. 11). Most likely these reflectors can be linked to sediment layers containing various wreck debris. The infill sequence has a maximum depth of 1.2 m and extends up to 15–20 m from the port side (fig. 13). The latter is probably a direct result of the inclination of the wreck, which caused the wreck debris to be spilled over a large distance on the port side. The eastern boundary coincides roughly with the limit of the shallow depression in the seabed that surrounds the wreck (fig. 13). Similar to the western starboard side, most likely also this eastern infilling zone can be linked to scouring processes when the wreck was still (partly) exposed.

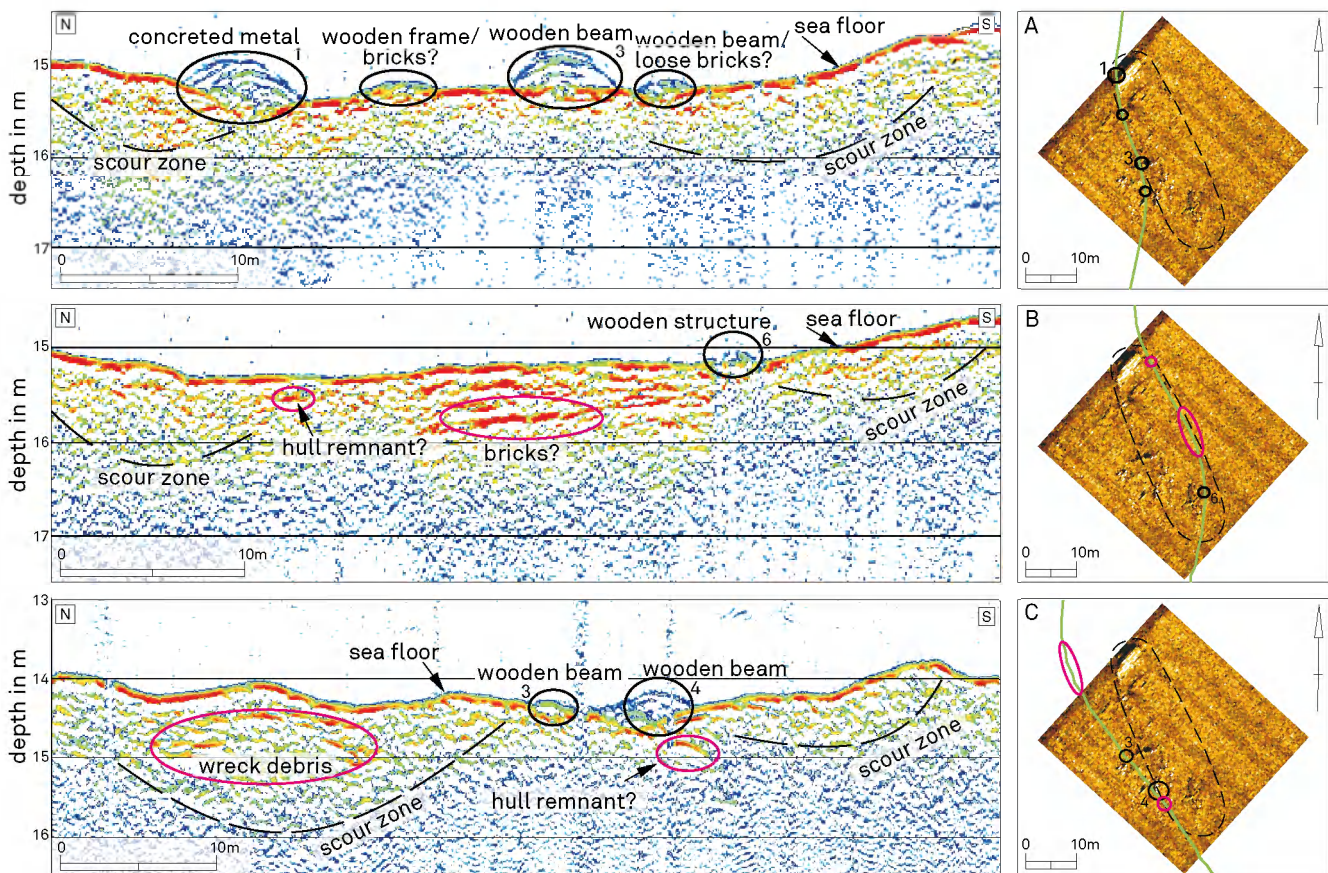
FIG. 12 Seismic profiles crossing the wreck site roughly N-S. Black circles = exposed objects; red circles = buried wreck remains (numbers refer to fig. 9). The high-amplitude reflectors on the port side are probably related to the brick cargo (profile B). Zones with discontinuous, shallow reflectors are most likely related to scattered wreck debris (profile C). Possible small hull remnants are observed near the stern and bow (profiles B & C). Exposed objects are seen either as large diffractions (profile A) or as small side-reflections (profiles B & C). *Seismische profielen doorheen het wrakgebied (N-Z oriëntatie). Zwarte cirkels = uitstekende objecten; rode cirkels = begraven wrakfragmenten (cijfers verwijzen naar fig. 9). De opvallend sterke reflectoren aan bakboordzijde zijn waarschijnlijk in verband te brengen met restanten van de bakstenen lading (profiel B). Zones met zwakke, ondiepe reflectoren zijn waarschijnlijk afkomstig van verspreide wrakresten (profiel C). Mogelijke kleine resten van de scheepsromp zijn te zien nabij de achtersteven en boeg (profielen B & C). De aanwezigheid van verscheidene objecten op de zeebodem is duidelijk, ofwel als grote diffracties (profiel A) ofwel als kleine (soms nauwelijks waarneembare) zijreflecties (profielen B & C).*

The port side of the wreck is often marked by a number of short, strong and shallow reflectors (figs. 11B–C & 12B). It is likely that this marked stratification can be linked to the cargo remains (bricks). It also confirms the excavation results from 2000 where locally buried layers of bricks were encountered (trench 2)⁶¹. The continuation of some reflectors east of the wreck could be due to the inclination which caused the cargo to be spilled outside the wreck on the port side. Towards the east the reflectors become weaker and discontinuous which seems to point towards more scattered wreck debris. The stratification often becomes more chaotic in the previously excavated areas which could be due to the disturbance in these trenches.

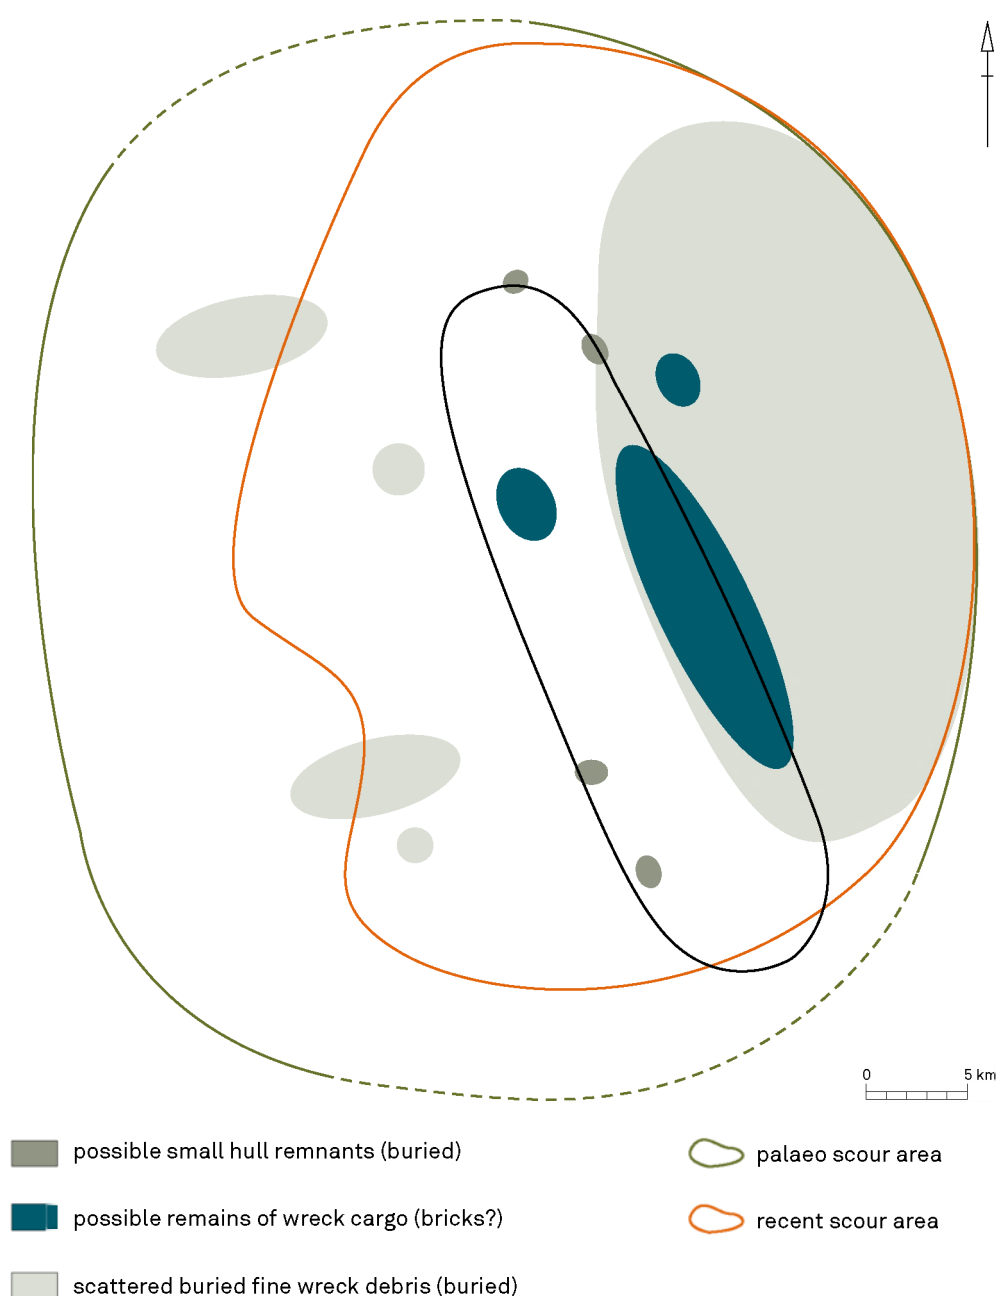
FIG. 13 Tentative interpretation map of the wreck site area, showing the distribution of buried cargo remnants, wreck debris and scour fill zones based on the seismic data. The (supposed) wreck location is marked by the black line.
