Chapter 3. Monitoring of hydrodynamic and morphological changes at the C-Power and the Belwind offshore wind farm sites – A synthesis

D. Van den Eynde^{1*}, R. Brabant¹, M. Fettweis¹,
F. Francken¹, J. Melotte², M. Sas² & V. Van Lancker¹

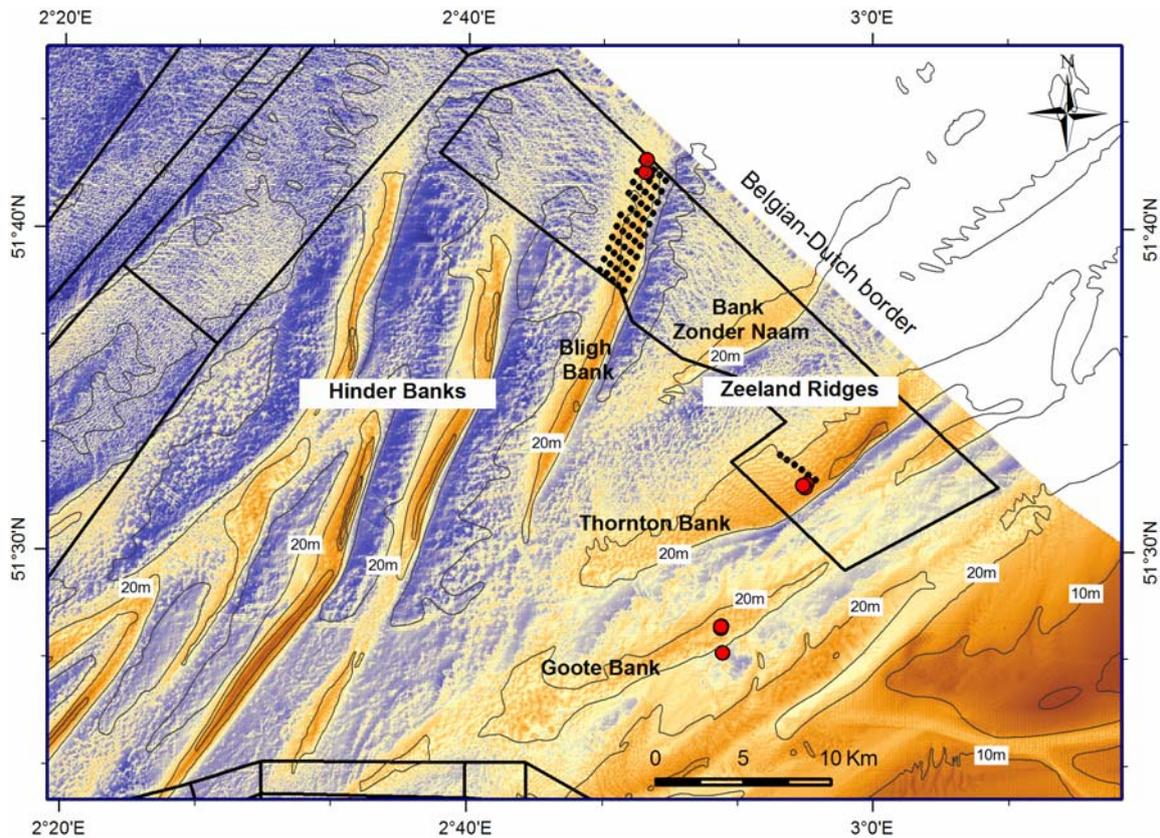
Figure 1: Bathymetry of the Thornton Bank, Bank Zonder Naam, Bligh Bank and Goote Bank. The black dots indicate the position of the windmills, the red dots indicate the position of the turbidity and current measurements.

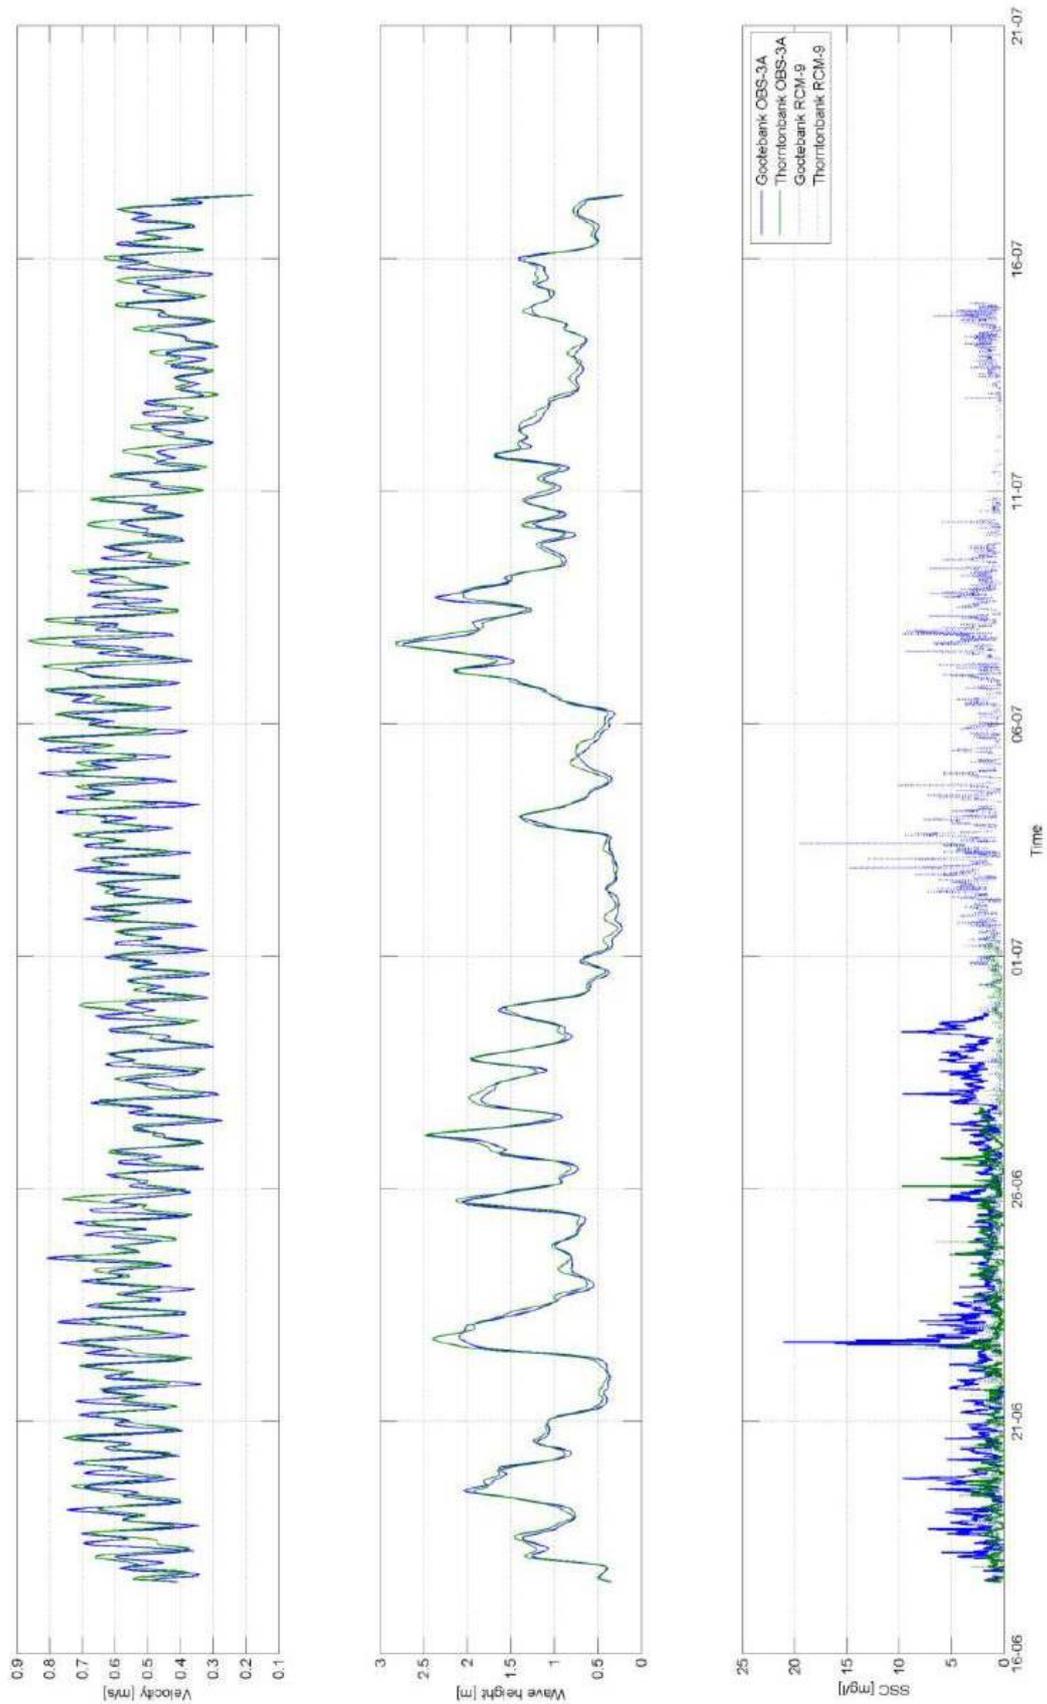
Figure 2: Measurements at the Thornton Bank and the Goot Bank in June-July 2009. Top: currents; middle: wave height; bottom: SPM measurements (from IMDC, 2009b).

In figure 2 the measurements during the works on the Thornton Bank of currents, waves and SPM are presented as an example (from IMDC, 2009b). It can be observed that after about 14 days, OBS3 measurements halted, due to biofouling on the sensors.

Waves were higher during the campaign in February 2008, in the winter period, than during the campaigns in June-July 2008 and June-July 2009, occurring in summer time. Around March 1st, 2008, a storm passed by, with significant wave heights higher than 3.5 m at the Thornton Bank.

Statistical analyses of wave, current and SPM concentration data was performed (IMDC, 2009b). The analysis showed that SPM concentration was low, on the Thornton Bank and Goote Bank. During the winter period, the median SPM concentration was 9 mg/l on the Goote Bank and 4 mg/l on the Thornton Bank. The analyses showed that high turbidity was correlated with higher wave conditions. However, during periods of high waves, low concentrations occur as well, indicating that wave action is not the only driving factor. During the summer periods, the median concentration of SPM on the Thornton Bank and Goote Bank was very low (1 to 2 mg/l). The measurements showed a similar behaviour of SPM concentration on the Thornton Bank and Goote Bank.

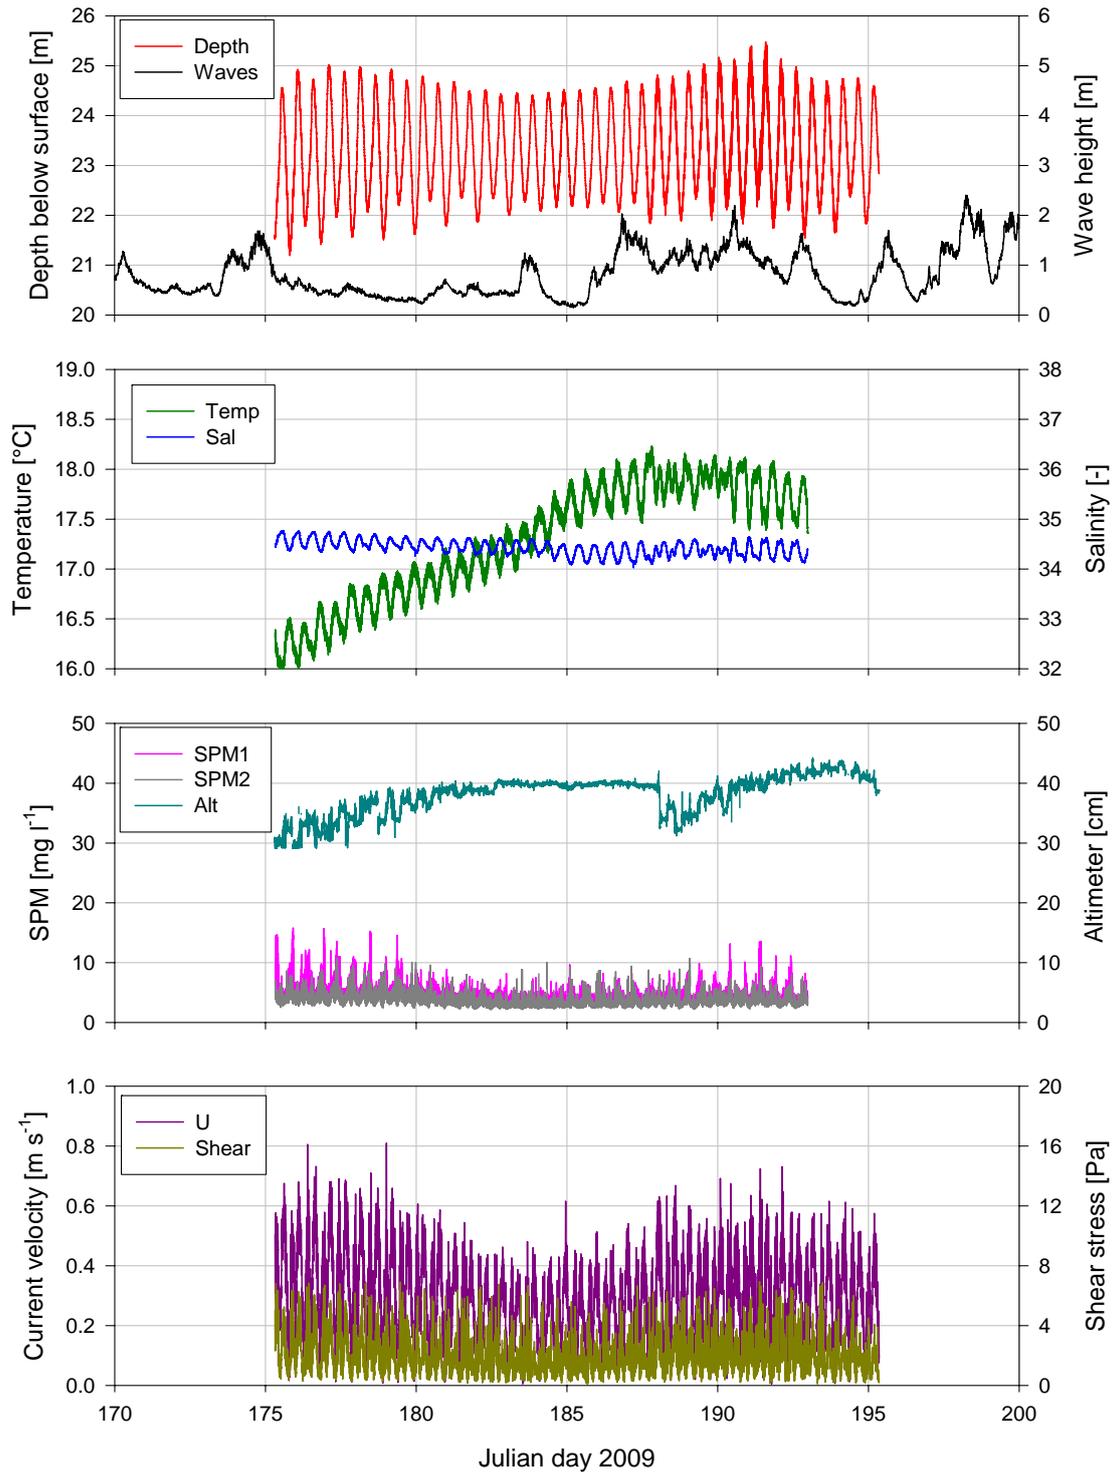
Figure 3: Measurements at the Bligh Bank (MUMM), during the Belwind monitoring campaign, before the works. Significant wave height data are from Akkaert Zuid (Meetnet Vlaamse Banken, Agentschap Maritieme Dienstverlening en Kust, Afdeling Kust); upper middle: temperature and salinity; lower middle: SPM1: SPM concentration at 0.2 m above bottom, SPM2: SPM at 2.0 m above bottom, Alt: distance between ADV measuring volume and sea bottom; bottom: current velocity from the ADV and calculated bottom shear stress.

In Figure 3, the measurements at the Bligh Bank, before the works, are presented. The SPM concentrations at the Bligh Bank during June-July 2009 show a clear correlation with spring-neap tidal cycle variation, and almost no influence of wave activity is visible. SPM concentrations are low (< 5 mg/l) at both locations, except during autumn 2009 when the SPM concentration was surprisingly high on the Goote Bank (see Table 3). The tidal cycle measurement, during the same period, indicated mean values of 32 mg/l and a maximum of 58 mg/l; data from the tripod confirmed these values during the first days of deployment. SPM concentration decreased again a few days later.

During the measurement periods, significant wave heights of up to 2.2 m were recorded. Median significant wave heights were lower during the measurements (62 cm: June-July 2009; 64 cm: October-November 2009) than during the corresponding season of 2009 (66 cm, 95 cm). Mean SPM concentration was only slightly higher during periods with significant waves higher than 1.5 m on the Goote Bank (0.2 mab: 5.5*/1.0; 2 mab: 5.4*/1.2) and on the Bligh Bank (2 mab: 3.2*/1.2; 2 mab: 3.2*/1.3), both for June-July measurements (compare with Table 3). During the October-November measurements, no correlation was found and highest SPM concentrations occurred during lower wave conditions.

Altimeter data combine information of bed level changes and vertical movements of the tripod itself, due to settling. During the deployment the bed level changed during spring tide, possibly due to moving ripples or erosion/deposition events. During neap tide, no sediment transport at the bottom is apparent and the bed level remained nearly constant for about 5 days.

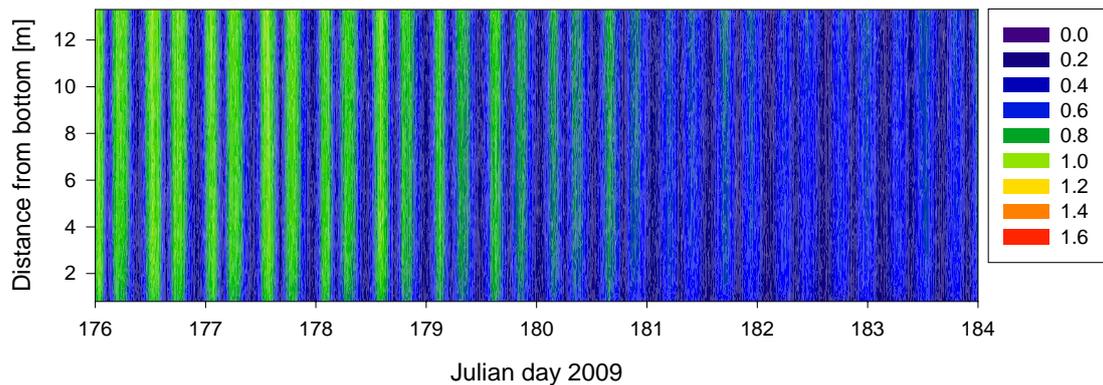
Figure 4: ADCP measurements at the Bligh Bank, during the Belwind monitoring campaign, before the works.

Current profiles at the Bligh Bank, during the works, are shown over the first 13 m above the bottom in Figure 4. Since no ADCP was available for deployment during this first campaign at the Goote Bank, an ADCP was used from Afdeling Maritieme Dienstverlening en Kust, Afdeling Kust. Unfortunately, no ADCP data were available during the second campaign.

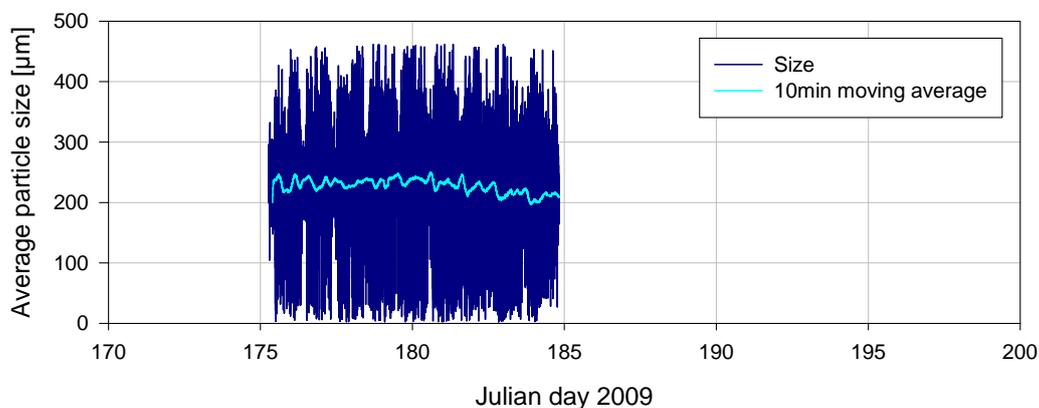
Figure 5: LISST measurements at the Bligh Bank, during the Belwind monitoring campaign, before the works, with a 10 minutes moving average.

Finally, the average particle size, as measured by the LISST, are shown for the same campaign in Figure 5. The measurements, with a frequency of 1 Hz, show large variability. A 10 minutes running mean shows that the average flock size is around 250 μm during spring tide, decreasing to 200 μm during neap tide.

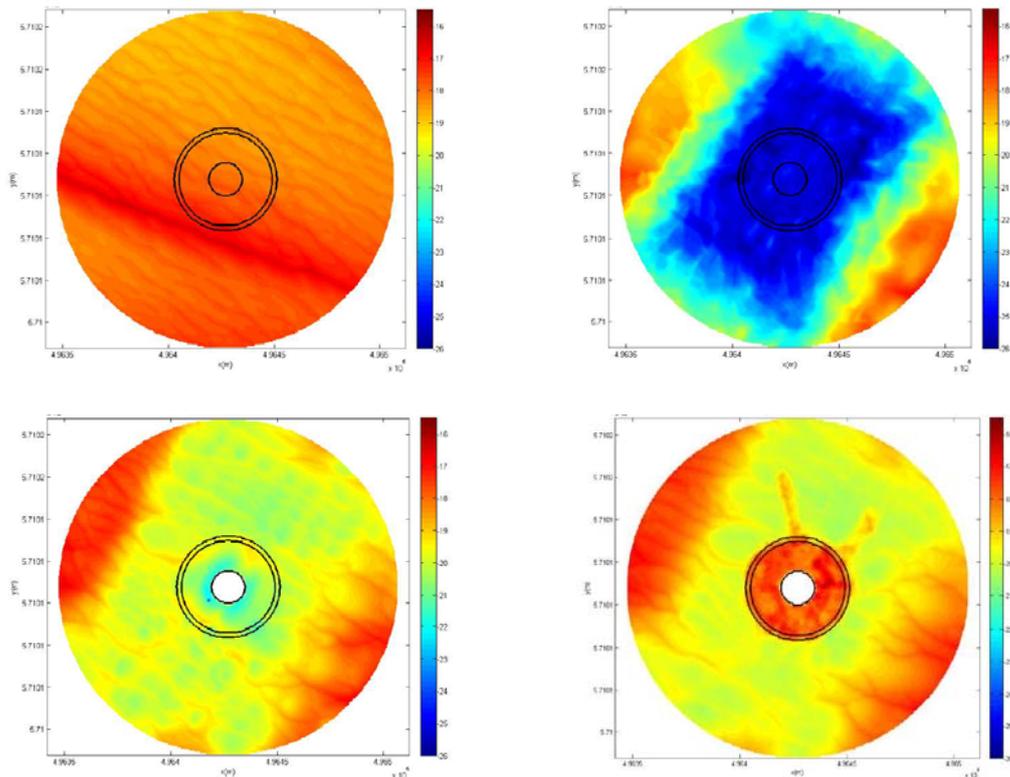
Figure 6: Depth variation near GBF2 (51°32'24.63"N, 2°56'49.75"E). Upper left: prior to the works; Upper right: after the dredging of the foundation pit; Lower left: prior to the installation of the filter layer; lower right: final survey after completion of the works (from: C-Power, 2009).

In Figure 6, the results of four surveys around one of the GBFs, *i.e.* GBF2 at (51°32'24.63"N, 2°56'49.75"E), are presented. The bathymetry before the works, after the dredging of the foundation pit, prior to the installation of the filter layer and after the works, are shown. The foundation pit is clearly visible. However, after the installation of the erosion protection, no indication of secondary scour is found.

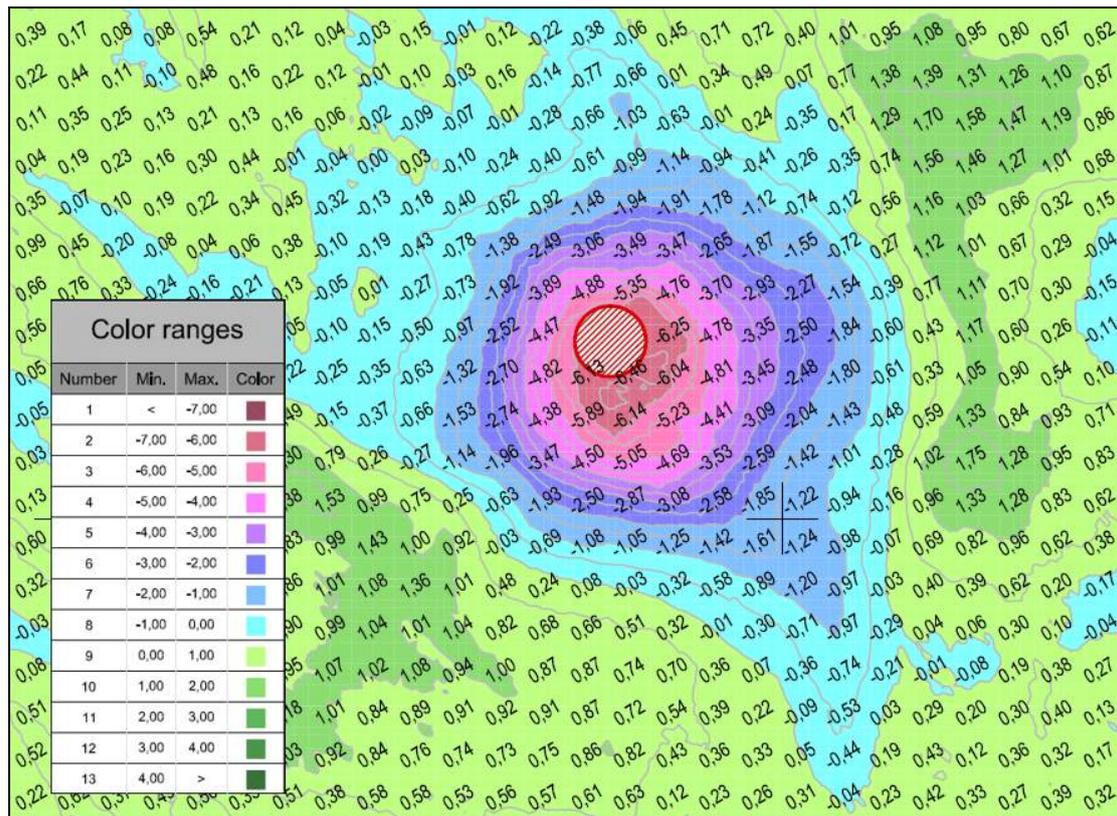
Figure 7: Differential bathymetry map between February 8th, 2010 and the reference situation, measured in August 2009. Monopile F03 in the Belwind wind farm (from: Belwind, 2010).

The erosion pits around the monopiles, during the dynamic erosion protection on February 8, 2010, were relatively limited and varying between 2 m (A10), 2.7 m (C05 and D06), 4-4.5 m (F04 and F05) and 6.5 m of depth (F03) (see Figure 7).

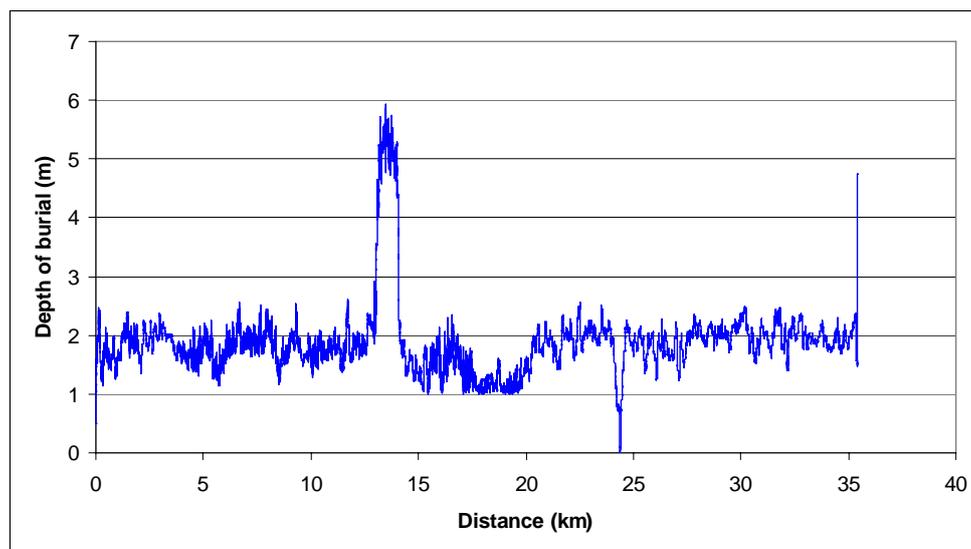
Figure 8: Depth of burial of the 150 kV cable from the C-Power wind farm from the most southern turbine (km 0) to the landing points at Oostende (km 36) (Figure prepared from data of C-Power, 2009b).

Over the entire length of the cable, a depth of burial of around 2 m was aimed for. In some cases, due to clay layers, only 1 m depth of burial was reached (Figure 8). Note that around km 14, a much deeper burial was observed, because of crossing of the navigation channel. This was required in the environmental permit for safety reasons. At km 24, a surface communication cable was crossed. At that place, gravel was disposed to protect the cable.

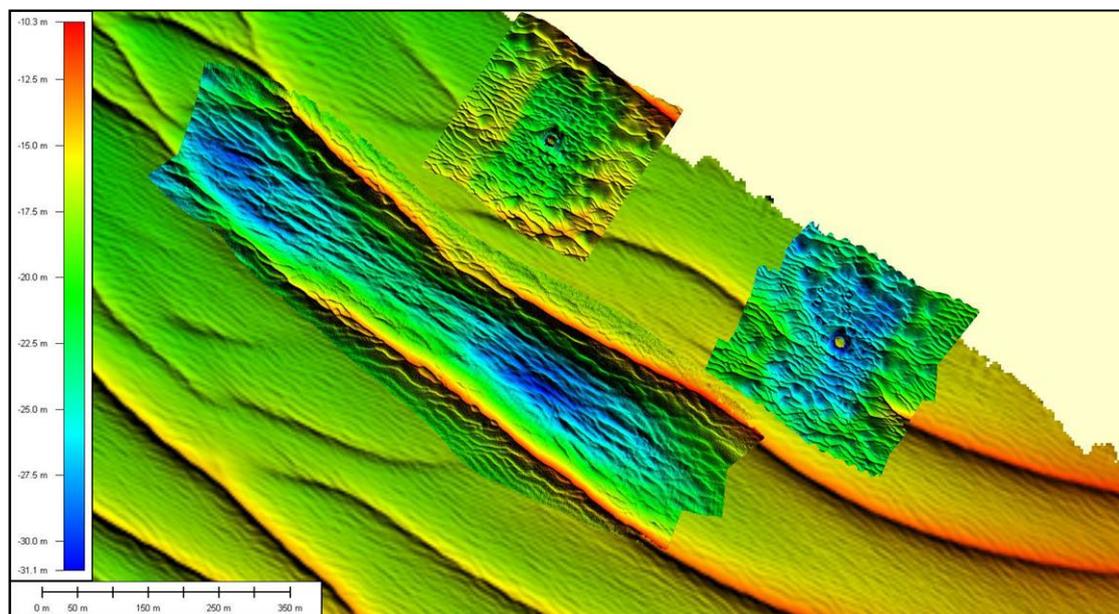
Figure 9: Example of 2 foundation pits with associated depression (2009 bathymetry). In the depression, sand from the GBF location was temporarily stored, though after infill of the GBFs and backfill of the cable, a sand deficit was encountered. This resulted in major depressions. (data: C-Power; visualization: M. Baeye UGent/MUMM). Background bathymetry is from 2006 (FPS Economy, SME's, Self-Employed and Energy).

In 2009, two additional surveys were executed to monitor the evolution of the depressions. Compared to October 2008, in June 14 2009, still 471,000 m³ was missing, indicating that over a period of 8 months only 9,000 m³ were naturally deposited in the depressions.
