FLOW SLIDE ON THE TIDAL FLAT OF WALSOORDEN IN THE WESTERN SCHELDT

D.R. Mastbergen¹, S.J. van Schaick², J.J. van der Werf¹, R.A. Schrijvershof¹

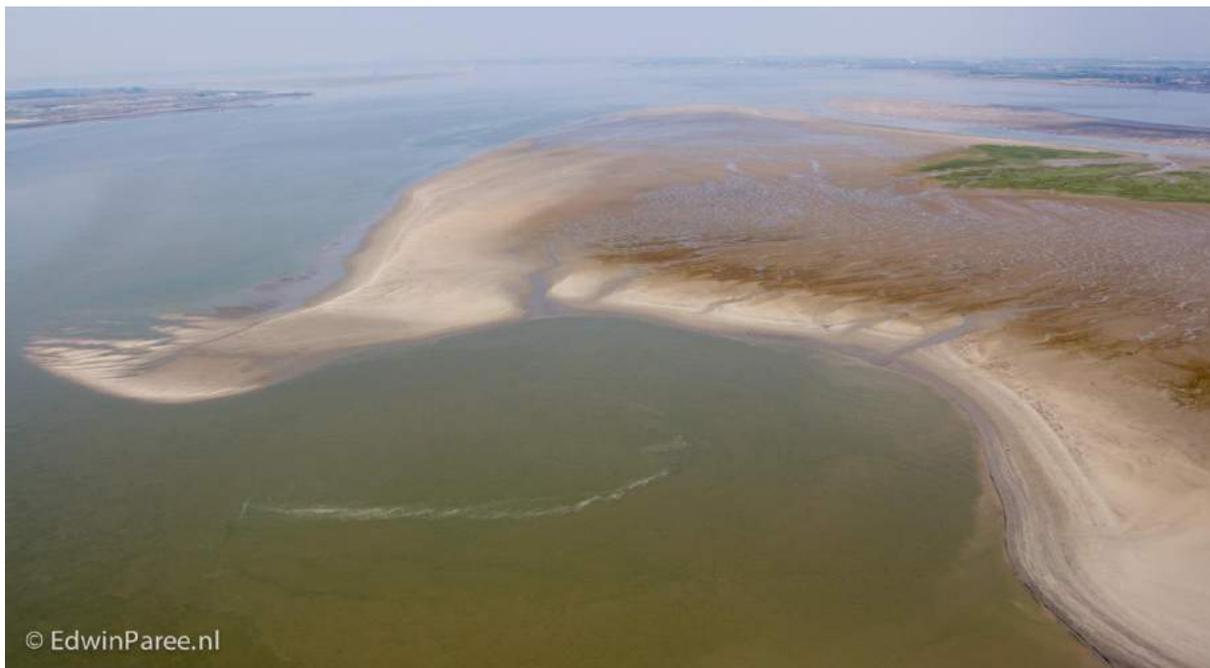
Figure 1 Aerial view of the gap created by the 22 July 2014 flow slide on the tidal flat of Walsoorden, Zuidergat and in the distance Perkpolder (E. Paree, September 2014).
