Morphodynamic responses of nourished beaches in SW Spain

Anfuso, G.; Benavente, J. & Gracia, F.J.*

Dept. of Geology, Faculty of Marine Sciences, University of Cádiz, 11510 Puerto Real, Cádiz, Spain;

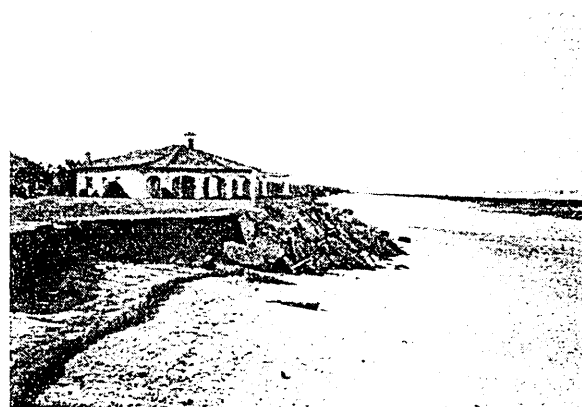
Fig. 2. Erosion problems near Punta Candor. The Quaternary cliff is eroded and summer houses are protected by a rip-rap revetment.

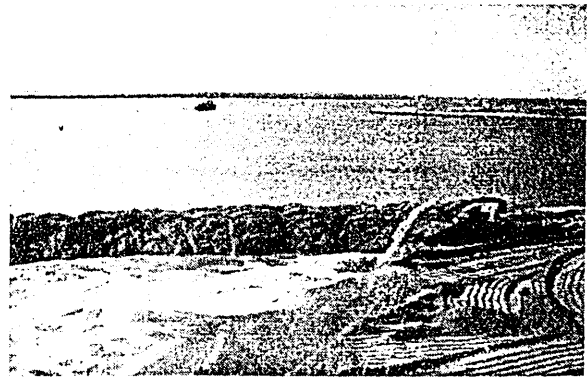
Fig. 3. Nourishment works on Aculadero beach, with the pipeline pumping sediment on to the beach. Note the dredging boat in the background.

In all cases the sand was dredged from the Cádiz harbour channel, at water depths between 8 and 14 m, and then pumped onto the beach through a short floating pipeline. The sediment was spilt on the back-shore and in the upper part of the foreshore to widen the visible beach (Fig. 3). Bulldozers were then used to reshape the back-beach to create raised, flat, berms, characterized by an important seaward slope and a narrow foreshore. By this procedure the initial dissipative profile was transformed into a fully reflective one.

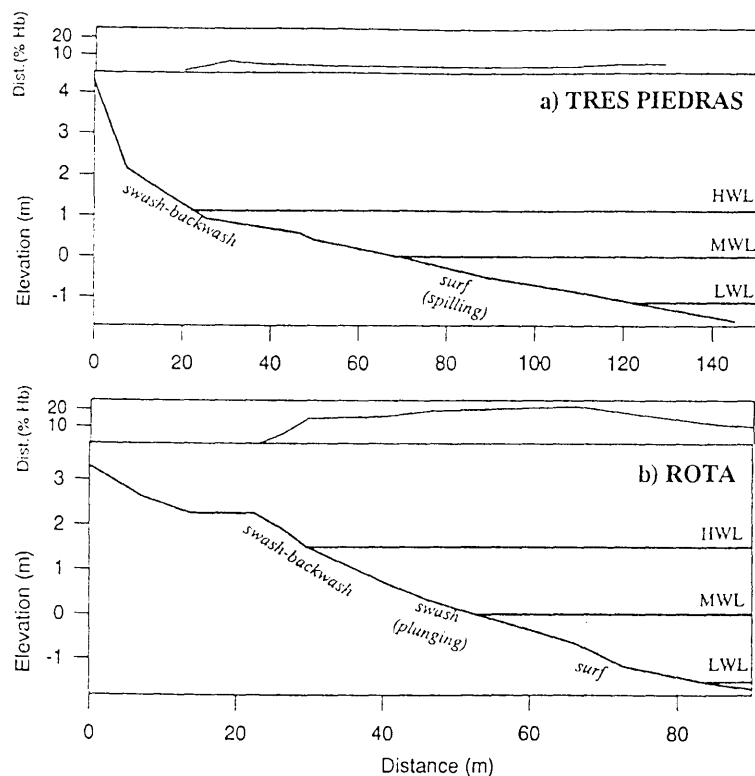
Fig. 8. Cross-shore variability of average disturbance depth in the two main morphodynamic classes: (a) dissipative, Tres Piedras beach; (b) reflective, Rota beach.

At Tres Piedras beach (Fig. 8a), an average and quite uniformly distributed value of disturbance depth of 4% H_b was recorded in the foreshore. Shoaling processes with spilling breakers dominated in the surf zone at every tidal stage. Swash and backwash processes achieved some importance only in the uppermost part of the beach, which had a slope somewhat controlled by the rip-rap revetment.

At Rota beach (Fig. 8b) the average value of disturbance depth reached 16% H_b and was approximately constant throughout the intertidal area. High values were recorded in the uppermost part of the beach, where a greater slope and a lesser compaction of the sand combined to form a more sensitive zone. Small values
