The Var River

a long history of human interference in its
morphological and sedimentological processes

**Some information before the field visit
and useful for the MIKE 11 modelling**

GEO-FLUVIOMORPHOLOGY OF THE LOWER VAR RIVER

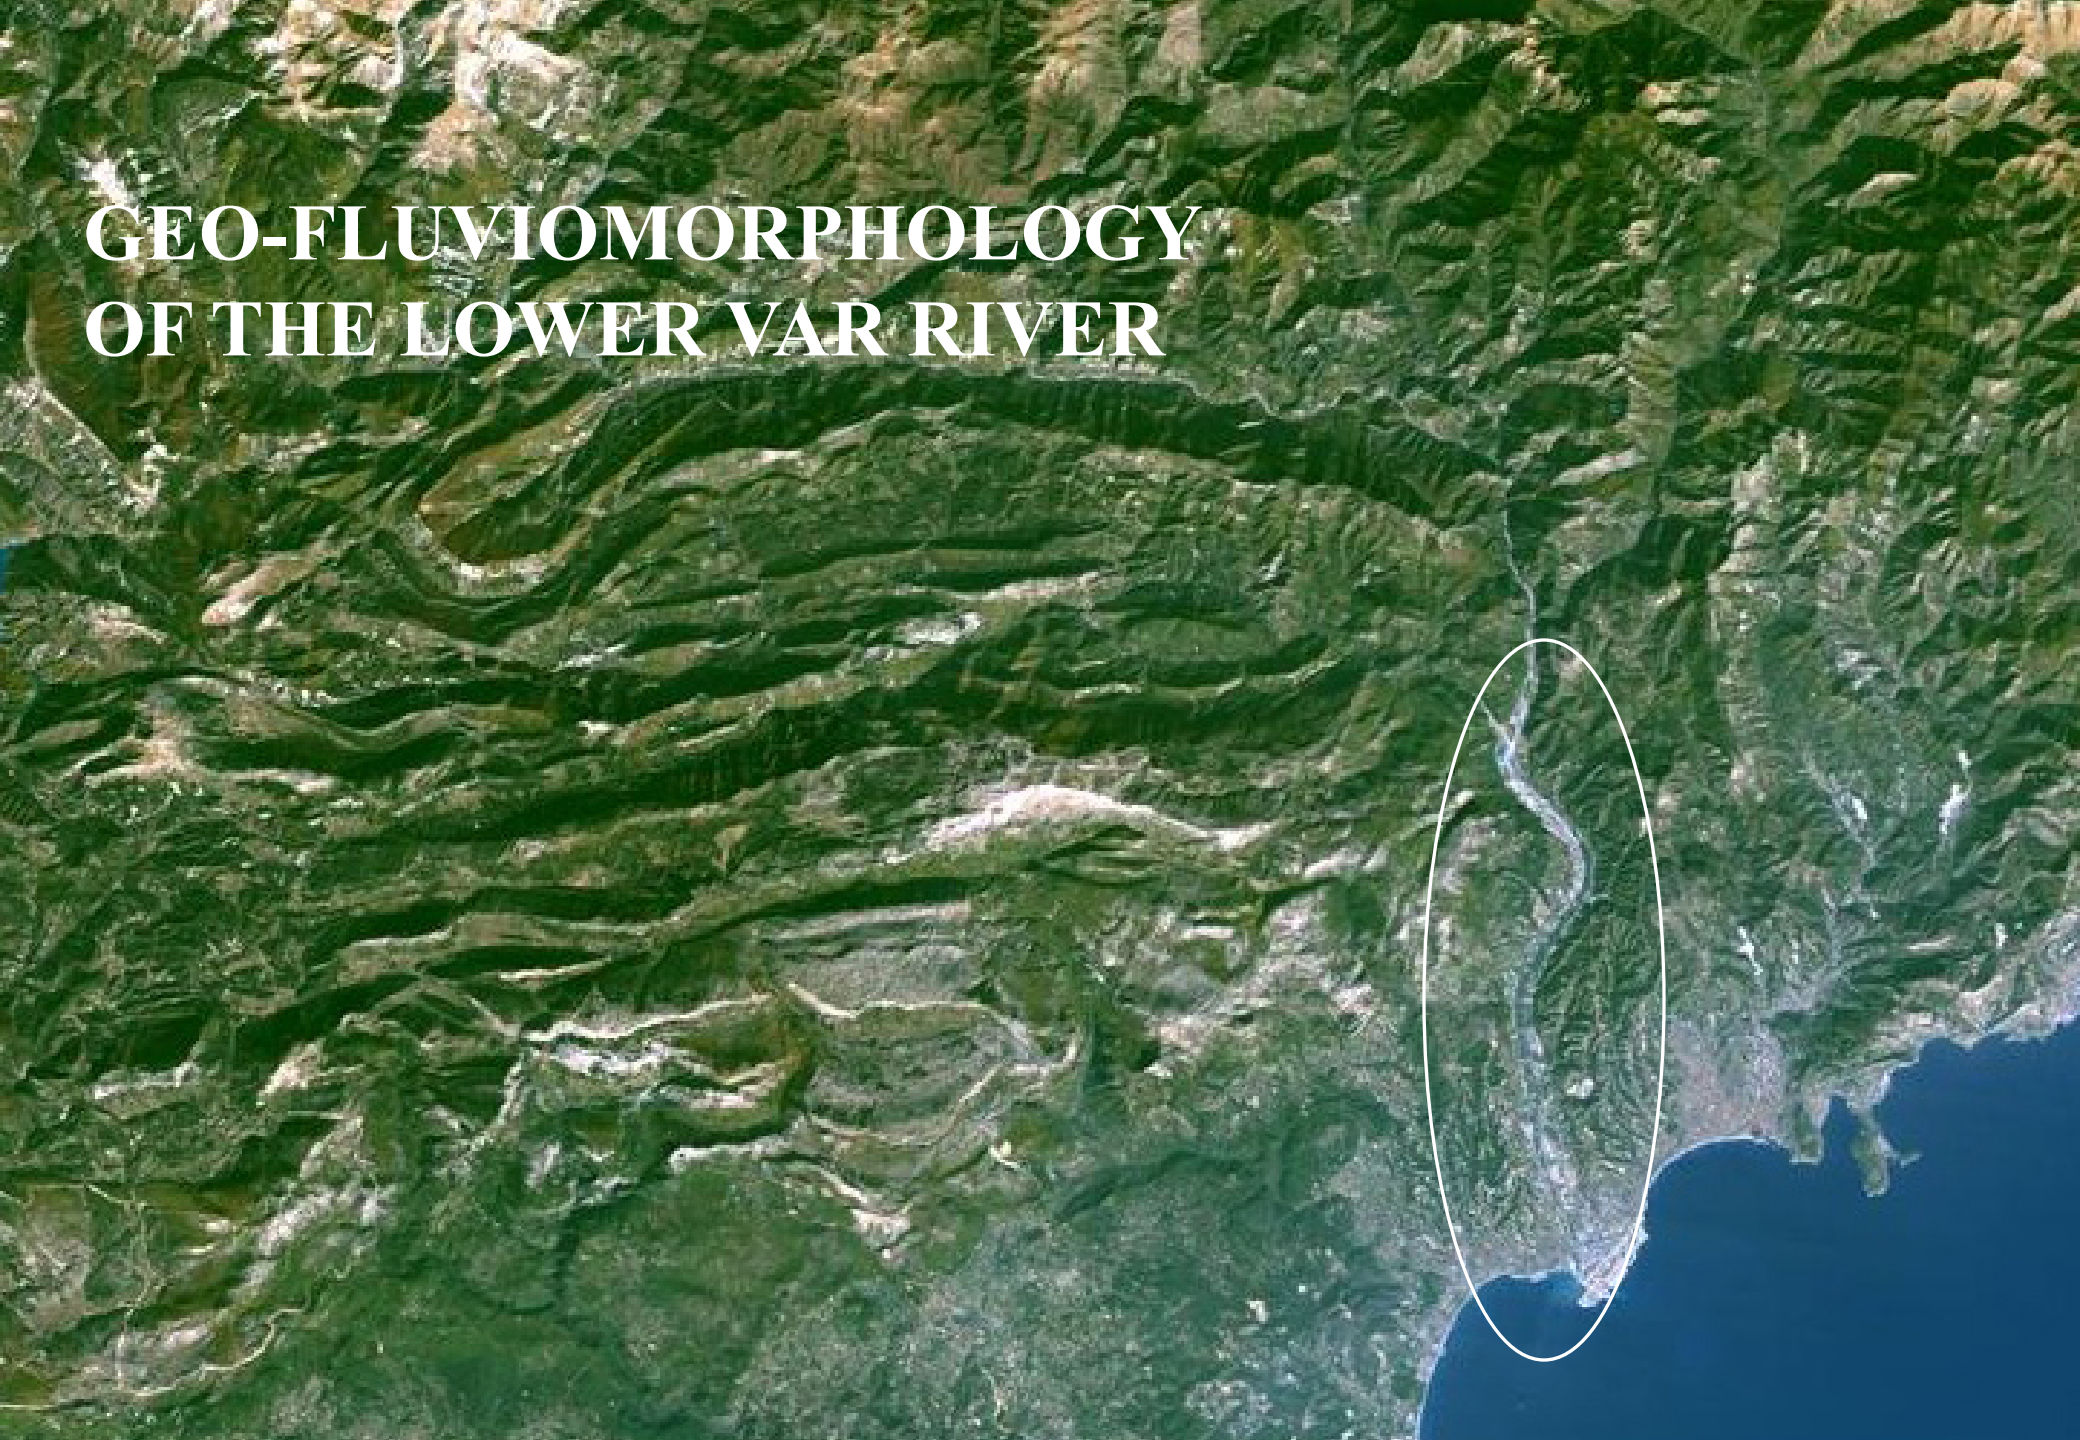
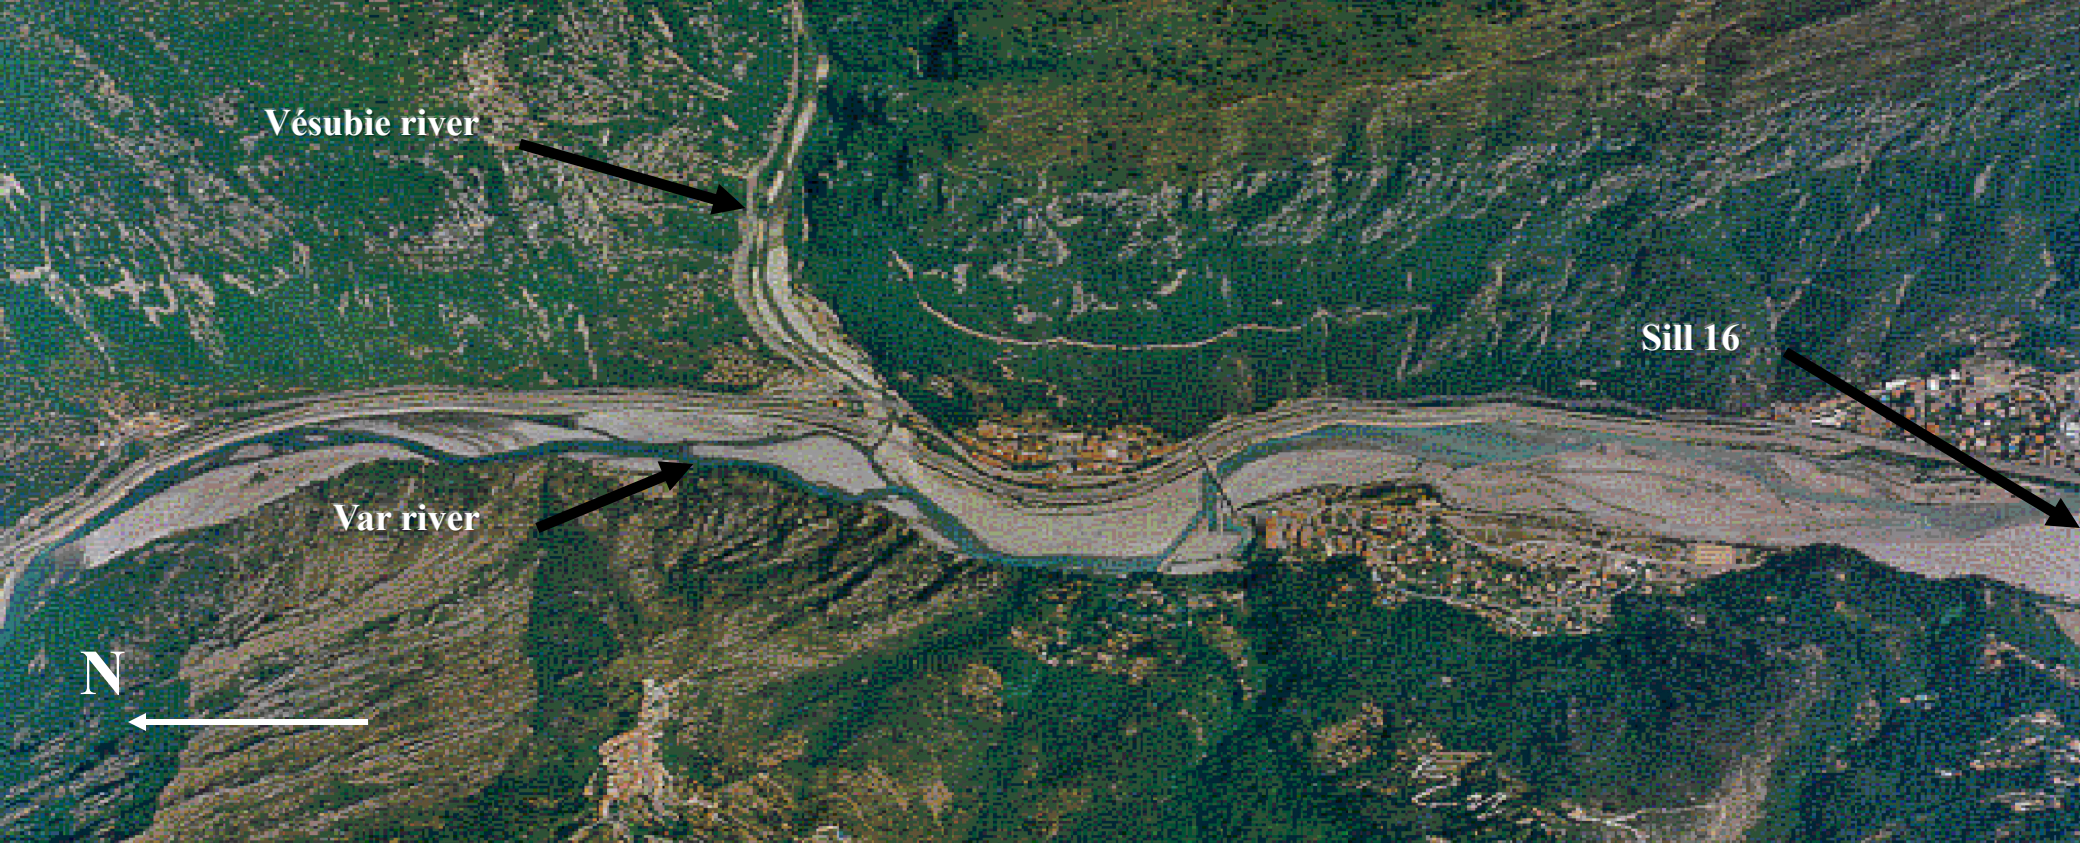
- In the Chaudan gorges, the river course is strongly controlled by valley borders, made of very hard rocks
- From there on starts the Lower Var, which was previously running freely between the valey slopes with large gravel bars, very mobile and composed of coarse bed material

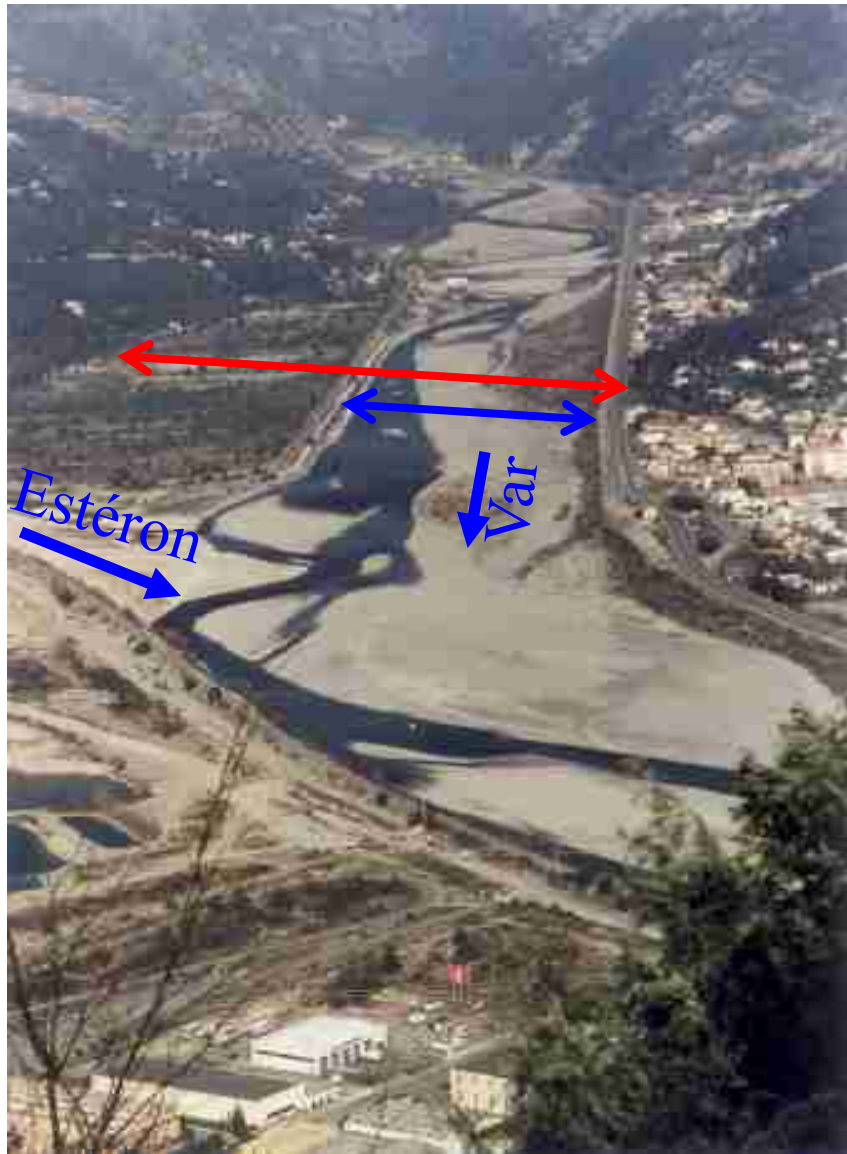
Human impacts in lower valley

Over its entire length of the lower valley, the river was canalized, reducing its width from about 1000 m (in average between valley slopes) to 300 m, and even 200 m in the last stretch, close to the sea.

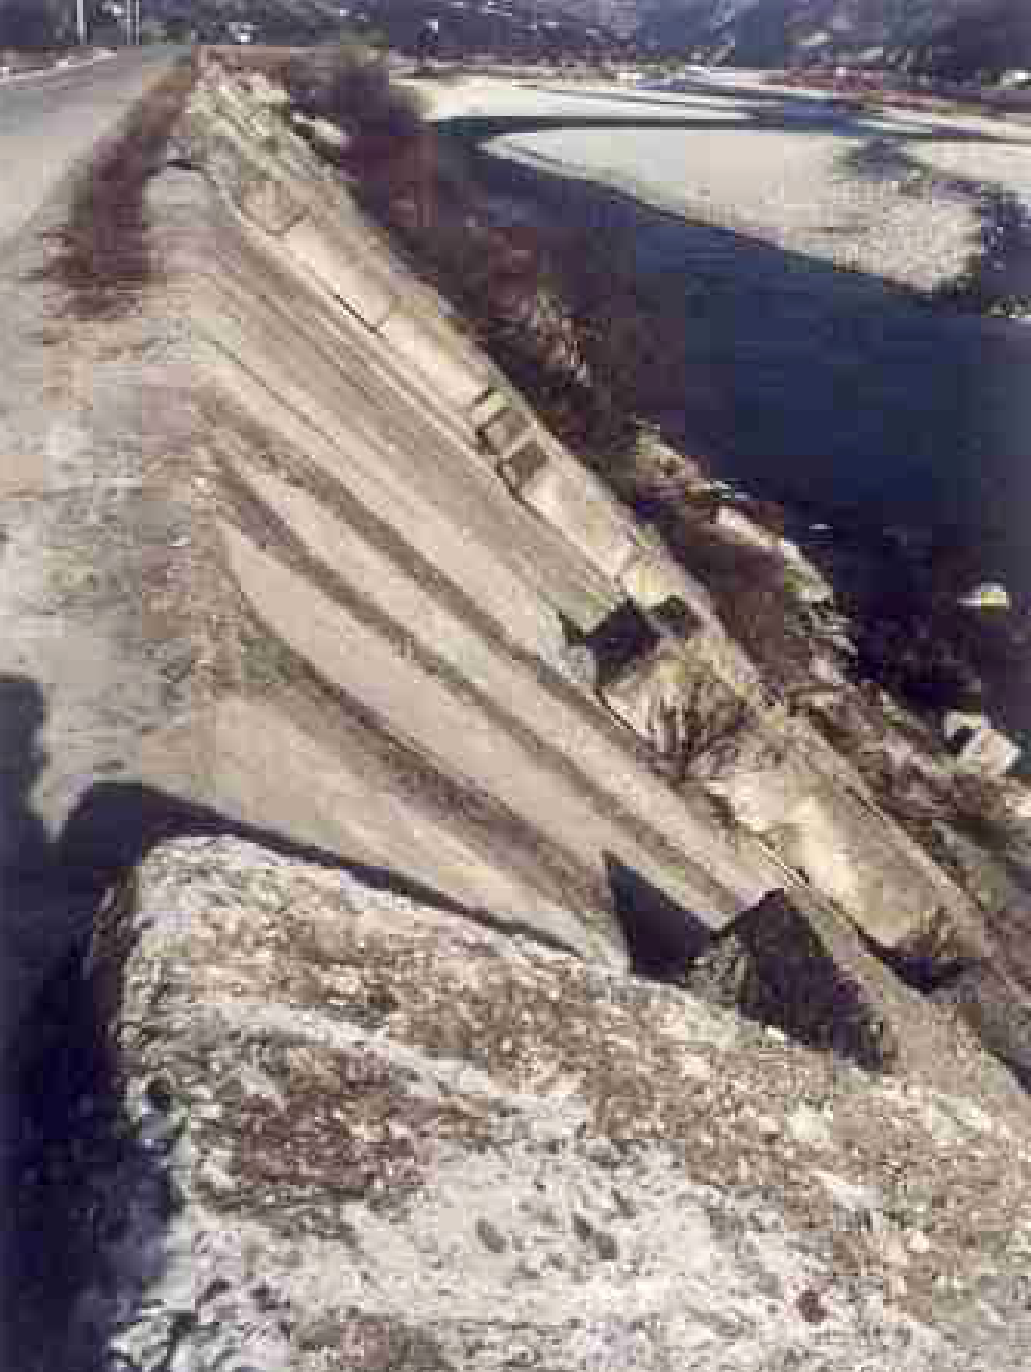
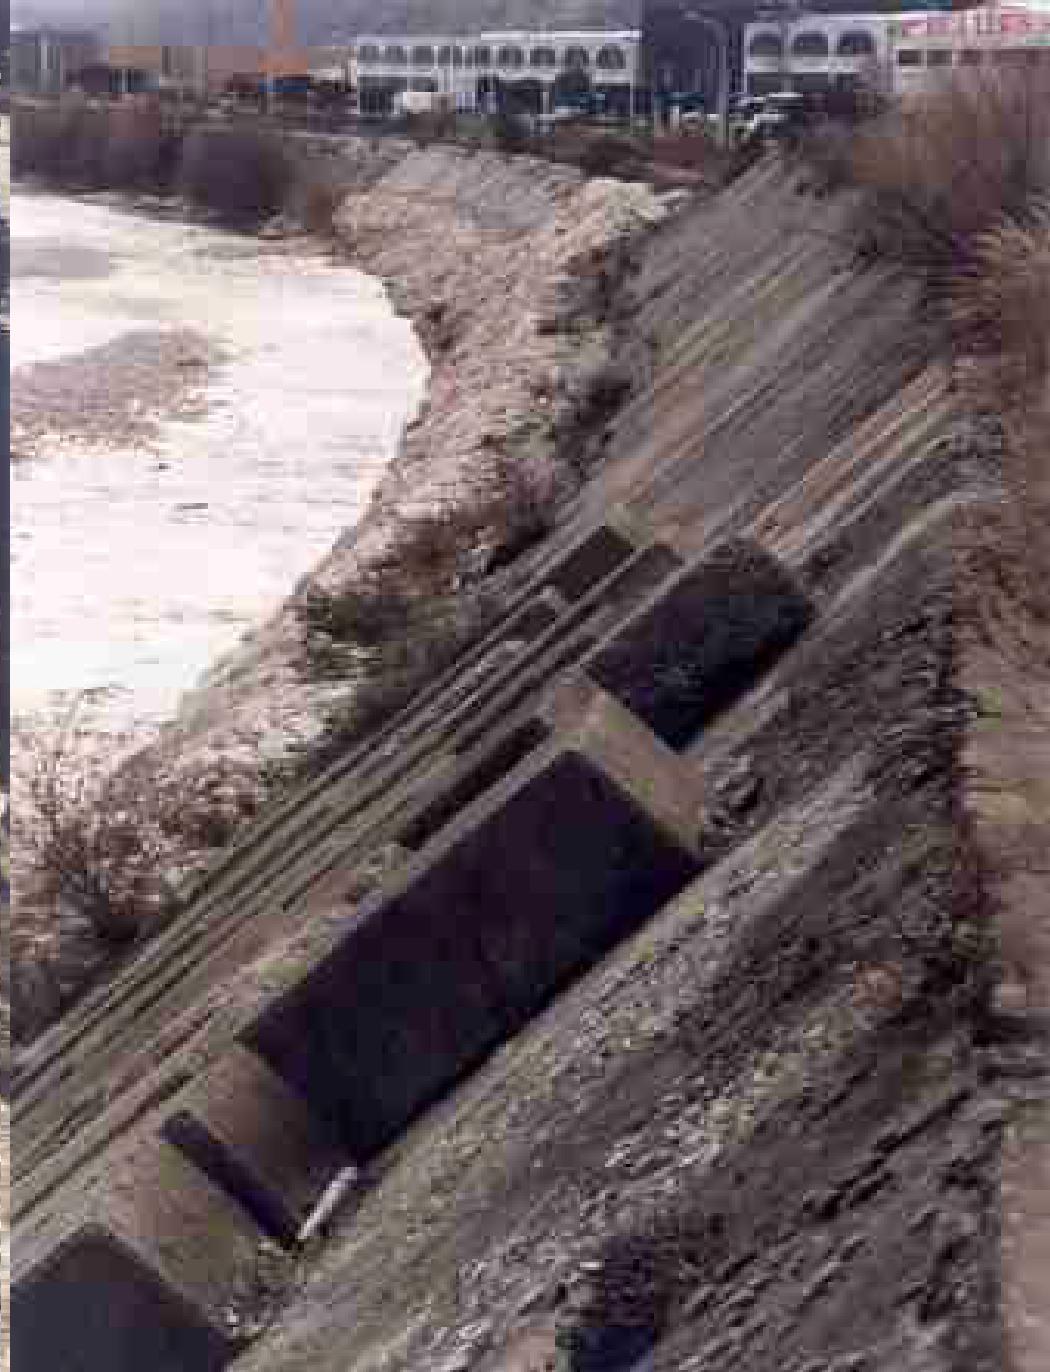
Gates at Manda Bridge, which were controlling the flow to artificial floodplain (sedimentation areas, 1960ies)

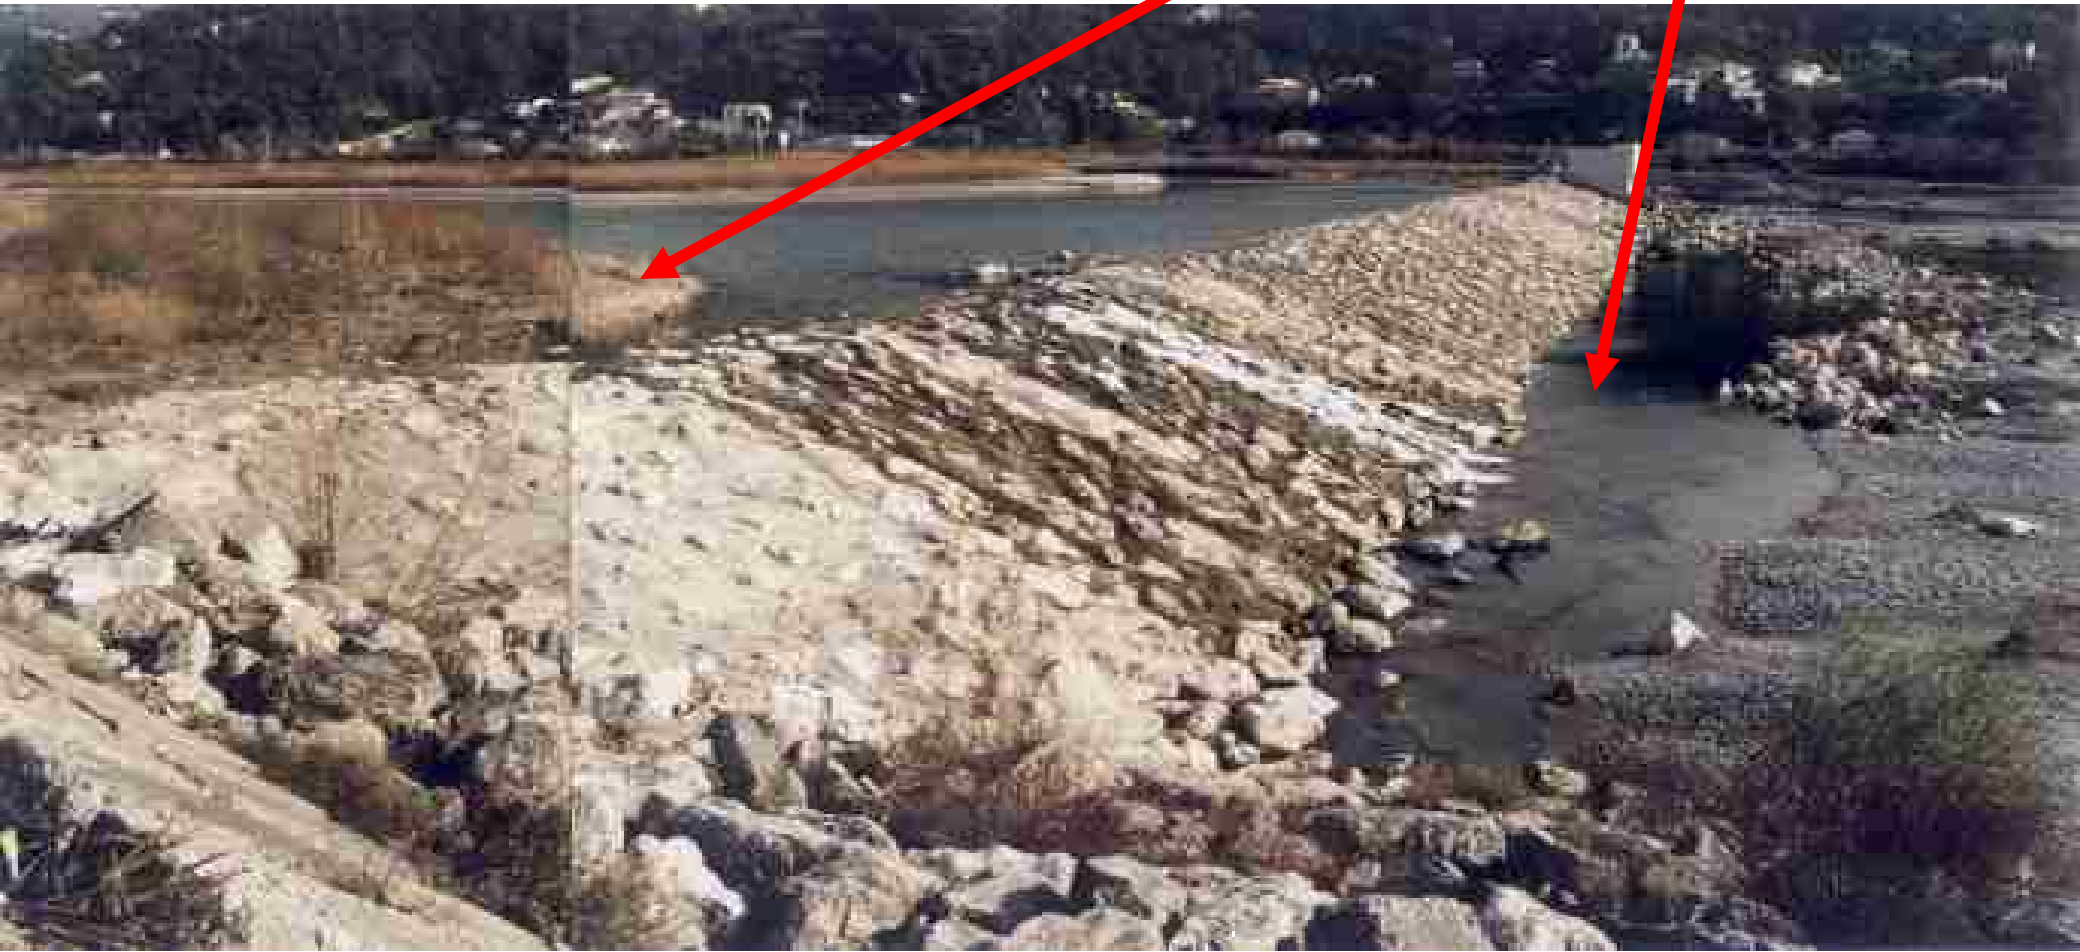
Sill No. 8, showing damages at foot and siltation upstream the weir

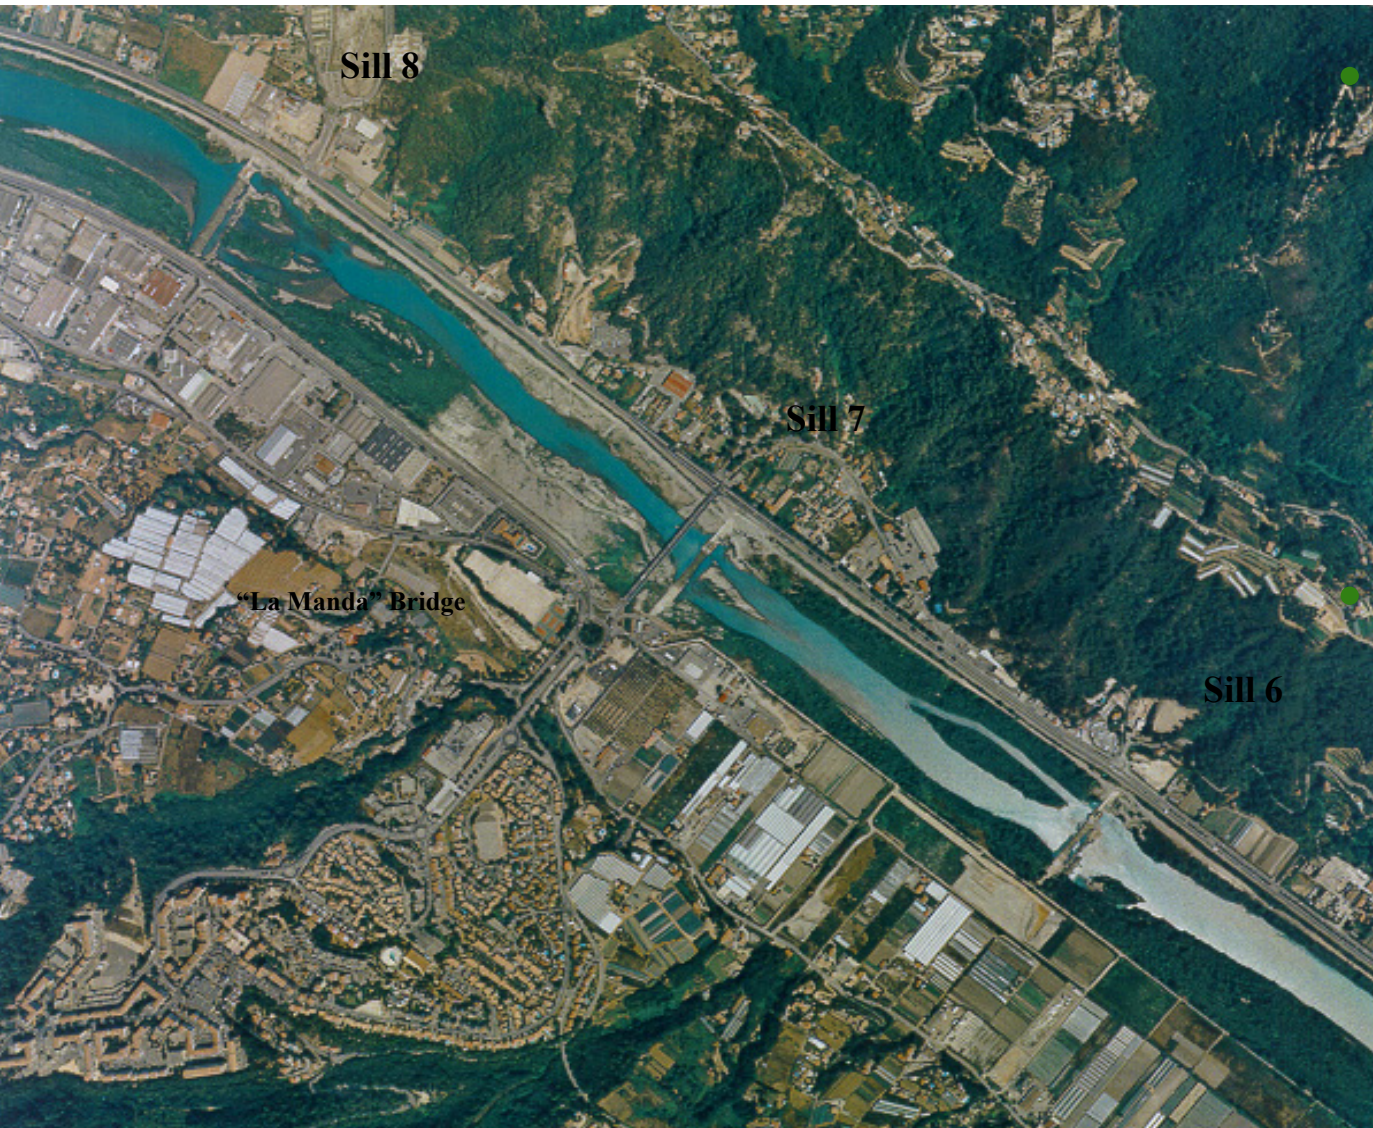
Morphological impact of the sills

- Fine silt deposits changed the river environment: narrow channels bordered with lateral terraces.

- Dense vegetation grew on these terraces in between the sills, changing the flow resistance.

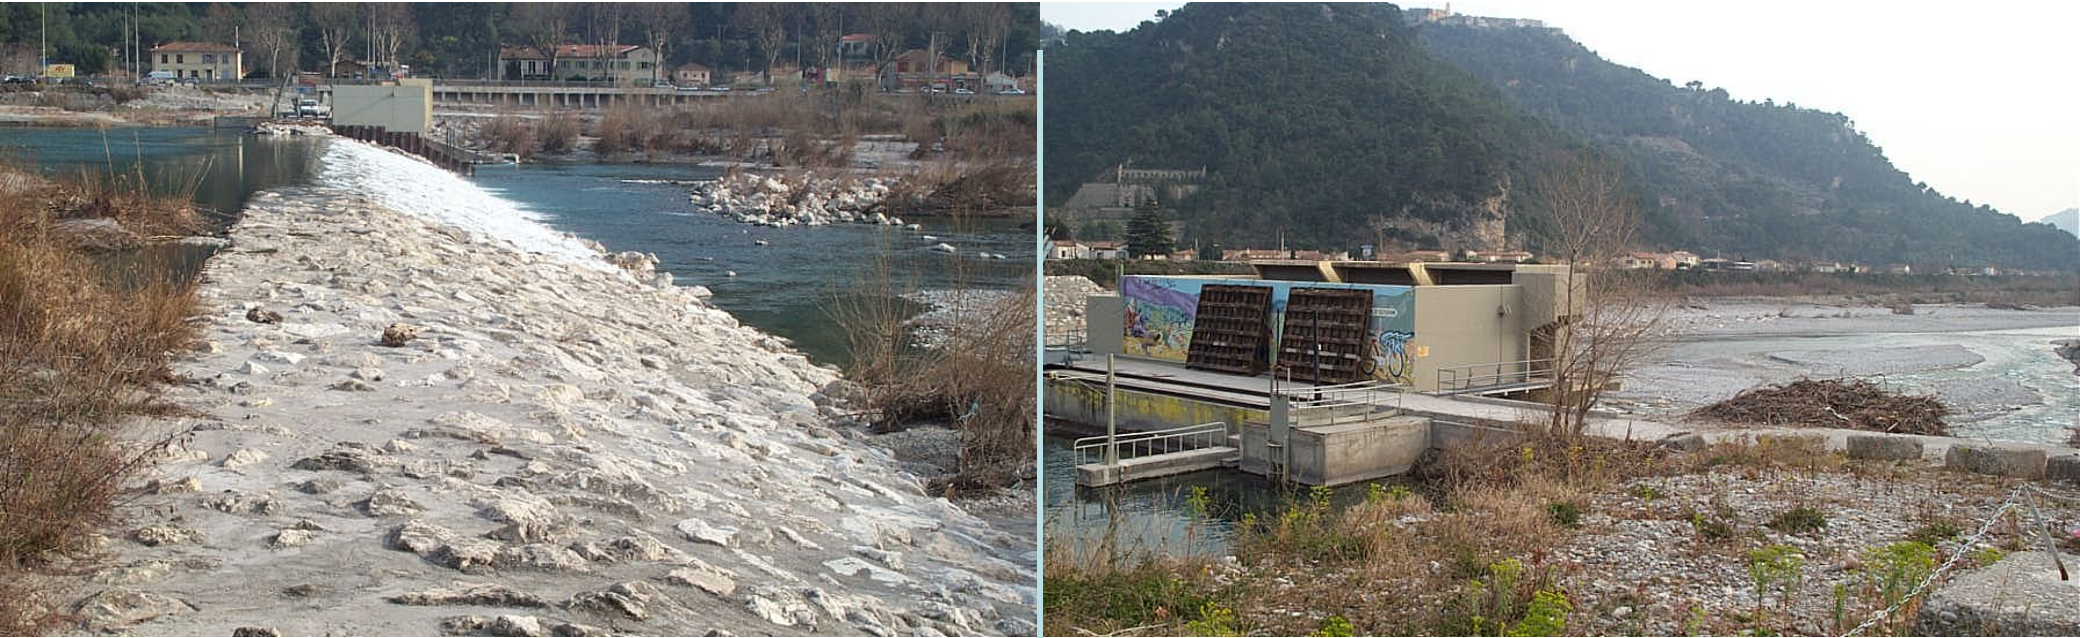
Sills / weirs, for what?

- To control the water levels (official reason)
- To demonstrate low-head hydropower and generate electricity (economic reason)
- Negative impacts were not anticipated (nobody concerned...)

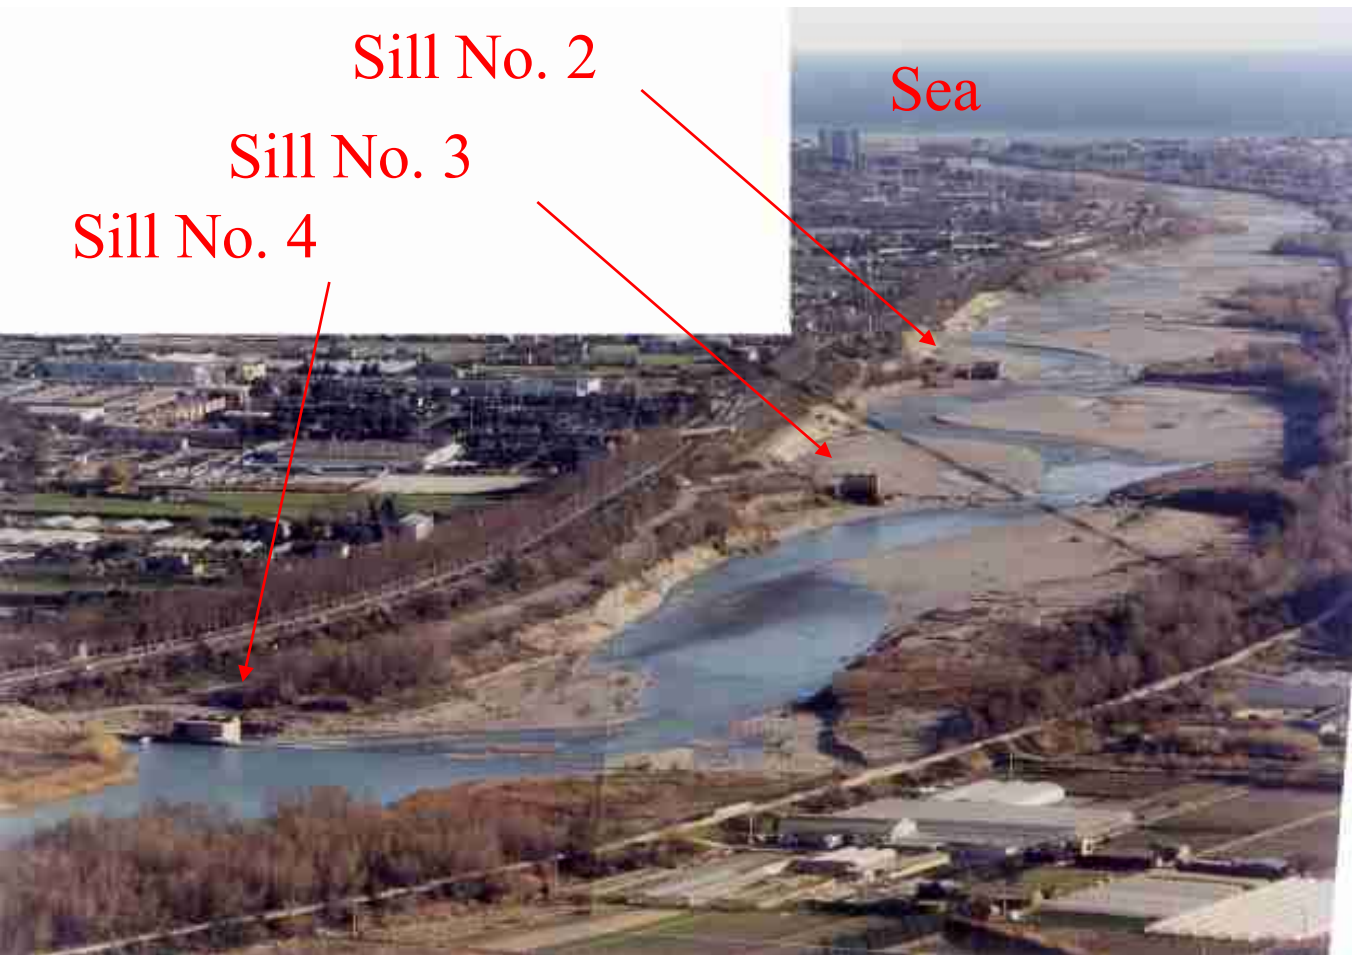
The collapse of sills 2 & 3

During the flood event of 5/11/94, sills 2 & 3 collapsed and the flood wave inundated part of the city and the airport.

Sill 4 was also in danger of collapsing because of high head

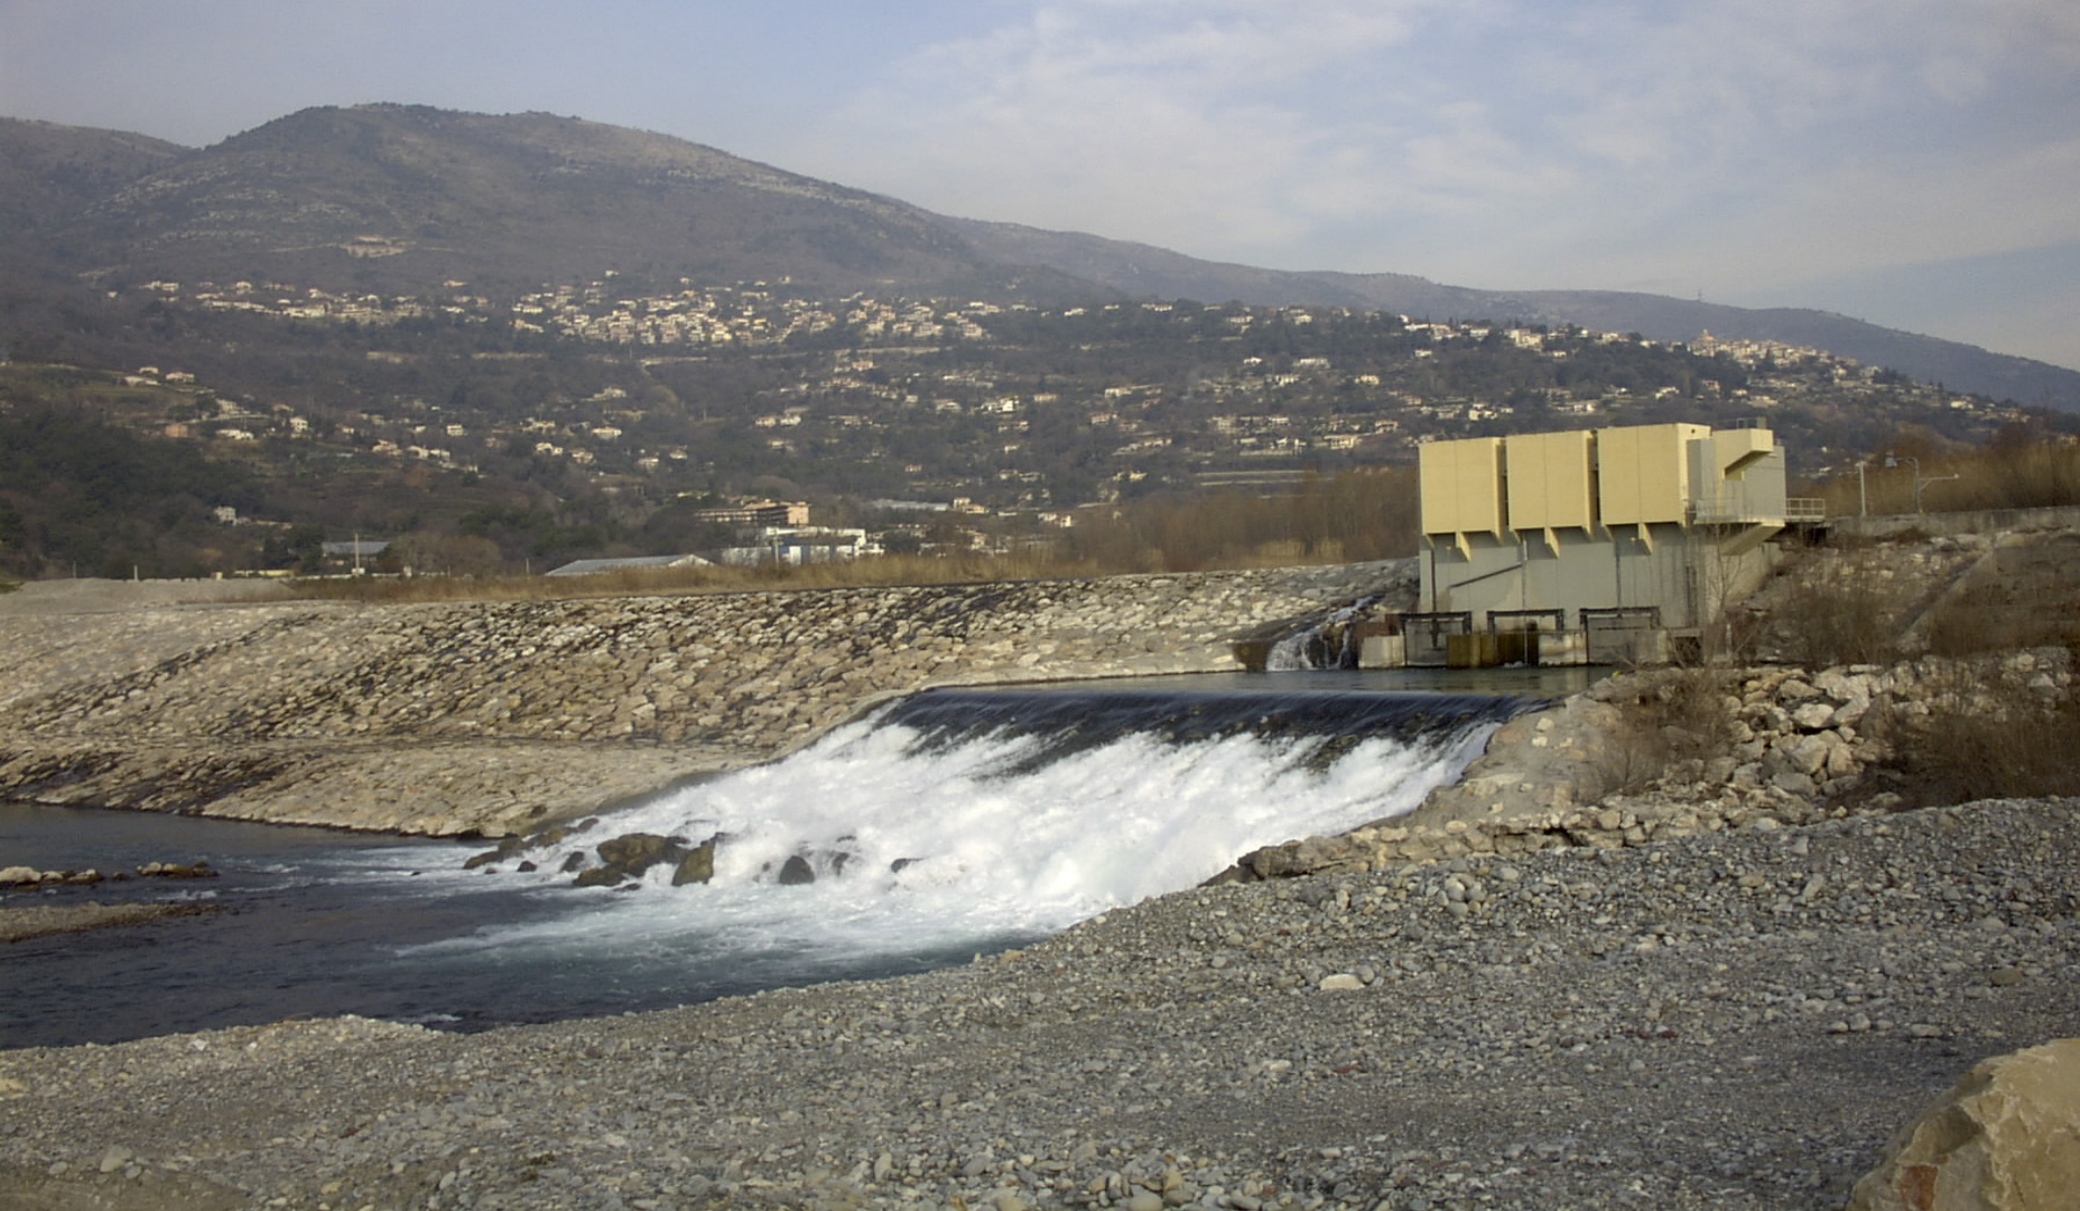
Downstream: Sill 4 was in great danger

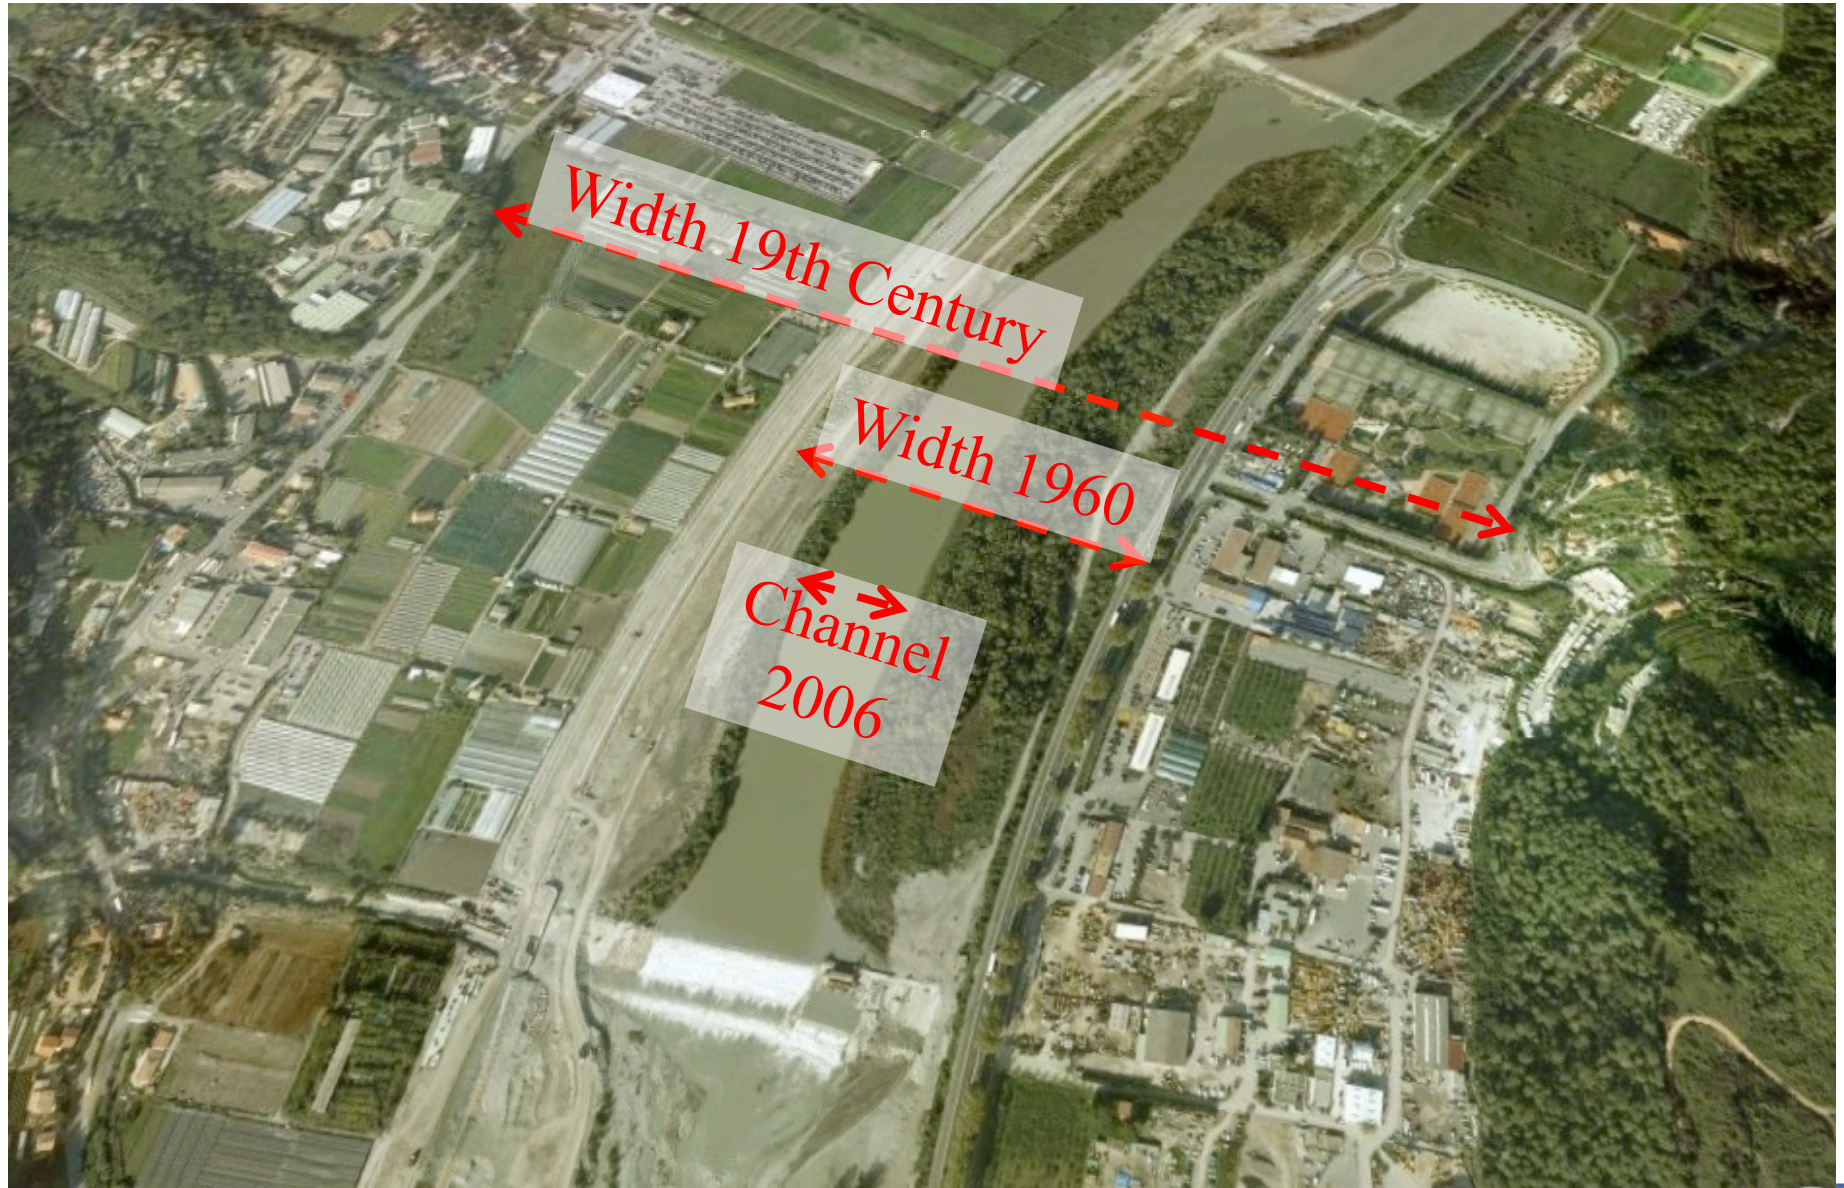
Sill 4 in 2006: vegetation; active width?

- Which formula to apply in the numerical models?
- How about the conditions to apply one or another formula?
- What about the active width to consider for the flow over the sill?

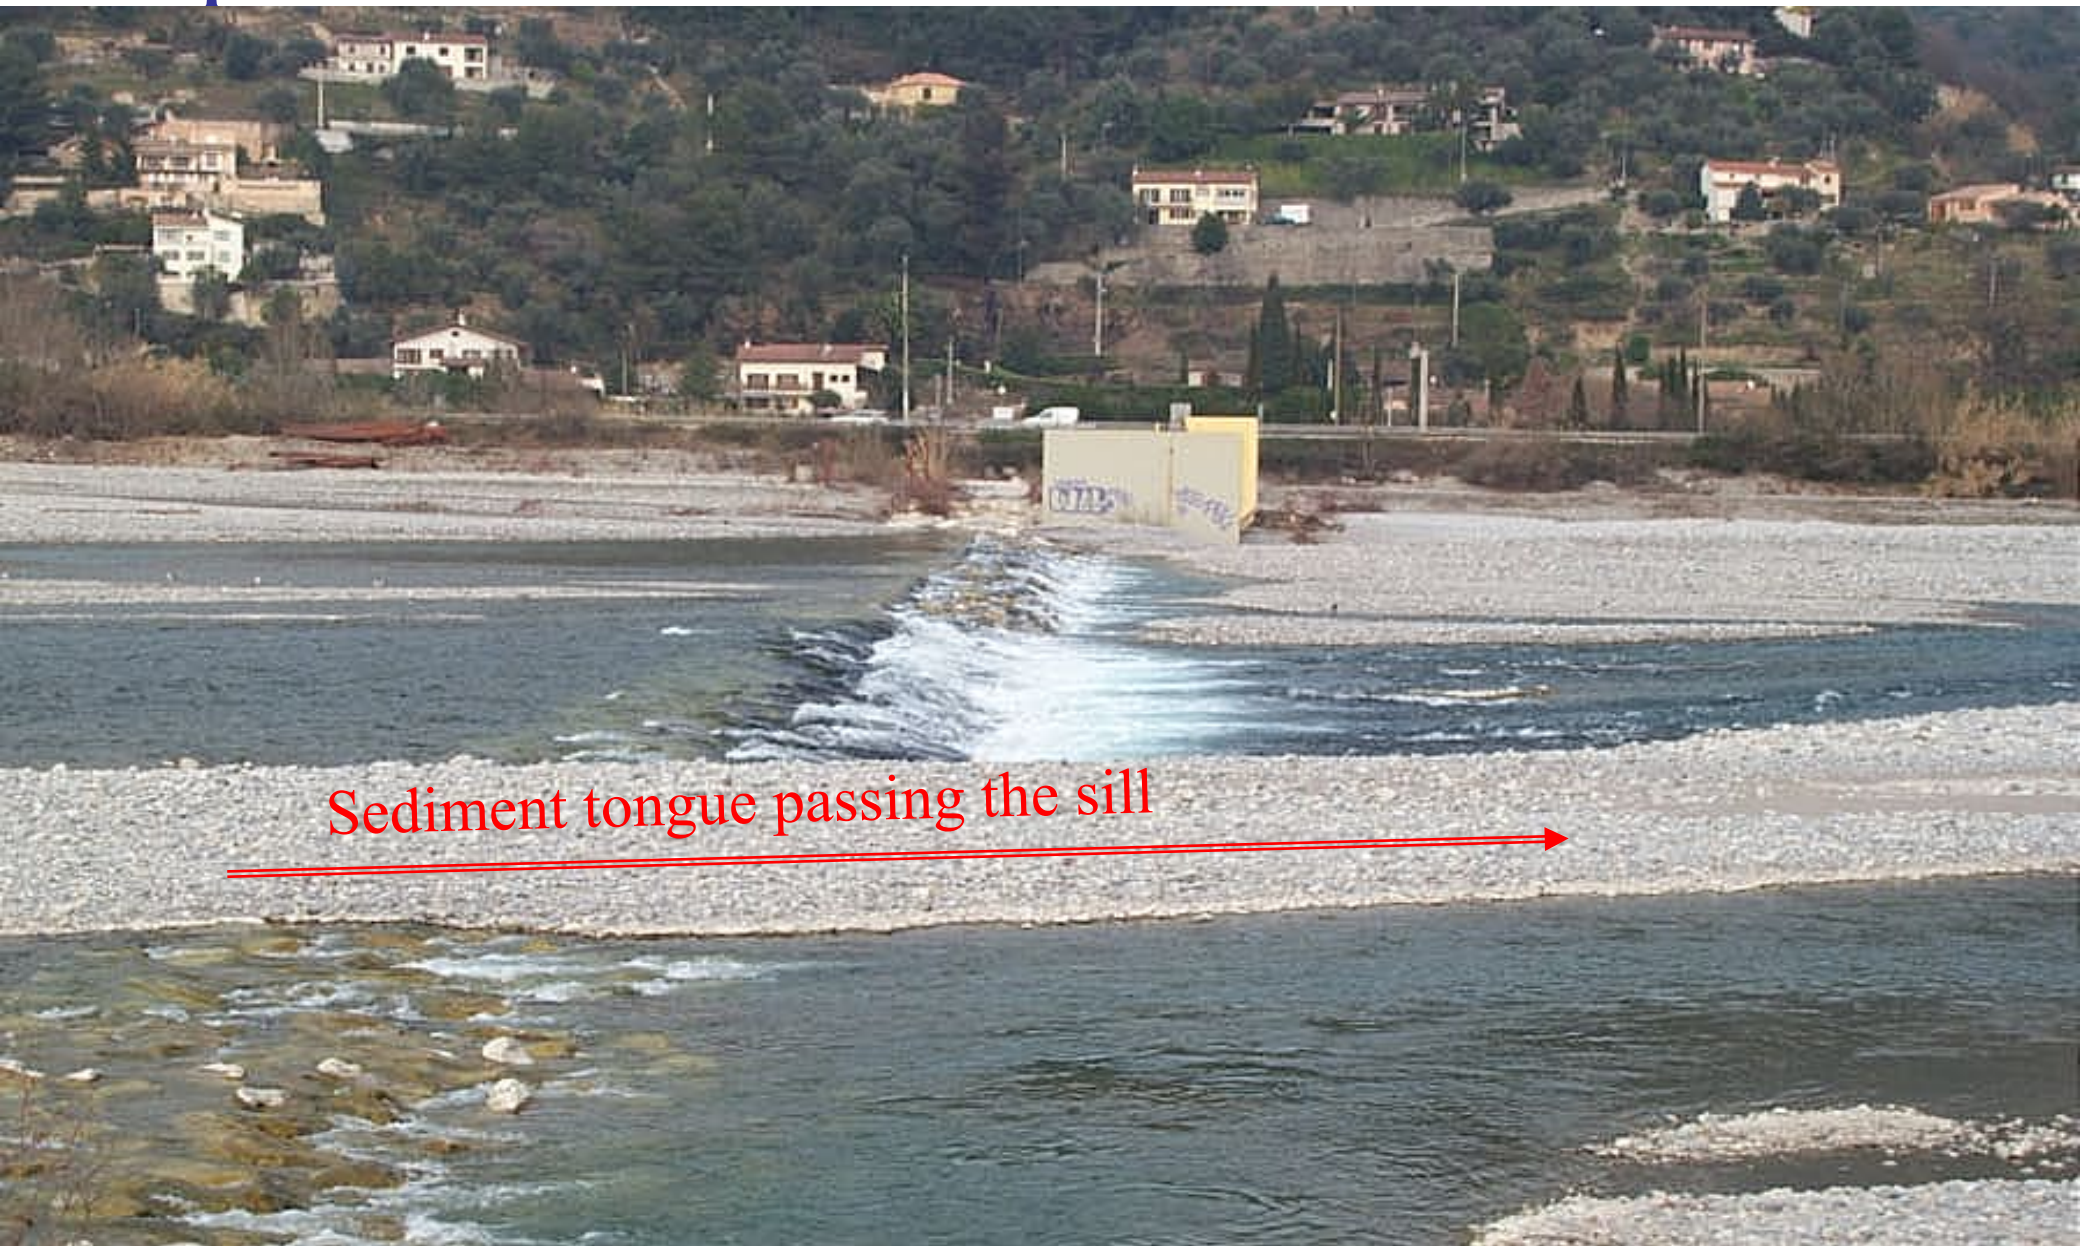
Upstream: Sill No 10 in 2002

Sediment tongue passing the sill
