The Var River

a long history of human interference in its
morphological and sedimentological processes

**Some information before the field visit
and useful for the MIKE 11 modelling**

GEO-FLUVIOMORPHOLOGY OF THE LOWER VAR RIVER

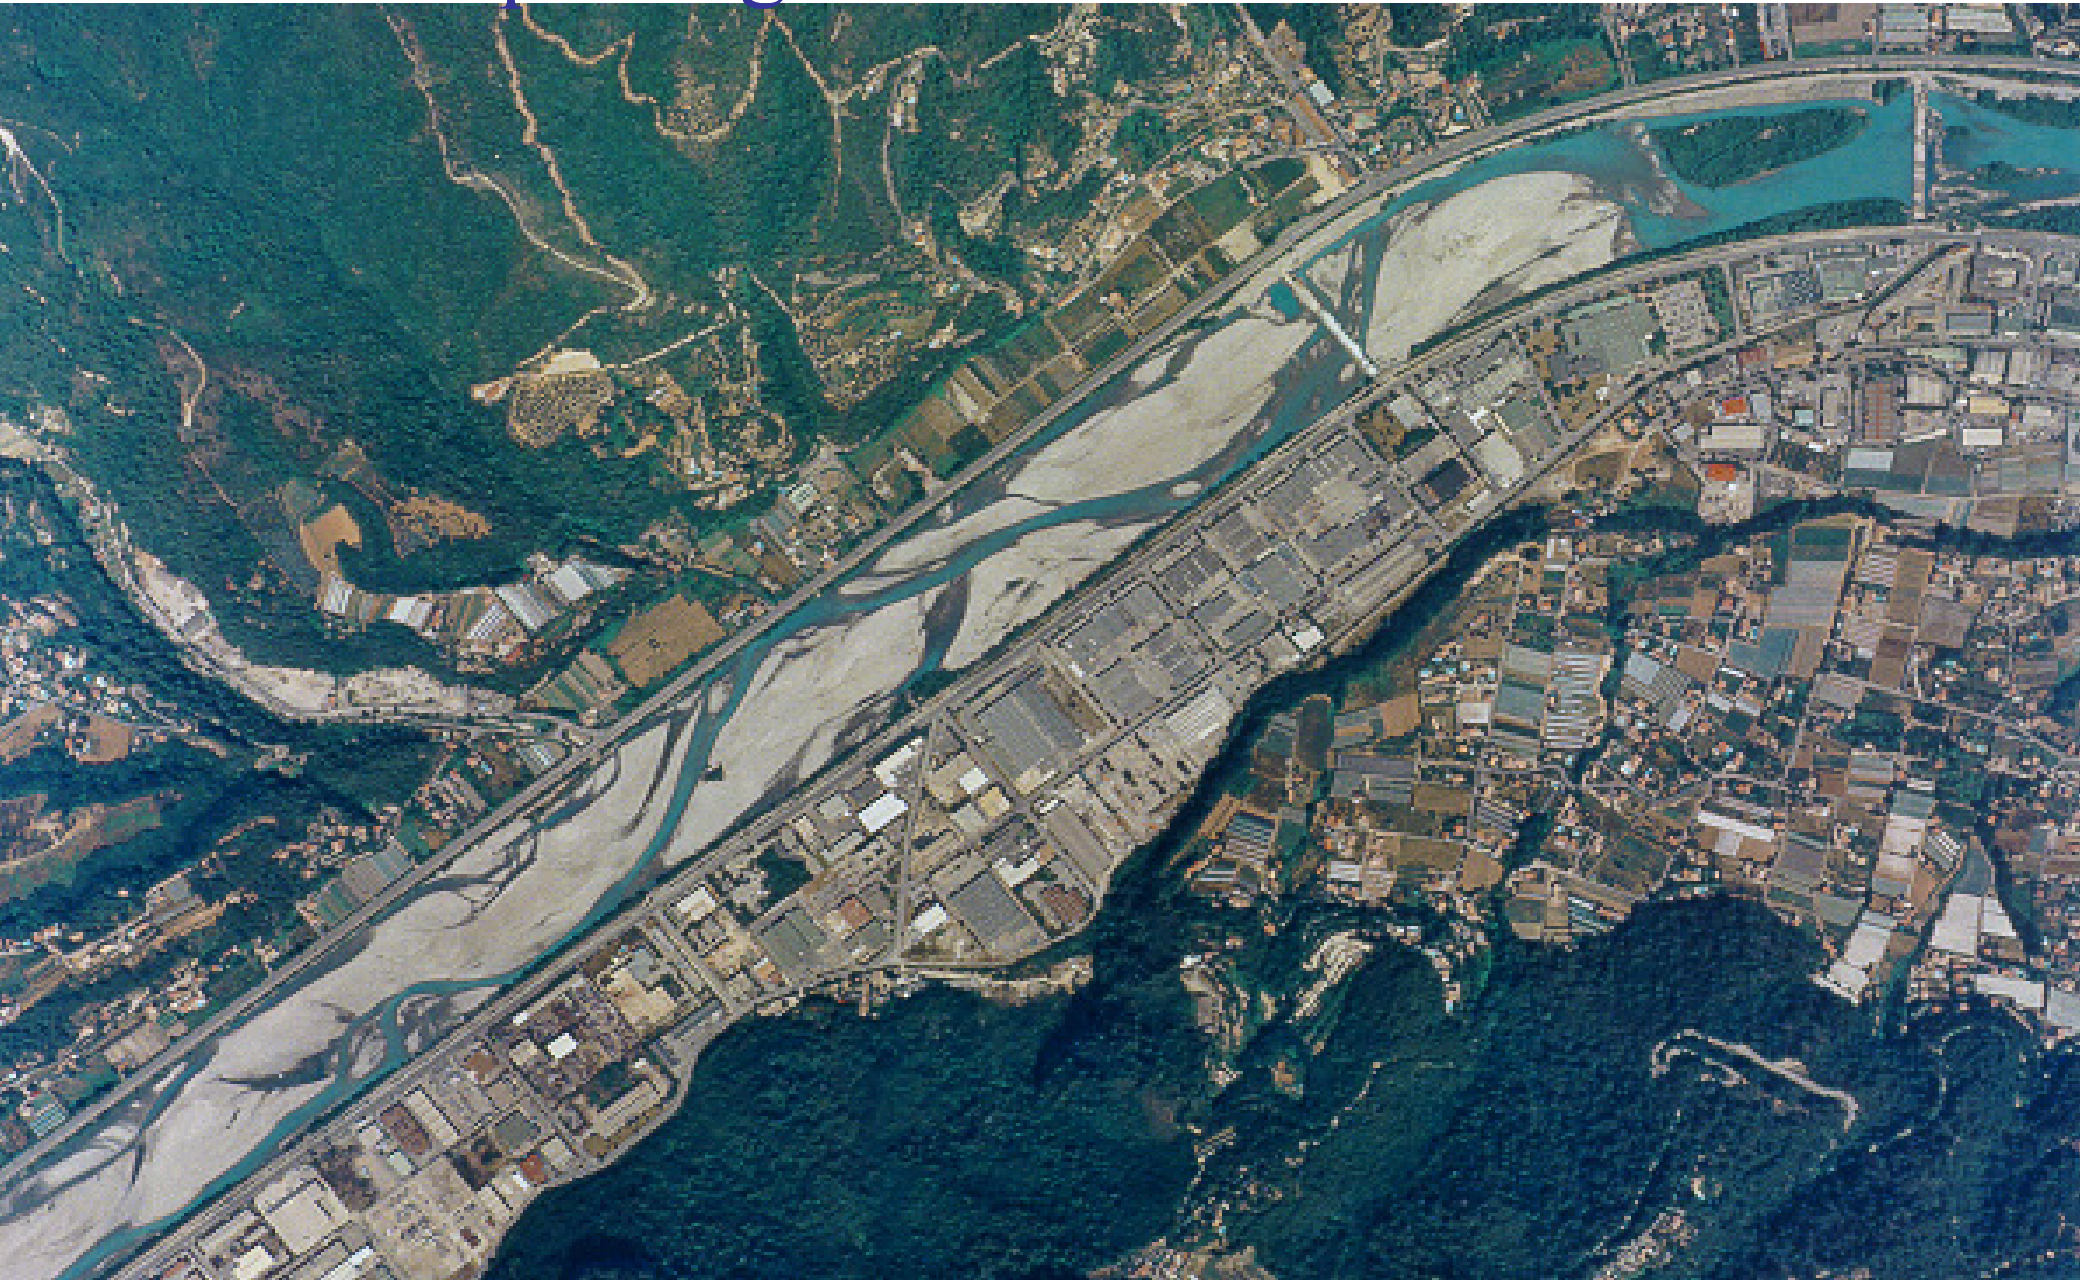
Sediment passing sill No 10 in 1997

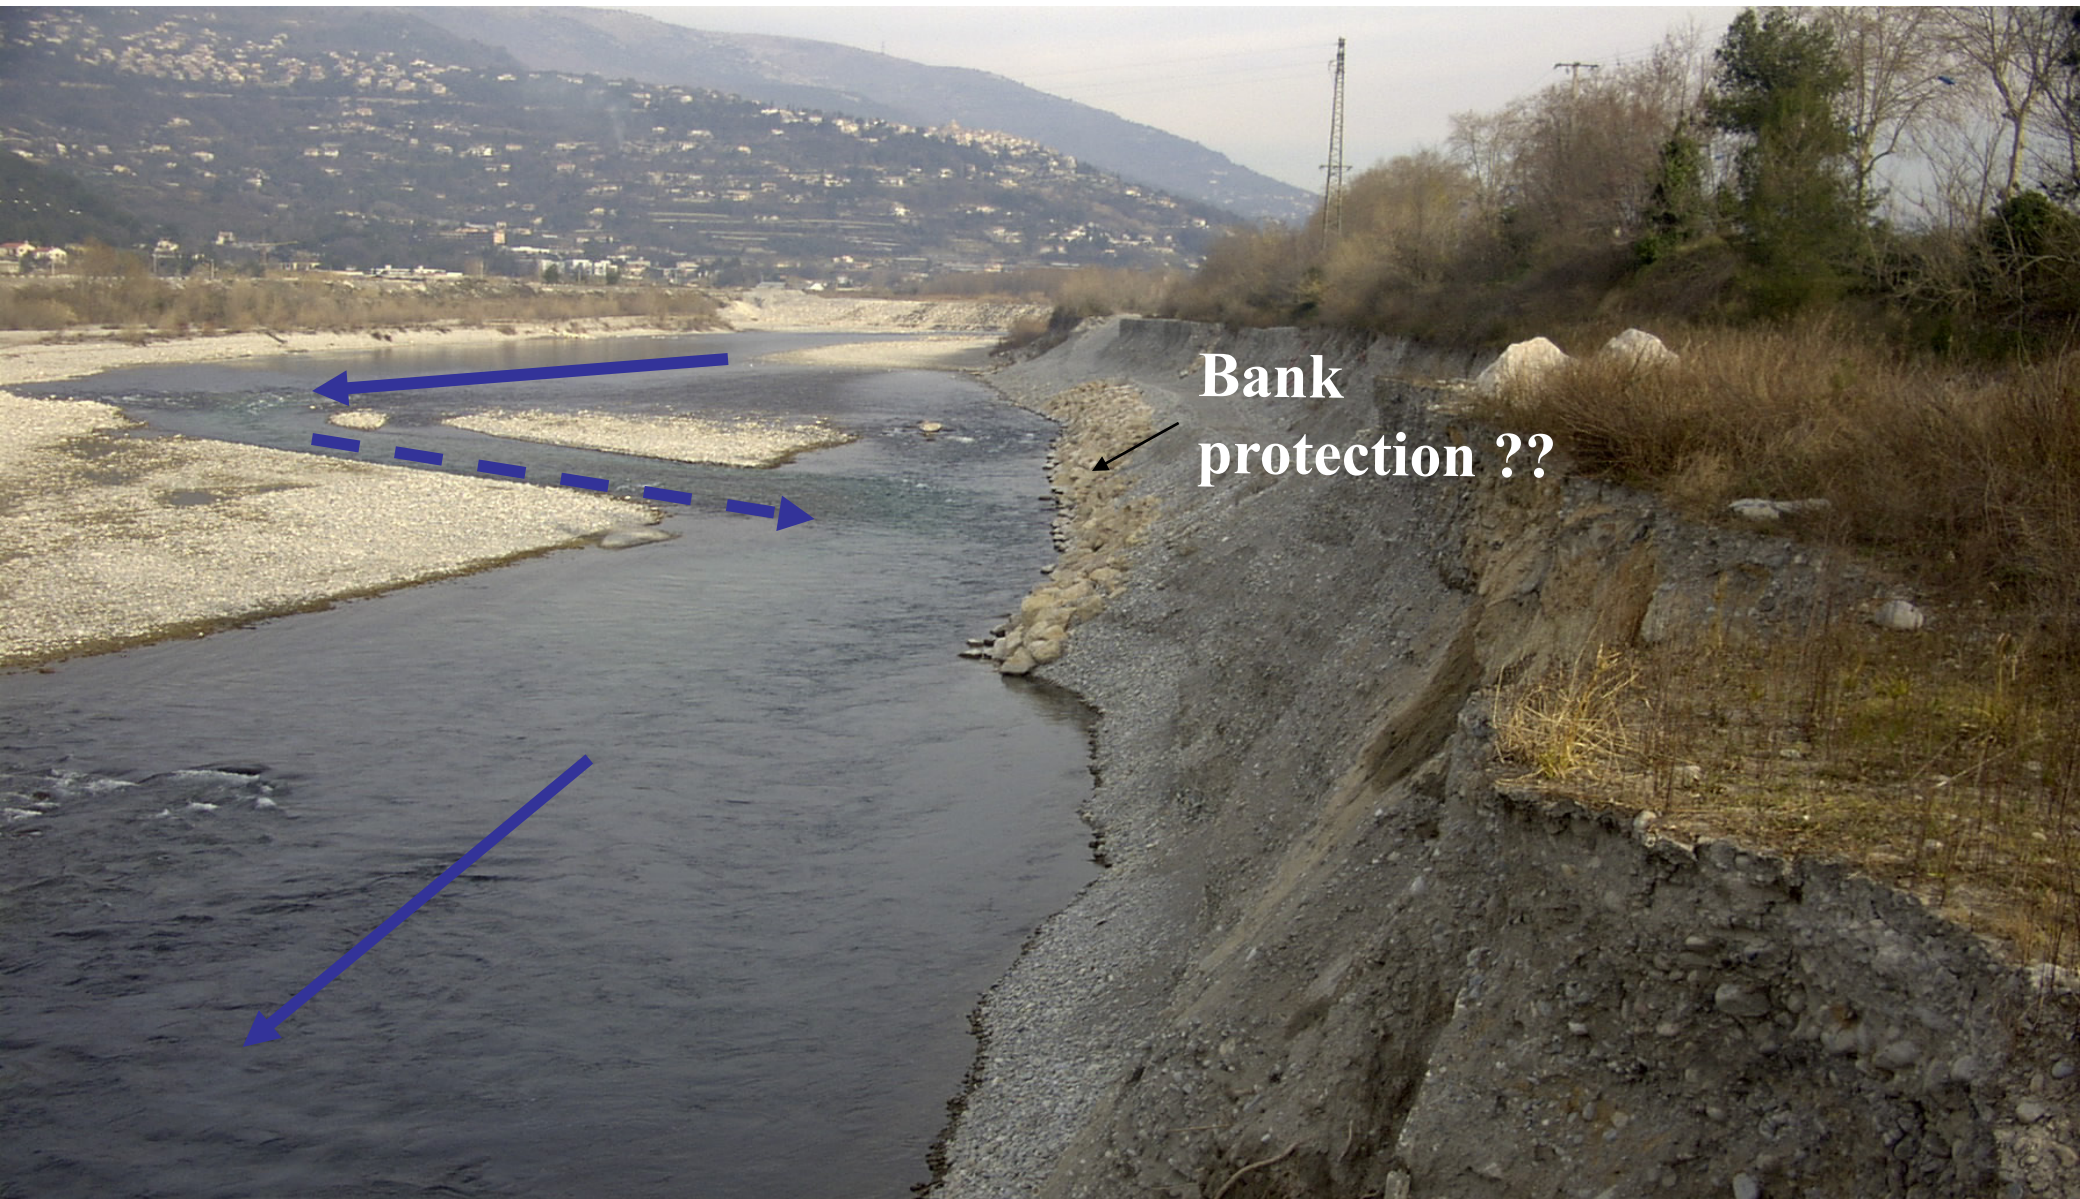
Still sediment deficit below sill 4

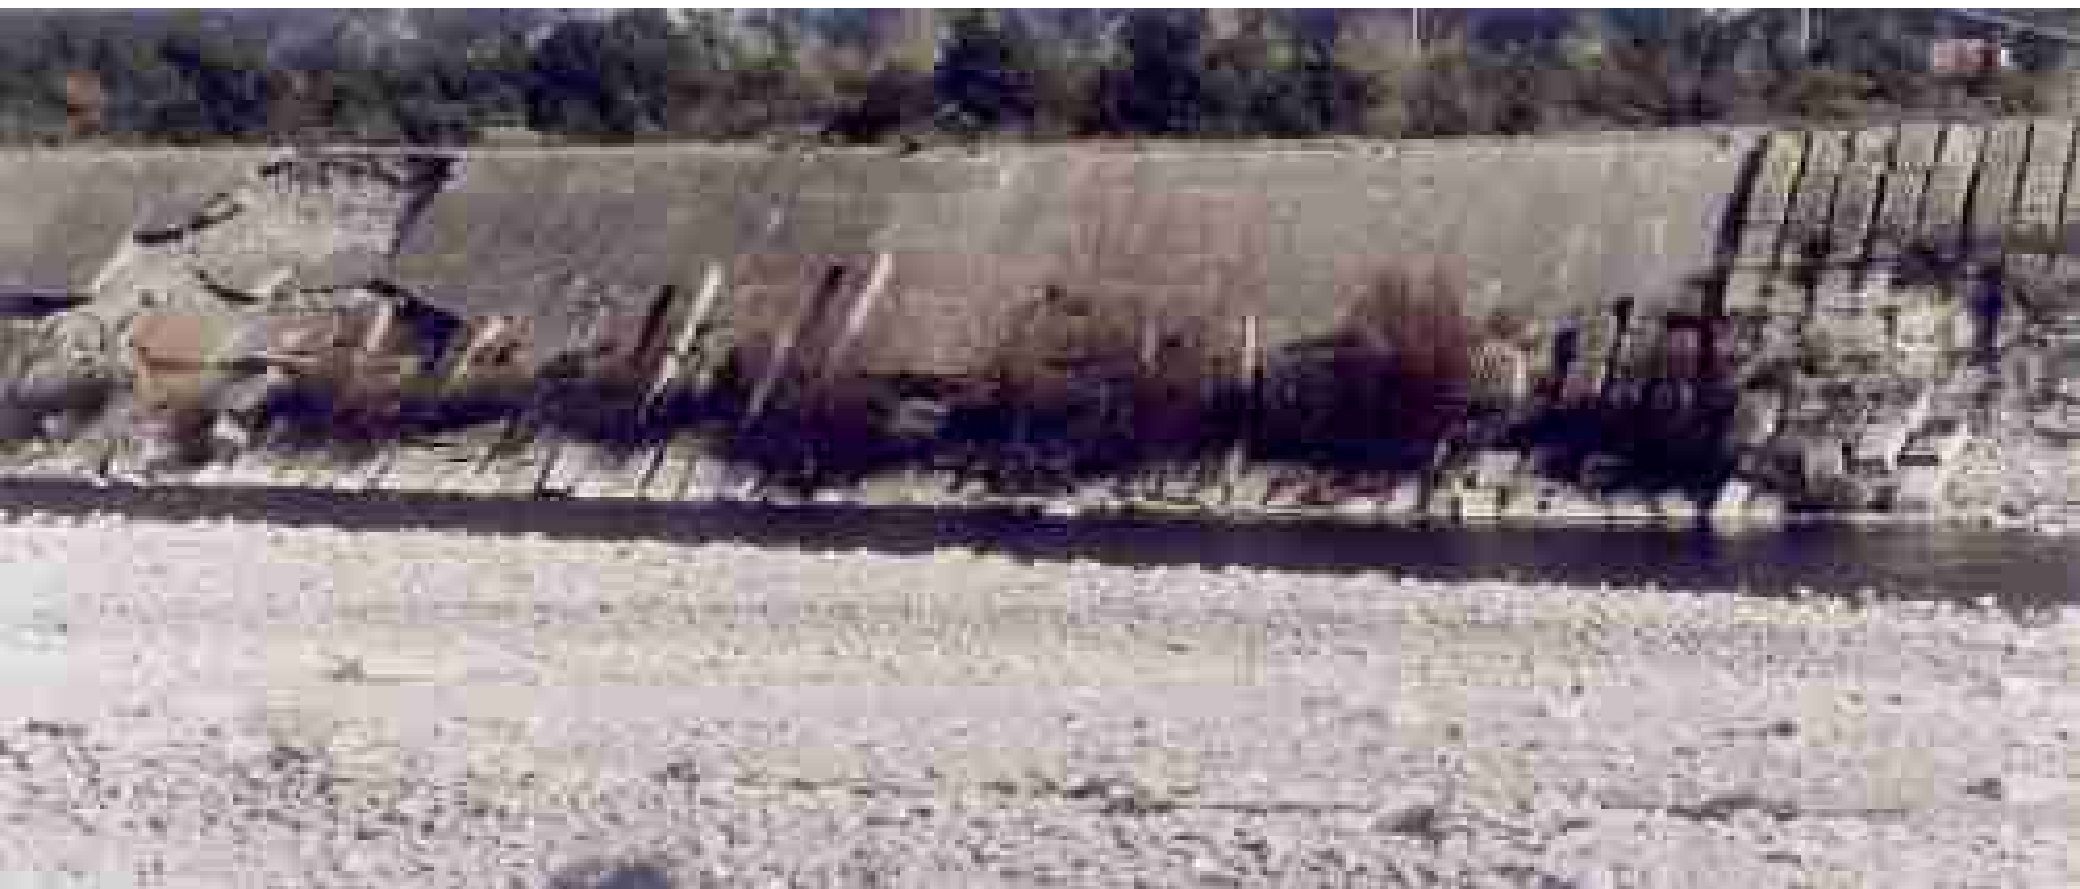
Bank protection: Concrete blocs on concrete revetment “old” method or “local knowledge”?

- The ‘sugar’ bank protection was developed by the locals by trial and error; it was very effective when the locals were in charge with their maintenance
- Replacing the ‘sugars’ by loose blocs (riprap) is the present solution, interesting for whom?
- The “Conseil Général” (regional government) is today in charge with the maintenance of the river and technical solutions decided by engineers and modellers not aware of the reality of the Var River ...
