Restoration of dune mobility in the Netherlands

Abstract

Pioneer stages in Dutch coastal dunes are under threat. In several areas experiments are executed to reactivate dunes. The aim is to restore aeolian processes in order to create new possibilities for the development of pioneer vegetation. How successful are these experiments? This paper compares the results of three different projects from three different areas. The results indicate that large-scale destabilisation of dunes by removal of vegetation leads to a massive increase of dynamic, aeolian processes in an area. In order to achieve durable dune mobility, the sand must stay in movement, either by regular disturbances or by the availability of high, erodable dunes.

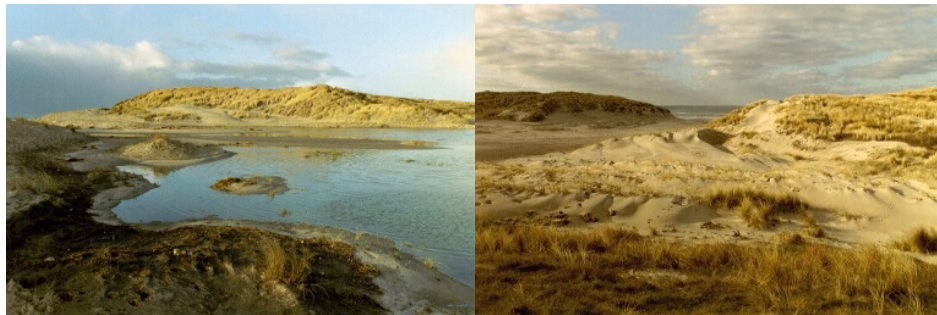
Fig. 2. Kerf with inundation (left) and dune development (right).

Parts of the dune slack are stabilised by vegetation after five years. The notch is still open, probably thanks to heavy recreational use. The width of the entrance has declined from 60m in 1999 to 36m in 2002. The dune slack is occasionally flooded by the sea, mostly in winter (Fig. 2). As a result, part of the slack is covered by water, and protected from aeolian processes. Sand is blown inland, resulting in deposition and the development of small dunes (Fig. 5). For the Kerf area, the supply of fresh beach sand and occasional flooding, in combination with high recreation pressure ensures continuous pressure acting against stabilisation. The input of fresh sand from the beach, containing carbonates, has important consequences for ecological development.

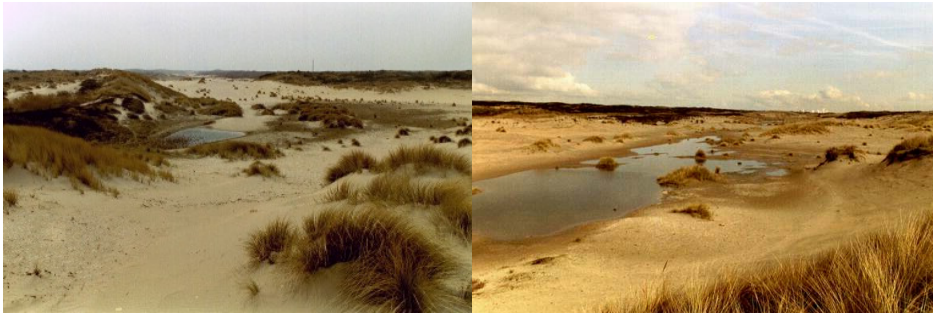
Fig. 3. Van Limburg Stirum area with slack development, facing southwest (left) and north (right).

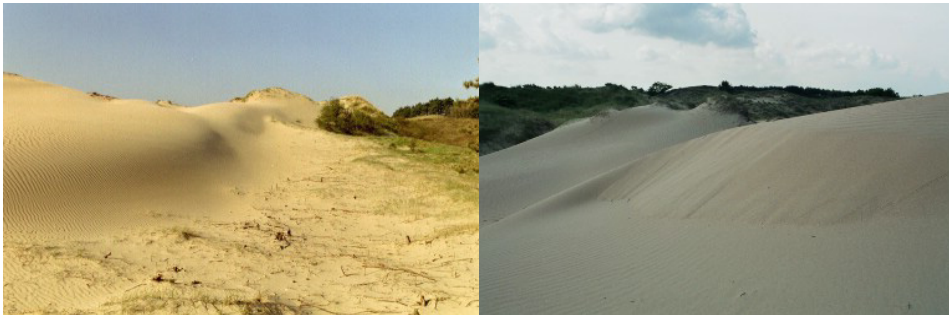
Fig. 4. Verlaten Veld: lee face of the parabolic dune.

On the parabolic dune, the reactivation resulted in huge erosion on the windward side and crest. Locally the height of the crest was lowered more than 4m. At the lee massive sand burial occurred (Fig. 4). In part of the area, the parabolic shape of the dune was transformed to a dome shape. The trailing edges tend to stabilise (Fig. 7). Formation of pioneer slack after migration of the dune has been observed for the first time in 2004. The dune now seems to be partly remobilised, moving over a distance of approximately $1\text{--}5\text{m}\cdot\text{year}^{-1}$. In the western part of the area the surface is deflated down to the groundwater, on average lowered by 0.6m. A large part was already close to the groundwater, and is stabilising relatively fast. On the parabolic dunes, stabilisation is prevented by the severity of aeolian processes. Deposition and erosion is so strong that establishment of vegetation is impossible thus far.

In the VV area, strong deposition in the lee faces of the parabolic dune prevents vegetation growth (see Fig. 4). In the other areas, deposition is not so strong that it results in remobilisation of buried dunes; the areas with deposition re-vegetate when the supply of fresh sand ceases. Continuous input is required in order to keep these parts dynamic. However, the input results in important ecological changes, which continues for a number of years. On the bare parts, slight erosion of about 5-10cm.year⁻¹ prevents establishment of seedlings.

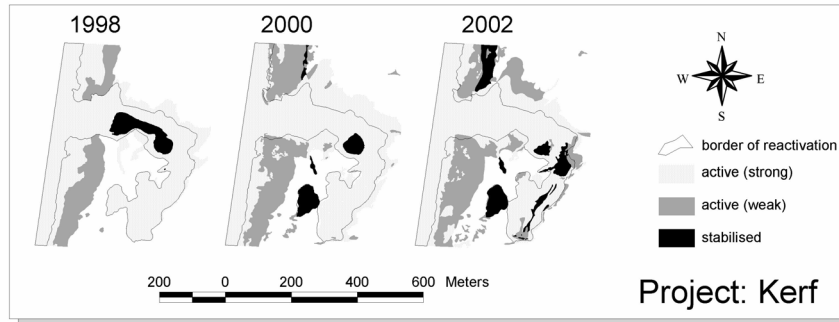
Fig. 5. Changes in extent of dynamic processes in the Kerf area between 1998 and 2002.

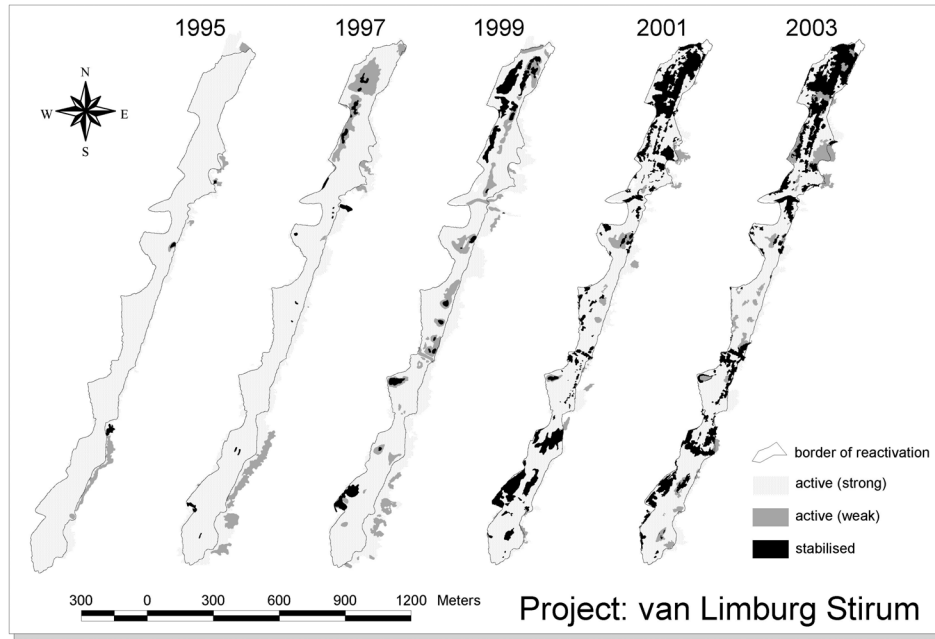
Fig. 6. Changes in extent of dynamic processes in the Van Limburg Stirum area.

In the van Limburg Stirum area, large parts are stabilised after eight years, and the landscape has changed to a mosaic of bare patches, pioneer vegetation, sand burial and stabilised surfaces (see photograph and Fig. 6). Only locally new dunes are formed, but these are mostly small. The landscape changed from a large sand drift area into a

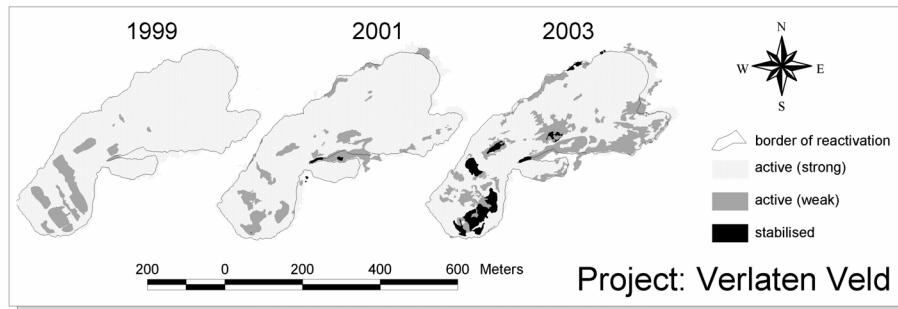
Fig. 7. Changes in extent of dynamic processes in the Verlaten Veld between 1999 and 2003.

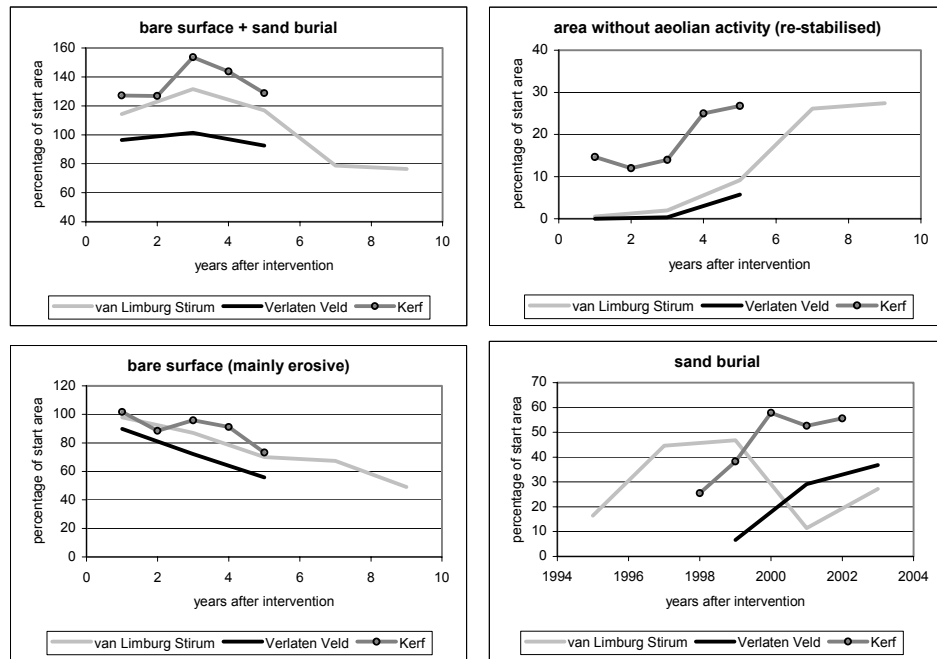
Fig. 8. Changes in dynamic and stabilised surfaces for the three areas.

In all areas, aeolian activity increased after the intervention, up to a maximum in the third year (Fig. 8a). From then on, the total area with activity started to decline, because of vegetation development on bare spots (Fig. 8bc). The area where vegetation is buried by drift sand, continues to expand in the first five years after reactivation (Fig. 8d). The size of this area seems to be correlated to wind activity: during years with less wind than average, the size may decrease temporarily. In the VLS area, and to a lesser extent in the Kerf, this is reflected in yearly variation of sand burial. The size of the bare, mainly erosive area is hardly or not related to meteorological conditions. Stabilisation starts from the beginning and proceeds gradually. It is striking that all lines in Fig. 8 follow more or less the same trend, which implies that meteorology is not the dominating factor in the response of the landscape after a large scale disturbance.

Relatively spoken, the expansion of area with dynamic processes is the smallest in VV (Fig. 8a). The purpose here is to mobilise a large dune form. If this succeeds, the dune moves only over a small distance, which means that expansion of the area covered by sand is slow as well. Meanwhile, in the deflation plain, stabilisation proceeds. A large reduction in activity was expected in the first years of the project, since large parts of the bare area in the west are close to the ground water.

The largest expansion occurred in the Kerf area (Fig. 8a). A large surface of formerly stabilised dunes is affected by sand burial. In this case, a continuous source of sand ensures ongoing burial by sand. The size of the influenced, but not devegetated area is about half the size of the devegetated area.
