Restoration of the Sieperda Tidal Marsh in the Scheldt Estuary, The Netherlands

Abstract

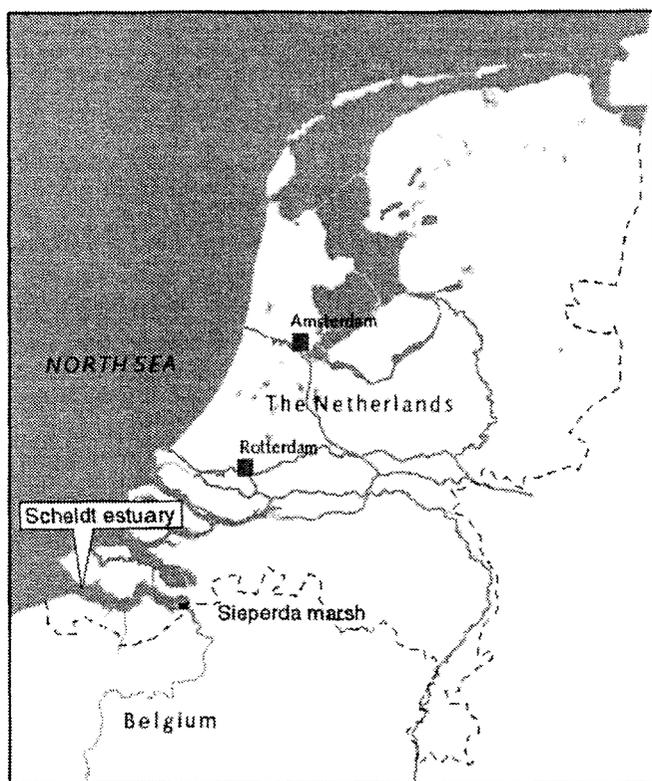
Figure 1. The location of Sieperda marsh in the Scheldt estuary.

The Scheldt River originates in northern France and flows through Belgium and the southwestern part of the Netherlands into the North Sea (Fig. 1). The Scheldt catchment area is approximately 21,000 km² and is inhabited by some 10 million people. The stretch from the city of Ghent (Belgium) to the North Sea (approx. 160 km) is known as the Scheldt estuary. It is a macrotidal coastal plain estuary and is important economically and ecologically. The estuary is primarily the navigation route to the port of Antwerp in Belgium, one of Europe's major ports. It contains important habitats for shellfish (cockles) and juvenile flatfish (plaice and flounder). Migratory birds use the estuary for foraging, and a number of coastal breeding birds nest along the estuary. The estuary has been in an almost continuous state of change during the 20th century. Because of land reclamation, reinforcement of dikes, and the deepening of the shipping channels, about 2,500 ha of mudflats and tidal marshes have been lost since 1900. Substantial parts of the remaining marshes have reached the final stage of succession. Sheltered areas with the potential to develop into intertidal areas and marshes have become very scarce. One way of stimulating the development of new marshes is the reintroduction of tidal influence in reclaimed polders. In addition to ecological benefits the restoration of tidal wetlands in this way may also reduce the maximum high water levels and may be beneficial to water quality, especially in the upper reaches of the estuary (Verbeek & Storm 2001). However, there is intense public distrust in the idea of allowing sea dikes

This article is about a pilot tidal wetland restoration project, which was made possible only because of an accidental dike breach in a remote part of the Scheldt estuary. The Sieperda area is located in the brackish part of the estuary near the Dutch–Belgian border (Fig. 1) and has experienced a number of changes over the past 35 years. Before 1966 the area was part of the much larger 2,000-ha Saeftinghe marsh and was characterized by a network of small and narrow tidal creeks. By comparison, the Sieperda area is only 100 ha large. In 1966 a sand dam was constructed on the marsh parallel to the existing sea dike to accommodate gas and water pipelines. The area between the dam and the sea dike was closed off from tidal influence by the construction of a relative low (summer) dike, turning it into a polder, 85% of which was leveled and used for cattle grazing and agriculture (Fig. 2). Only the easternmost part of the polder, closest to the estuary, kept its natural geomorphologic structure. A long ditch was dug along the sand dam for drainage of rainwater and occasional floodwater. Several smaller ditches were linked onto the main drainage system (Fig. 3A). Because the summer dike was relatively low the area fre-

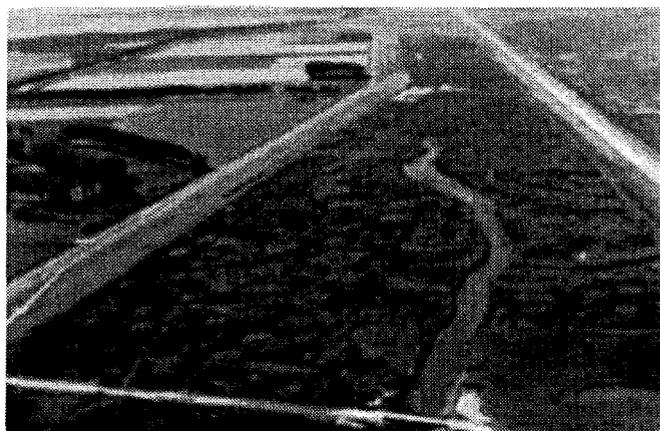
Figure 8. Aerial photograph of Sieperda marsh in 1996.

ish. From 1995 onward the colonization of the mudflats progressed rapidly (Figs. 6b and 8), probably as a result of improved drainage after the construction of the new creek in 1993. In recent years *Phragmites australis* became established in the marsh and expanded rapidly.
