What happened in 1953? The Big Flood in the Netherlands in retrospect

BY HERMAN GERRITSEN

During the weekend of Saturday 31 January to Sunday 1 February 1953, a storm tide raged across the northwest European shelf and flooded the low-lying coastal areas of the countries around the North Sea. The peak high waters occurred during the night and the storm surprised many people in their sleep. The resulting disaster in terms of loss of life and damage to infrastructure was enormous. In the Netherlands, 1836 people fell victim to the flood; in the UK and Belgium, the casualties were 307 and 22, respectively. The large number of fatalities in the Netherlands was related to the fact that much of the affected area is below sea-level.

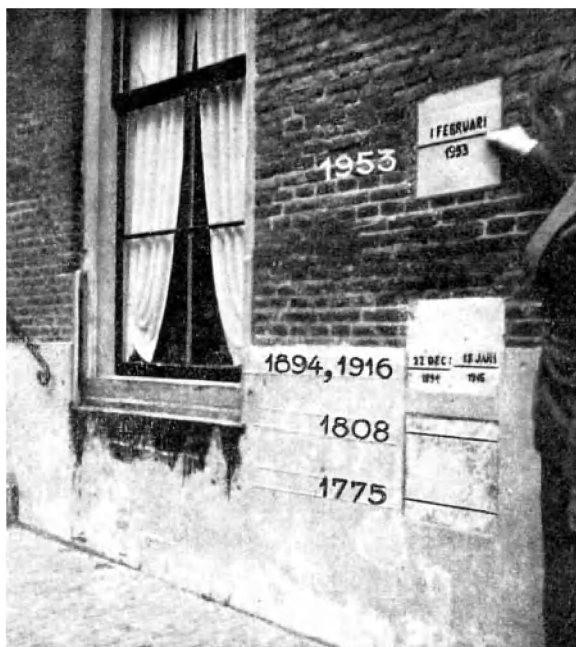
Figure 3. Flood marks in the delta area (from [Van Veen 1962](#)).

experienced (figure 3). This was accepted by the people as an act of nature, which can never be fully tamed, or it was seen as simply the consequence of some neglected and quickly repaired, local dyke stretch. Alternatively, for some, it was accepted as the will of God (Slager 1992). The people realized that absolute safety did not exist. However, they created a physical environment and a unique system of mutual cooperation in the form of polder boards that allowed them to live below sea-level and to live with the threat of the sea.

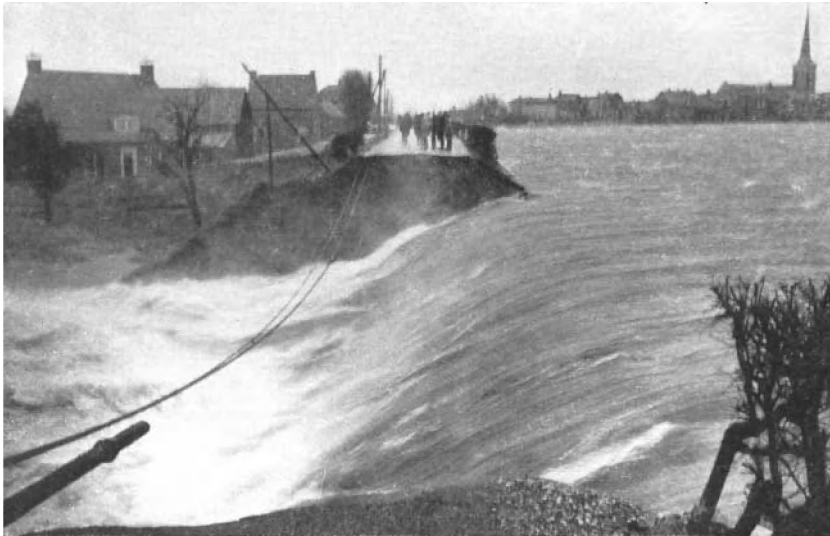
Figure 8. Breach at Ouderkerk aan de IJssel, upstream along the tidal reach of the river Hollandse IJssel, at the time of tidal low water (from [Van Veen 1962](#)).

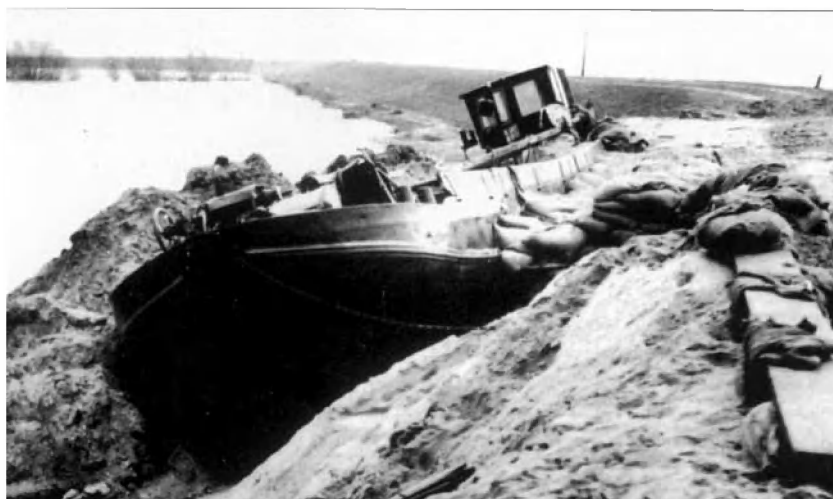
Figure 9. The ship that closed the dyke breach and saved the central parts of Holland from flooding (from [Slager 1992](#); photo: C. van Gennip).

farmer Sieling, who noted that at the time of low water, the water slightly flowed back through the still small breach in the dyke near Herkingen. He concluded that the breach should be enlarged by removing the clay toe of the dyke to let the water flow to sea more quickly than would be possible by using the pumping station. As a member of the Dike Council, he overruled the urgent pleas not to do so. His action to prevent salt water ruining his land eventually led to a 300 m wide tidal gap, washing out to a depth of 10–14 m. 2500 trucks with stone and rubble and 100 000 sandbags were needed to close this scornfully called ‘Sieling Canal’ 6 weeks later ([Slager 2003](#)). There were also cases of heroism, such as that of Nieuwerkerk aan de IJssel to the east of Rotterdam. Here, a noted weak spot in the dyke collapsed at approximately 05.00, threatening to flood the vast low-lying area behind. Parts of this polder area are over 6.5 m below sea-level, making it the lowest polder in the country. Mayor Vogelaar resolutely commandeered a nearby river freight ship and ordered skipper Evegroen to manoeuvre it into the dyke breach and sink it ([figure 9](#)).

Immediately consolidated with tarps and sandbags, the ship closed the breach and prevented the inundation of Central Holland, saving its 3 million inhabitants from the flood ([Slager 2003](#)).

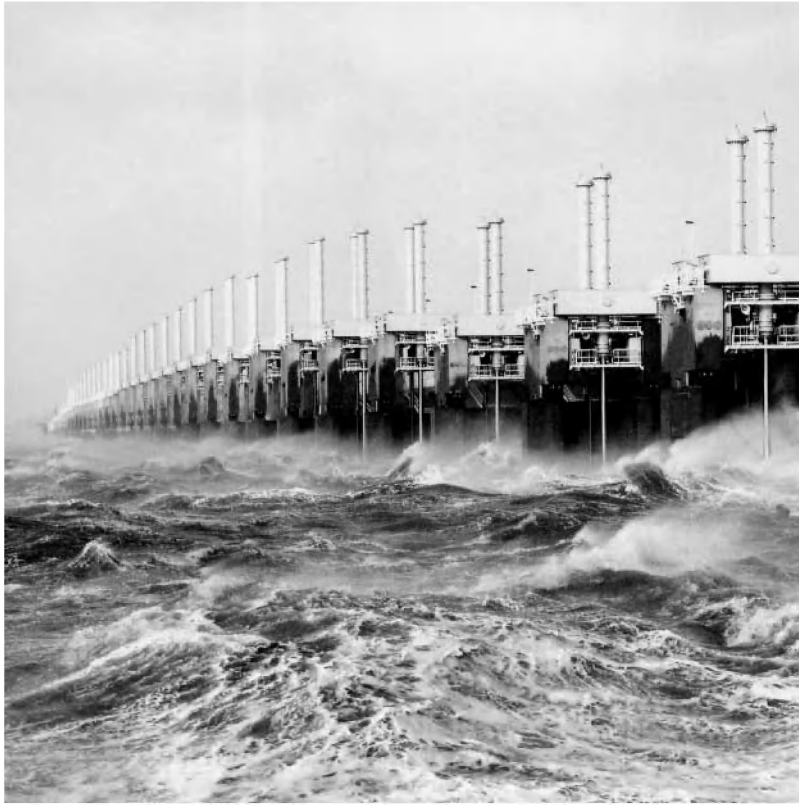
Figure 14. The Eastern Scheldt storm surge barrier (source: Rijkswaterstaat, the Hague).

In 1975, owing to pressure from fishing, oyster and mussel culture and much increased environmental awareness, the Netherlands' parliament approved the additional cost for changing the plans for full damming of the eastern Scheldt by a plan for a movable storm surge barrier. The sheer size of a barrier for the 8 km wide inlet of enormous tidal volume required novel engineering solutions in its design, foundation and hydraulic systems. In normal situations, an average tidal cycle forces some 950 million m³ water in and out of the eastern Scheldt through its 62 massive steel gates, keeping the tidal nature and the environment of the basin largely intact (see figure 14). On 4 October 1986, Queen Beatrix inaugurated this major engineering complex. The inauguration of the barrier also marked the completion of the Delta Plan, more than 33 years after the Big Flood.
