Paardenmarkt Bank, a WWI ammunition dump site off the Belgian coast

Tine Missiaen

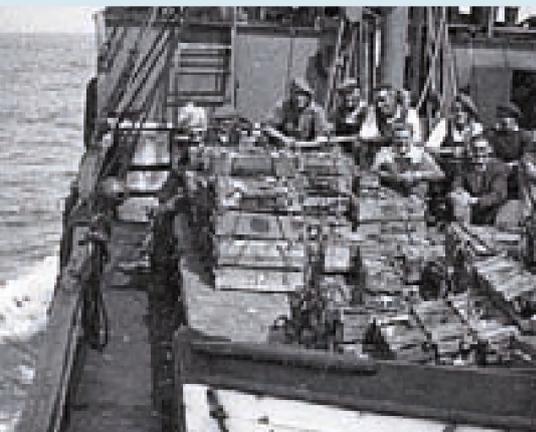
■ The dumping of ammunition at sea after WWI (ORO Nieuws Knokke-Heist)

The dumping operation on Paardenmarkt Bank began on 22 October 1919. It was carried out by the Marine Affairs Administration in close cooperation with the Ministry of Defence. The operation progressed steadily without many incidents, except for a small boat whose cargo exploded at just five metres from the quay wall on 18 December. The vessel sank and one of the persons on board was killed. On 17 January 1920 it was announced that the operation was finished, much to the relief of the Marine Affairs Administration. Because many unexploded shells turned up afterwards, new boat trips were made to Paardenmarkt Bank from the end of March 1920 onwards.

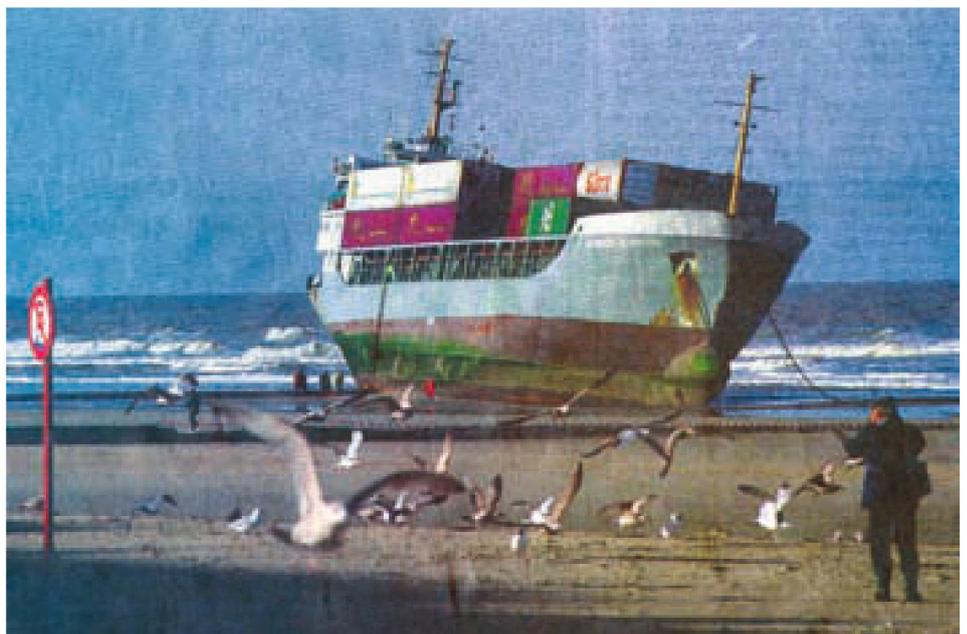
■ The German container ship Heinrich Behrmann was stranded on the beach of Blankenberge in November 2001. There is a real danger that such an accident could occur near Paardenmarkt Bank (VLIZ)

On the face of it, it seems very unlikely that a large ship will run aground on Paardenmarkt Bank. Ships with a relatively deep draught (such as tankers and container ships) are likely to get stranded before they reach the ammunition dump site. Yet several ships have run ashore on the Belgian coast in stormy weather over the past decades. The most recent accident took place in November 2001, when a German container ship was stranded on the beach of Blankenberge (see image).

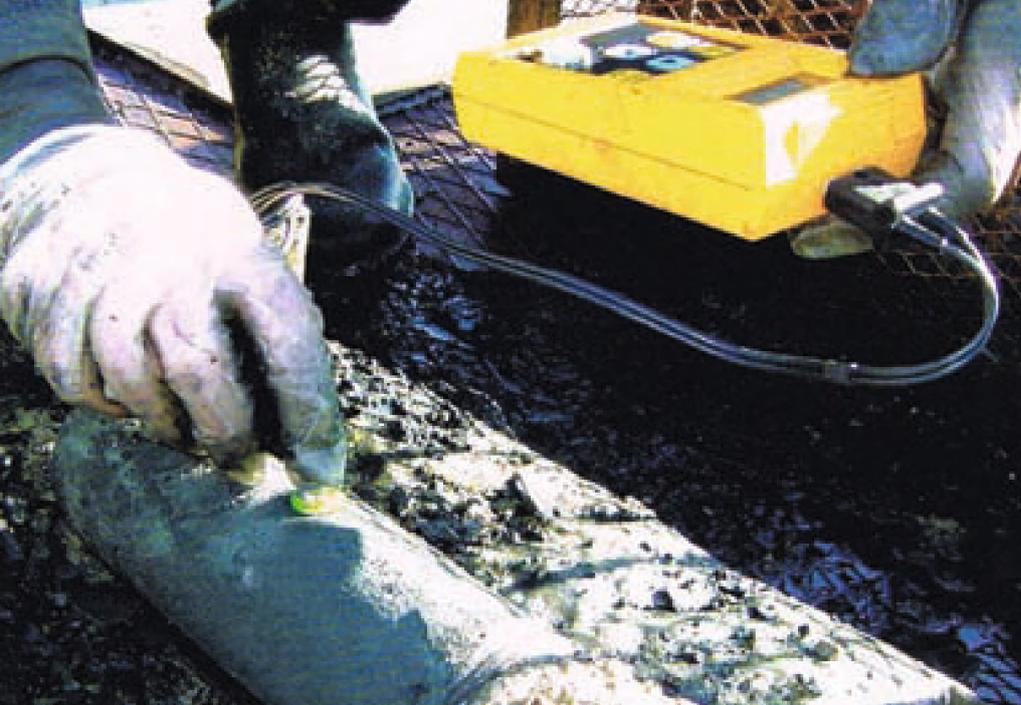
■ The activity of a dredged up shell is checked.
(EOS N° 6, 2013, 'Duizend bommen en granaten')

A number of shells were brought to the surface in 1972. The condition of the shells was “remarkably good” according to the reports written at the time. This may be explained by the occurrence of natural gas (methane) in the seabed, caused by the bacterial decomposition of organic matter. This creates a low-oxygen environment, which can slow down corrosion to a considerable extent. No ammunition has been brought to the surface since 1972, however, so the current state of the shells is unknown. Nevertheless, it seems plausible that the ammunition has not corroded very much at this moment.
