The state of the coast

The South-Westerly Delta

Alessio Giardino
Kees den Heijer
Giorgio Santinelli

1209381-006

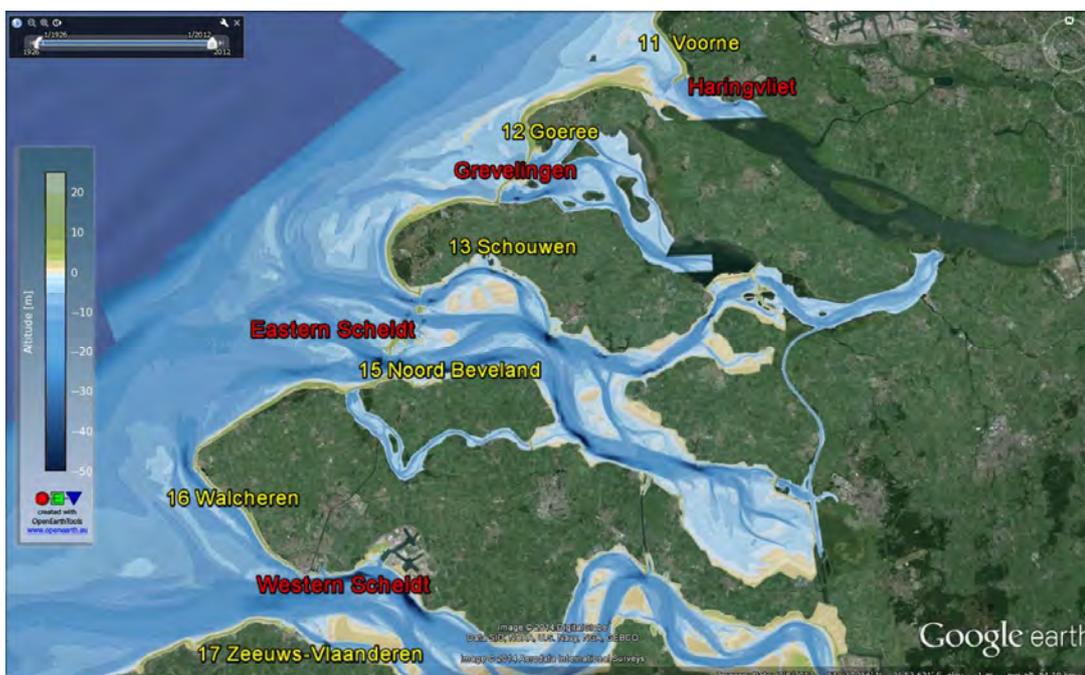
Figure 4.1 Bathymetry of the South-Westerly Delta. In yellow, the different regions (kustvakken) are given with their respective numbering. In red, the names of the different estuaries are shown.

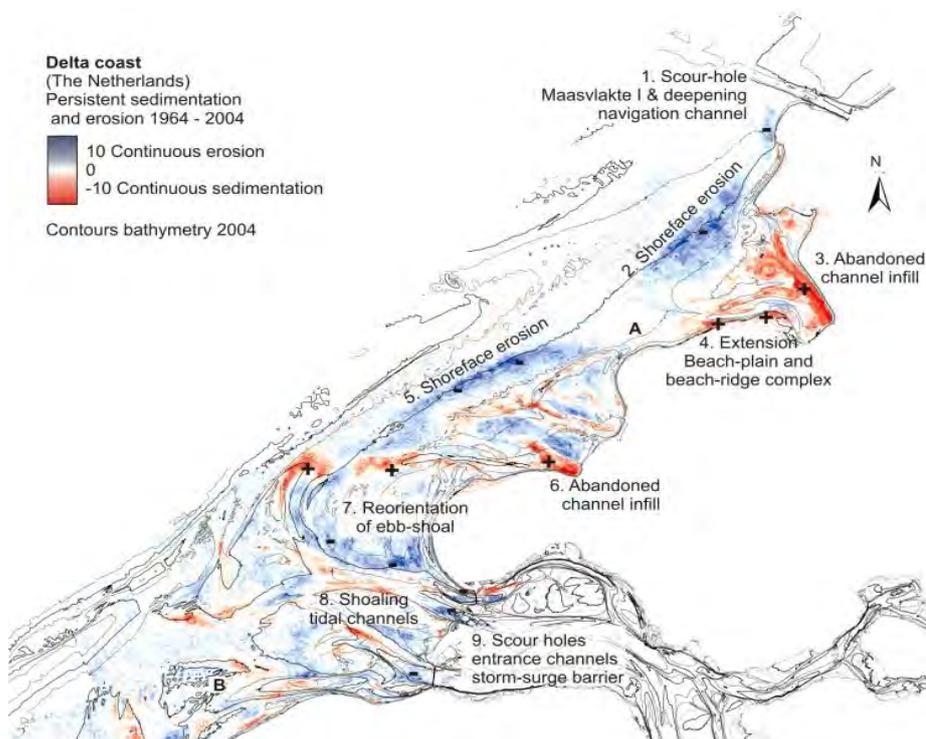
Figure 4.2 Sedimentation (red) and erosion (blue) plot in the Outer Delta in the period 1964-2004 (Cleveringa, 2008).

dominated system (Cleveringa, 2008). Sedimentation of the major tidal channels, which were dammed, has been observed. In particular, the most pronounced changes have been observed as a result of the closure of the Grevelingen and Haringvliet (3 and 6 in Figure 4.2). The closure of the Eastern Scheldt has resulted in minor and more localized changes in the proximity of the storm-surge barriers, as this tidal inlet is still connected to the outer delta and only closed during extreme storm surge events (9 in Figure 4.2), with, in the outer delta, some shoaling of the tidal channels (8 in Figure 4.2).

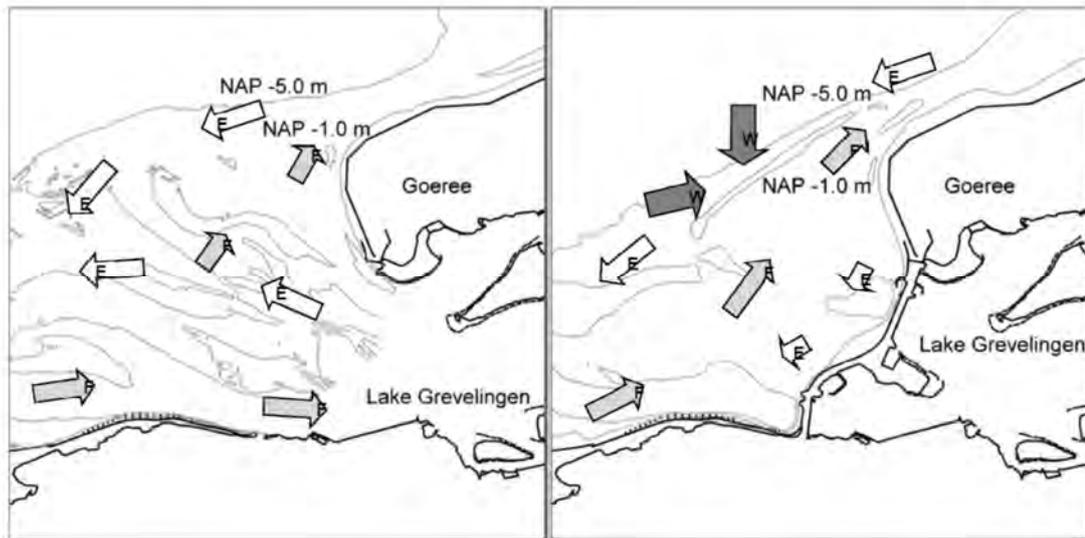
Figure 4.3 Ebb-tidal delta of Lake Grevelingen in 1964 (left) and 2010 (right) after construction of the Brouwersdam. Depth contour lines of NAP -1 m and NAP -5 m and dominant tidal velocities are shown. (E)= Ebb-dominated flow. (F) = Flood-dominated flow. (W) = Dominant wave load. (Nipsius, 1998).

The area is characterized by a mesotidal regime with a tidal range decreasing from South to North from about 5 m to about 3 m. Due to the closure of the Grevelingen and Haringvliet the current velocities at those locations decreased in terms of tidal velocities and changed towards a direction sub-parallel to the coast. Figure 4.3 shows for example the changes in tidal velocities and direction at the delta of the Grevelingen.

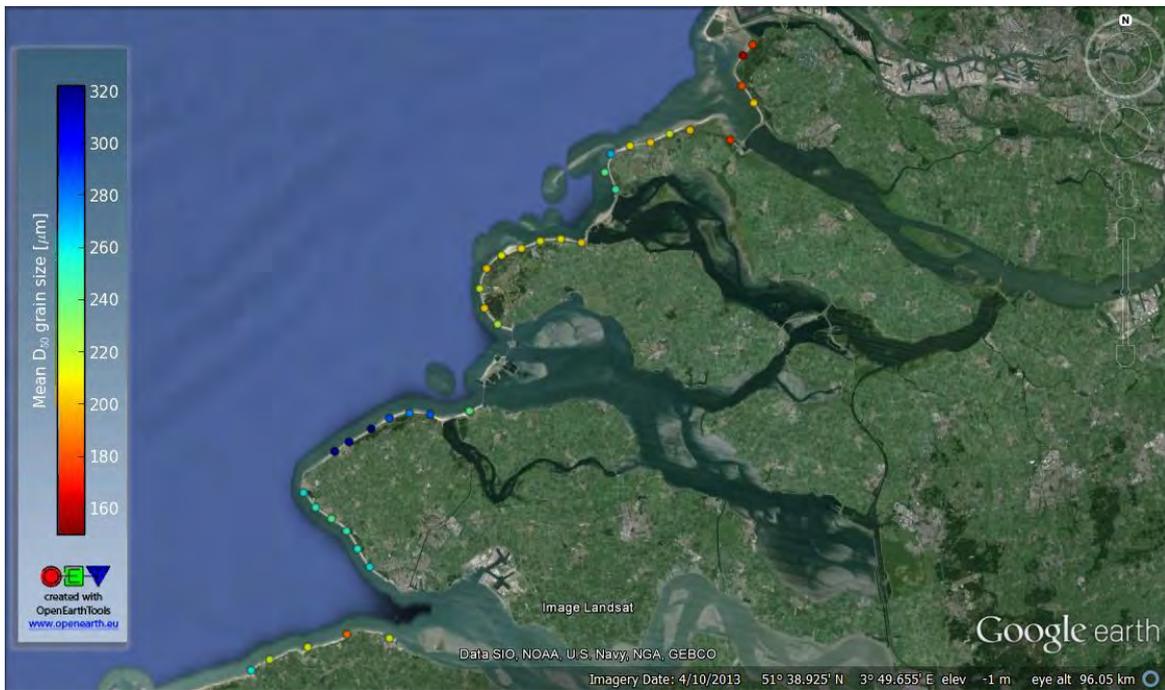
Figure 4.5 Median grain size (in μm) along the Holland coast (TAW, 1984).

The median grain size (D50) on the foreshore ranges approximately between 160 μm and 320 μm as shown in Figure 4.5 (TAW, 1984). The alongshore grain size in the 80's, when the last measurements were collected, show coarser sediments at Walcheren and finer at Voorne.

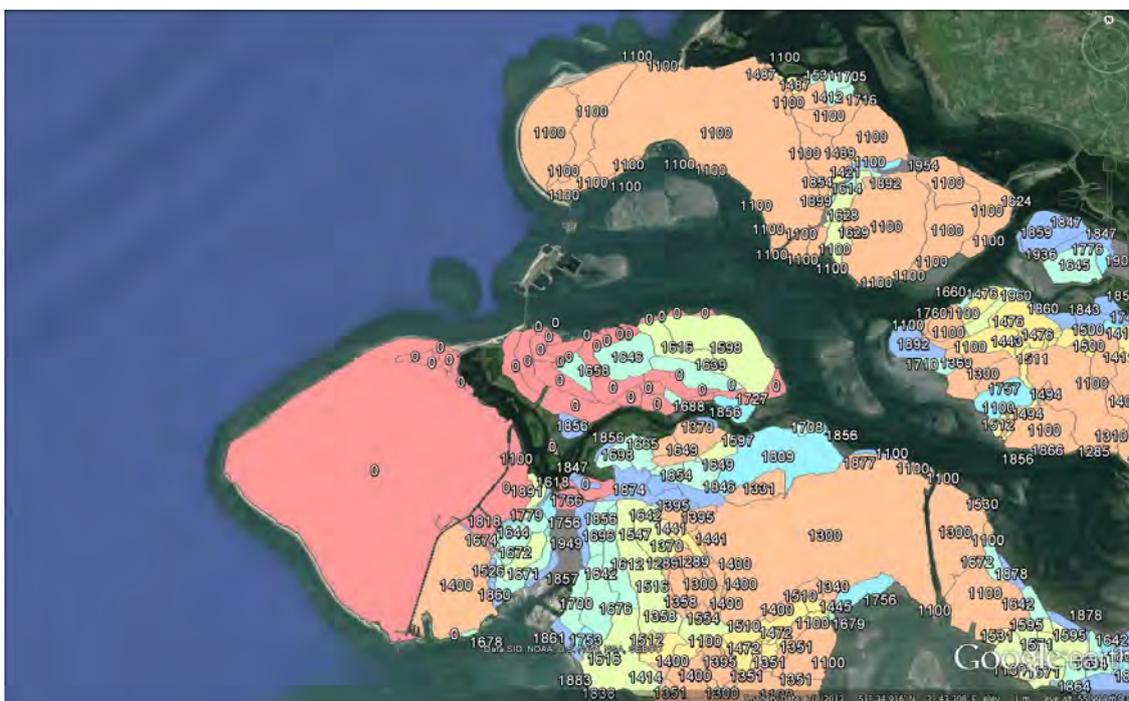
Figure 5.1 History of polder construction. The years indicate the approximate time when the polder was constructed.

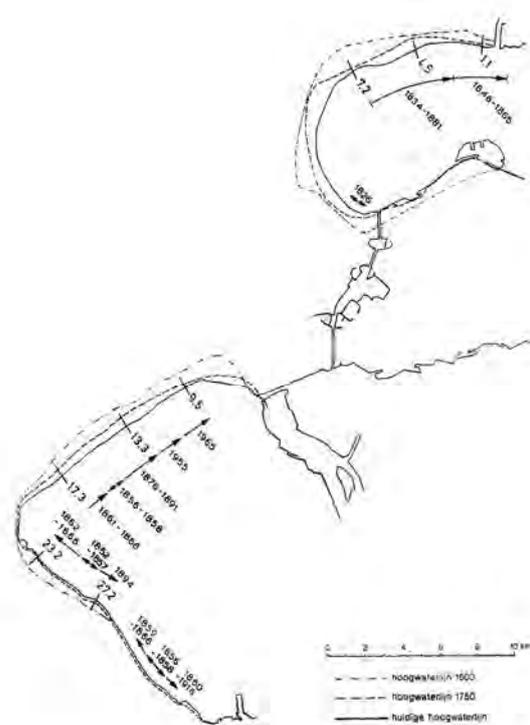
Figure 5.2 Morphological development of the coastline of Schouwen and Walcheren from the 17th century until the end of the 20th century (Verhagen, 1989b).

Several groins were also built in the past. In Schouwen, groins started being built in 1834. The erosion trend, which between 1750 and 1865 ranged approximately between 1 and 5 m per year, was replaced by a nearly stable coastline (Verhagen, 1989b). Figure 5.2 shows an

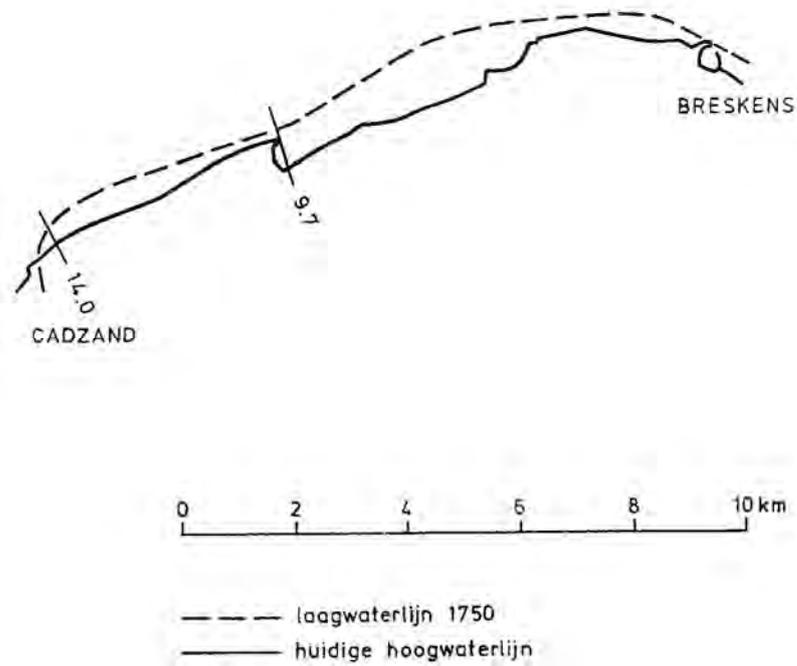
Figure 5.3 Morphological development of the coastline of Zeeuws-Vlaanderen between 1750 and the end of the 20th century (Verhagen, 1989b).

In Zeeuws-Vlaanderen the erosion trend has also been largely reduced by the groins, from about 3 m/year to a nearly stable coastline (see Figure 5.3). An overview of the structures along the entire coast is given in Figure 5.4. A detailed overview of the structures for single stretches of coast can be found in Appendix B.

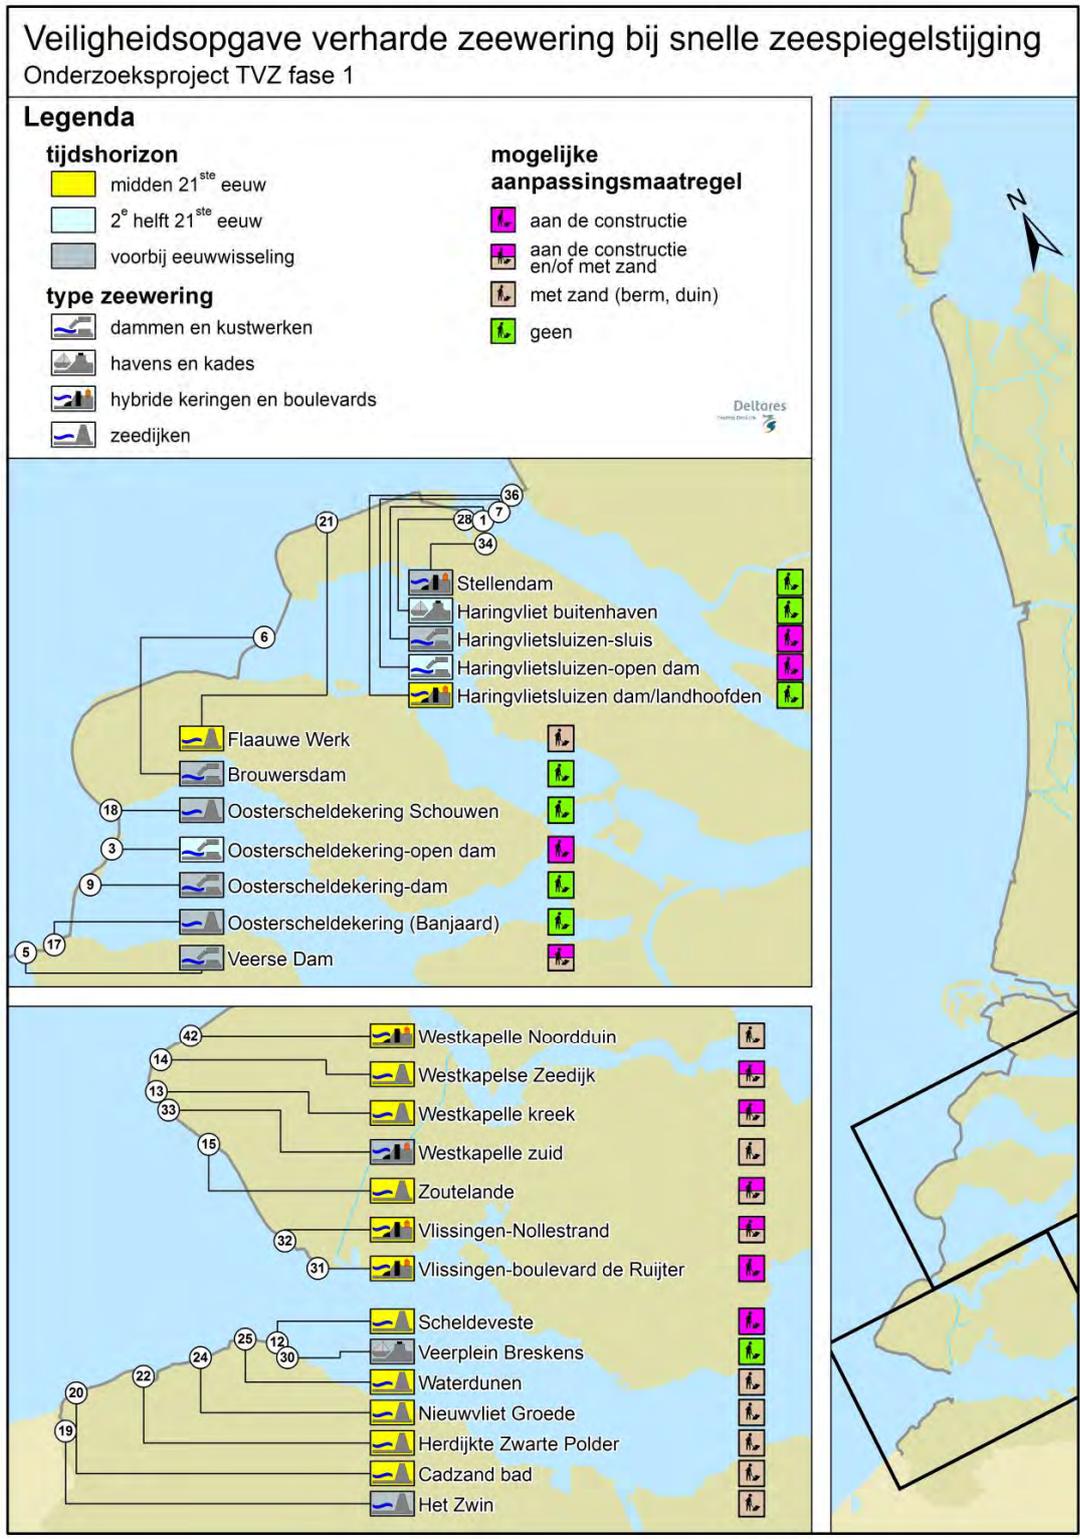
Figure 5.4 Overview of hard structures in Zeeland (Stronkhorst and Lagendijk, 2012).

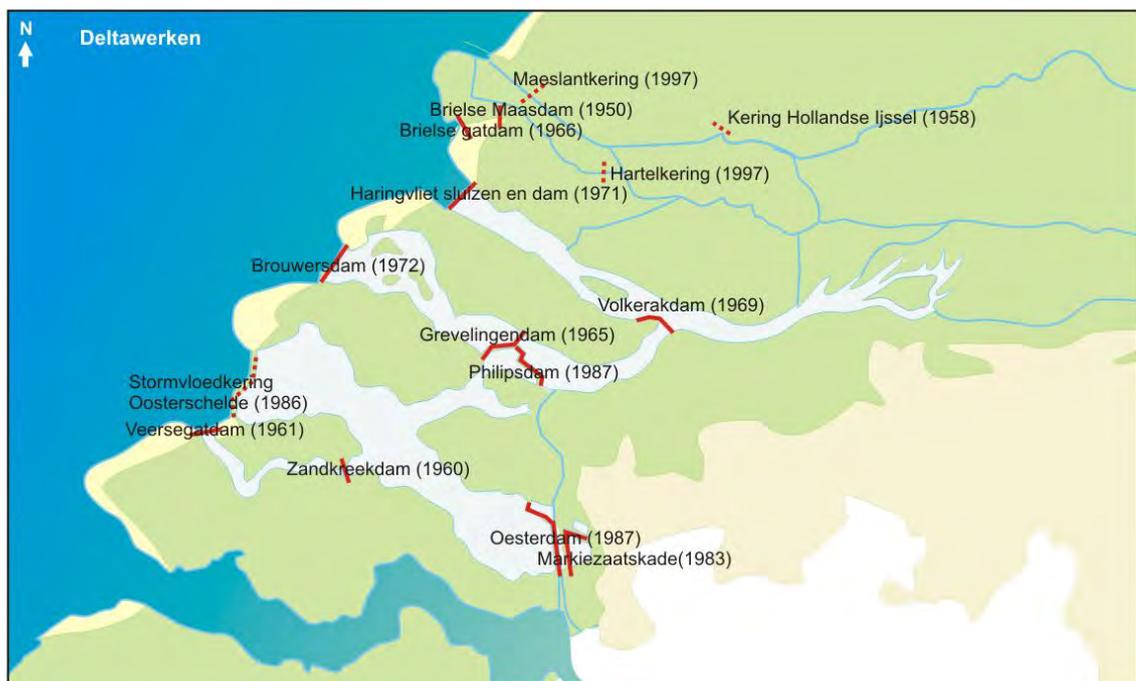
Figure 5.5 Overview of the Deltaworks and other major projects in the South-Westerly Delta. The year when the project was completed is given in brackets.

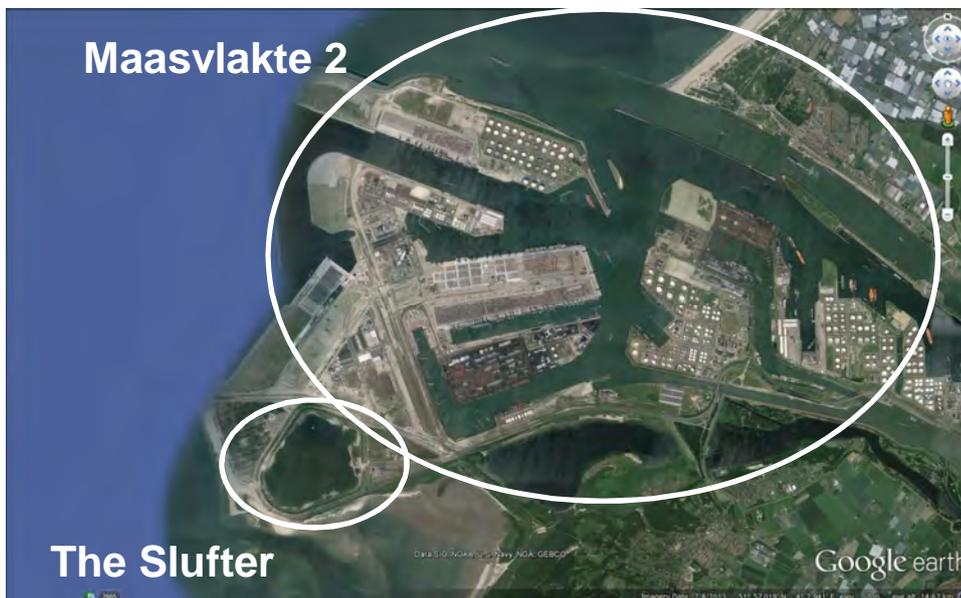
Figure 5.6 Aerial view of the Maasvlakte harbour and the Slufter

The Slufter is a deposit for polluted sediments built in 1985 and with a surface area of 260 ha (Figure 5.6). The polluted sediments come from the maintenance of the harbour of Rotterdam.

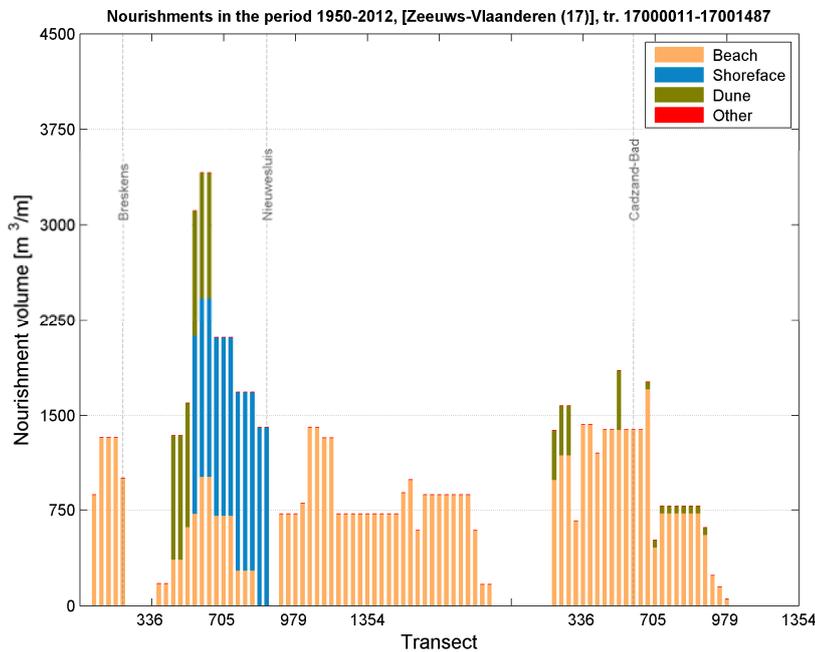
Figure 5.13 Total volume of nourishments in Zeeuws-Vlaanderen (Kustvak 17) for the period 1950-2012.

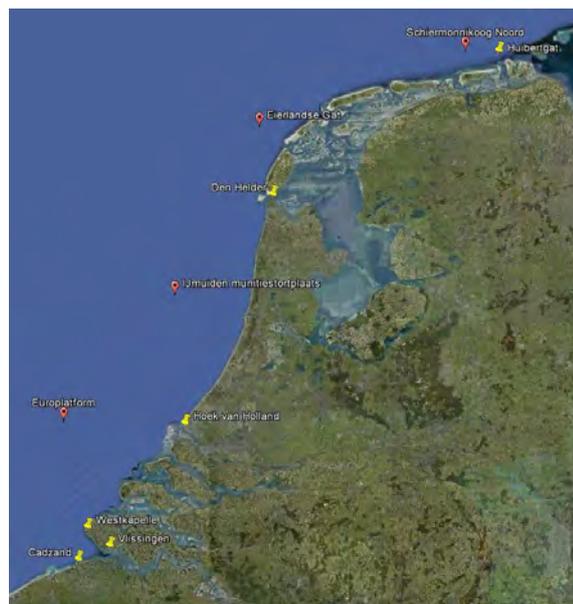
Figure 6.1 Location water level station (in yellow) and buoy (in red) used for the analysis (Vuik et al., 2012).

As a year, the period between two Jarkus measurements was considered. The storminess parameters were derived by using meteorological data derived from different stations and then interpolated at each Jarkus transect (Vuik et al., 2012). In particular, for the South-Westerly Delta, the following stations have been used: “Hoek van Holland”, “Westkapelle”, “Vlissingen” and “Cadzand” for the water levels and “IJmuiden munitiestortplaats” and “Europlatform” for the wave data. The locations of the different stations can be found in Figure 6.1.

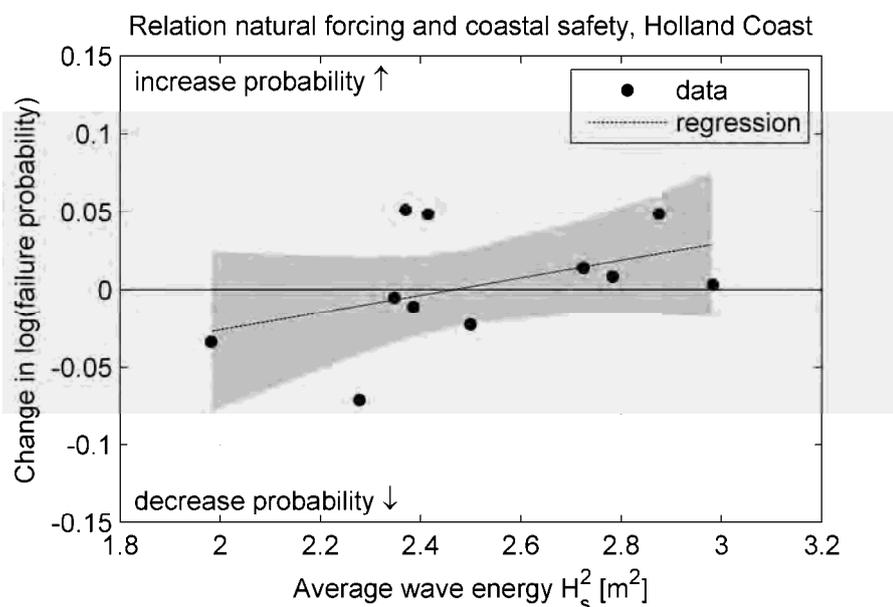
Figure 6.2 Changes in probability of breaching as a function of the yearly averaged wave energy for the Holland coast (Giardino et al., 2014).

activity for a specific year, the higher is the expected increase in probability of breaching (Figure 6.2).

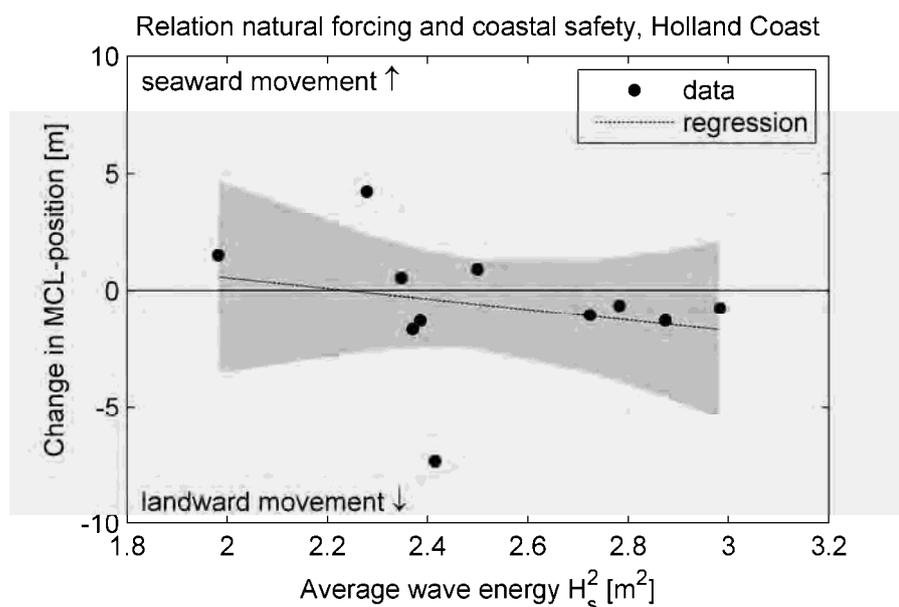
Figure 6.3 Changes in MKL position as a function of the yearly averaged wave energy for the Holland coast (Giardino et al., 2014).

The most suitable storminess parameter to describe changes in MKL (“M”omentane “K”ust“L”ijn; Van Koningsveld and Mulder, 2005) is also the yearly averaged wave height (Vuik et al., 2012). In general, it can be expected that an increase of the yearly averaged wave height will lead to an average decrease of the MKL position (Figure 6.3).

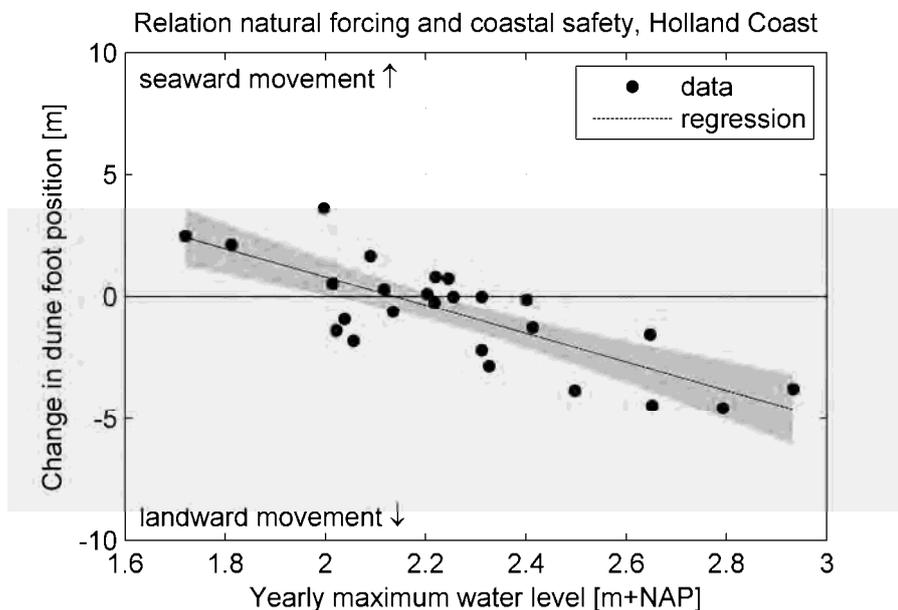
Figure 6.4 Changes in dune foot position as a function of the maximum yearly water level for Holland coast (Giardino et al., 2014).

The most suitable storminess parameter which was identified to describe changes in dune foot position is the maximum yearly water level (Vuik et al., 2012). The dune foot position is in fact only affected by the extreme storm surge events rather than the yearly averaged wave energy. In general, an increase in maximum yearly water level, will lead to a retreat of the dune foot position (Figure 6.4).

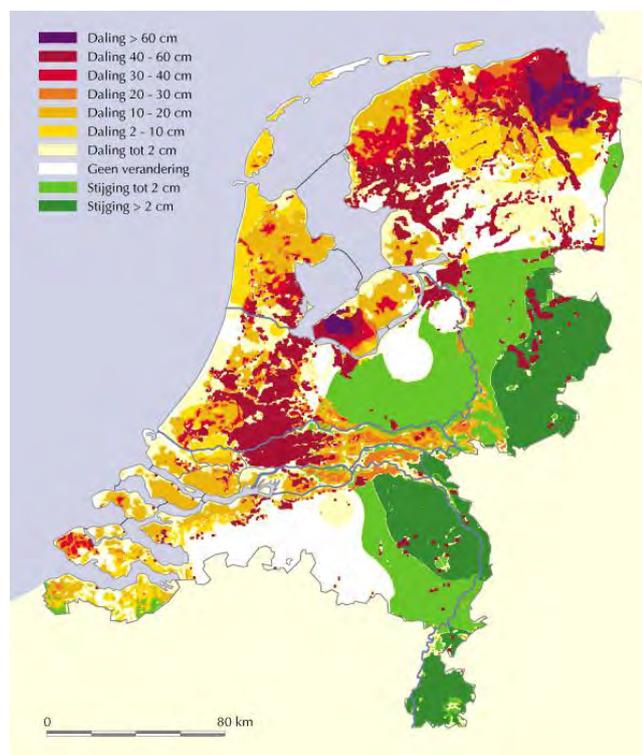
Figure 6.5 Expected subsidence and uplift for the all Netherlands by year 2050 (Rijkswaterstaat, NAM).

A map showing the possible predicted subsidence by year 2050 is shown in Figure 6.5. The map includes the effects of subsidence due to soil compaction, glacial isostatic adjustments and gas extraction. The map indicates a possible value for subsidence up to 40 cm by year 2050 at Walcheren. This value will be most likely much lower at the location of the primary defences and along the coast than in the hinterland where subsidence and soil compaction were caused by ground water extraction and compaction of the peat layer.

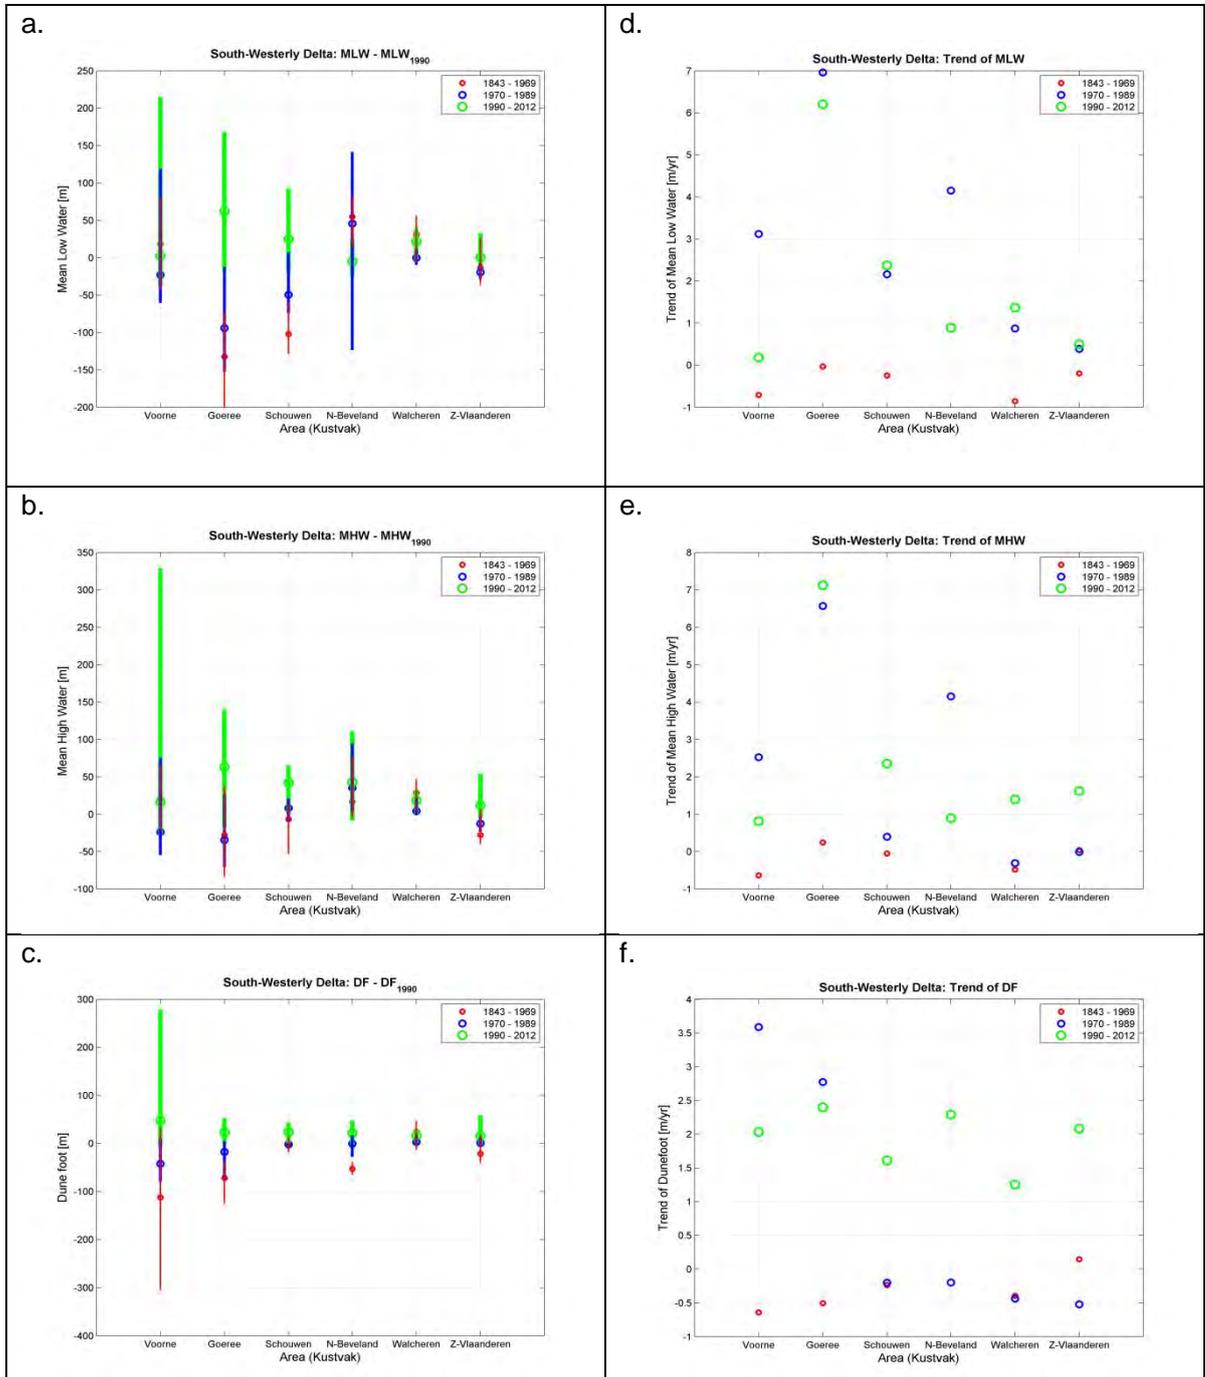
Figure 7.1 MHW, MLW, DF w.r.t. values in 1990 (a., b., c.) and linear trends of MHW, MLW, DF within the three periods 1843-1969, 1970-1989, 1990-2012 (d., e., f.). Negative values mean onshore shift, while positive values offshore migration. Due to lack of data, there is no value for Noord-Beveland for the time-window 1843-1969.

- In general, the indicators show that the entire South-westerly Delta coast was subject to a slightly erosive trend before 1969, as shown by the consistent negative trends during the first time window. The picture has changed completely after the human interventions of the last 40 years (Chapter 5). All the trends have been replaced by positive trends, with the average of the absolute values during the last time window, consistently above (more seaward) with respect to the first time window.

- The largest changes have been observed in regions 12 (Goeree) with total average changes in mean low water and mean high water line position of more than 50 m. This is due to the permanent closures of the Grevelingen and Haringvliet, which largely influenced this region.

The figures show a general trend toward a decrease of the probability of failure (safer situation) as a consequence of the general increase in sand volumes, also shown by the other indicators. In particular, it is very visible at Schouwen and Walcheren, where the trend in probability of failure changes from increasing towards decreasing. As shown in Giardino et al. (2014) there is in fact a close relation between increase for example in MKL or seaward shift in dune foot position and a decrease in probability of failure.

In Appendix D, the trends in indicators at each transect used to compute the average values as reported in Figure 7.1 are also given. Next to the observations mentioned above, those plots also show the presence of sand waves migrating along the coastline (see for example at Schouwen).

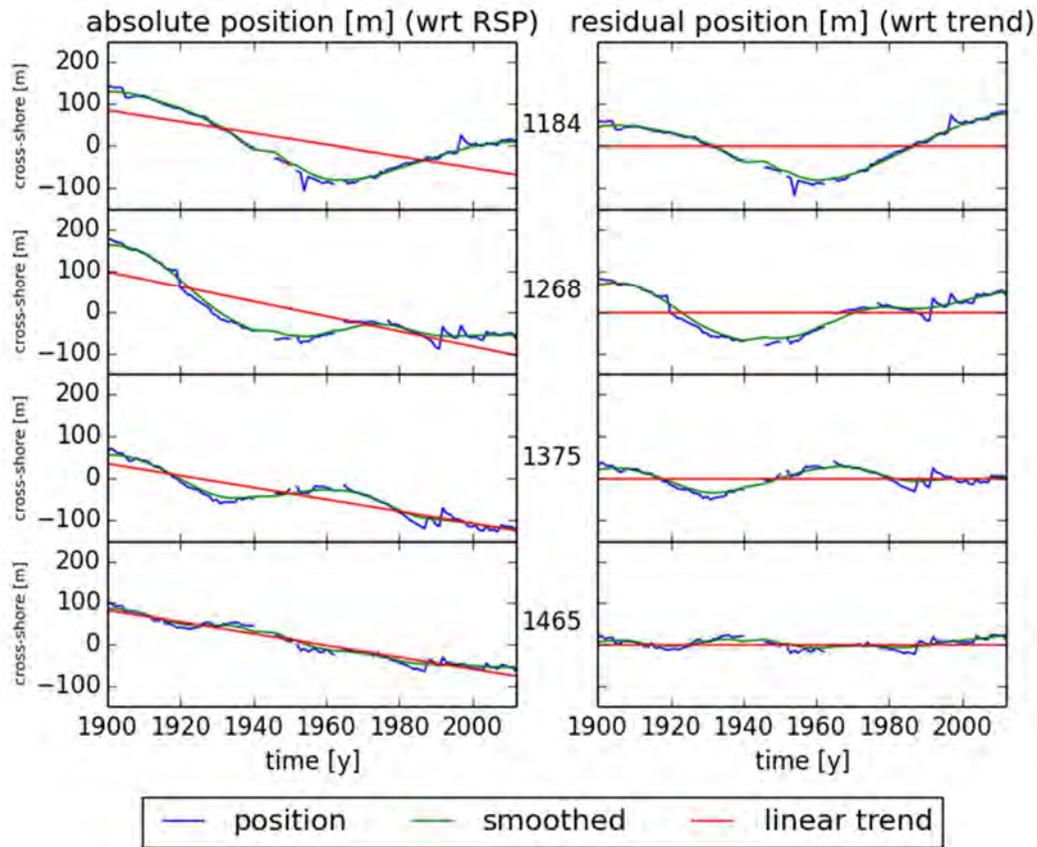
Figure 8.1 Dune foot position for four transects at Schouwen. The blue line represents the actual dune foot position changes, the green line the smoothed dune foot position after applying a low-pass filter, and the red line the linear trend. The figures in the left panel show the absolute values, while the figures in the right panel show the values relative to the linear trends.

This section describes the sand waves and the way of visualizing them for 4 transects at the coastal area Schouwen. Figure 8.1 shows at the left hand side the dune foot position (w.r.t. RSP“Rijks“S“trand“P“aal) in blue. The locations of the four transects is shown in Figure 8.2. In green, the smoothed dune foot position, after applying a moving average low-pass filter, is presented. In this way, only the signal on a longer time scale is highlighted and yearly oscillations are filtered out. The red lines give the linear trends per transect through the dune foot positions for the whole time series. On the right hand side of Figure 8.1, similar lines are presented, but in this case relative to the linear trend line, thus showing the residual. The smoothed residual together with the gradient give the most important information to show how the coastline develops, especially regarding the long-term variations (sand waves). The smoothed residual has been presented in a filled contourplot in Figure 8.3, together with the gradient of the corresponding trends in the top panel. This way of presenting makes it easier to show a larger coastal area (e.g. whole *kustvak*) and to show not only the information on the dune foot position, but also the mean high water and mean low water lines.

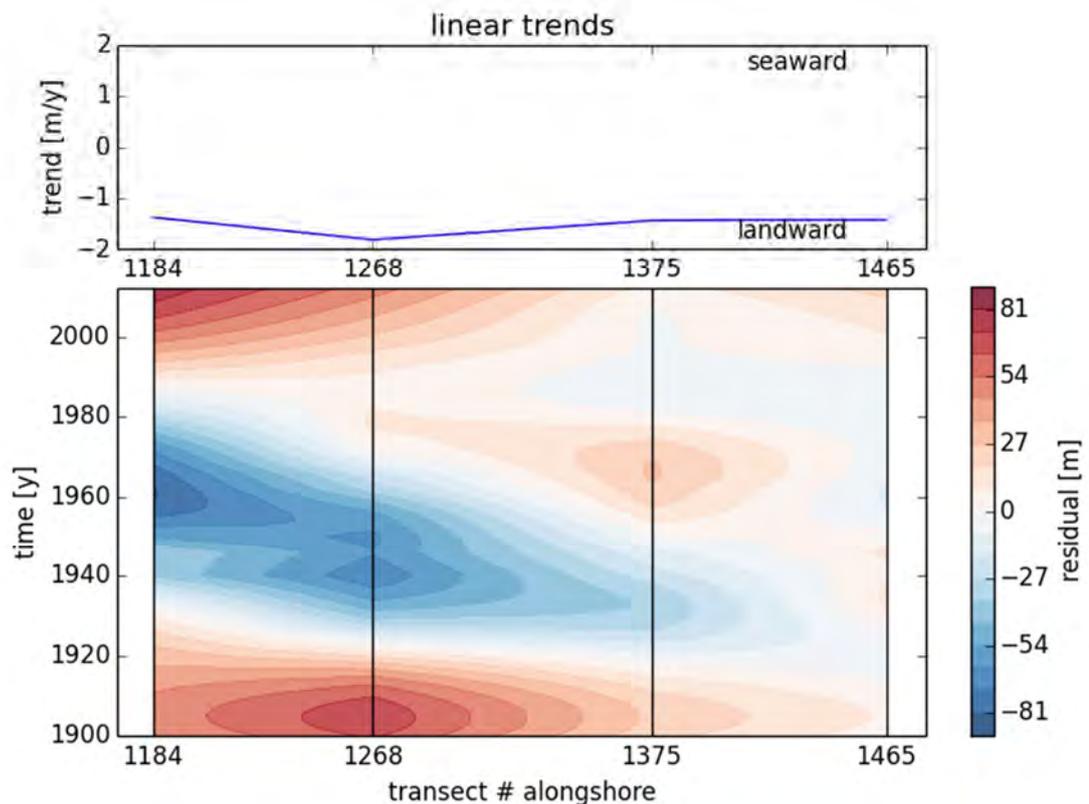
Figure 8.3 Linear trend of dune foot position (top) and contour plot of residual sand wave (below) of a part of Schouwen. See Figure 8.8 for the location.

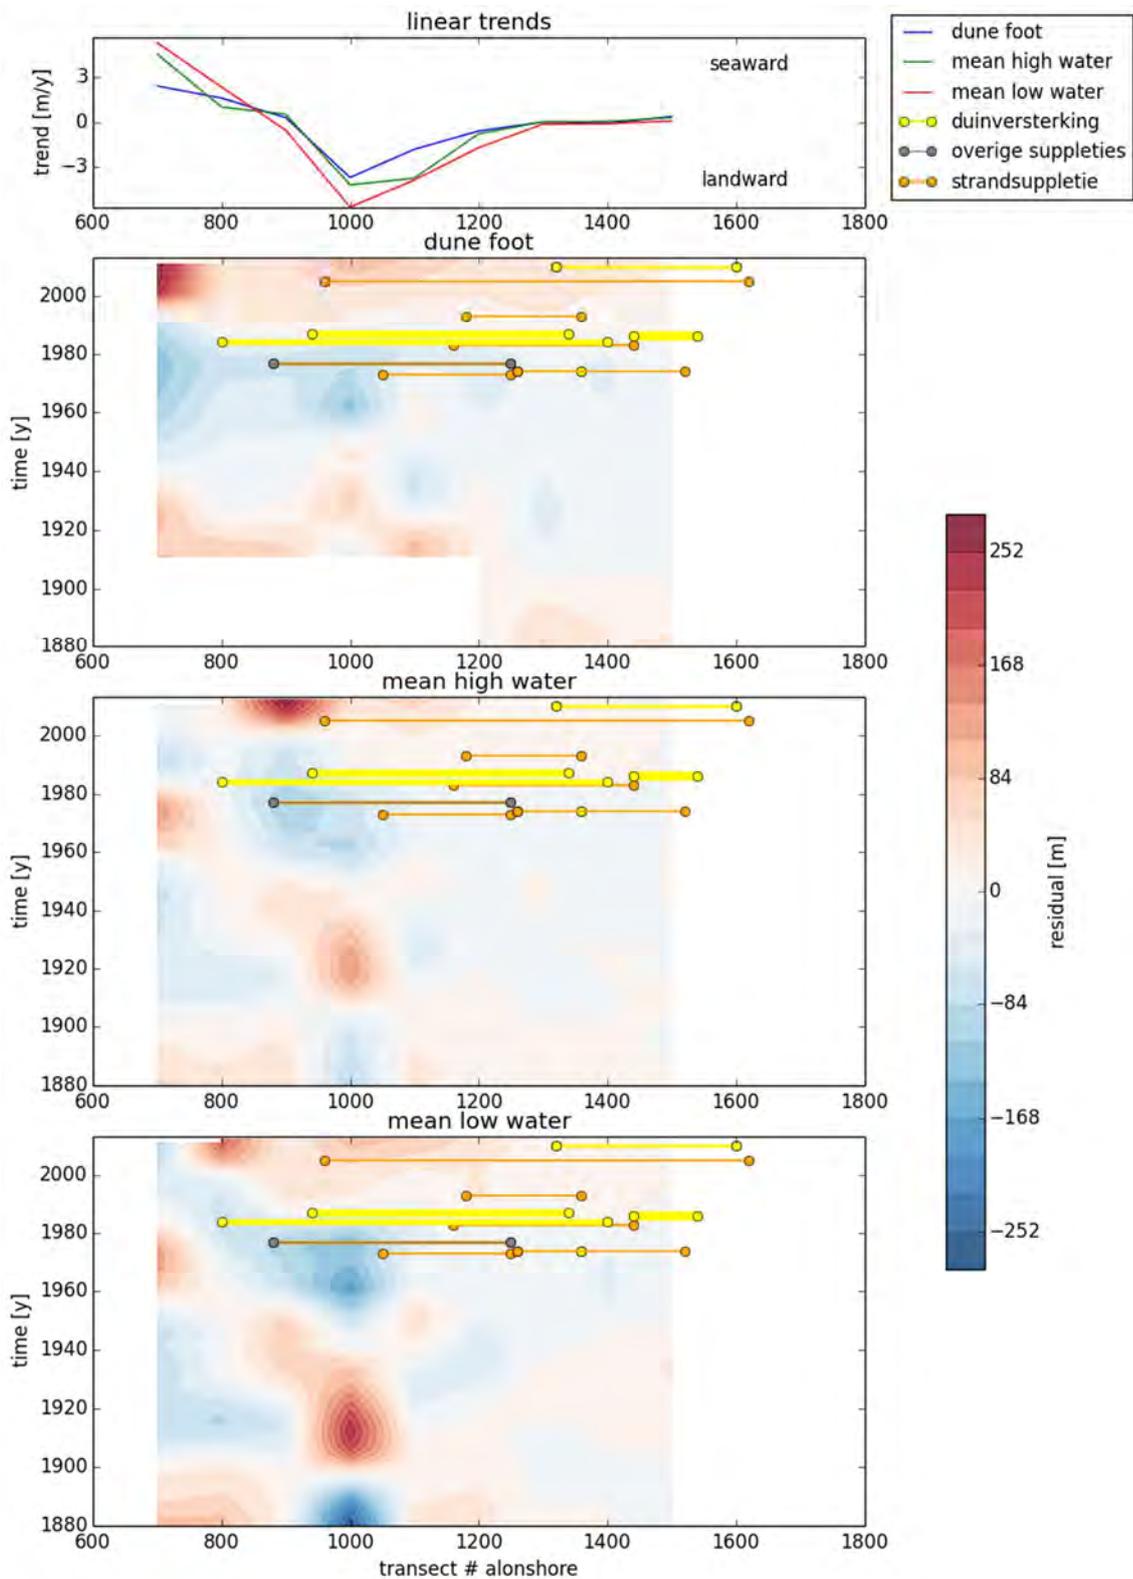
Figure 8.4 (a) Map of Voorne with the positions of transects used as ticks in b. (b) Contour plots of residuals of dune foot, mean high and mean low waterline positions of Voorne. The respective linear trends for the entire period are in the top panel.

The investigation underlying this report, as visualised in Figure 8.4, Figure 8.6, Figure 8.8, Figure 8.11, and Figure 8.13, show that sand wave patterns are most clearly visible at Schouwen (kustvak 13, specifically between transect 600 and 1400) and Walcheren (kustvak 16, most pronounced between transect 600 and 1300). For comparison with Verhagen (1989a), Table 8.2 gives amplitude, celerity and period for five coastal areas in the South-Westerly Delta based on manual interpretation of Figure 8.4, Figure 8.6, Figure 8.8, Figure 8.11, and Figure 8.13. It should be noted that the figures are based combining qualitatively information on how crests and troughs visible in the figures of dune foot position, mean high and mean low water lines shift in time. Except for the celerity for Goeree, most figures show the same order of magnitude, but not necessarily equal, as estimated by Verhagen. The differences can be attributed to several reasons: at first, the way of computing the sand wave characteristics is different as Verhagen used volumes while in this report different coastal indicators were used. Moreover, for this study more than 20 years of recent data were available during which sand wave characteristics were not necessarily the same.

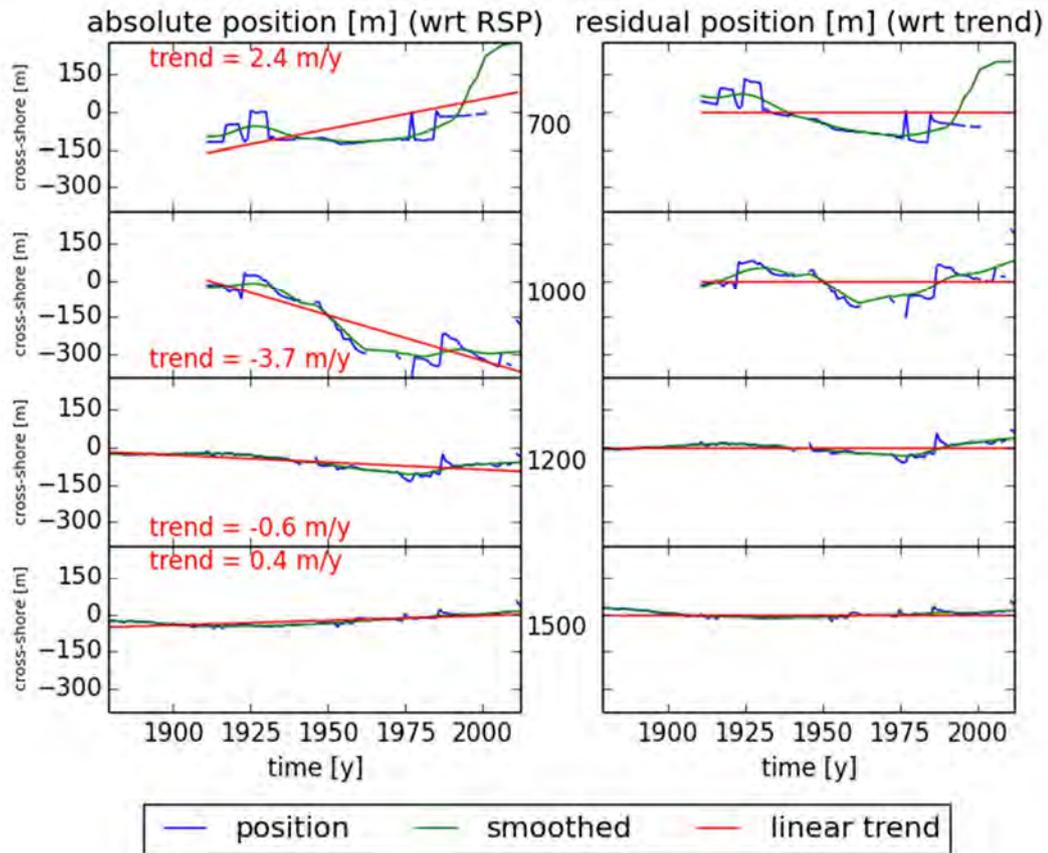
Figure 8.5 Dune foot position for four transects at Voorne. The blue line represents the actual dune foot position changes, the green line the smoothed dune foot position after applying a low-pass filter, and the red line the linear trend. The figures in the left panel show the absolute values, while the figures in the right panel show the values relative to the linear trends.

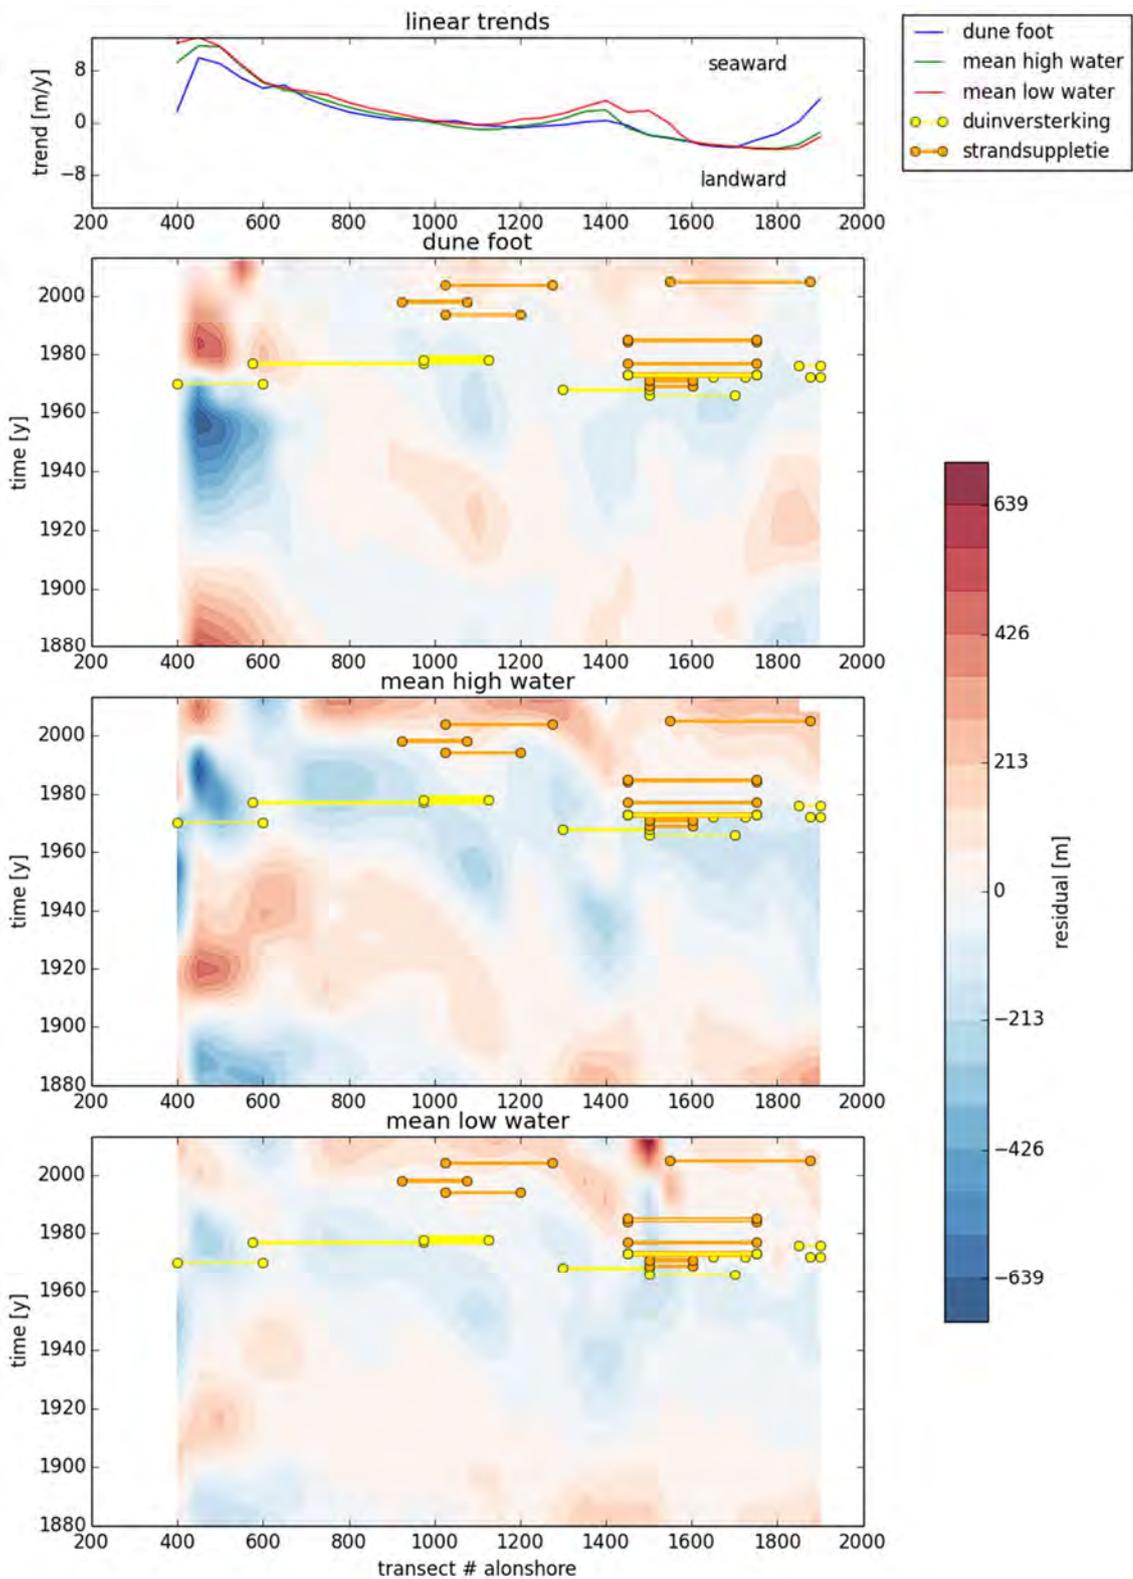
(b) Figure 8.6 (a) Map of Goeree with the positions of transects used as ticks in (b). (b) Contour plots of residuals of dune foot, mean high and mean low waterline positions of Goeree. The respective linear trends for the entire period are in the top panel.

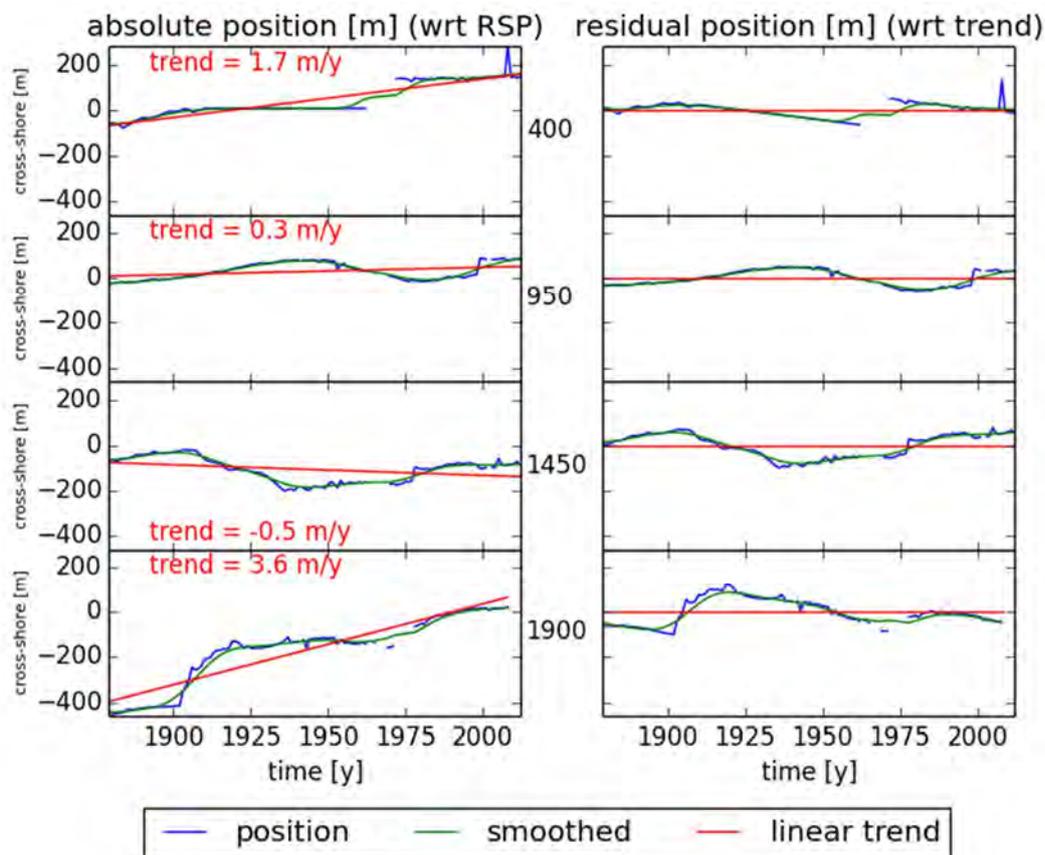
Figure 8.7 Dune foot position for four transects at Goeree. The blue line represents the actual dune foot position changes, the green line the smoothed dune foot position after applying a low-pass filter, and the red line the linear trend. The figures in the left panel show the absolute values, while the figures in the right panel show the values relative to the linear trends.
