The state of the coast

The South-Westerly Delta

Alessio Giardino
Kees den Heijer
Giorgio Santinelli

1209381-006

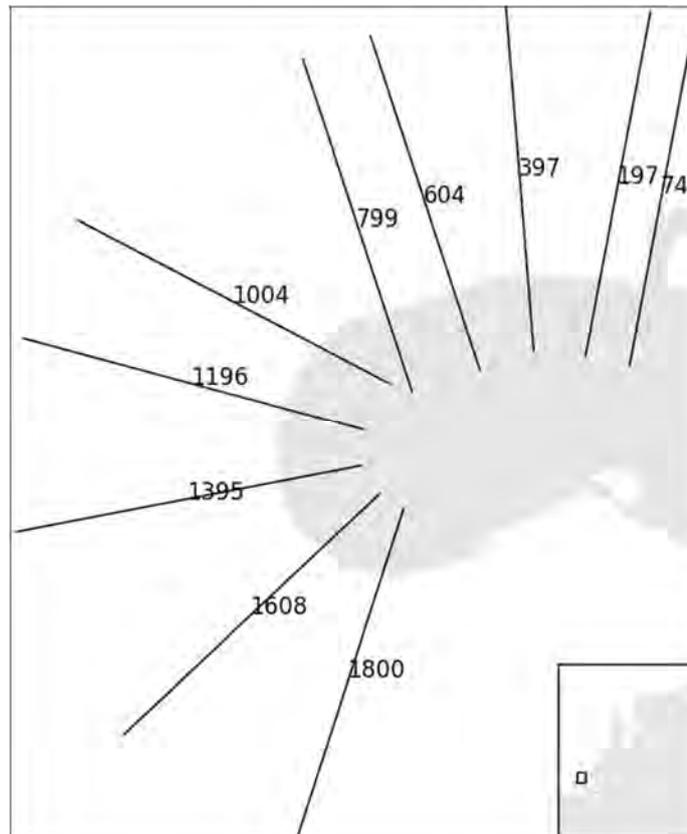
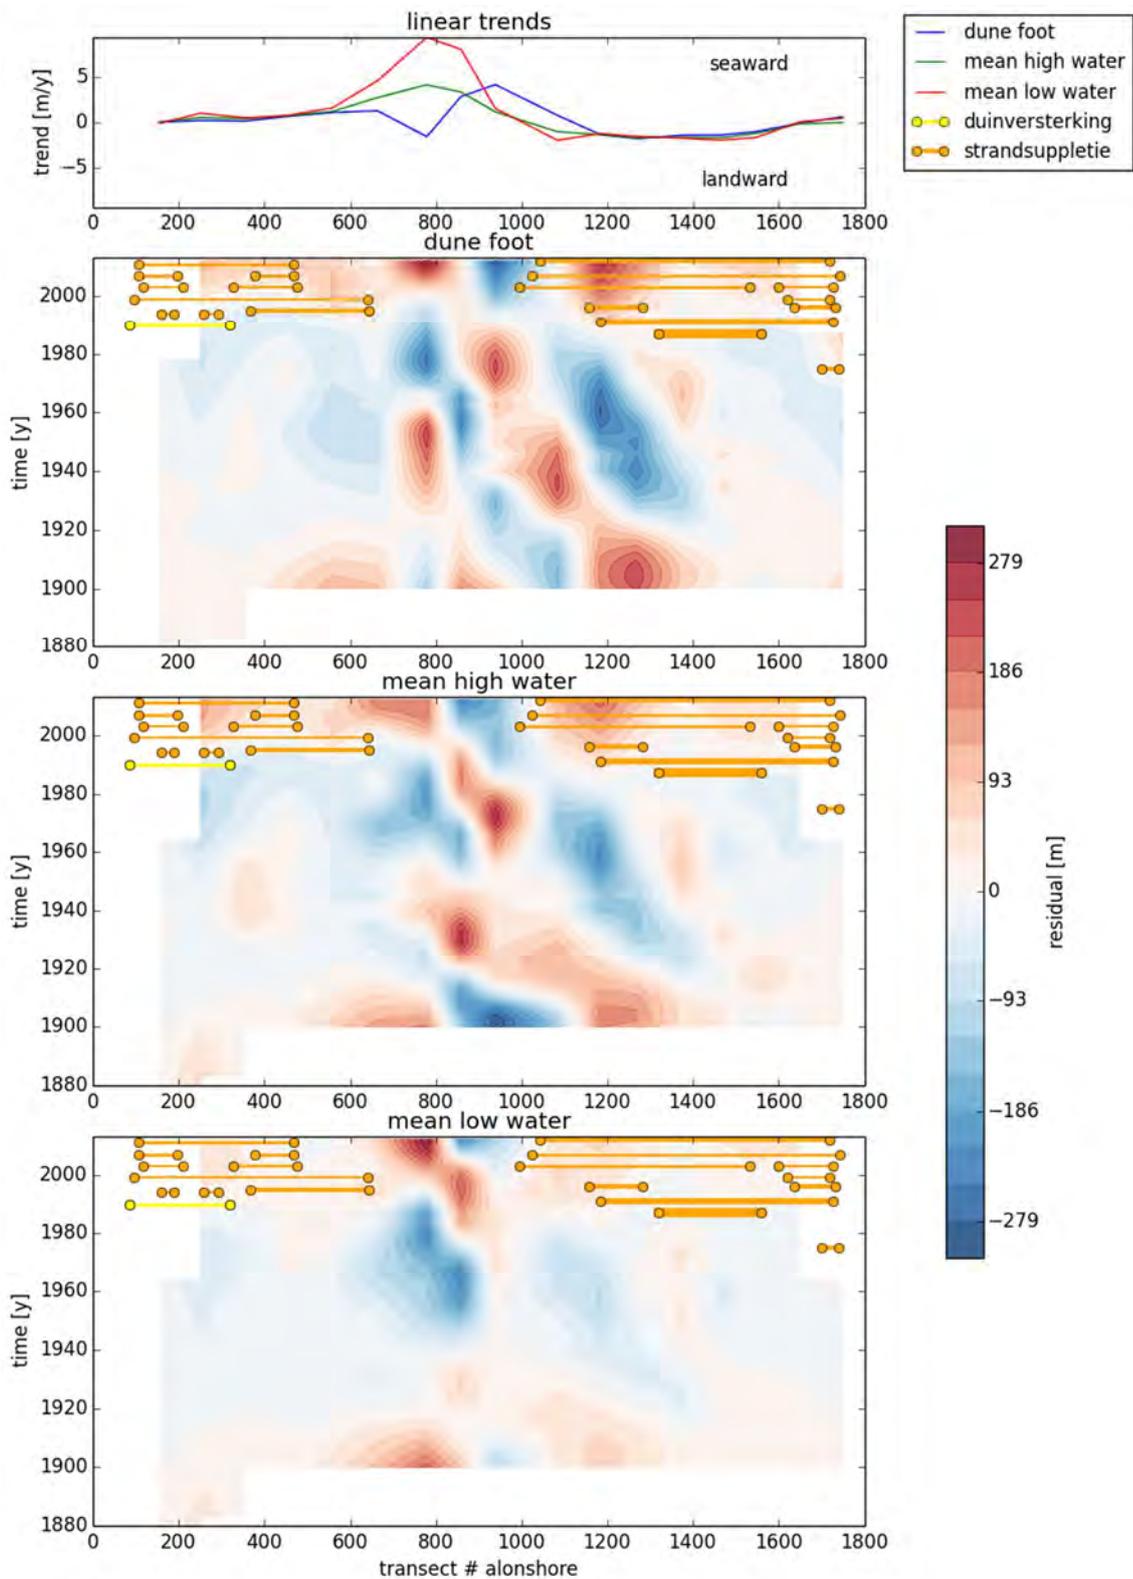
Figure 8.8 (a) Map of Schouwen with the positions of transects used as ticks in (b). (b) Contour plots of residuals of dune foot, mean high and mean low waterline positions of Schouwen. The respective linear trends for the entire period are in the top panel.

At Schouwen, sand wave patterns are visible at almost the whole area, but most clearly between transects 600 and 1400 (Figure 8.8). Also here, the waves are propagating towards the (north) east. In this area, approximately one and half sand wave cycle it is visible since 1900. This is confirmed also by Figure 8.9, showing the time variation in dune foot position at four different transects (transect 155, 664, 1268, 1750). In particular, sand wave type of features are visible for the two central transects (transect 664 and 1268). The origin of these morphological features in Schouwen and of their migration, are not further investigated within this report. Next to respond to the local hydrodynamic conditions, they are likely to be influenced by the northern migration of the Krabbengat in front of it, which has a very similar migration rate (≈ 60 m/year; Section 8.3.1).

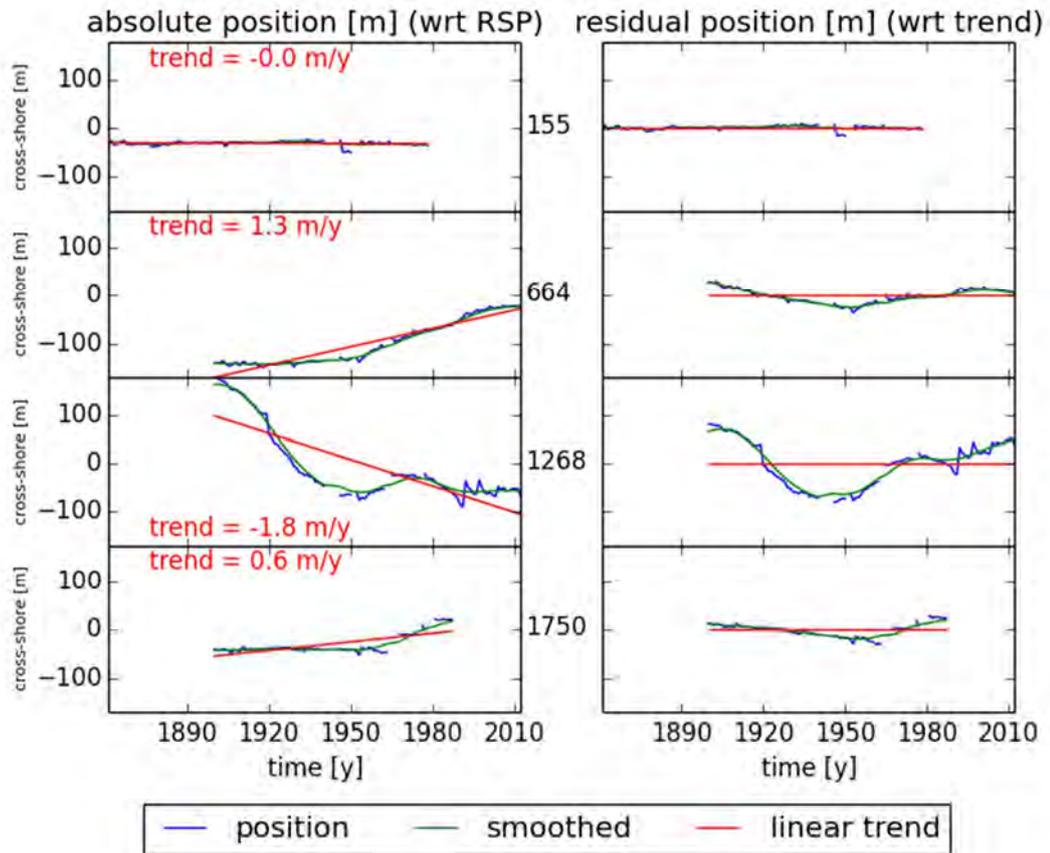
Figure 8.9 Dune foot position for four transects at Schouwen. The blue line represents the actual dune foot position changes, the green line the smoothed dune foot position after applying a low-pass filter, and the red line the linear trend. The figures in the left panel show the absolute values, while the figures in the right panel show the values relative to the linear trends.

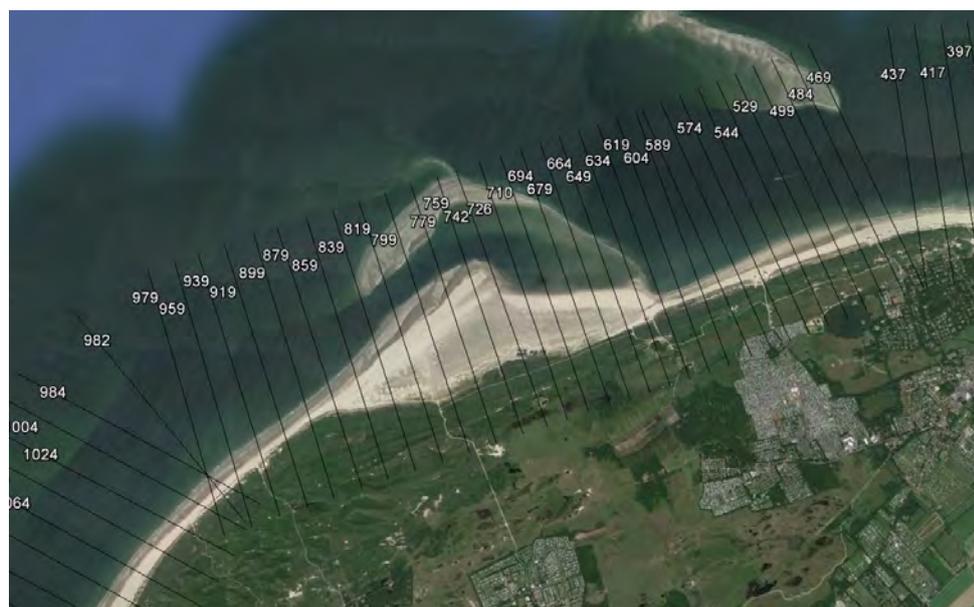
Figure 8.10 Aerial photo of Northern Schouwen with zoom on the shoal "Relict Schaar van Renesse".

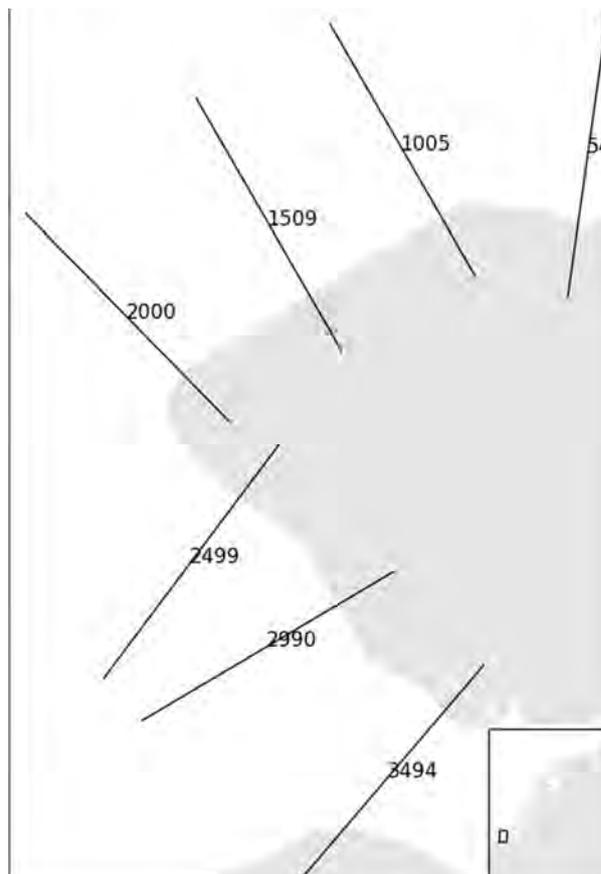
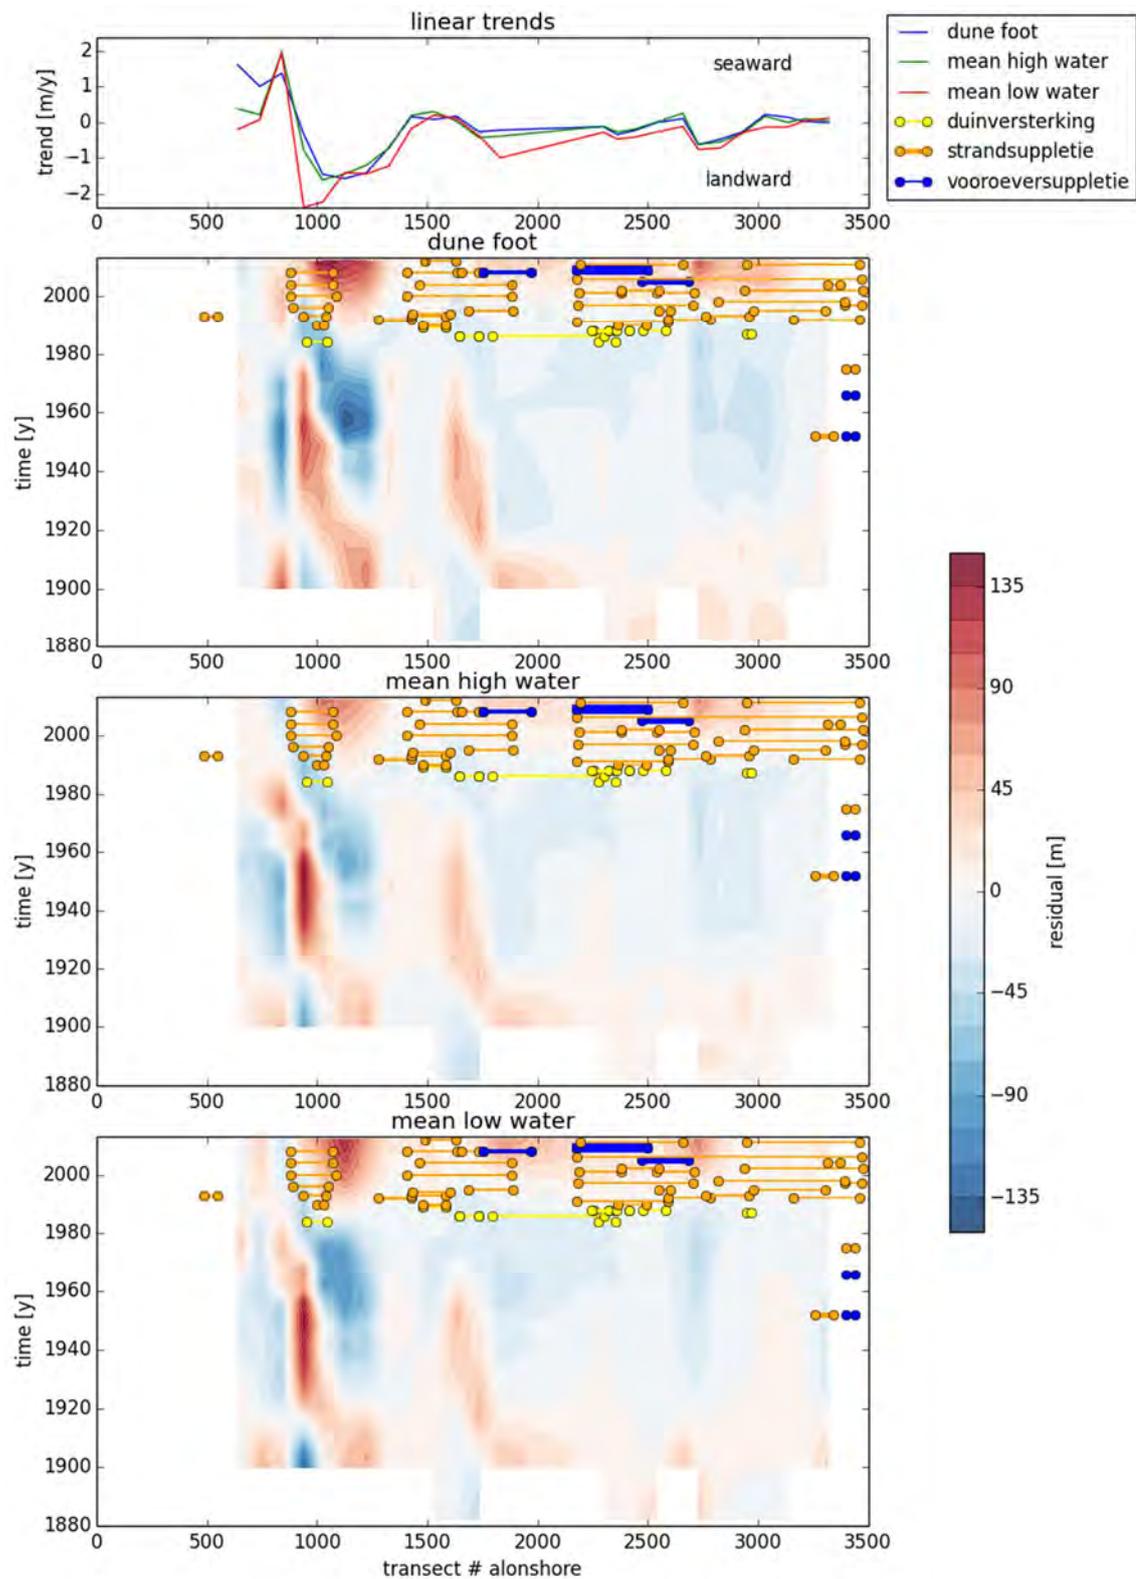
(b) Figure 8.11 (a) Map of Walcheren with the positions of transects used as ticks in (b). (b) Contour plots of residuals of dune foot, mean high and mean low waterline positions of Walcheren. The respective linear trends for the entire period are in the top panel.

At Walcheren, the sand waves are mainly visible at the north western part of the island (Figure 8.11). The waves propagate from transect 2000 in north eastern direction along the coast. The largest amplitude (amplitude ≈ 140 m) is found between transect 1300 and 800. Outside this area the sand wave amplitude is negligible as confirmed by the time series for four different transects (transect 640, 1428, 2541, 3320) in Figure 8.12.

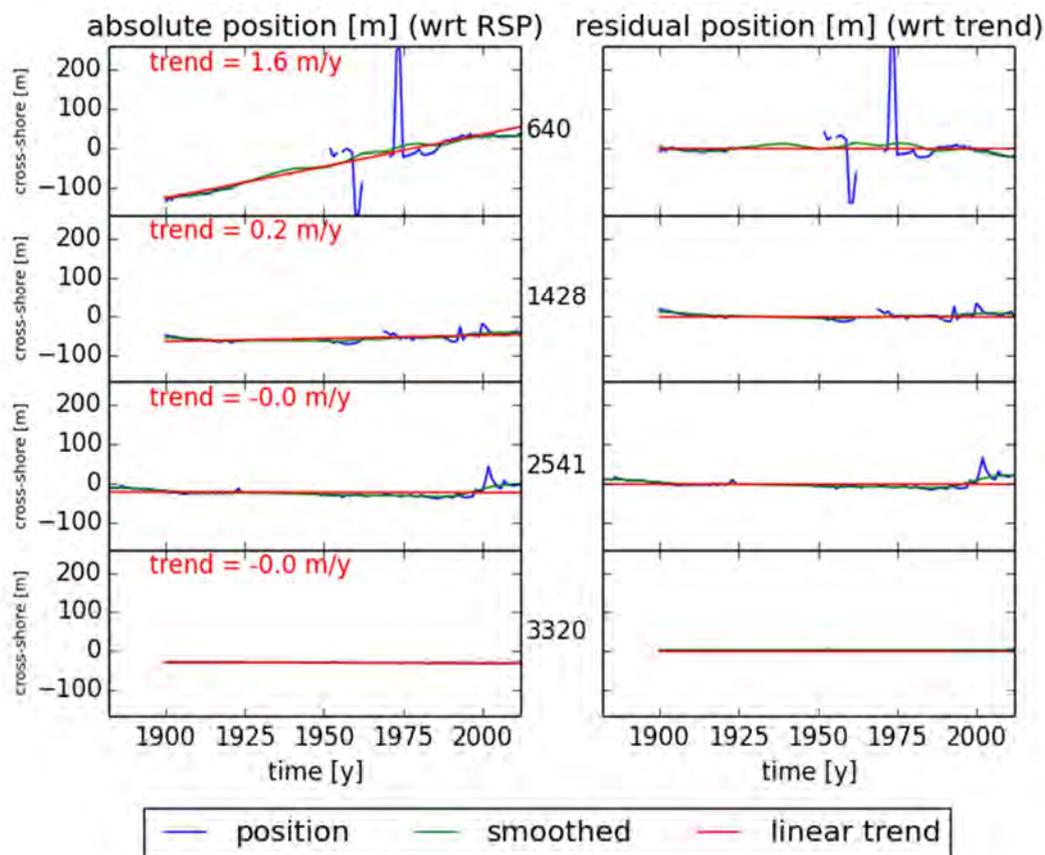
Figure 8.12 Dune foot position for four transects at Walcheren. The blue line represents the actual dune foot position changes, the green line the smoothed dune foot position after applying a low-pass filter, and the red line the linear trend. The figures in the left panel show the absolute values, while the figures in the right panel show the values relative to the linear trends.

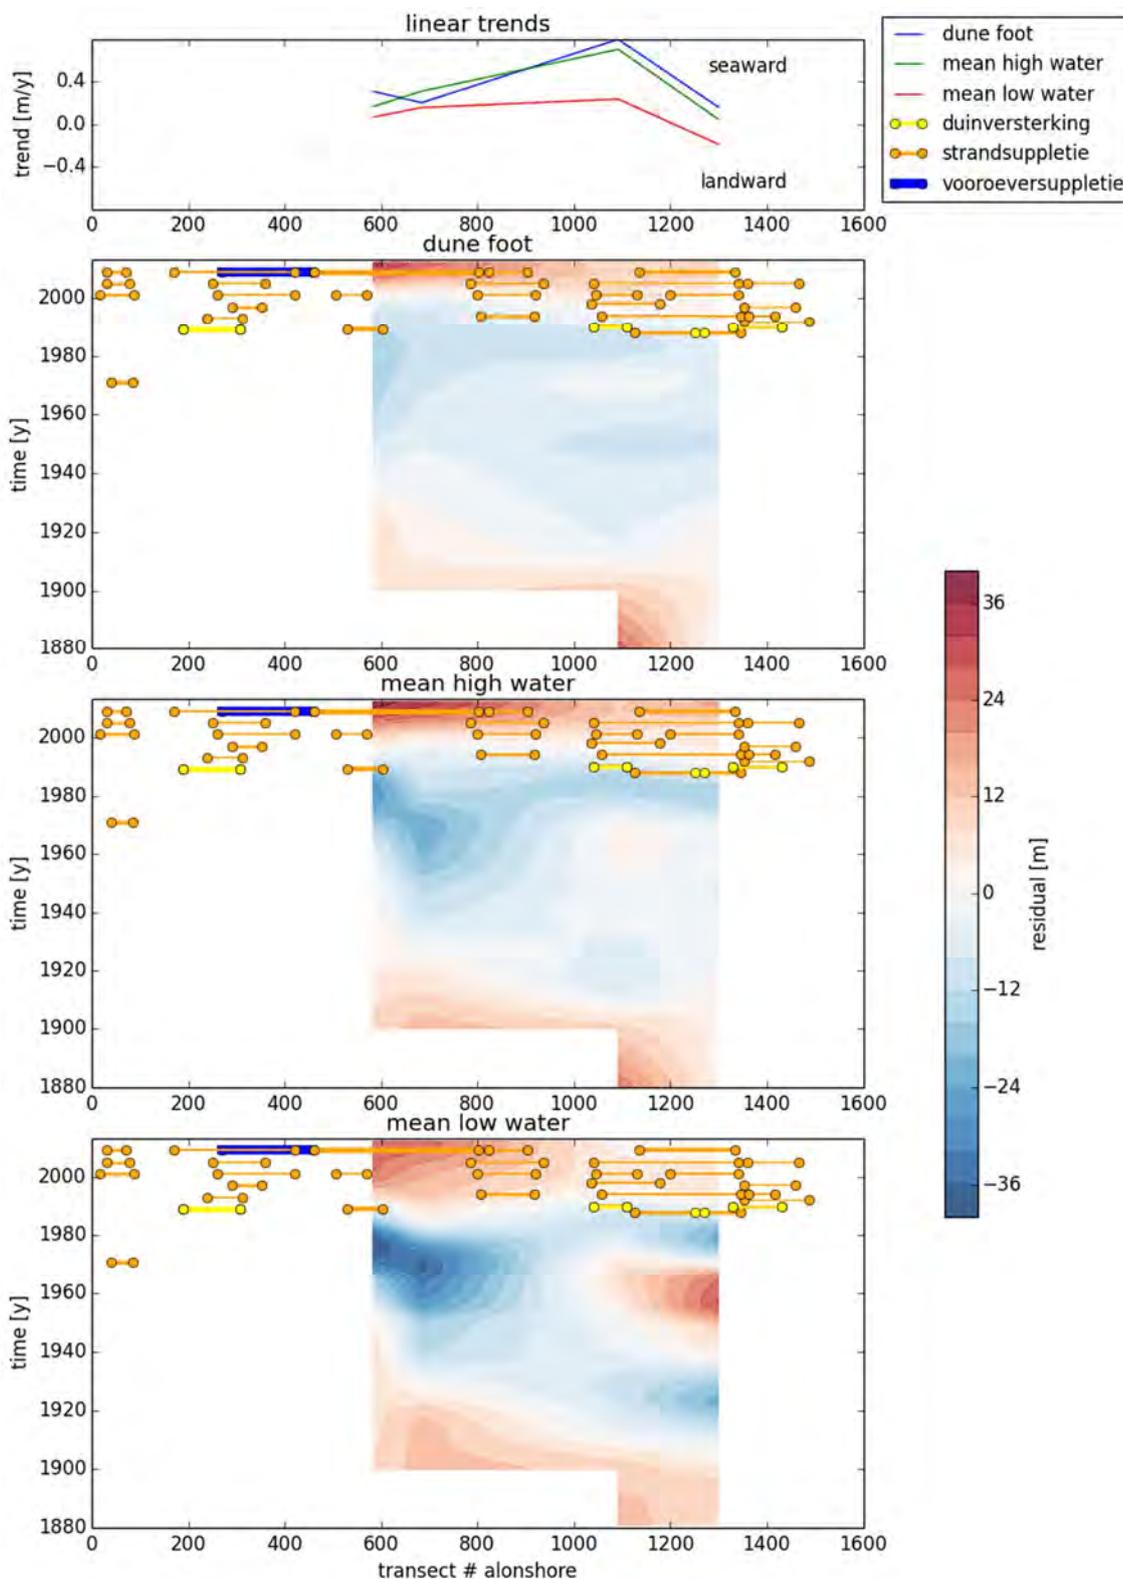
Figure 8.13 (a) Map of Zeeuws-Vlaanderen with the positions of transects used as ticks in (b). (b) Contour plots of residuals of dune foot, mean high and mean low waterline positions of Zeeuws-Vlaanderen. The respective linear trends for the entire period are in the top panel.

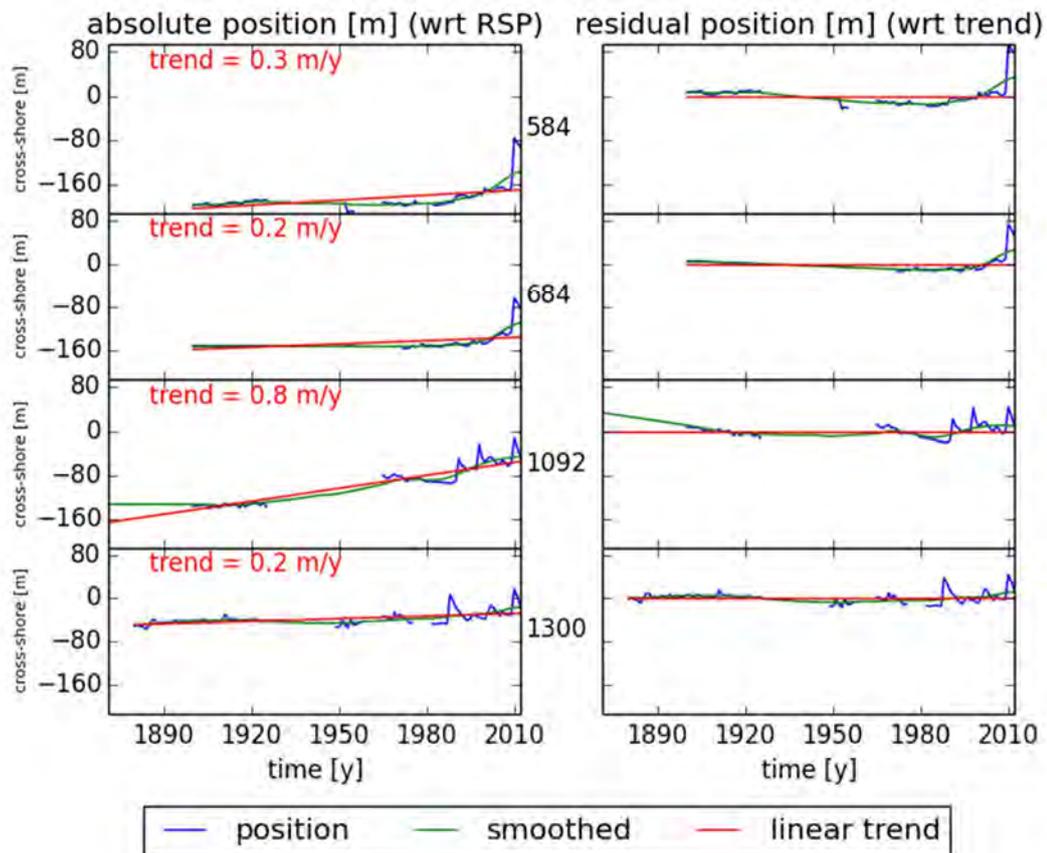
Figure 8.14 Dune foot position for four transects at Zeeuws-Vlaanderen. The blue line represents the actual dune foot position changes, the green line the smoothed dune foot position after applying a low-pass filter, and the red line the linear trend. The figures in the left panel show the absolute values, while the figures in the right panel show the values relative to the linear trends.

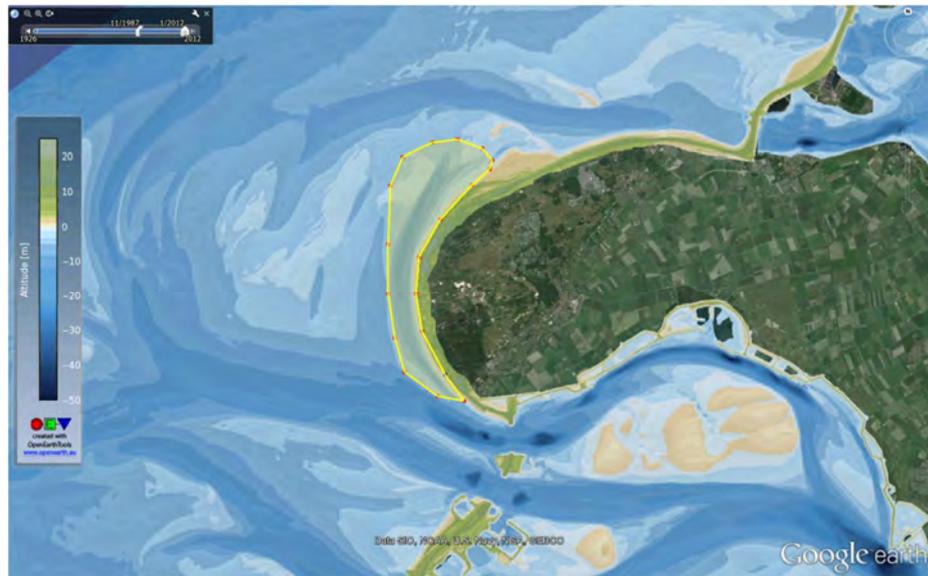
Figure 8.16 Limit of the area defining the Krabbengat.

Figure 8.16 shows the location of the Krabbengat and the region around the channel used for the analysis.

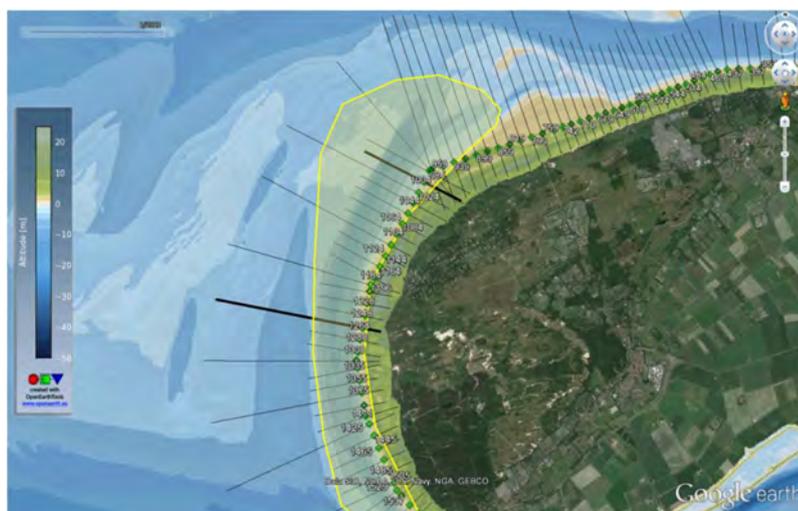
Figure 8.19 Detail of the Krabbengat. Coastal indicators for the highlighted transects (13001004, 13001268) are investigated.

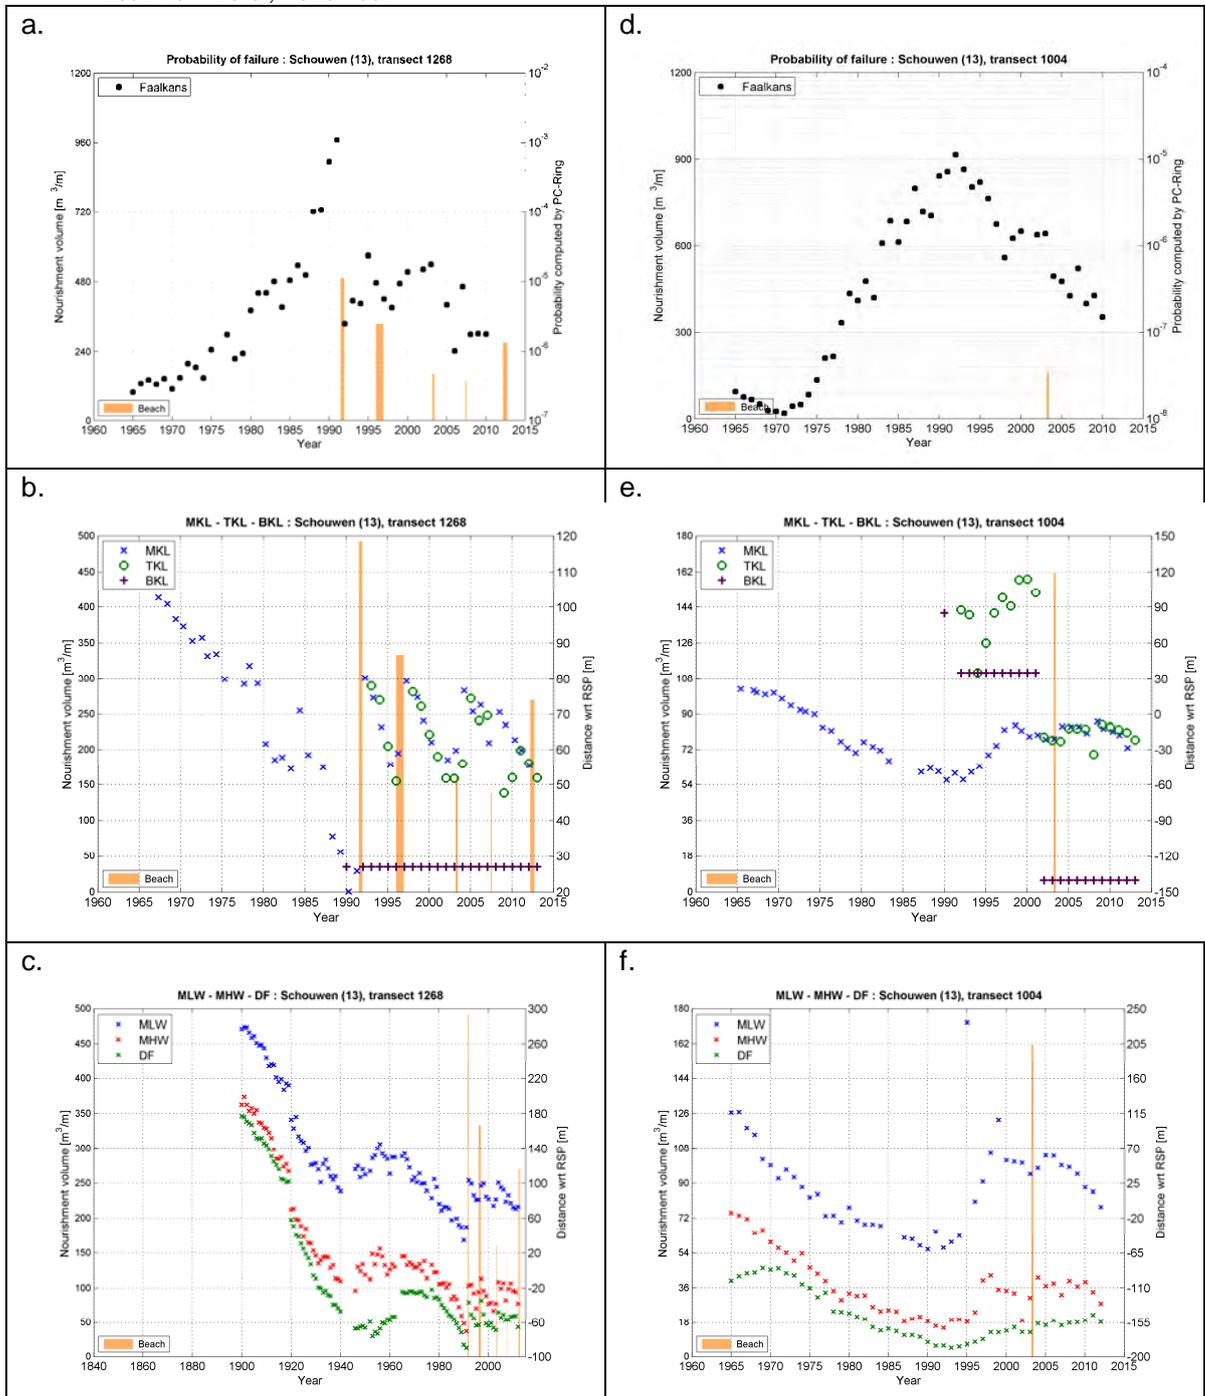
Table 8.3 Coastal indicators for transect 13001268 (left panel) and transect 13001004 (right panel). Figures a., d.: Probability of failure of the first dune row. Figures b., e.: MKL, TKL, BKL. Figures c., f.: Mean High Water, Mean Low Water, Dune Foot.

As a consequence of those interventions, at transect 13001268 the probability of failure decreases about ~ 3 orders of magnitude from the beginning of the 1990's. For clarity, 1:4000 year is the limit admitted by law for wave load during testing of the coastal defences in the South-Westerly Delta. The MKL, MHW, MLW and DF are kept in place with nourishment campaigns every ~ 4 years (Table 8.3 a, b, c).

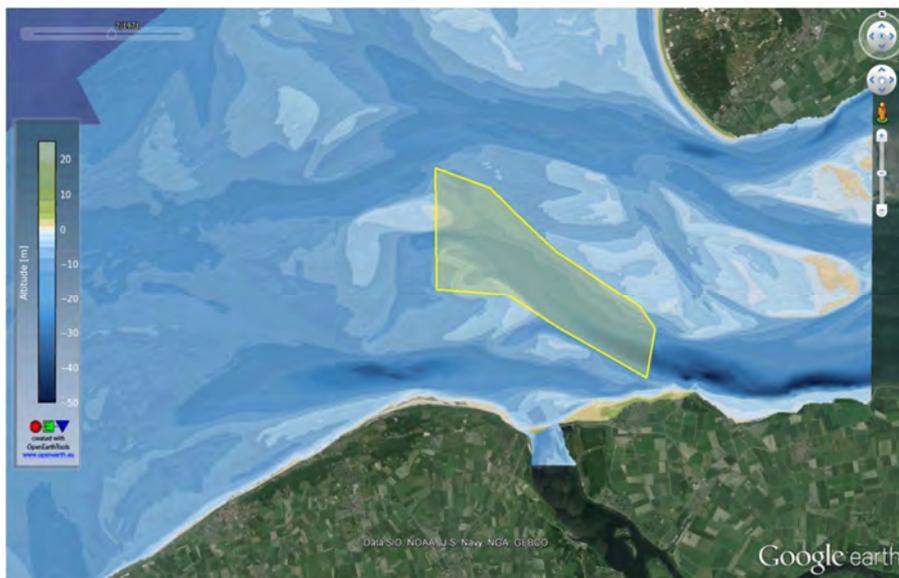
Figure 8.20 Limit of the area defining the Oude Roompot.

The Oude Roompot has faced a shift in its evolution caused by the construction of the Delta Works (“Oosterschelde Stormvloedkering” and “Veersegatdam” – Section 5.2). A region of the channel in the outer Delta, right seaward of the storm surge barrier, is considered (Figure 8.20).

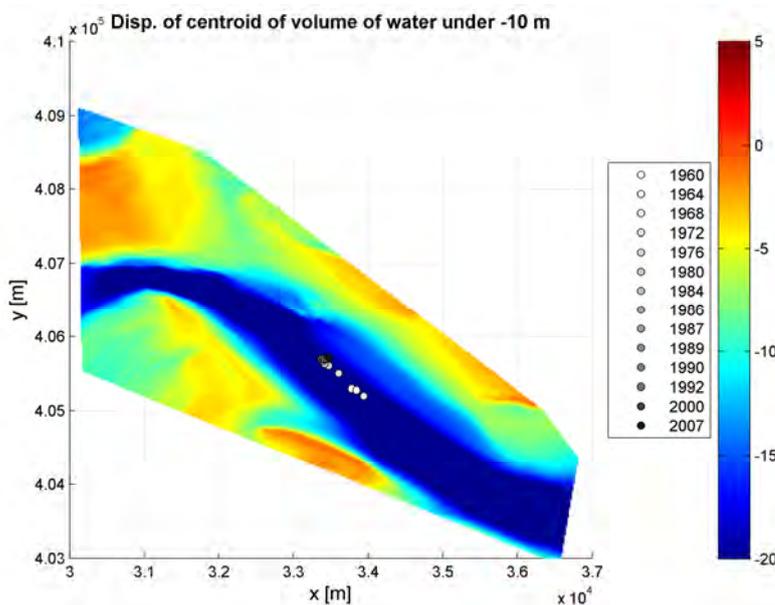
Figure 8.22 Displacement of centre of mass of water between the -10 m contour and the Oude Roompot seabed.

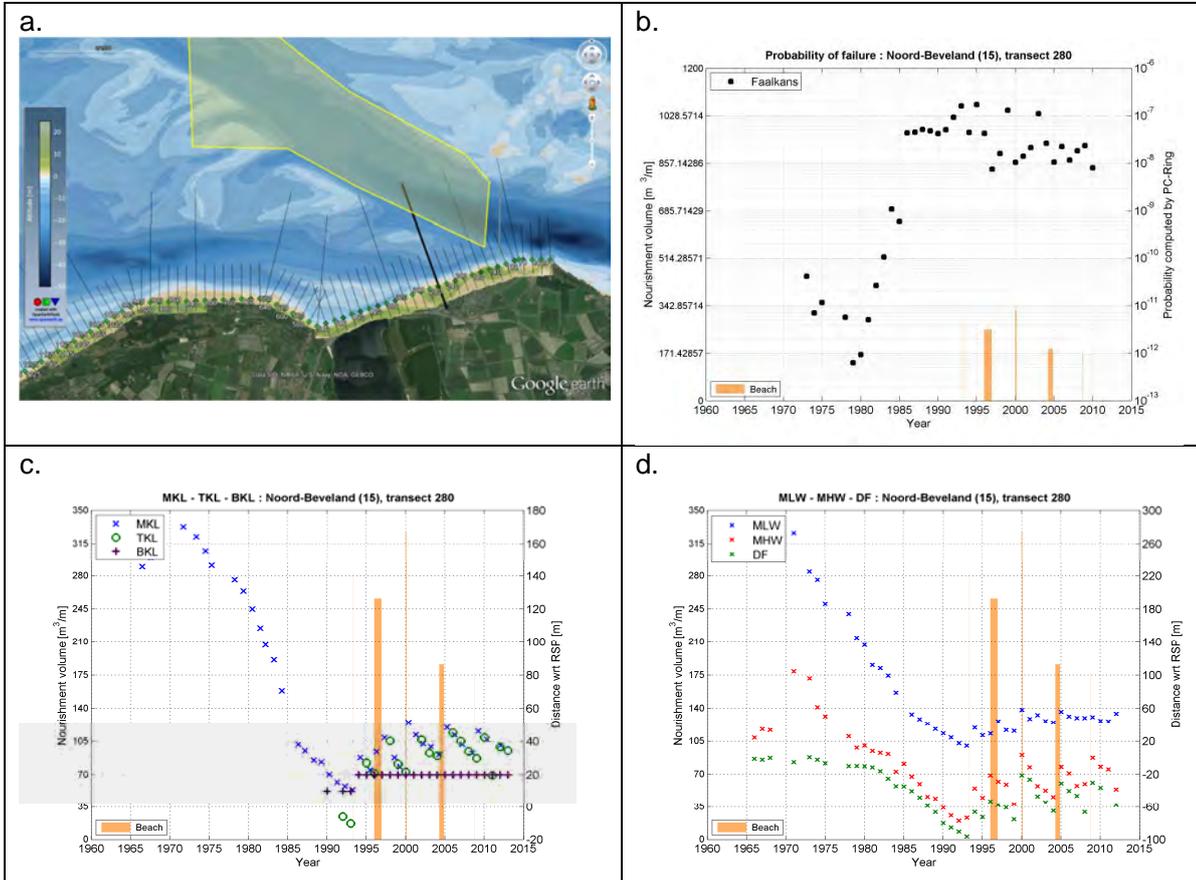
Table 8.4 Coastal indicators for transect 15000280. Figure a.: Detail. Figure b.: Probability of failure. Figure c.: MKL, TKL, BKL. Figure d.: Mean High Water, Mean Low Water, Dune Foot.

Coastal indicators are analysed for a single cross-shore transect in the Oude Roompot (Table 8.4 a). Transect at km 2.80 in Noord-Beveland has been nourished with a cumulative volume of ~1250 m³/m of sand between 1994 and 2008. The positive effects of coastal management can be observed from the 1996, when nourishments started being applied on a 4 years base. As a result of the nourishments, the probability of failure is maintained on a safety level, as well as the MKL position (Table 8.4 b, c, d).

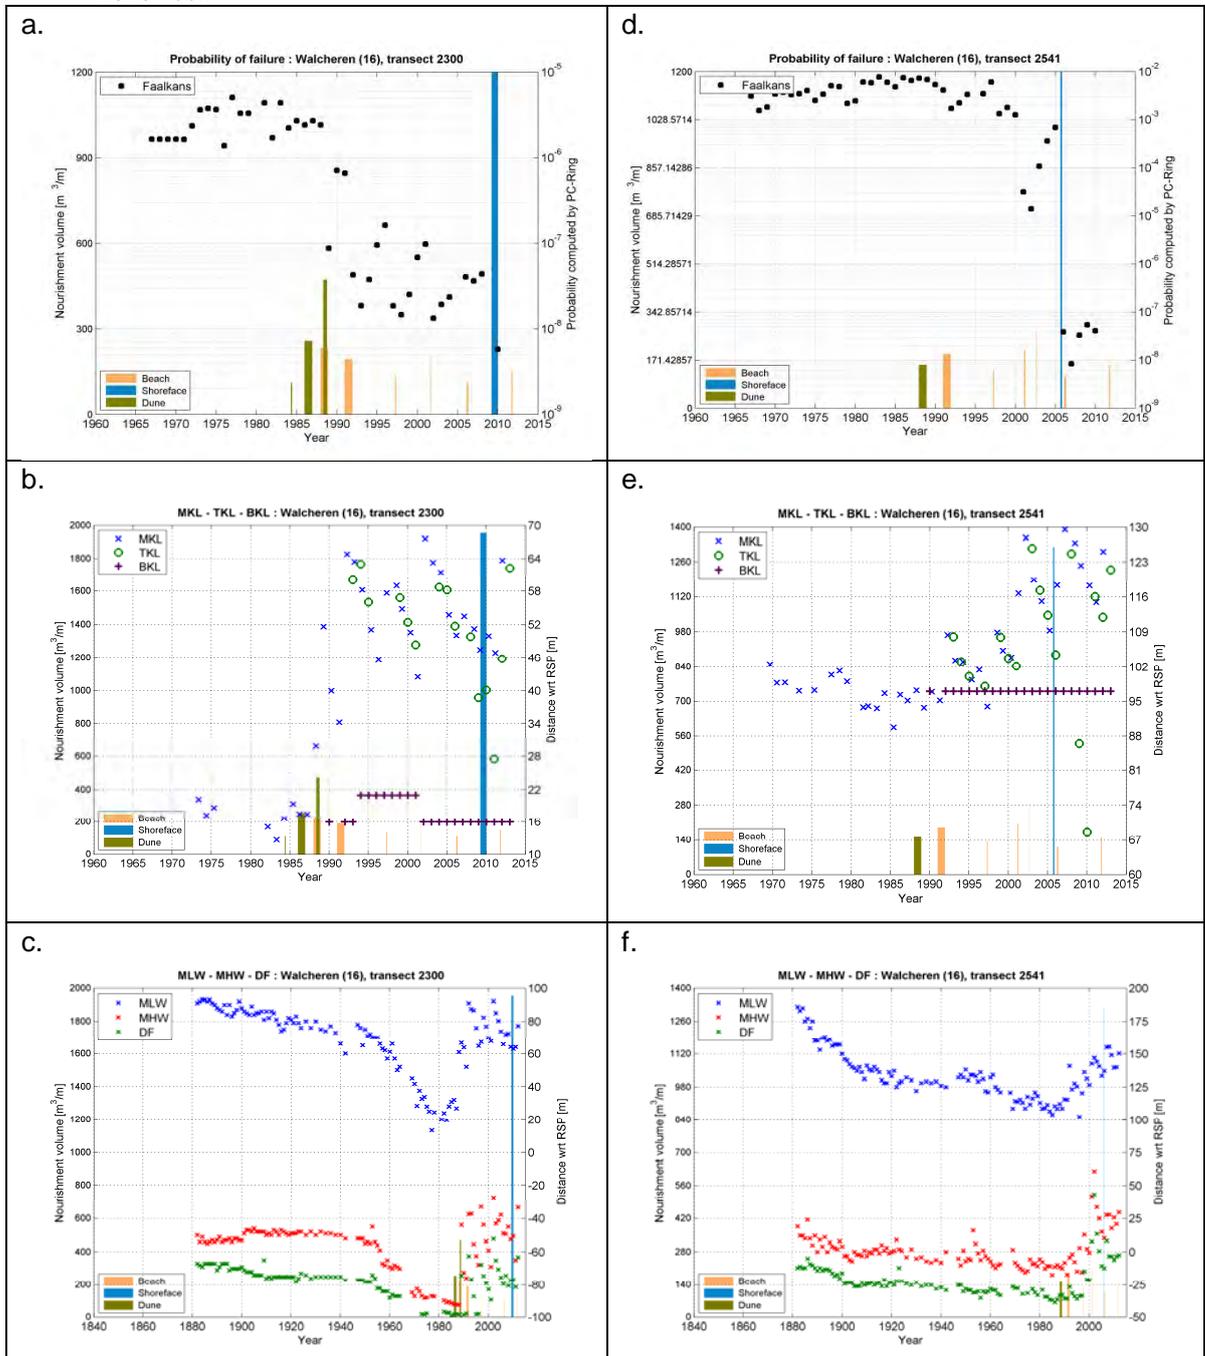
Table 8.5 Coastal indicators for transect 16002300 (left panel) and transect 16002541 (right panel). Figures a., d.: Probability of failure. Figures b., e.: MKL, TKL, BKL. Figures c., f.: Mean High Water, Mean Low Water, Dune Foot.

The positive effects of the coastal management can be observed already since the 1980s, when this coastal stretch started being nourished. Probability of failure decreased with about 2 orders of magnitude and a seaward shift of ~40 m in MKL position is observed (Table 8.5a, b, c).

Table 8.5b and e shows that, in between nourishments, the MKL moves landwards about~ 20 m in 5 years (~4 m/year). This result is comparable with the landward shift of the centroid which is likely to be the cause of the MKL landward movement (Figure 8.25).

The underwater nourishment decreased the probability of failure of transect 16002541 with ~4 orders of magnitude; nourishment policy from the 1980s' contributed to a MHW, MLW and DF shift of about 50 m in seaward direction (Table 4.1d., e., f.).

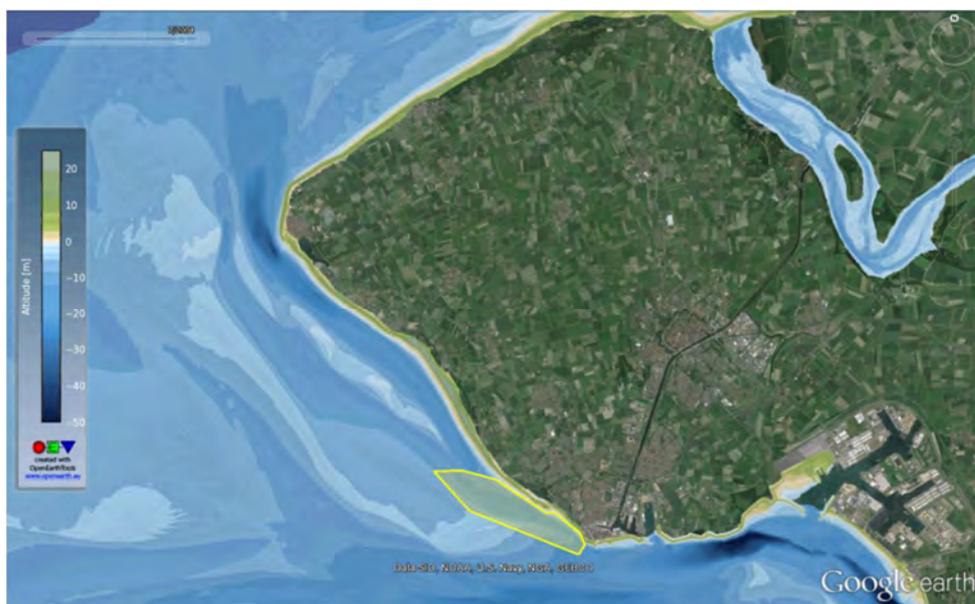
Figure 8.27 Limit of the area defining the Sardijneul.

The Sardijneul is located in front of Vlissingen, and it is confined in the region shown in Figure 8.27. The channel has been kept at its depth through a number of dredging campaigns carried out since 1992. The dredged material was used as nourishments on the coast. The volume of water under the -10 m contour line did not face major changes (Figure 8.28). Minor horizontal shift of the centroid of that volume is observed, indicating a rather stable channel (Figure 8.29).

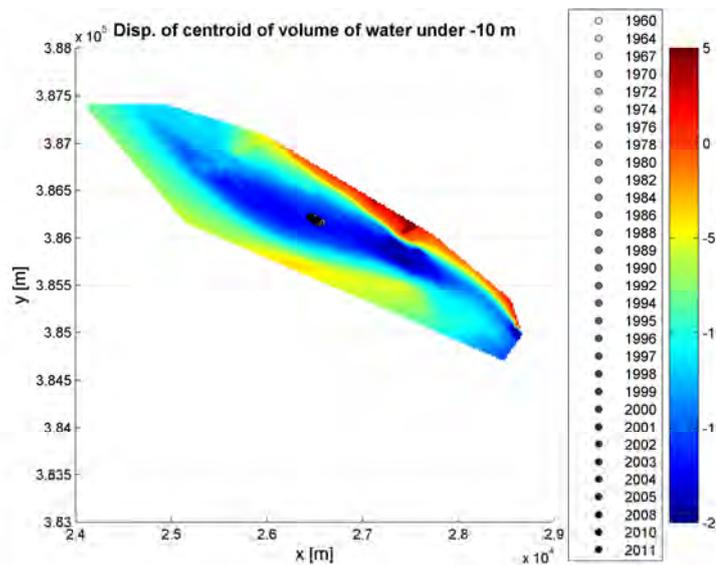
Figure 8.29 Displacement of centre of mass of water between the -10 m contour and the Sardijngel seabed.

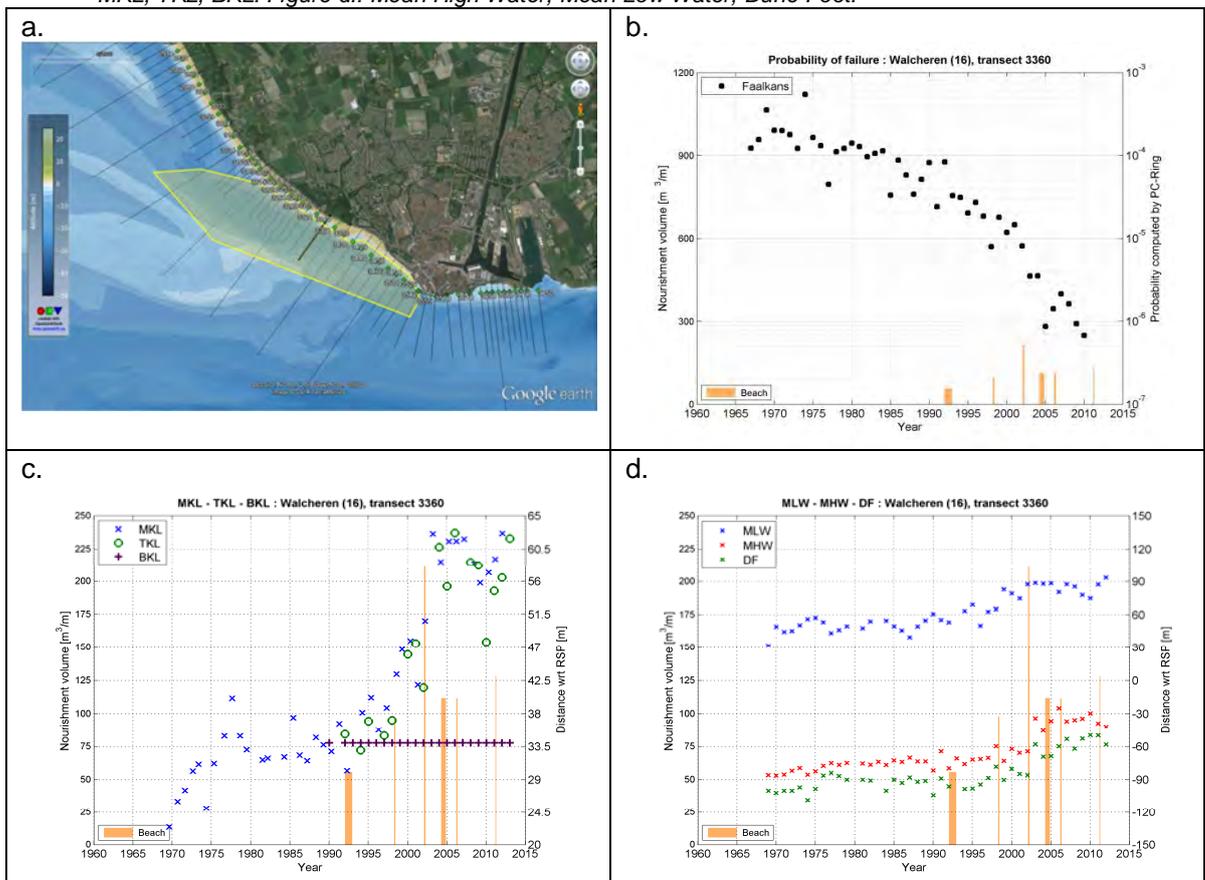
Table 8.6 Coastal indicators for transect 16003360. Figure a.: Detail. Figure b.: Probability of failure. Figure c.: MKL, TKL, BKL. Figure d.: Mean High Water, Mean Low Water, Dune Foot.

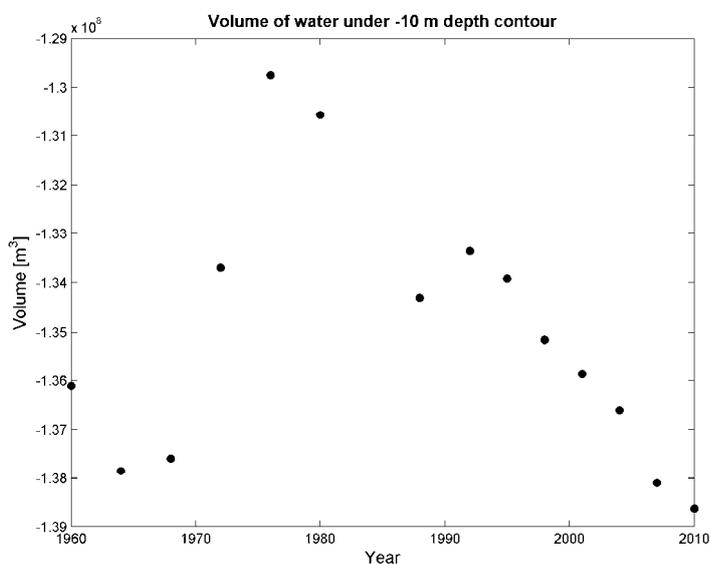
Figure 8.31 Roompot and Schaar van de Onrust. Evolution over time of the volume of water delimited by the channel bed and -10 m contour line (from Vaklodingen data).

Looking at vaklodingen data, the eastern part of the selected region is the most dynamic one, which is undergoing a deepening and extension towards the storm-surge barriers. As a result, the centroid of the channels has moved to the East with ~ 600 m in 50 years (Figure 8.32). Moreover, the centroid has also shifted with ~ 100 m in landward direction during the same period. This can most likely explain the erosive trends which are observed in this part of the coastline (i.e. between transect 16000880 and 16001085) and which have pushed towards the construction of a number of nourishments. Coastal indicators are analysed for transects 16000740 and 16000900 (Figure 8.33). Transect at km 7.40 in Walcheren has never been nourished. Probability of failure is very low

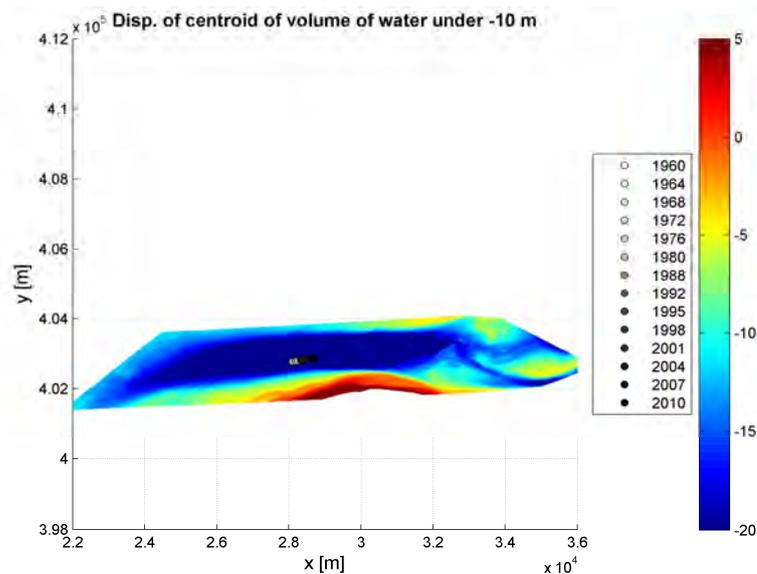
Figure 8.32 Displacement of centre of mass of water between the -10 m contour and the Roompot and Schaar van de Onrust seabed.

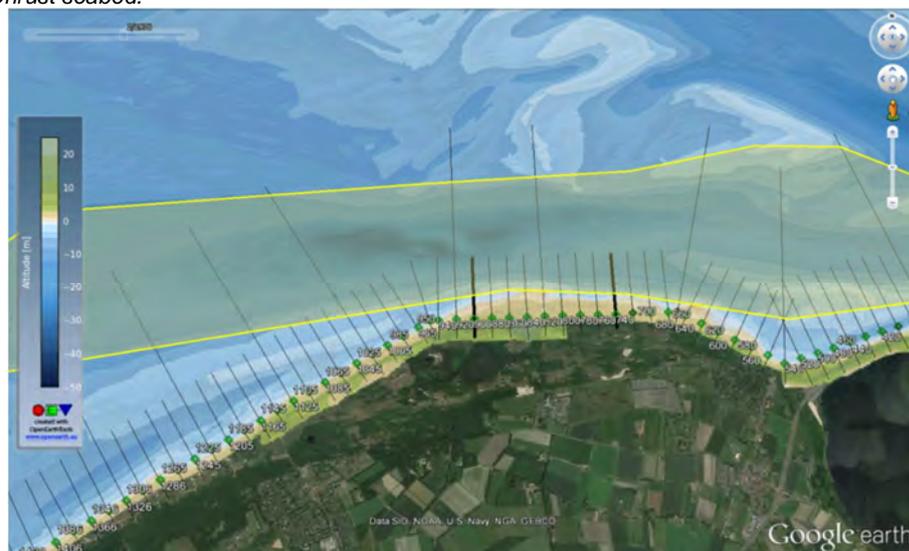
Figure 8.33 Detail of the Roompot and the Schaar van de Onrust (Walcheren). Coastal indicators for the highlighted transects (16000740, 16000900) are investigated.
