The state of the coast

The South-Westerly Delta

Alessio Giardino
Kees den Heijer
Giorgio Santinelli

1209381-006

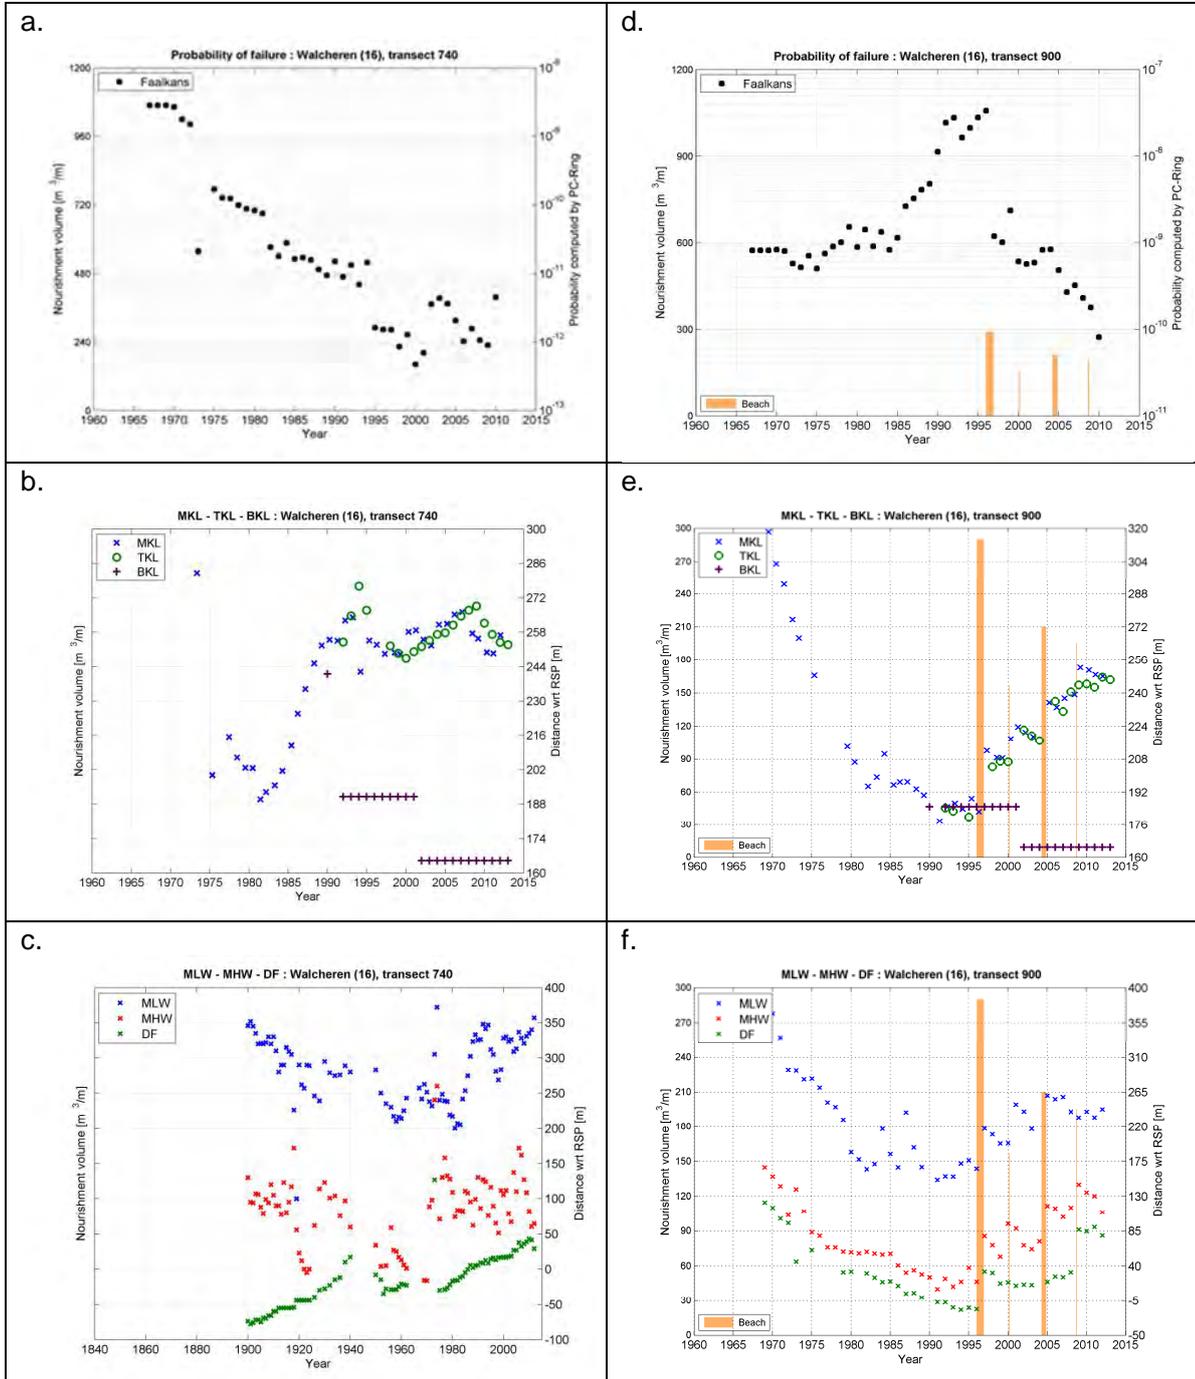
Table 8.7 Coastal indicators for transect 16000740 (left panel) and transect 16000900 (right panel). Figures a., d.: Probability of failure. Figures b., e.: MKL, TKL, BKL. Figures c., f.: Mean High Water, Mean Low Water, Dune Foot.

in magnitude ($\sim 10^{-12}$) and MKL has a buffer of ~ 80 m with respect to BKL (Table 8.7 a, b, c). Although the gully has deepened, MKL and probability of failure moved towards safer conditions. Transect at km 9 has been nourished with $850 \text{ m}^3/\text{m}$ between 1996 and 2008, with a beach nourishment campaign every 4 years. The effects of the nourishments on coastal indicators are visible in Table 8.7 d, e, f, leading to a decrease in probability of breaching of almost three orders of magnitude, a seaward shift of MKL, mean high water, mean low water line and dune foot position of about 100 m.
