Morphodynamic responses of nourished beaches in SW Spain

Anfuso, G.; Benavente, J. & Gracia, F.J.*

Abstract. Coastal erosion in SW Spain is affecting man-made structures and beaches that represent an important economic resource in the area. In the last decade the Spanish government carried out several nourishment works that have limited durability. Most of the artificial beach fills consist of a spill of natural dredged sand on the visible beach, leading to a flat, artificial berm with an important seaward slope and a narrow foreshore. As a result, the initial dissipative profile was transformed into a fully reflective one. A beach monitoring program was carried out to record morphological evolution after the nourishment works. Several field assessments of disturbance depth were also made to characterize beach morphodynamics of a nourished beach (Rota) and a natural dissipative one (Tres Piedras), whose slope was similar to the pre-nourishment gradient of Rota beach. Natural dissipative beaches were characterized by spilling breakers that did not significantly affect bottom sand. The severe erosion recorded in the nourished zones was related to the new morphodynamic regime acting

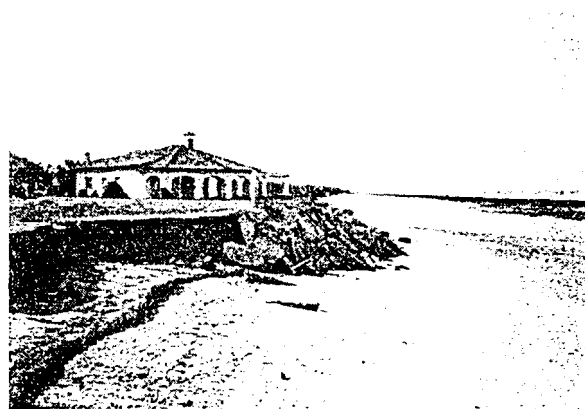
Fig. 2. Erosion problems near Punta Candor. The Quaternary cliff is eroded and summer houses are protected by a rip-rap revetment.

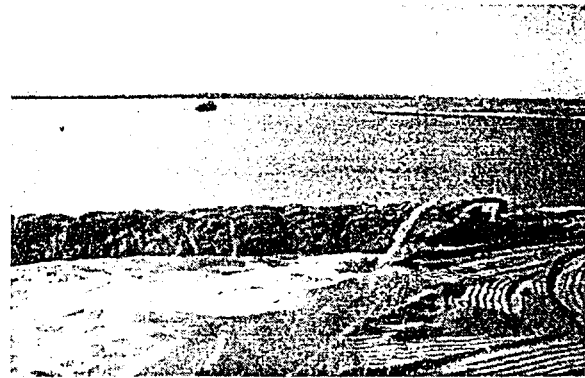
Fig. 3. Nourishment works on Aculadero beach, with the pipeline pumping sediment on to the beach. Note the dredging boat in the background.

In all cases the sand was dredged from the Cádiz harbour channel, at water depths between 8 and 14 m, and then pumped onto the beach through a short floating pipeline. The sediment was spilt on the back-shore and in the upper part of the foreshore to widen the visible beach (Fig. 3). Bulldozers were then used to reshape the back-beach to create raised, flat, berms, characterized by an important seaward slope and a narrow foreshore. By this procedure the initial dissipative profile was transformed into a fully reflective one.

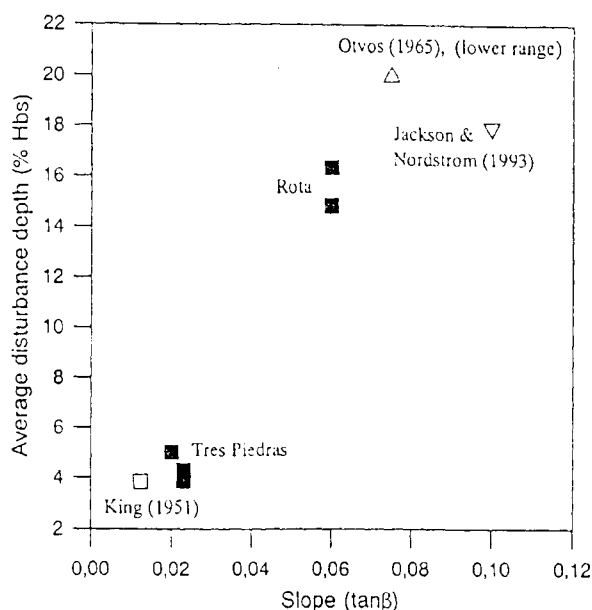
Fig. 9. Relation between average disturbance depth (percentage of breaking wave height) and beach gradient for the studied beaches (full symbols) and average values observed by other authors (empty symbols).

point is directly dependent upon the beach gradient (Galvin 1972). Following Hardisty (1990), as the beach slope increases, the wave celerity brings the wave into shallower water too quickly for the wave energy to be gently dissipated in spilling breakers, so instead a lot of energy is rapidly dissipated. It is clear that the acquisition of high beach gradients after the replenishments constitutes a very important contributing factor to the greater depths of sand removed by waves, compared to natural, non-replenished beaches (Fig. 9).
