# Evaluation of pore water pressures and breach growth in an existing dike during an in situ test at Wichelen (Belgium)

Master's dissertation submitted in order to obtain the academic degree of  
Master of Science in Civil Engineering

Department of Civil Engineering  
Chair: Prof. dr. ir. Peter Troch  
Faculty of Engineering and Architecture  
Academic year 2015-2016

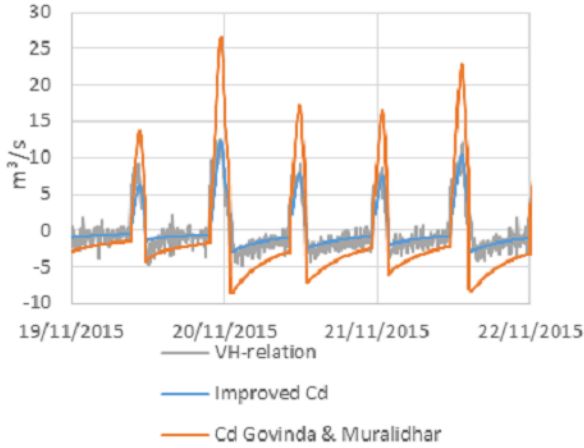
A new coefficient of discharge is calculated. This coefficient of discharge is obtained by minimalizing the RMSE compared to the measured water volume and derivated discharge in the polder. An evaluation is done by performing an ADCP measurement in the breach. The best solution was obtained when using a constant value of Cd and optimizing it using the measured water discharge in the polder. In Fig. 3 the discharge calculations are shown.

Fig. 3 Discharge calculations

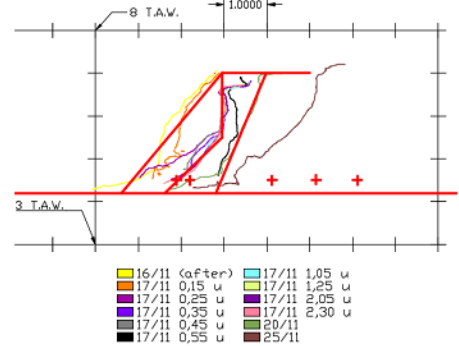
The measured water pressures are simulated using SEEP/W for a period from 8:07 h 17/11/2015 to 8:00 h 24/11/2015. The geometry inserted in SEEP/W consists out of three time steps 0-1200 sec, 1200-100380 sec, 100380 sec-end and is show in Fig. 5. These time steps are chosen in accordance with the observed breach growth. The crosses in the figure represent the sensors placed in the dike. The inserted soil properties were obtained by soil investigation.

Fig. 5 SEEP/W model compared to observations

A good similarity was found between the measurements and the calculated values. The accuracy of the simulation is in direct relation to the inserted geometry. If there are fast changes in geometry the similarity between the simulation and the measurement is less.

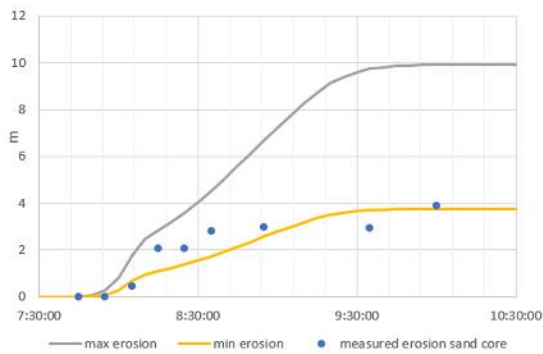
The breach growth is calculated using analytical formulas: the method of Van Rijn [6] and an excess shear strength equation. The inserted parameters in the formulas are obtained from ground research. Using the different obtained parameters a minimum and maximum value for erosion is given in Fig. 6. The method of Van Rijn [6] gives a good result when compared to the measured width. When the excess shear stress equation is used too large values are obtained (36-268 m).

Fig. 6 Calculated erosion each side of the breach using Van Rijn[6]

The further breach growth is more prone to slope failure, therefore it is assumed that the formula of Van Rijn [6] isn't valid.

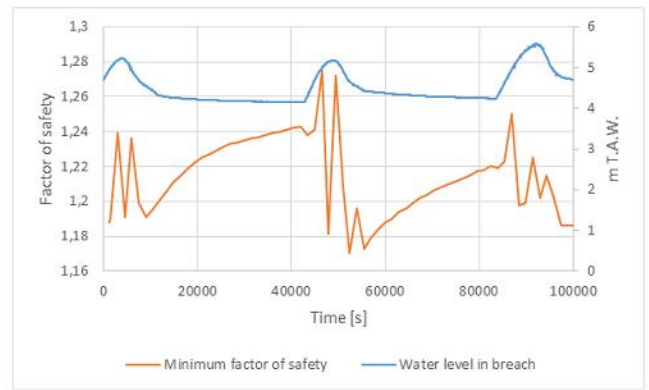
For the subsequent geometry the calculated factor of safety is shown in Fig. 9. The most critical moment in time is just after high tide when the water is flowing out of the sides causing a destabilizing gradient. A piece of toe of 1 meter was removed at the most critical moment (52000 seconds). This calculation gave a higher factor of safety. This can be explained due to model errors: the flow is modelled for the non-eroded part. If the toe is removed, the part where the destabilizing gradient occurs is removed. In reality the flow will penetrate deeper into the soil.

Fig. 9 Factor of safety second geometry 1200-100380 sec

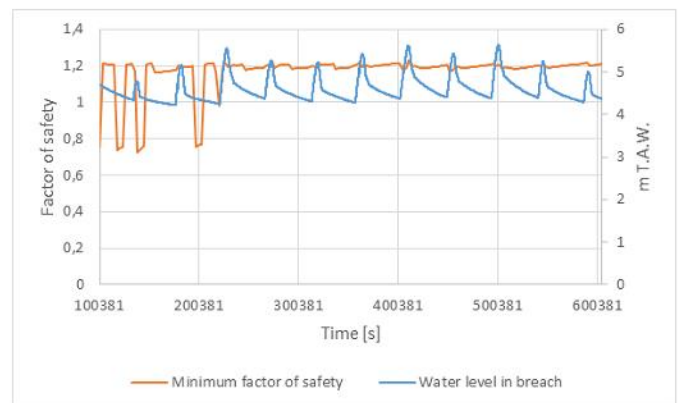
When calculating the final geometry it was found that only shallow slip surfaces occurred. In Fig. 10 the factor of safety is given in time. The depth of these slip surfaces was approximately 0,3 m. This failure mechanism is in agreement with the observations.

Fig. 10 Factor of safety second geometry 100380 min -end

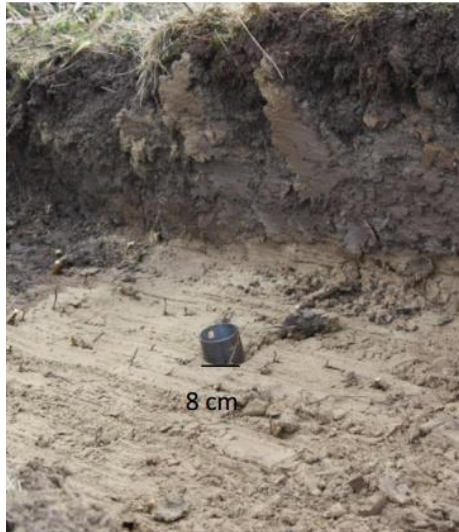
*Figure 1-4 clay lining and inner sand core (Irstea, 2015)*

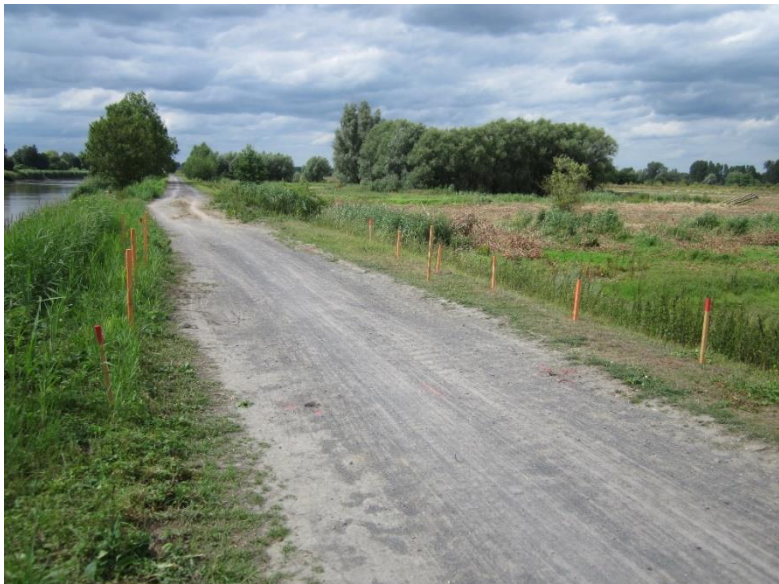
In Figure 1-5 the dike is shown at the breach location. At the river side a rip rap revetment is present almost until the crest. There is also some vegetation at the river side mainly consisting out of reed. At the polder side an old grass cover is present. On the dike crest there is a bicycle path made out of small stone chippings.

*Figure 1-5 Dike at location breach experiment*

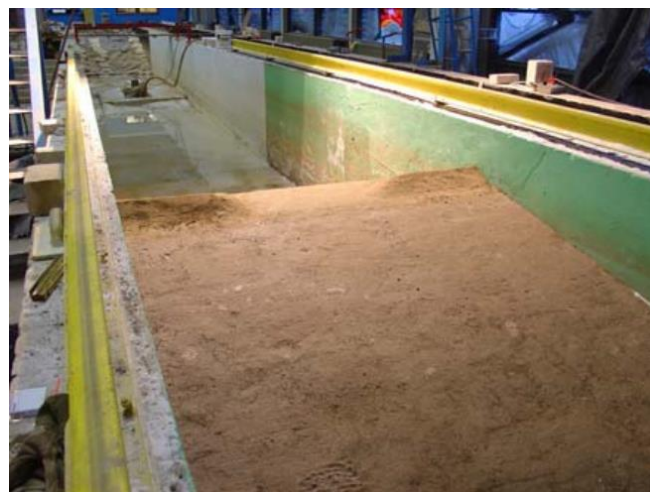
Figure 2-6 Dike model view from seaward side

The dike failed due to erosion which started from the landward dike toe at the connection with the concrete flume. The sand had been removed, chunks of the clay layer on top failed consecutively and fell downwards so that a backward erosion of the clay layer occurred on the landward side of the dike.

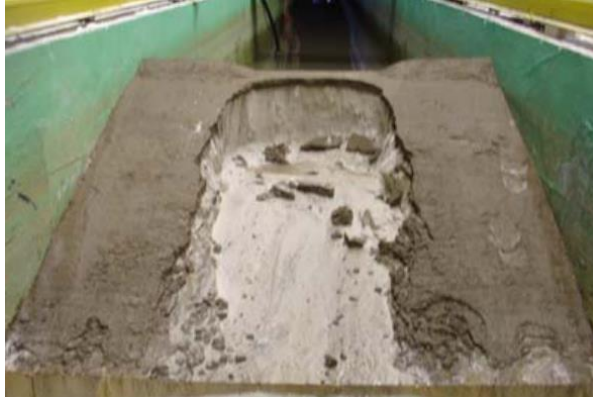
Figure 2-7 Model after breach test (Geisenhainer & Kortenhaus, 2006)

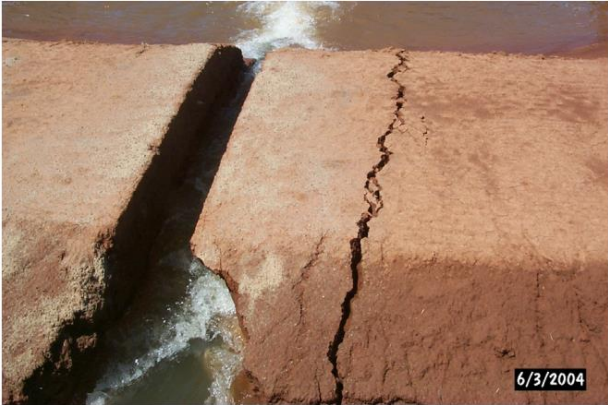
During all three tests the breach channel widened to a large extent as the breach slopes became undermined, causing mass failures to occur. The undermining was observed to occur as a detachment process, resulting in an overhang developing. This is in accordance with (Coleman, Jack, & Melville, 1997). A crack along the surface was observed at the initiation of mass failure of the bank. The breach widening happened in steps, the average speed was between 0,022 and 0,88 m/hour.

Table 2-3 Tension crack (Hunt S. L., Hanson, Crook, & Kadavy, 2005)

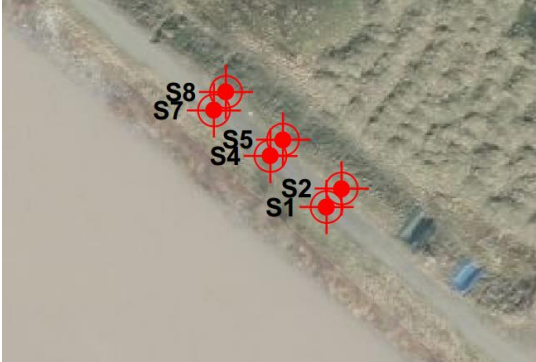
The zone where the breach test can be executed has a length of 100 m. At both ends of this zone in the dike a concrete plug is installed. This is done to prevent any further erosion of the dike after the breach test. The initial plan was to make the breach in the middle of the test zone at S4 & S5 on Figure 3-2.

Figure 3-2 CPT-tests on dike crest (DOV, 2016)

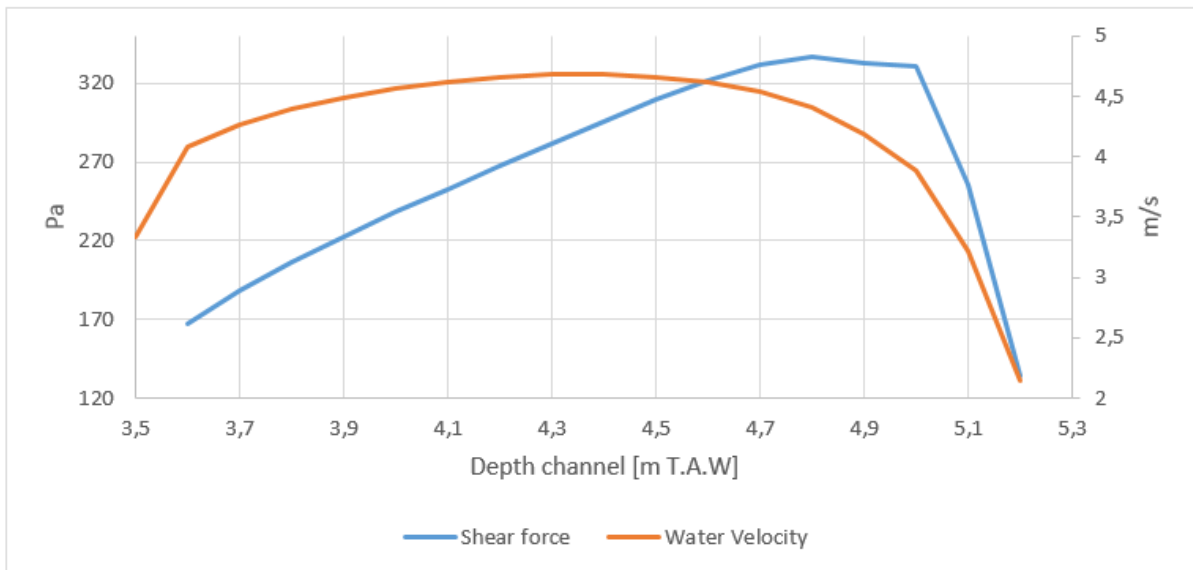
Figure 3-7 Shear force and water velocity at the toe for different channel depths

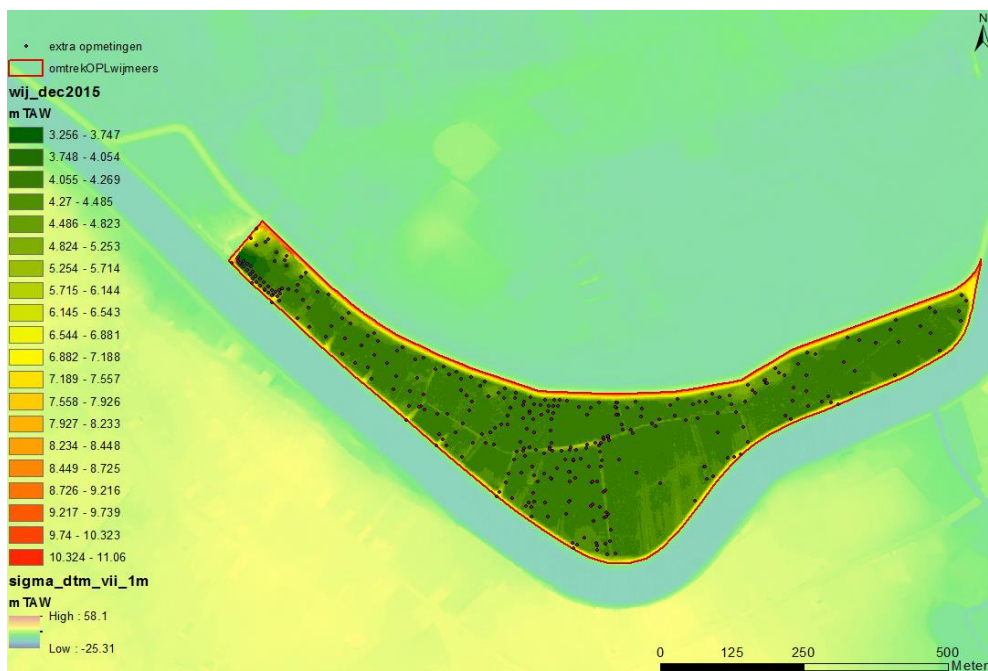
By executing height measurements of the polder, as shown in Figure 3-9, a volume to height relationship is derived by FHR as shown in Figure 3-10. Only a global image of the height of the polder can be given, small local irregularities like ditches and vegetation aren't taken into account. If the water height of the polder is known, the volume of water can be derived. Therefore in time, the change in volume can be derived, so the flow through the breach can be calculated.

Figure 3-9 Topography of the polder anno 2015

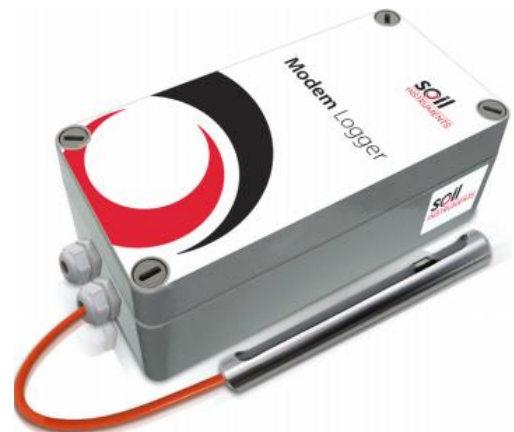
The MEMS sensor consists of a filter element with underneath the actual sensor. The filter element is made of hydrophilic porous polyethylene material which has the property that it completely saturates itself when brought in contact with water, even after repeated drought. Therefore the sensor is suitable for use in a non-continuously saturated zone. It is recommended that prior to installation the filter element is saturated with water or silicone oil. (Alert Solutions, 2011)

Figure 3-11 MEMS sensor (Soil instruments)

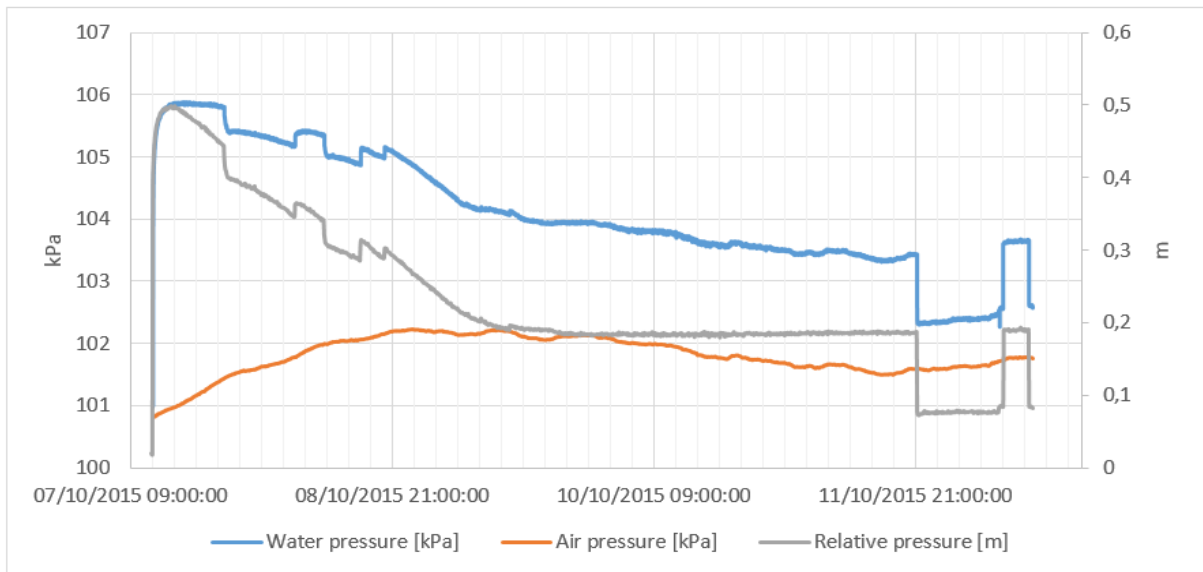
A unsaturated MEMS sensor was tested to have an indication of the saturation time when placed in water. This was done by placing the sensor in a bucket filled with water ( $\approx 20$  cm). During the test, the sensor was placed at two different water heights, approximately 10 and 20 cm. Every 30 seconds, the actual air and water pressure were logged. The results are displayed in Figure 3-12. There is an overpressure at the beginning of the test which gradually decreases. During the test the alternation of the water height can be seen as the pressure jumps.

Figure 3-12 Saturation test of MEMS sensor

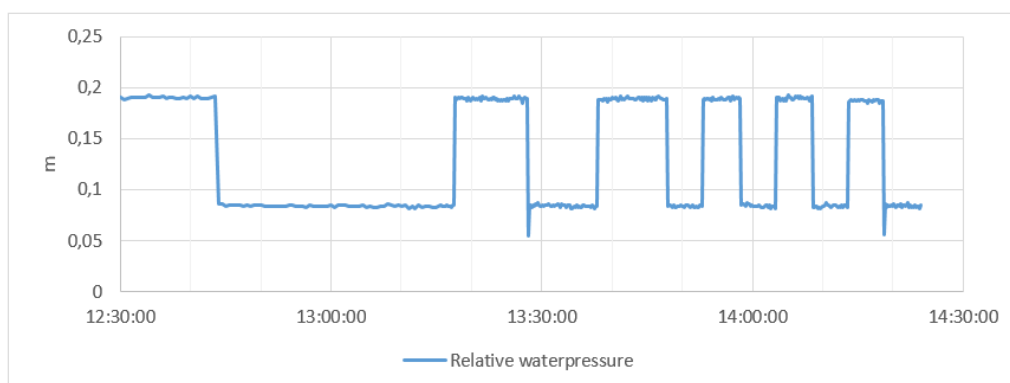
The reaction speed of the sensor is also tested, this was done by decreasing the log time to 10 seconds and alternating the water level. The results of this test is shown in Figure 3-13. The jumps occur where the water level was changed, at two moments in time there is an under pressure measured. It is possible that during the transfer between the two water containers the sensor logged the pressure when it was exposed to air, this can explain the under pressure. It is found that the measurements are instantaneous in water, there is no delay on the measurements. This can be different when installed in soil due to the permeability. When installed in a soil with a low permeability it is possible that there is a delay. The effect of hindered erosion will be measured in the sand core of the dike. Sand has the property to have a good permeability so it is assumed that the measurements will be instantaneous.

Figure 3-13 Reaction speed test MEMS sensor

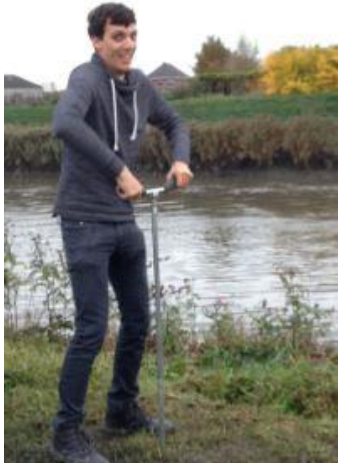
The actual depth of the measuring sensor was at 2,57 m from the dike crest. The sensor was placed by drilling a hole. This has the advantage that the ground in which the sensor is placed can be examined. A picture of the installation is shown in Figure 4-2. If clay was found at the installation depth the sensor is installed a bit higher in the sand layer. Due to this reason BAT 3837 is installed 10 cm higher.

Figure 4-2 Installation of sensors using an auger

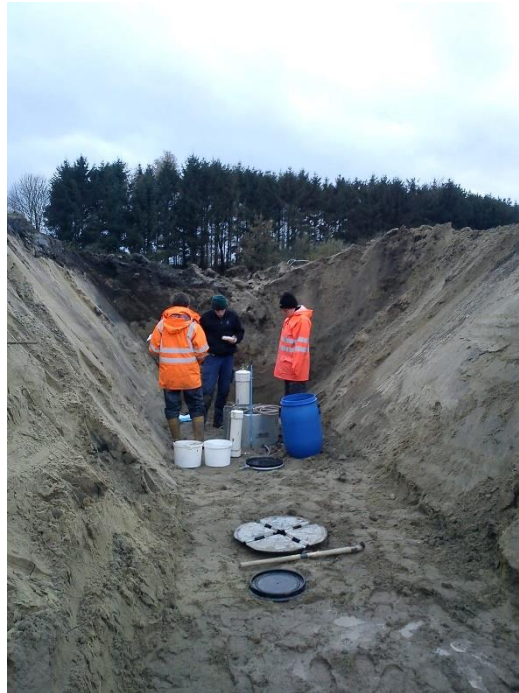
Before the breach experiment a single ring infiltration test is executed on the slope of the dike and a double ring infiltration test is done on the bottom of the pilot channel. This last test is displayed in Figure 4-3. Several ground monsters, disturbed and undisturbed were taken for further testing. The results of these tests can be found in annex A. The positioning of the tests is displayed in annex B.

Figure 4-3 Double ring infiltration test in pilot channel

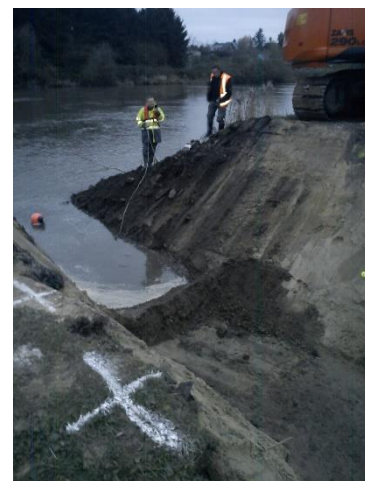
To have an indication of the breach growth, a grid of 1mx1m was drawn on the dike and on the crest every one meter a picket is placed. This can be seen in Figure 5-1.

Figure 4-4 Pilot channel before test

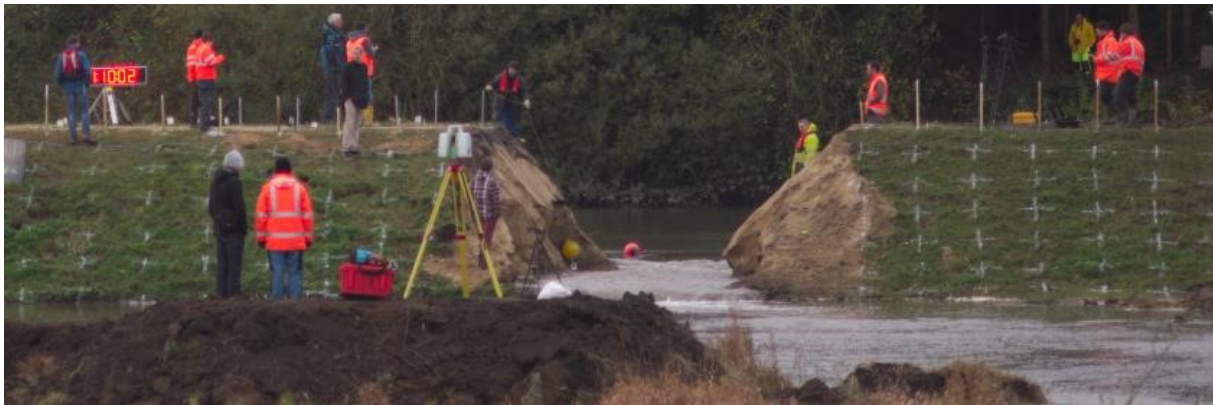
During the first test, the water level reached only 5,02 m T.A.W, this was 0,3 m lower than expected from the astronomical data. There was water flowing through the breach for approximately an hour and a half. The pilot channel was deepened but no real headcut was formed during the test.

*Figure 5-1 Breach test on 16/11/2015 (Janssens, 2016)*

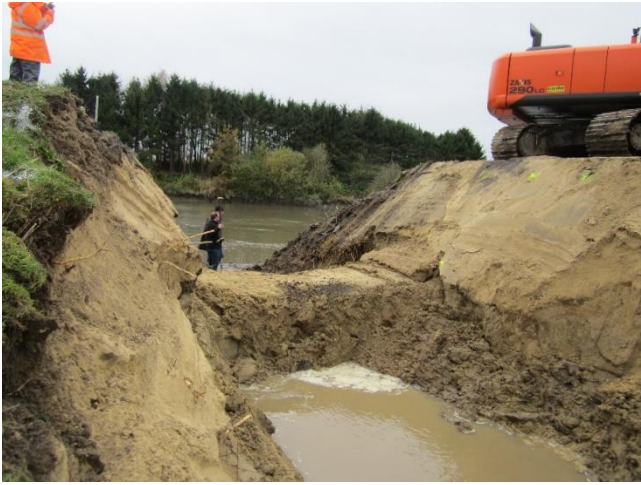
There was some erosion of the dike laterally but this was only very minor as can be seen in Figure 5-2. The water didn't have enough energy to undermine the sides of the dike causing failure. The pilot channel was widened only approximately 1 meter. It was impossible to determine the different breach phases.

A temporary dike was placed inside the pilot channel to prevent the water from entering the pilot channel during the high tide in the evening as shown in Figure 5-2.

Figure 5-2 Breach after breach test I 16/11/2015

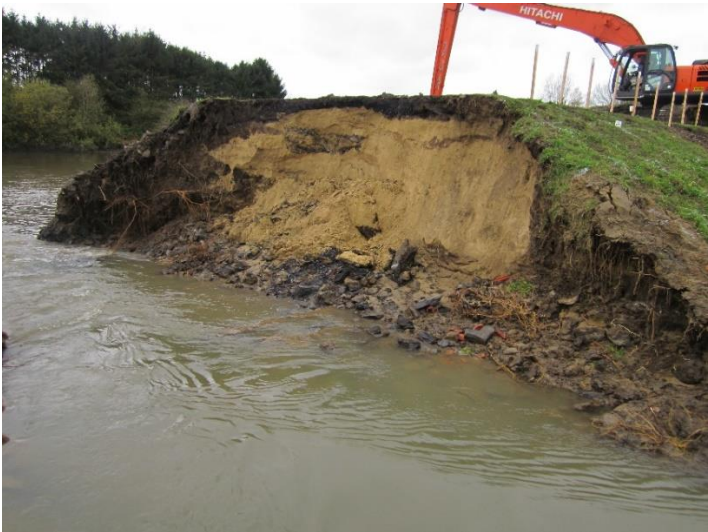
During the test the water eroded the lower part of the sides of the dike, until the moment that slope failure occurred and a chunk of soil fell into the breach. It could be noticed that the shape of the breach was more an O-shape. This can be seen in Figure 5-3 and Figure 5-5. The inner sand core easily eroded and caused a decrease in support for the outer clay layer, but even with the decrease in support the outer layer stayed in place due to the roots that were present. The roots reinforced the outer clay lining so it could hang over the sand core.

Figure 5-3 Breach during test II 17/11/2015

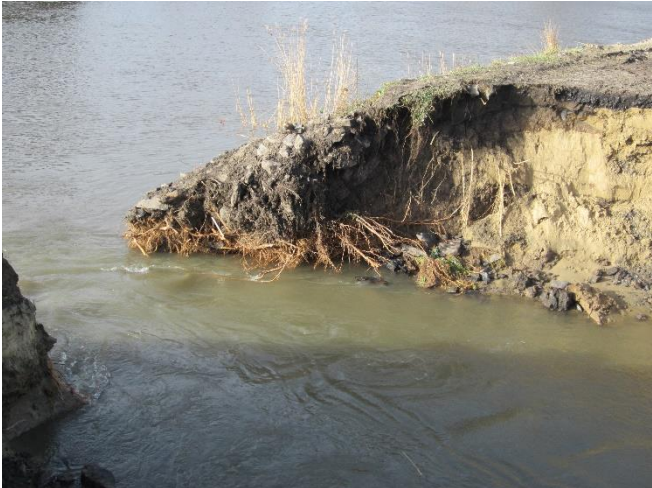
For larger periods, the outer layer was only supported by roots in the dike as can be seen in Figure 5-4. Pieces of this outer layer only fell into the water when enough sand was eroded, leading to too high forces in the roots. The outer layer eroded also by washing out of the clay particles from the dense root network, but this phenomenon happened more slowly.

Figure 5-4 Roots at the riverside 17/11/2015

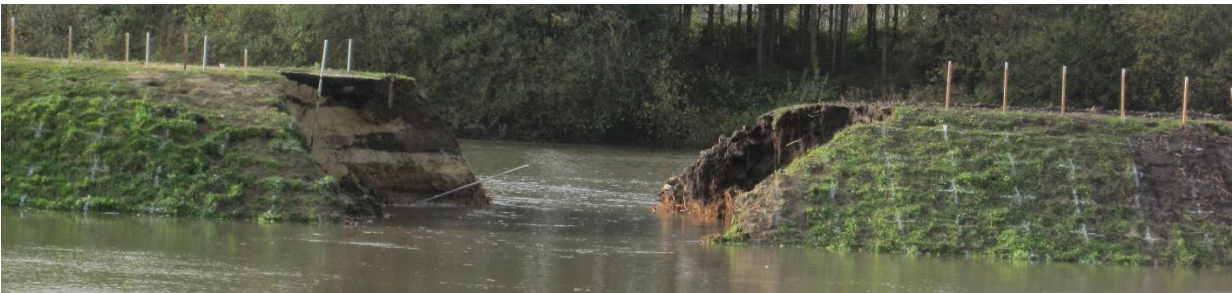
The outer clay layer on the river side was thicker compared to the polder side. This can be due to sedimentation between the riprap. The clay layer at the river side was very hard to erode due to a larger thickness, reed, tree roots and the riprap revetment. After the test the shape of the dug pilot channel could still be seen clearly at the river side (Figure 5-5). The width of the breach after the first tide was approximately 7 à 8 meters at the top.

Figure 5-5 Breach after day II photographed from the polder 17/11/2015

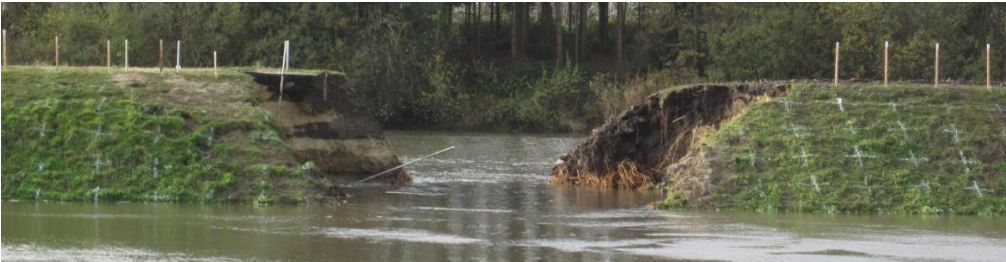
Figure 5-6 Breach 18/11/2015

The breach was followed up daily until the breach growth stagnated. The breach growth wasn't linear, It was mainly influenced by the high tide level. The largest growth was recorded between 25/11/2015 and 26/11/2015, corresponding to a spring tide period. The water level at high tide was then around 6 m T.A.W. From Figure 5-6 until Figure 5-10 photos from the polder side are shown at different time instances. The most observed failure mechanism in time was slope failure. The erosion of the sand in the breach due to the water flow was small.

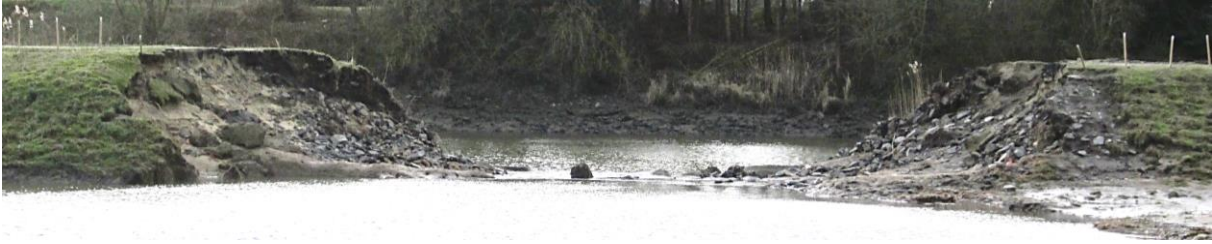
*Figure 5-10 Breach 8/02/2016*

The width at the end of the observations was approximately 20 meters. The final shape of the breach was more V-shaped with the widest side at the polder side. In Figure 5-11 the inside of the breach is shown. It is remarkable how many rocks were found in the breach. It is assumed that these rocks came from the riprap revetment that was present at the riverside of the dike. These rocks protect the sand core from further erosion. Also the stiff clay layer at the base of the breach can be noticed. There was nearly no erosion of this layer even after 5 months of flow over it. It is noticed that the side of Schellebelle eroded more than the Uitbergen side. An explanation can be that after the breach test on 17/11/2015 the riprap revetment was removed from the Schellebelle side.

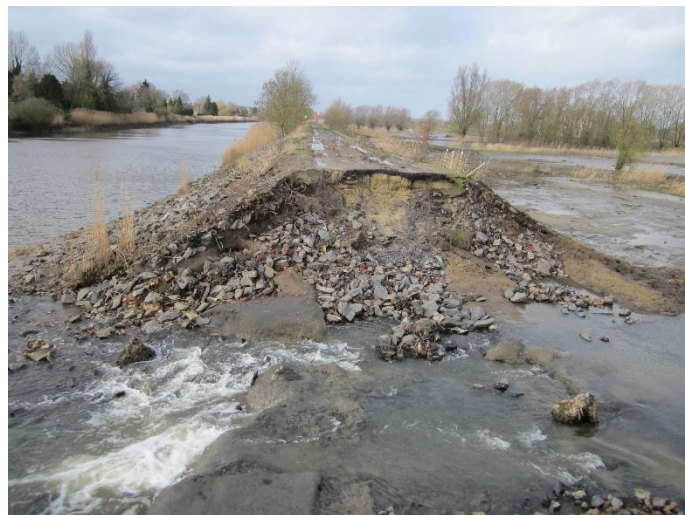
*Figure 5-11 Inside of the breach 8/02/2016*

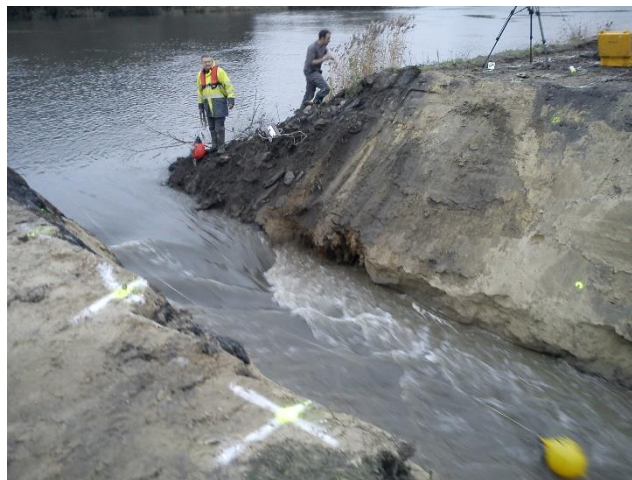
Two floats equipped with a GPS sensor (Garmin 60 Cx) were used during the test. The floats were thrown alternately in the breach at the riverside as can be seen in Figure 6-1. The flow dragged them through the breach. When the floats reached the polder they were retrieved using a rope. During the time in the breach care is taken that the rope didn't slow down the float, to have the most accurate measurement possible.

*Figure 6-1 Floats in breach*

The GPS sensors have an accuracy of +/- 5 m when used stationary with a good signal reception. The water velocity in the breach is small (<5m/s) and the length of the breach is small (15 meter), therefore the accuracy of the measured velocity will be small. The mean value of each measured series is taken. A series consists out of the location measurement between the two rest moments at the river and polder side of the breach.

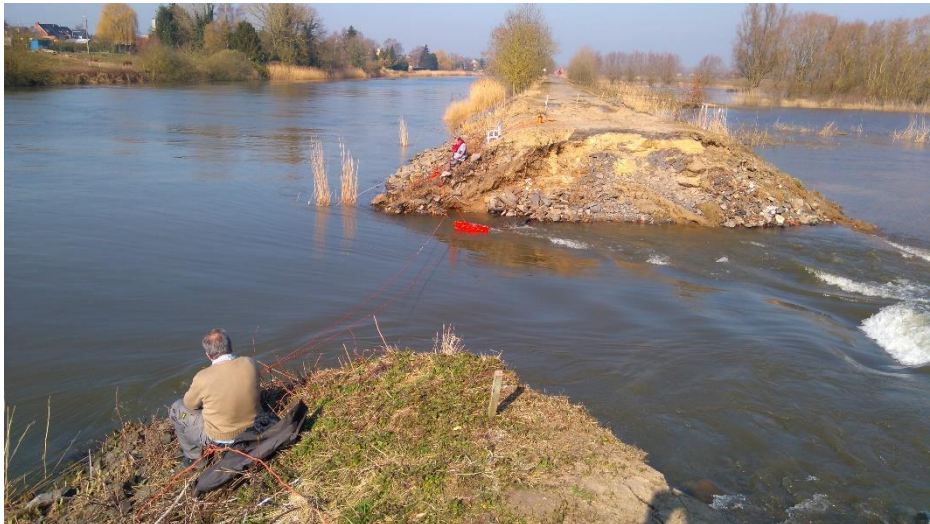
An ADCP measurement is done by HIC on 15/03/2016 in the breach. An acoustic beam is sent through the water measuring the depth and the water velocity every meter in the cross section of the breach. This gives an indication of the water velocity in different sections of the breach. The duration of one series of measurements is approximately 15 minutes, the flow will change during this period so the measurement is only an estimation. The maximum water level during the ADCP measurement was 4,84 m T.A.W. An ADCP measurement measures the water velocity using an acoustic beam, this is done for every 10 centimetre of depth. The lateral distance between two measurements is one meter. When the depth and velocity is known, the discharge can be calculated. In Figure 6-15 the ADCP measurement is shown.

*Figure 6-15 ADCP measurement Scheldt side*

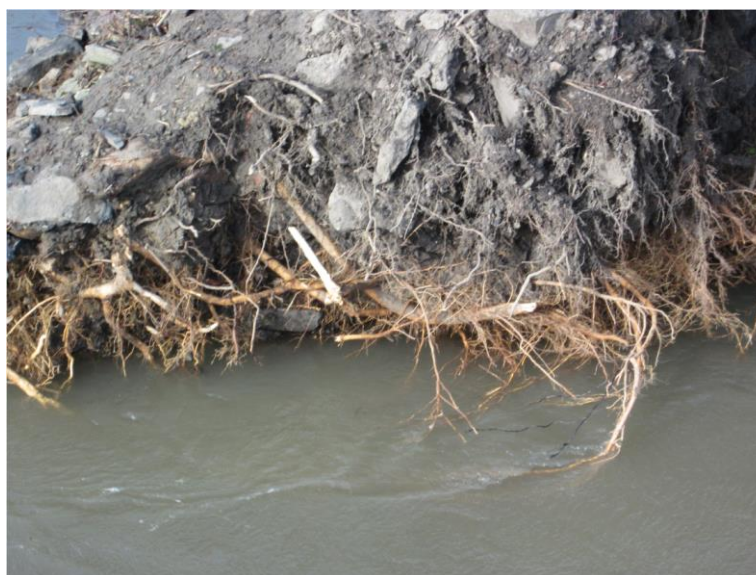
Figure 8-7 Roots in clay lining
