# Risk assessment of war wrecks – a comprehensive approach investigating four wrecks containing munitions in the German Bight/North Sea

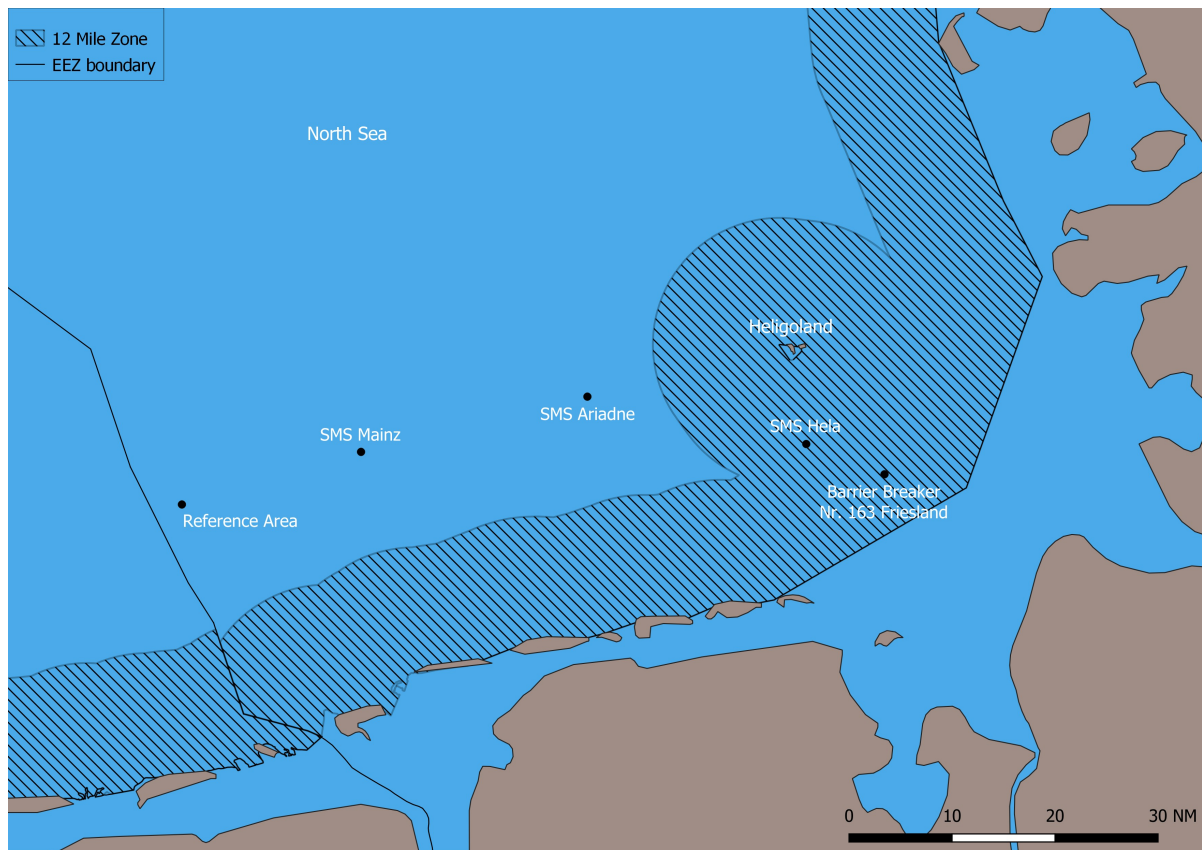
**FIGURE 1** Map of the German Bight including the positions of the researched wrecks and reference area. Data Source: BSH, Natural Earth, Flanders Marine Institute (2019). Maritime Boundaries Geodatabase: Maritime Boundaries and Exclusive Economic Zones (200NM), version 11 and Maritime Boundaries Geodatabase: Territorial Seas (12NM), version 3. Available online at <http://www.marinerregions.org/>. <https://doi.org/10.14284/386> and <https://doi.org/10.14284/387>.

For the German pilot investigations we focus on the wrecks of the SMS MAINZ, the SMS ARIADNE, the SMS HELA and the Barrier Breaker Nr. 163 FRIESLAND. All wrecks are located today in suitable distances west or south of the island of Heligoland (Figure 1).

The wreck is situated  $\approx 25$  nautical miles (nm) north off the island of Borkum and  $\approx 40$  nm west-southwest off Heligoland in nearly 30 m depth. (see Figure 1) It lies on keel, is slightly inclined to the portside and, with the exception of some smaller protruding parts, preserved up to the level of the former armoured deck. The wreck is preserved over a length of about 114 m. However, the entire bow area is badly damaged and only preserved up to the level of the front chain locker. Therefore,  $\approx 16$  m of the total length of  $\approx 130$  m are missing in the bow area. The width of the wreck is 14 m and it protrudes from the surrounding sediment to a height of  $\approx 5$  m.

The wreck is situated  $\approx 23$  nm north-northeast off the island of Norderney and  $\approx 20$  nm west-southwest off Heligoland in nearly 37 m depth (see Figure 1). It lies keel

The wreck is situated  $\approx 15$  nm north off the island Wangerooge and  $\approx 9$  nm south-southeast off Heligoland in nearly 35 m depth (see Figure 1). It lies on keel and is slightly inclined to starboard. The wreck seems to be preserved in total length of 105 m and a width of 11 m. It

The wreck is situated  $\approx 11$  nm west-northwest off the island of Scharhoern and  $\approx 14$  nm southeast off Heligoland in nearly 25 m depth (see Figure 1). It lies on keel and has a large gap in front of the area of the former bridge (Figure 8). Still the wreck is preserved almost in total length of 70 m and a width of 9 m. It protrudes from the surrounding sediment to a height of about 5 m, mainly in the former bridge area. A slightly smaller gap can be seen in the fore ship area directly in front of the former forecastle. In general, the fore ship, including the bow, and the aft, including the stern, are in good condition. The area of the former bridge is clearly visible with the deck superstructures and protrudes the furthest. In the bow area, the remains of a gun platform are clearly visible.

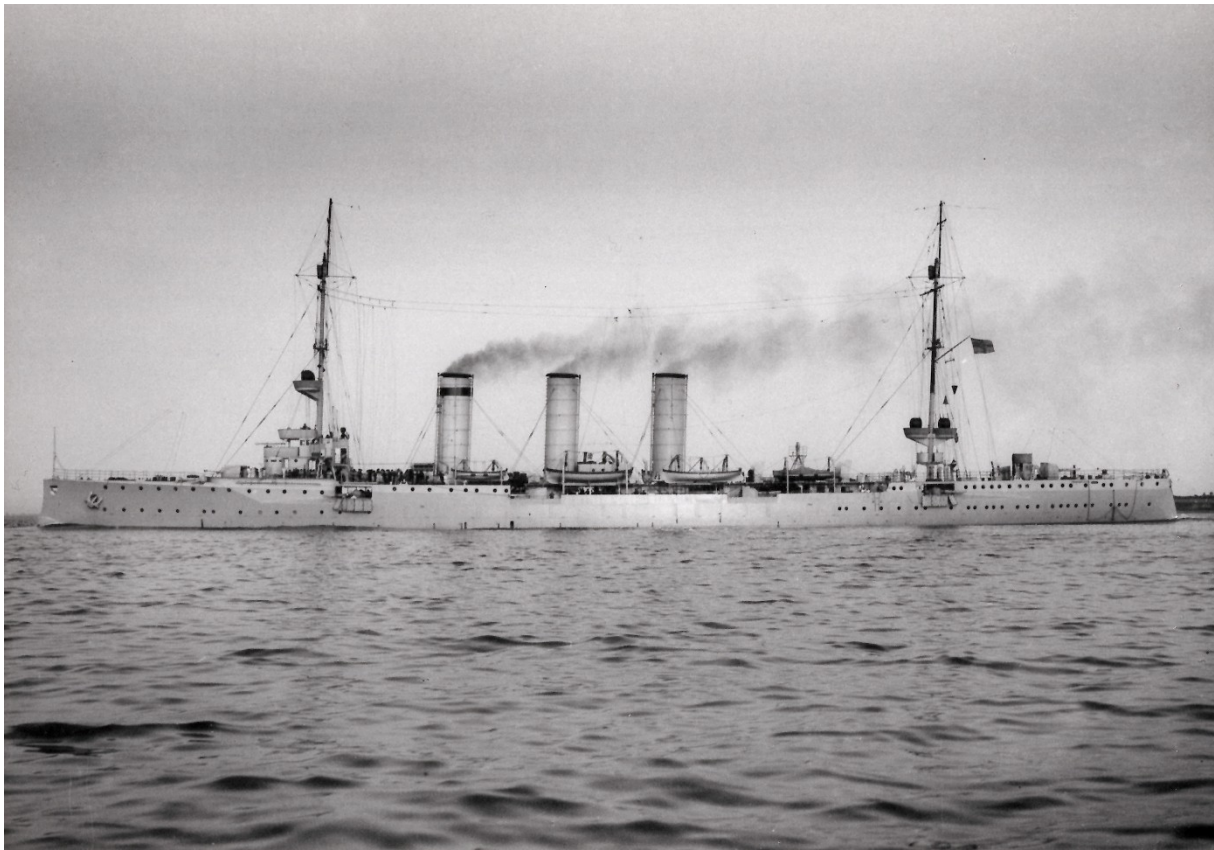
FIGURE 2 Photo of the SMS MAINZ from portside abeam, dating from the year 1912 (Photo archive German Maritime Museum).

The SMS MAINZ had a displacement of 4.889 tonnes, an overall length of 130.55 m, a breadth of 14 m and a maximum side-height of 8.1 m [22]. The ship had a maximum speed of  $\approx 26$  knots and was able to carry max. 970 t of coal to fire 15 water-tube boilers. The crew of the SMS MAINZ consisted of 383 people including 18 officers.

The armament of the MAINZ consisted of twelve Quick-Loading (QL) guns, six on the portside and six on the starboard side, with a calibre (cal.) of 10.5 cm. Furthermore, the ship was equipped with two torpedo tubes cal. 45 cm in the fore ship, including five torpedoes (type C/06) and two machine guns cal. 8 mm with  $\approx 6.200^1$  to 10.000 rounds each [22, 23]. The munition budget for the QL guns cal. 10.5 cm consisted of  $\approx 2.000$  rounds.<sup>2</sup>
