## WESTERN SCHELDT ESTUARY (THE NETHERLANDS)

## 1. GENERAL DESCRIPTION OF THE AREA

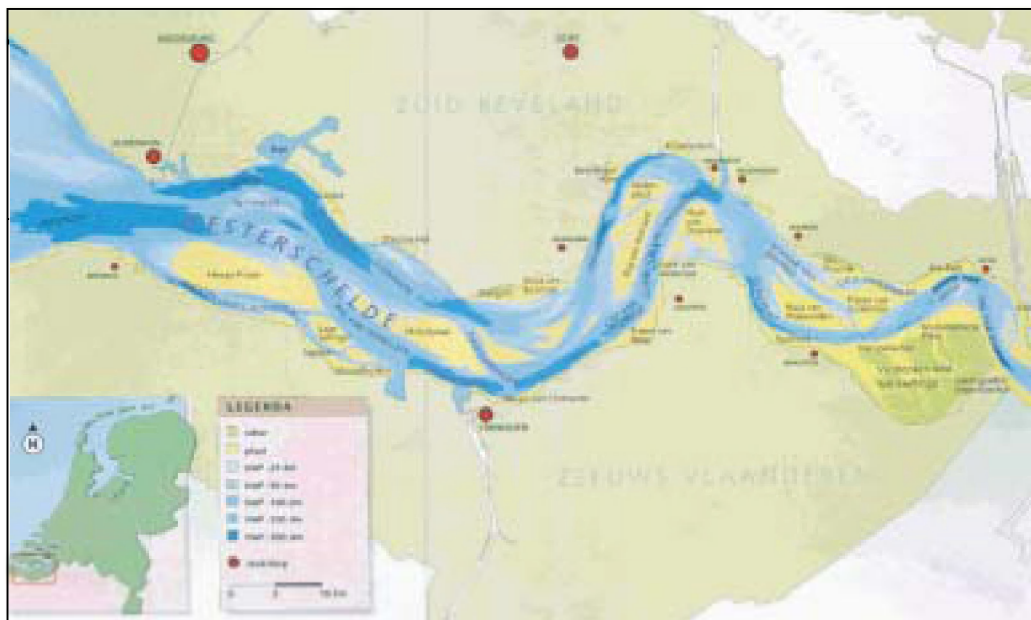
The Western Scheldt exhibits a well-developed system of channels and shoals (see Figure 2). It has a funnel-shaped geometry and covers an area of about 370 km<sup>2</sup>. Its cross-sectional area decreases exponentially from the estuary mouth at Vlissingen to the estuary head near Gent. The width averaged depth decreases from about 15 m at Vlissingen to only

The estuary can be characterized as a multiple channel system, separated by elongated tidal flats. The large channels form a more or less continuous meandering channel, constrained by fixed points along the estuary (dikes, harbour moles). Due to the meandering of the channels shallow areas are formed (so-called sills, positioned at transitions between channel bends). Regular dredging at these sills is required in order to secure safe navigation to the port of Antwerp. Presently, ships with a draught of about 14 m can reach the port of Antwerp from Vlissingen within one tidal cycle.

*Fig. 2: Overview of the Western Scheldt.*

Both natural and human factors have determined the present configuration of the Western Scheldt. In general, the surface area of the estuary has decreased, mainly by land reclamation. Since 1800 about 15.000 ha. of intertidal area has been reclaimed (RIKZ, 1996). Between 1960 and 1990 the area of shallow water zones and intertidal salt marshes and mud flats has decreased with about 3200 ha, partly due to land reclamation and dike reinforcement, but also due to erosion caused by sea level rise, climate change and tidal cycles. Another type of human interference that is of great importance in the Scheldt estuary is dredging. In the beginning of the 1970's and also in the end of the 1990's, the Flemish government deepened and widened the navigation channel to Antwerp. As a result, the yearly amount of maintenance dredging has increased from 4 Mm<sup>3</sup> (1970) via 8-10 Mm<sup>3</sup> (1995) to an expected amount of 14 Mm<sup>3</sup> in 2002. Most of the dredging was done in the eastern part of the estuary (east of Hansweert, see Figure 2).

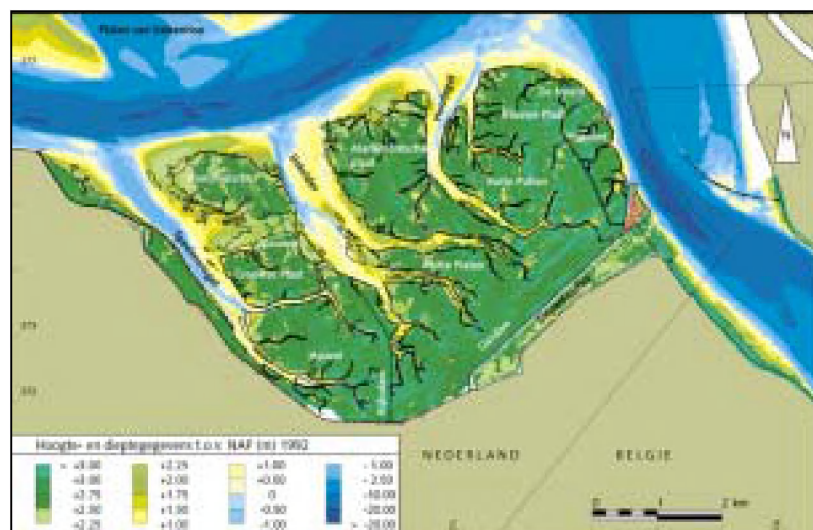
Fig. 4: The 'Verdrongen Land van Saeftinghe', near the Belgian border. Depths are given with respect to N.A.P. (Dutch Ordnance Level, approximately equal to the mean water level).

- **Nature conservation:** The Western Scheldt comprises a number of internationally recognized nature reserves, which are important for birds. One of them is the 'Verdrongen Land van Saeftinghe', near the Belgian border (see Figure 4), one of the largest brackish water salt marshes in Europe (about 3500 ha.), which has been a Ramsar-site since 1995 ([www.ramsar.org](http://www.ramsar.org)). Yearly, about 400-500 seals are counted.

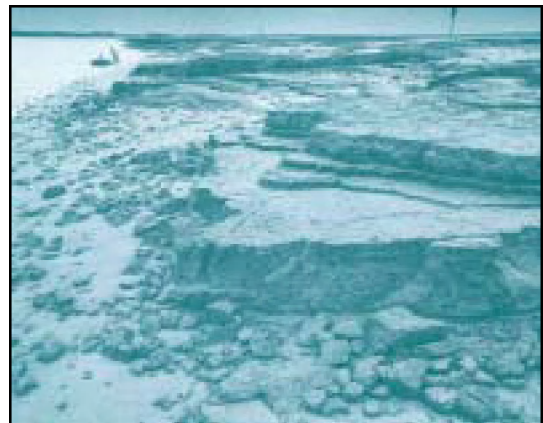
*Fig. 6: Local erosion in intertidal area.*

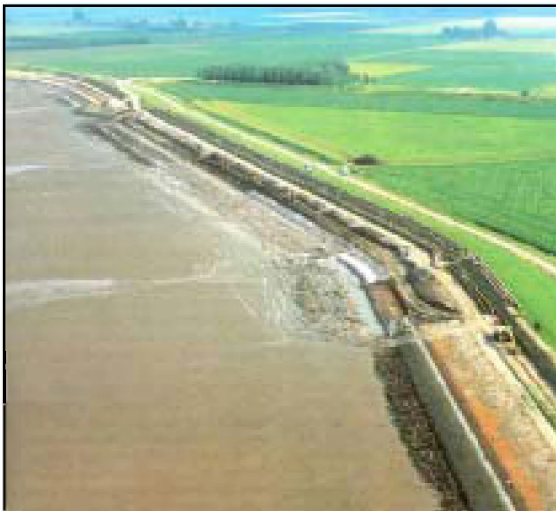
*Fig. 7: dike at Western Scheldt*

The increased propagation of the tidal wave has led to increased high water levels. The dikes are raised to ensure the safety of the hinterland.

At other locations, an attempt is made for the rehabilitation of intertidal salt marshes. Here, plans have been developed for the construction of small piers, with the purpose of creating protected areas where sedimentation of fine sediment is stimulated. Here, a 'move seaward' strategy is adopted (see Figure 7).

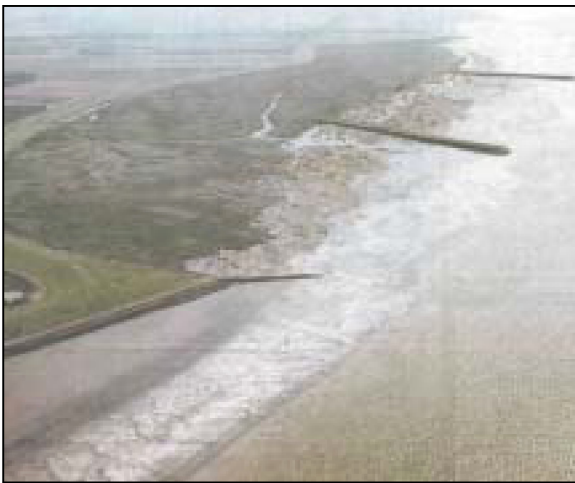
3. Thirdly, intertidal salt marshes are rehabilitated by constructing small piers (pile rows or stones) with the purpose of creating protected areas where sedimentation of fine sediment is stimulated (see Figure 9).

*Fig. 9: Protection of eroding salt marsh near Waarde.*
