ONGOING RESEARCH AT TWO TEST AREAS IN BELGIAN WATERS (FLANDERS)

INE DEMERRE & INGE ZEEBROEK

The first MACHU report included an introduction to the two MACHU project test areas in Belgian territorial waters, 'Buiten Ratel' and 'Vlakte van de Raan'. On the basis of the results of desk-based research the Flemish Heritage Institute (VIOE) has been organising the investigation of listed wreck positions from two private vessels, 'Ephyra' and 'Divestar', and the research vessel 'Zeeleeuw' (with the use of 'Vloot', the governmental shipowner) in cooperation with a team of voluntary divers (see article: *Cooperation with non-archaeological scientific institutes, organisations and individuals - Ine Demerre, page 30*).

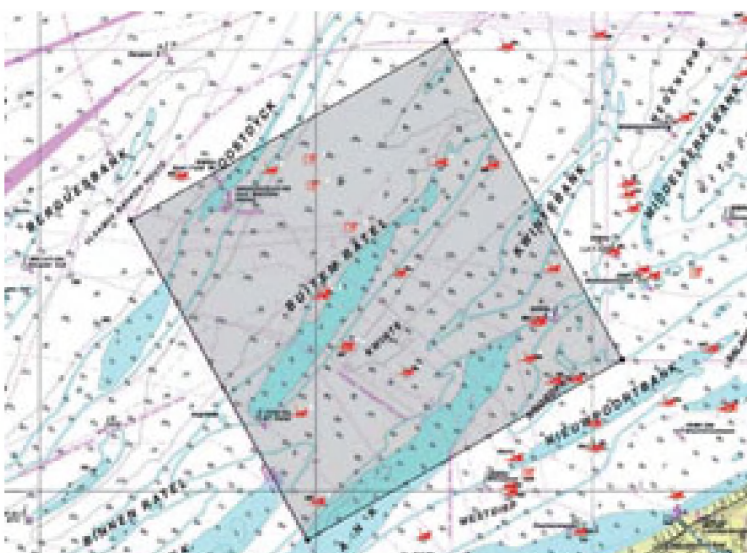
FIGURE 1: The Buiten Ratel area, 1 of the two 2 areas of the MACHU project, in which 21 wreck sites could be localised so far. © VIOE

Of the 21 recorded wreck sites in the 'Buiten Ratel' area (figure 1), 11 have been investigated in this way. In two cases the reported wreck was not found. This may have been because of inaccuracy in the identification of the location – perhaps the result of some non-archaeological feature such as an anomaly in the seabed – or because the wreck has

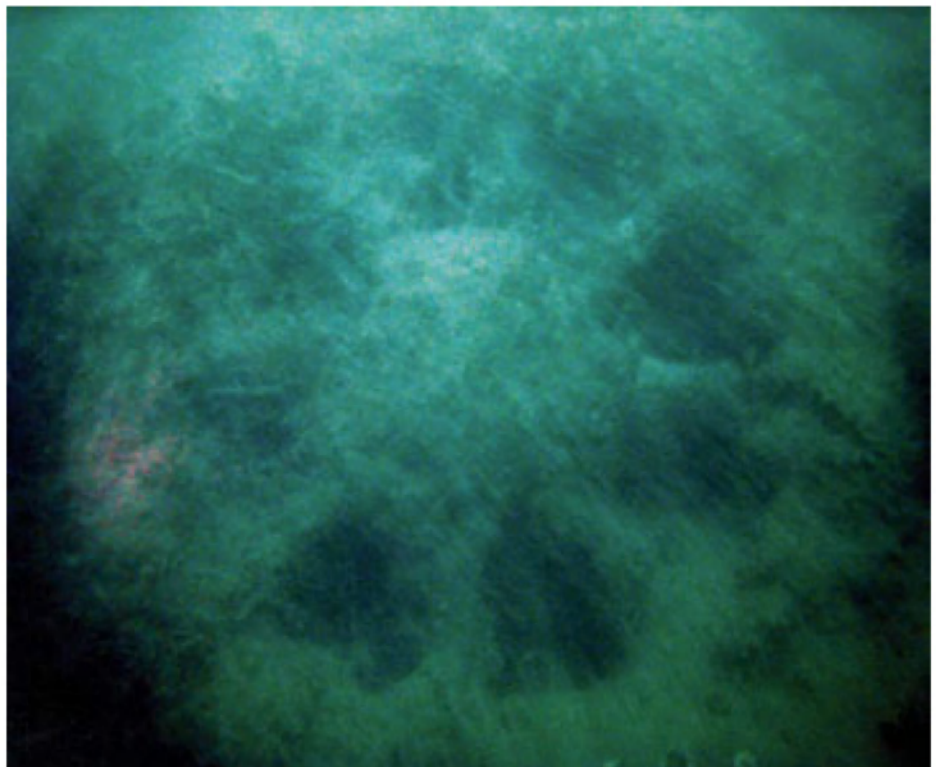
Most of the wrecks in the Buiten Ratel area are covered with a thick layer of sediment – this is especially true for two WWI destroyers, 'G-96' and 'Branlebas' (figure 4). One site, B109/230, yielded only pieces of metal, wheels and wooden beams; perhaps the cargo of a 19th century ship carrying materials for railway construction (figure 5 & 6).

FIGURE 5: One of the five wheels detected on wrecksite B109/230, probably part of a train locomotive. © VIOE
