A preliminary assessment of the state of preservation of the wreck of the *Belgica*

David Gregory¹, Poul Jensen², Kristiane Strætkvern³,
Tom Lenaerts⁴ & Marnix Pieters⁵

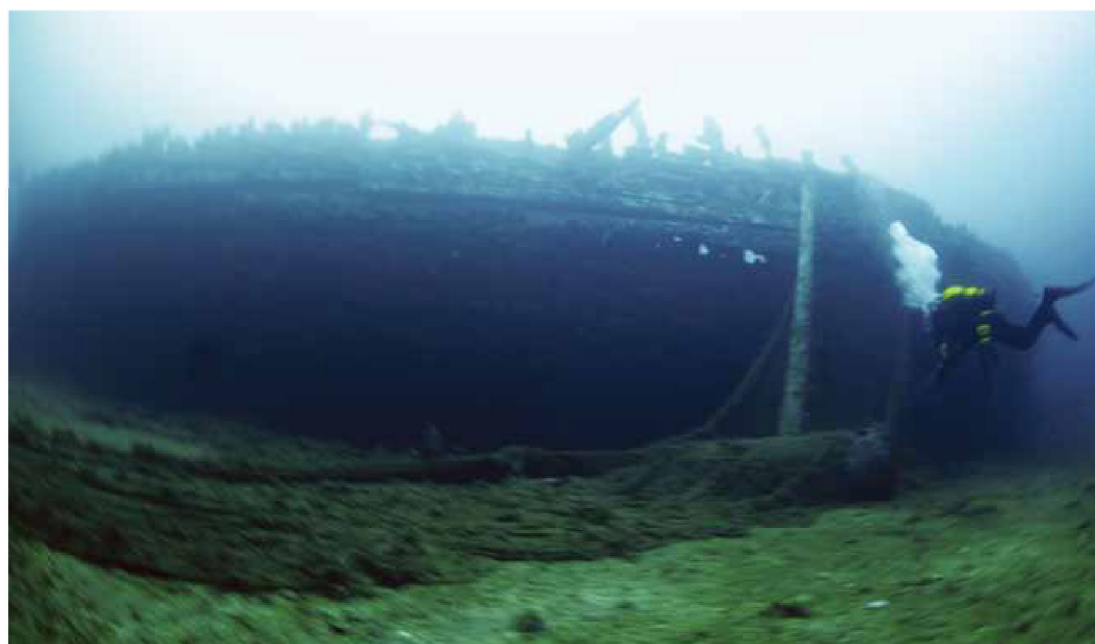
FIG. 4 The wreck of the *Belgica* lying on the seabed, view on starboard side (Courtesy Tom Leys).

In order to obtain the necessary field data for the assessment of the state of the preservation of the *Belgica* two successive field campaigns were organised in the first half of 2008. The aim of the first campaign was to make a comprehensive photographic record of the wreck. This was carried out in February to ensure maximum underwater visibility due to limited algae in the water during winter months. In order to facilitate this documentation, a large fishing net that had been colonised with seaweed and was covering the central and lower parts of the wreck, was removed. A photomosaic of the wreck was taken (fig. 8) with overlapping pictures for the mosaic being taken along the longitudinal axis of the wreck, more or less at the same level above the wreck. This photomosaic allowed for the first time a visual overview of the entire wreck and was subsequently used to locate the samples taken for assessing the structural strength of the wood. The mosaic will also be used for the further archaeological analysis of the wreck. During this campaign, details as well as overviews, such as fig. 4, showing the starboard side of the wreck were also taken.

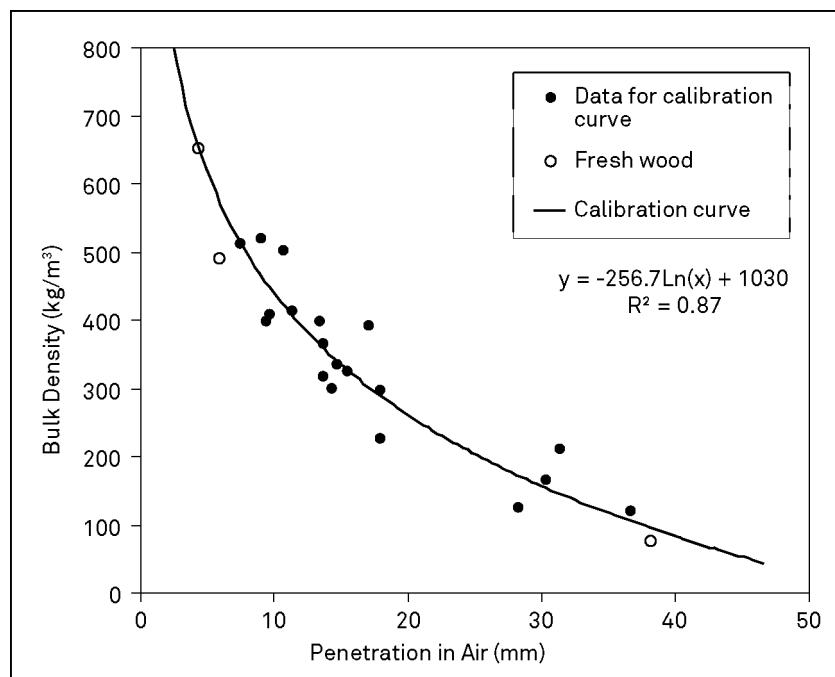
FIG. 12 Correlation between the depth of pin penetration and bulk density of waterlogged archaeological wood.
Correlatie tussen de penetratiediepte van de pin en de schijnbare dichtheid van het waterverzadigde archeologische hout.

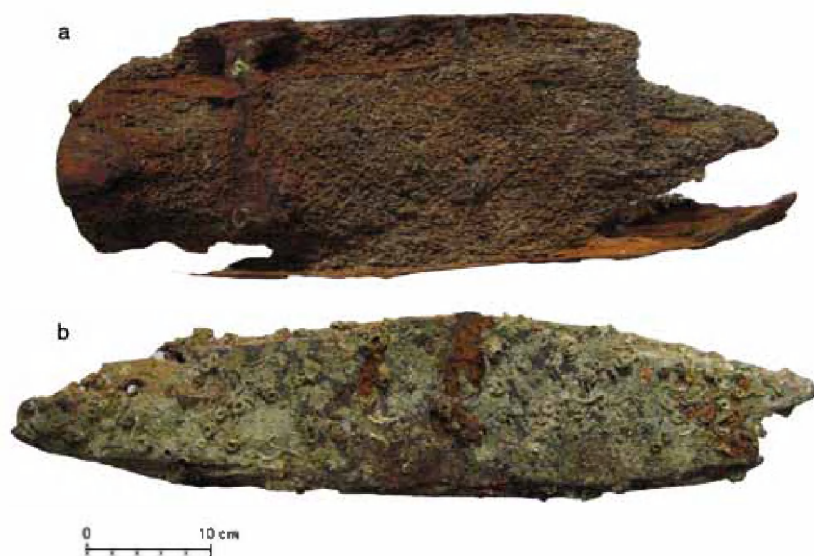
Figure 13 shows the two samples of oak wood taken to assess the activity of wood boring organisms. There were definite signs of colonisation by fouling organisms. These organisms tend to live on the surface of the wood rather than bore in to the wood (figures 14 and 15).

FIG. 13 Two samples of wood taken from the wreck of the *Belgica*.
Twee houtstalen van het scheepswrak van de Belgica.

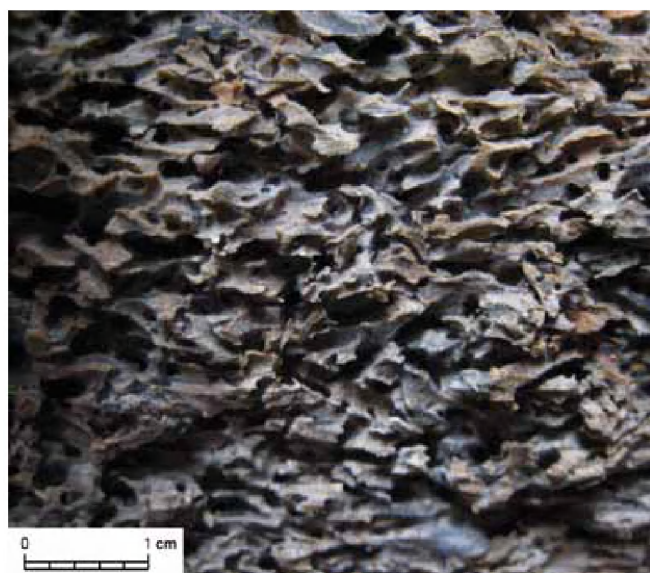
FIG. 14 Surface of wood sample (figure 13a) extensively degraded by gribble.
Oppervlak van een houtstaal (figuur 13a) dat in sterke mate is aange-tast door paalpissebed.

The surfaces of both wood samples were heavily degraded by the activity of wood boring crustacea (figure 14). Although there were no signs of living organisms on the wood, it should not necessarily be concluded that they are not present and active on other parts of the wreck.

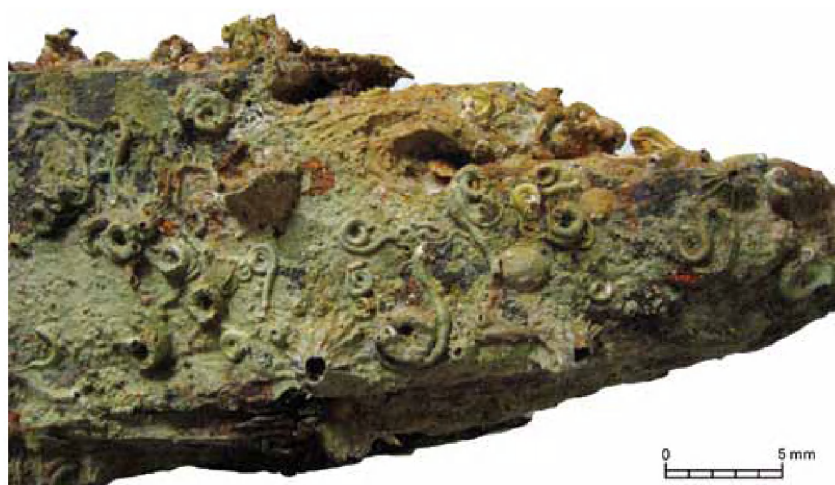
FIG. 15 Close up of biofouling organisms on the surface of wood (figure 13b), including calcareous tubeworms and barnacles.
Detailopname van biologische aangroei op het houtoppervlak (figuur 13b) met inbegrip van kalkhoudende buiswormen en zeepokken.

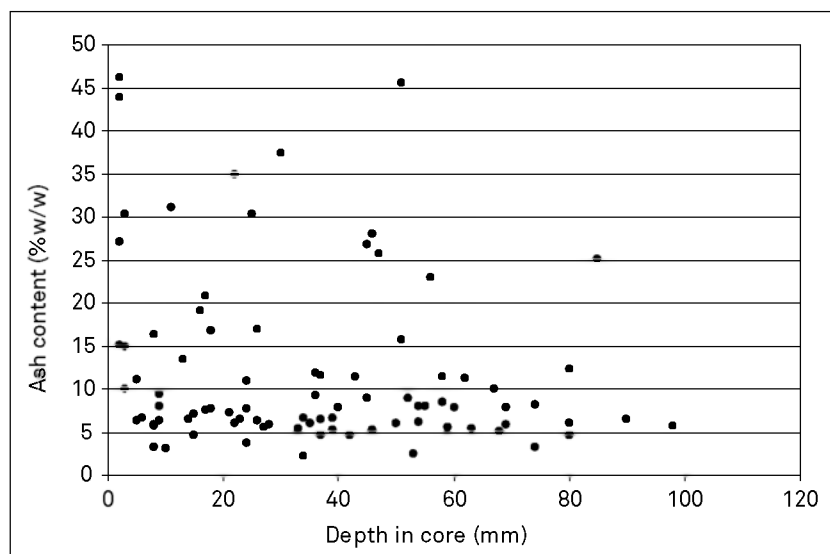
FIG. 19 Depth in core sample versus ash content.
Diepte in het boorstaal versus asgehalte.
