ZEEBRUGGE – KNOKKE HEIST (BELGIUM)

**HAECON
Harbour and Engineering
Consultants**

1. GENERAL DESCRIPTION OF THE AREA

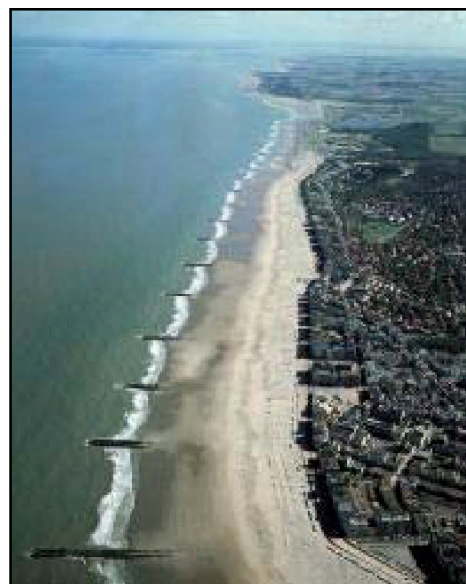
Fig. 5: Groins at Knokke-Heist.

Zeebrugge has had a small port since about 1900. Before the seaward extension of the harbour in the 1970's groins and a seawall were already present at the Knokke-Zoute beaches to protect the hinterland from flooding and the beach from eroding.

At that time there rather narrow beaches had already developed due to the harbour breakwaters intersecting the longshore transport. Notwithstanding the protection provided by the groins, erosion of the beaches continued; the Appelzak tidal gully already played an important role in the erosion process. At high tide the beach disappeared, leaving the seawall exposed to attack by storms.

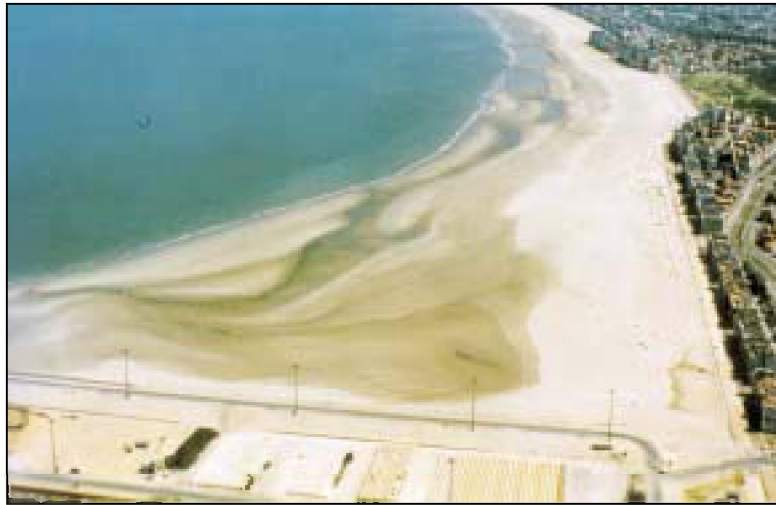
Fig. 9: Nourishment directly downstream of harbour breakwater.
