All quiet on the sea bottom front? Lessons from the morphodynamic monitoring

Dries Van den Eynde, Matthias Baeye, Robin Brabant, Michael Fettweis,
Frederic Francken, Piet Haerens, Mieke Mathys, Marc Sas and Vera Van Lancker

The impact of the construction of the offshore wind farms on the turbidity was local and temporary, with no significant difference between the before and after situation. Erosion pits were formed, both around gravity based foundations and monopiles, though erosion protection provided the necessary stability. Dredging/filling works were more complex than expected. Large volumes of sand were lost and sand pits did not refill naturally. In dune migrating areas the coverage of export cables could not be guaranteed. As a result they are now buried 1 m below the base of the dunes.

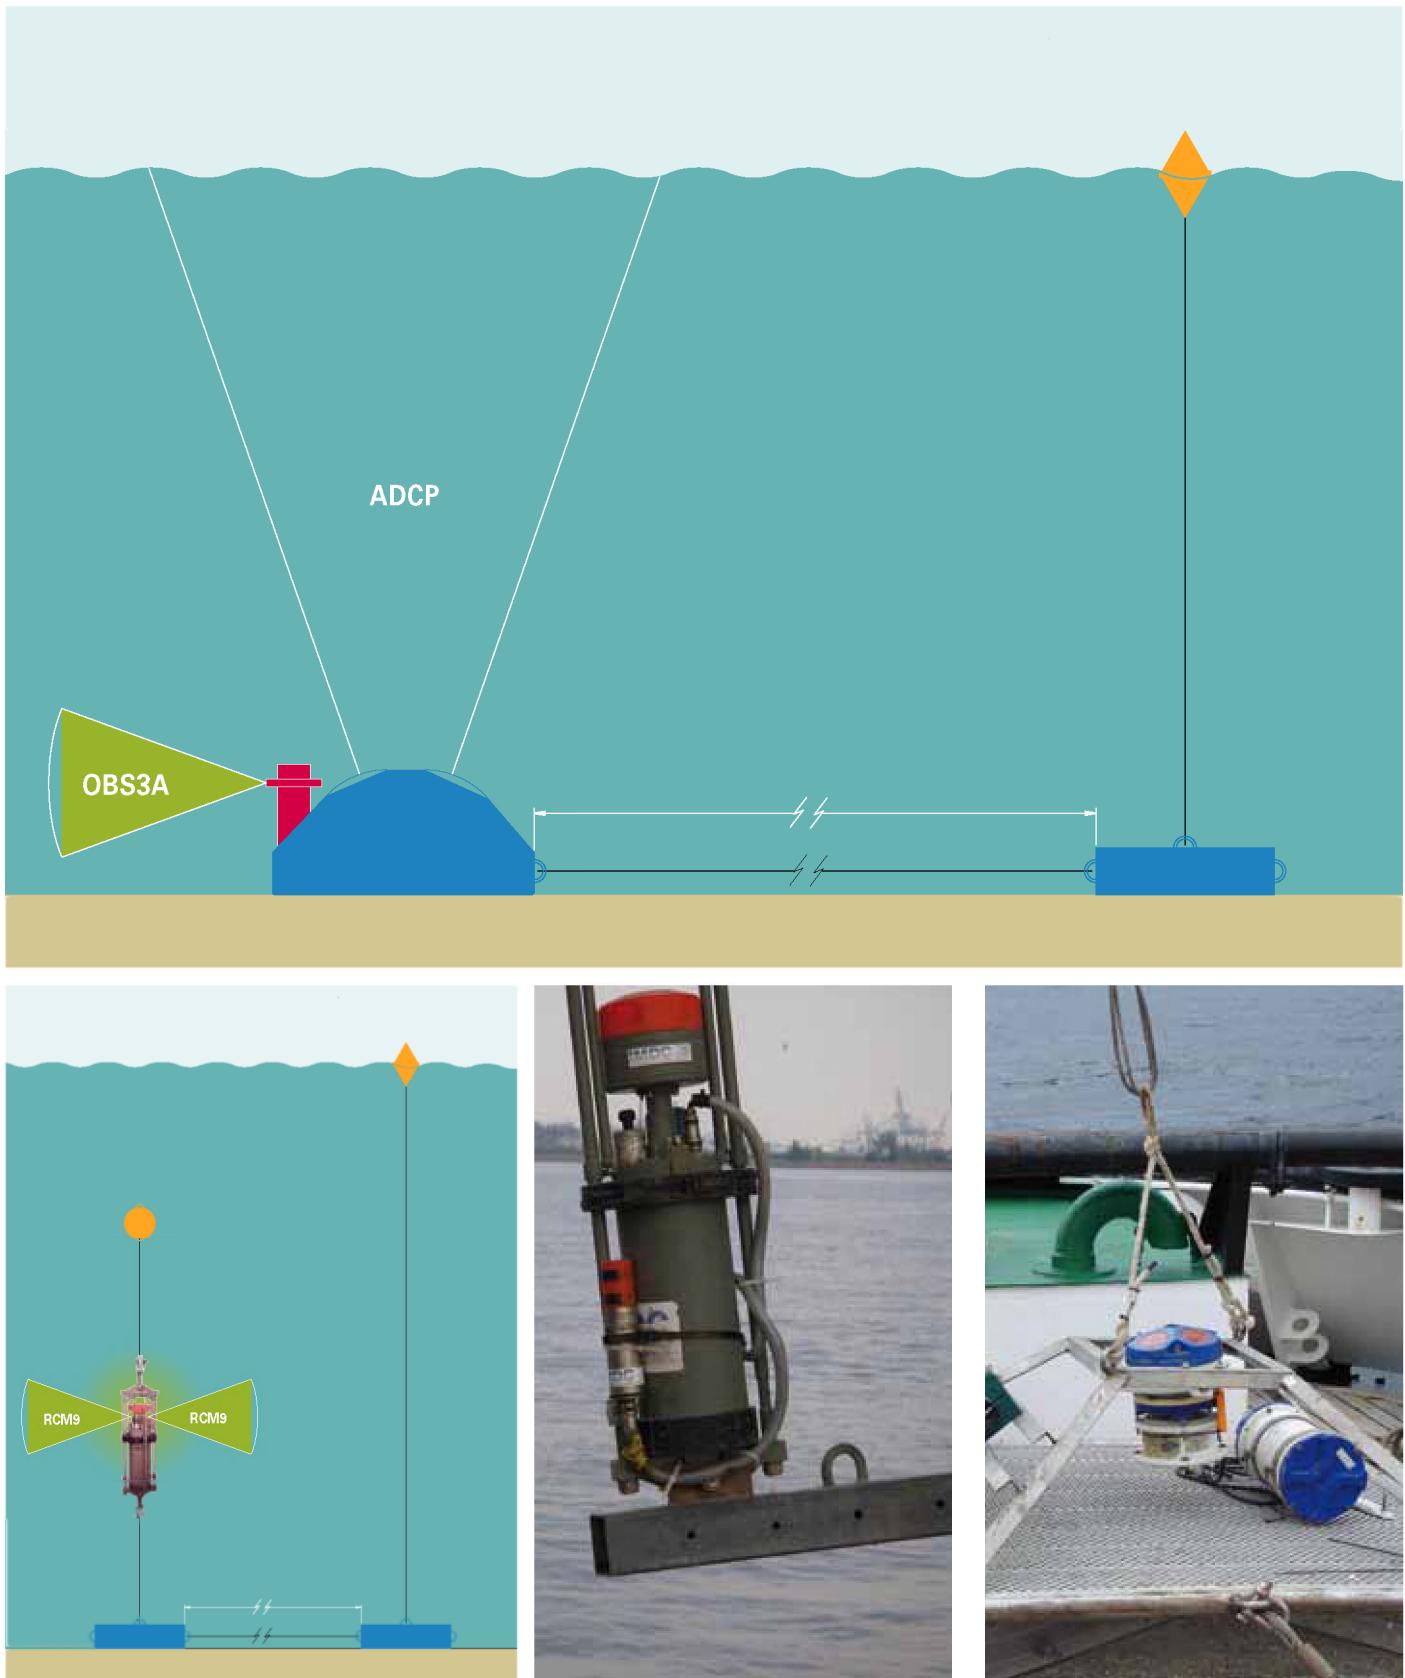
Figure 2. ADCP and RCM9 as deployed on the Gootebank in water depths of -17 m (IMDC, 2010).

On the Thorntonbank and on the Gootebank, measurements were performed using a bottom-mounted Acoustic Doppler Current Profiler (ADCP) (IMDC 2008a; 2008b; 2008c; 2009a)

(Figure 2). This device measured current profiles over the entire water column, water level and wave heights. An optical back scatter sensor (OBS), measuring turbidity, was mounted on the ADCP at about 0.7 m above the bottom. Furthermore, an RCM9 current meter (Figure 2) was used as backup for current, turbidity and water level measurements. To convert the values from the OBS into material in suspension in mg/l, the instrument was calibrated in the laboratory using fine material from the harbour of Oostende. To estimate the effect of the construction works of the first phase on the suspended particulate matter (SPM) concentration, three measuring campaigns were executed: before (February-March 2008), during (June-July 2008) and after the works (June-July 2009). The positions of the measurements are indicated in Figure 1. The instruments were deployed along the gentle slope or on the top of the sandbanks in water depths of around -16 to -17 m.

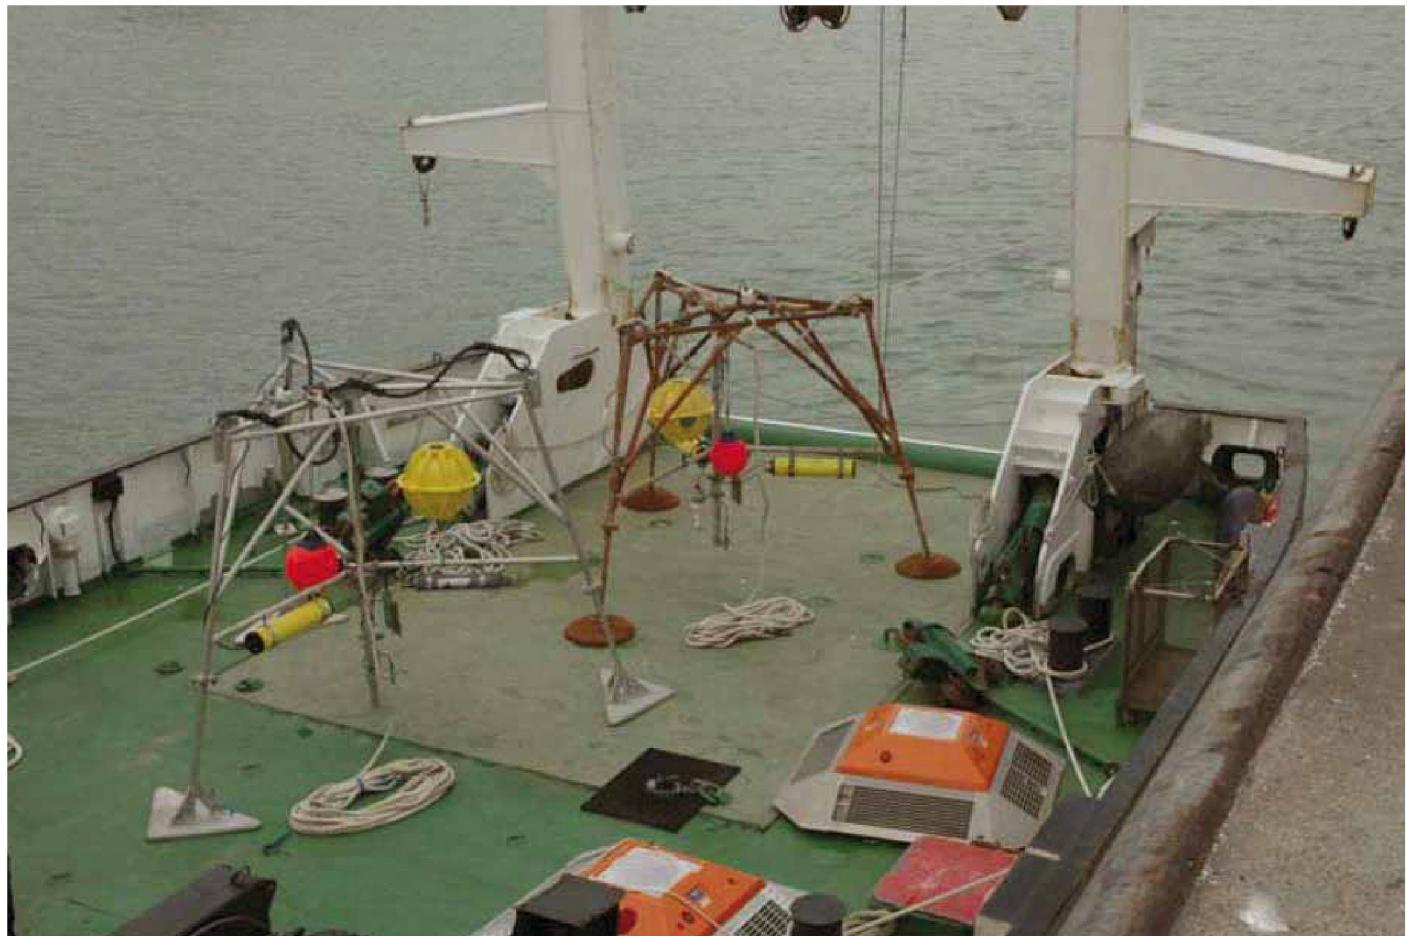
Figure 3. Two tripods and two ADCPs ready for deployment on the Bligh Bank and the Gootebank (RV Belgica).

On the Bligh Bank and on the Gootebank, two tripods (Figure 3) were used for measuring SPM concentration, suspended particle size distribution, salinity, temperature and current velocity. Water depths were around -26 m on the Bligh Bank, around -24m on the Gootebank. An Acoustic Doppler Profiler (ADP) measured the velocity profile from the top of the tripod to the bottom; an Acoustic Doppler Velocimeter (ADV) measured the velocity near the bottom with a high frequency; a CTD conductivity sensor system measured temperature, salinity and water depth; two OBS sensors measured turbidity at 0.2 m (SPM1) and 2 m (SPM2) above the bottom; finally a LISST 100C measured the particle size of the material in suspension. The ADP housed an altimeter, to measure the distance from the measuring point to the bottom, hence providing information on seabed evolution and

thus indirectly on sediment transport. Furthermore, from the backscatter of the ADP, also SPM concentration profiles were derived. To measure current profiles from the bottom to the water surface, a bottom-mounted ADCP was deployed nearby the tripod. Water samples were taken and filtered to obtain SPM concentration, further used for the calibration of the OBS measurements.

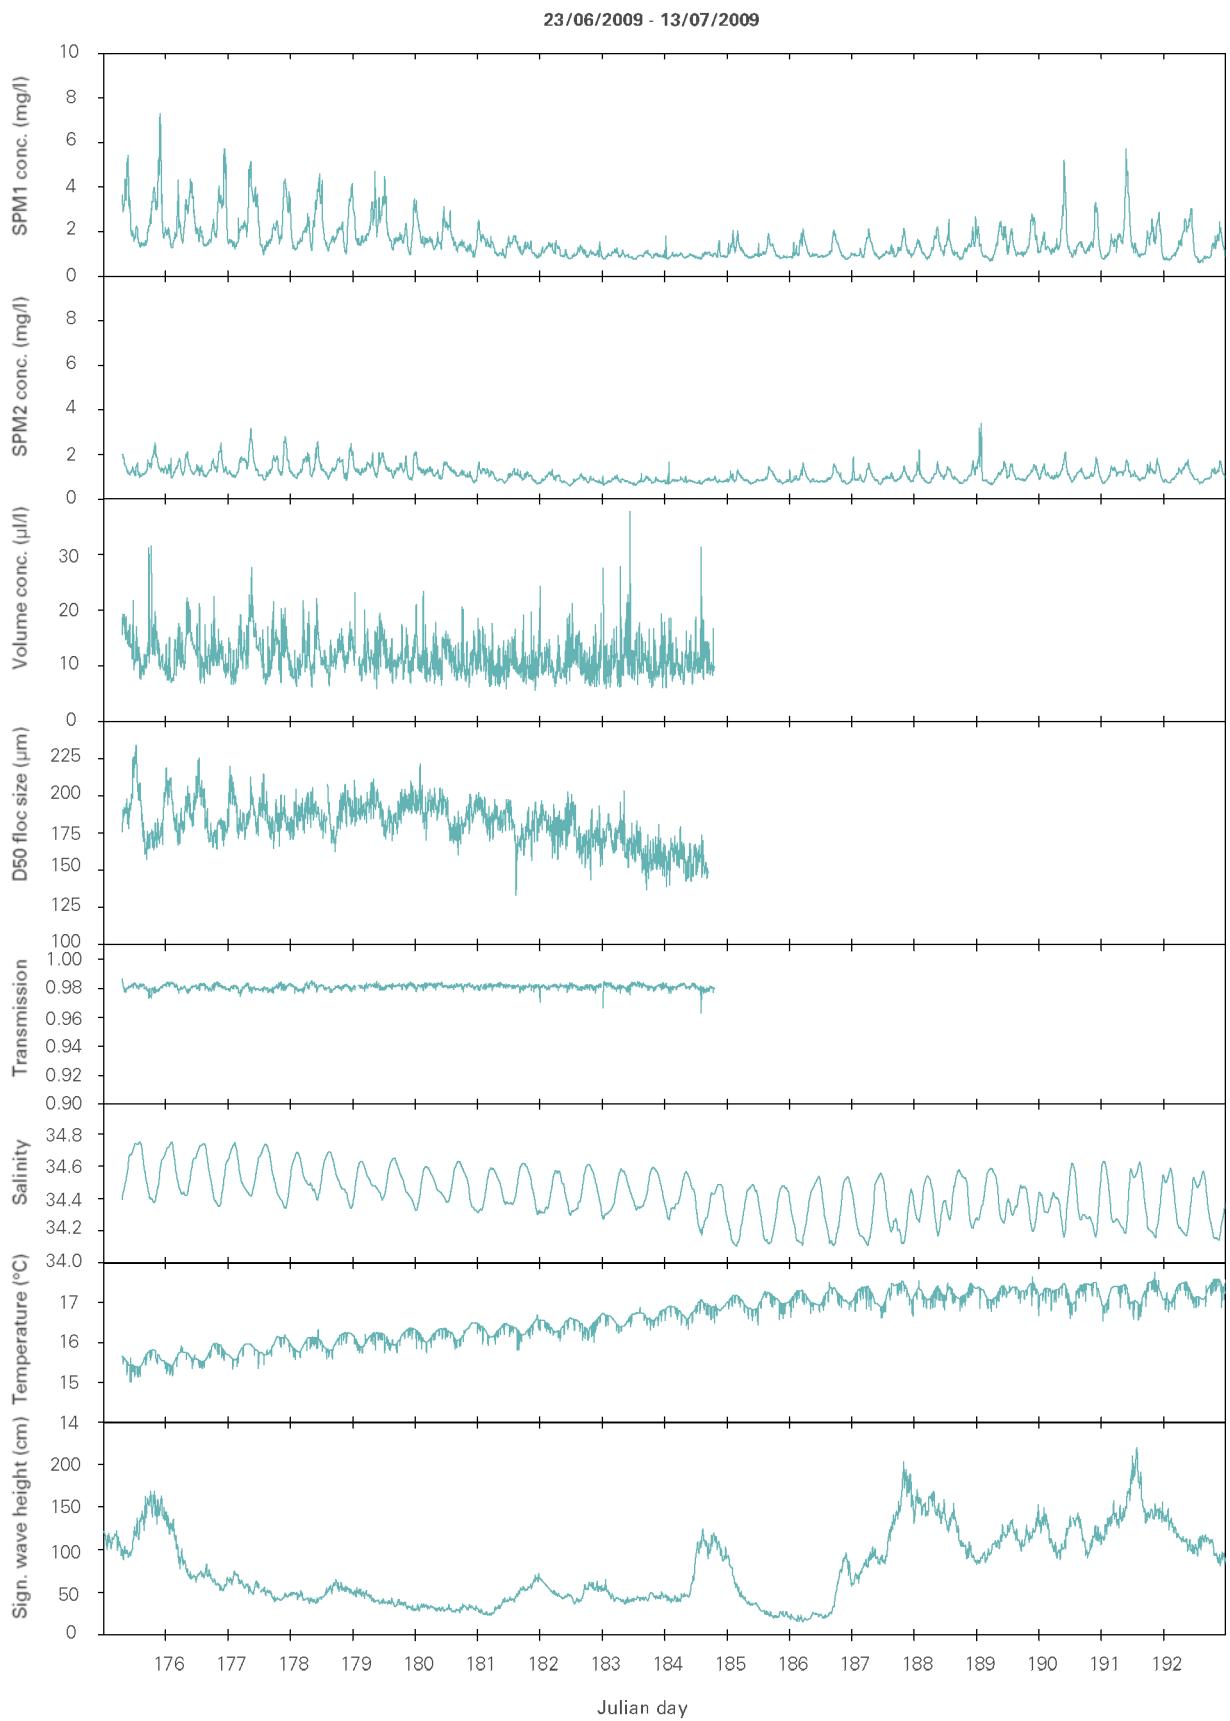
Figure 4. Variation in SPM concentration (from the OBS sensors); SPM volume concentration, median particle size and transmission (from LISST); and temperature and salinity (from CTD sensor) at the Bligh Bank (-26 m water depth) from June, 24th, 2009 until July, 14th, 2009. Wave height at Zuidwest Akkaert (from Meetnet Vlaamse Banken, Flanders Hydrography). SPM1 at 29 cm above the bottom, SPM2 at 234 cm above the bottom.

Figure 4 shows SPM mass and volume concentrations, transmission, median particle size, temperature and salinity at the Bligh Bank, before the start of the construction works. Also the significant wave height at the Zuidwest Akkaert (Meetnet Vlaamse Banken, Flanders Hydrography) is shown. Figure 5 shows SPM concentration profiles (from the backscatter of the ADP) and seabed evolution (from the ADP altimeter), after the execution of the construction works at the Bligh Bank. SPM concentrations were very low (< 5 mg/l) at both locations and during almost all campaigns (Van den Eynde et al., 2013). SPM concentrations showed a clear correlation with spring-neap tidal cycle variation, without a clear visible influence of wave activity. This is also shown in the scatter plot between significant wave height and SPM concentration on the Bligh Bank after the works (Figure 6). Remark that before and after the works, the significant wave heights were relatively low, with waves up to 2.2 m, before the works, and up to 2.0 m,

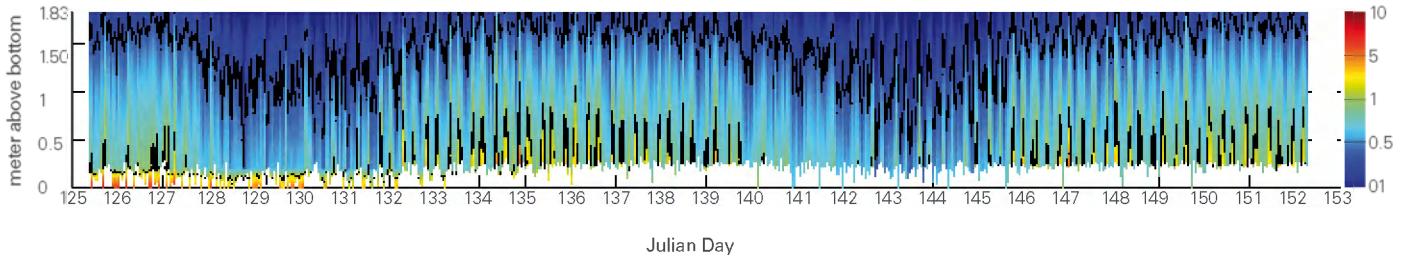
Figure 5. Measurements of SPM concentration in the lowest 1.5 m above the bottom, derived from the backscatter of the ADP, together with the seabed evolution from the ADP altimeter, at the Bligh Bank from May, 5th, 2010 till June, 3rd, 2010.

Altimeter data showed a seabed variation of several tens of centimetres, probably due to migrating bed forms. During spring tide, the bottom is lower than during neap tide, possibly caused by higher erosion.

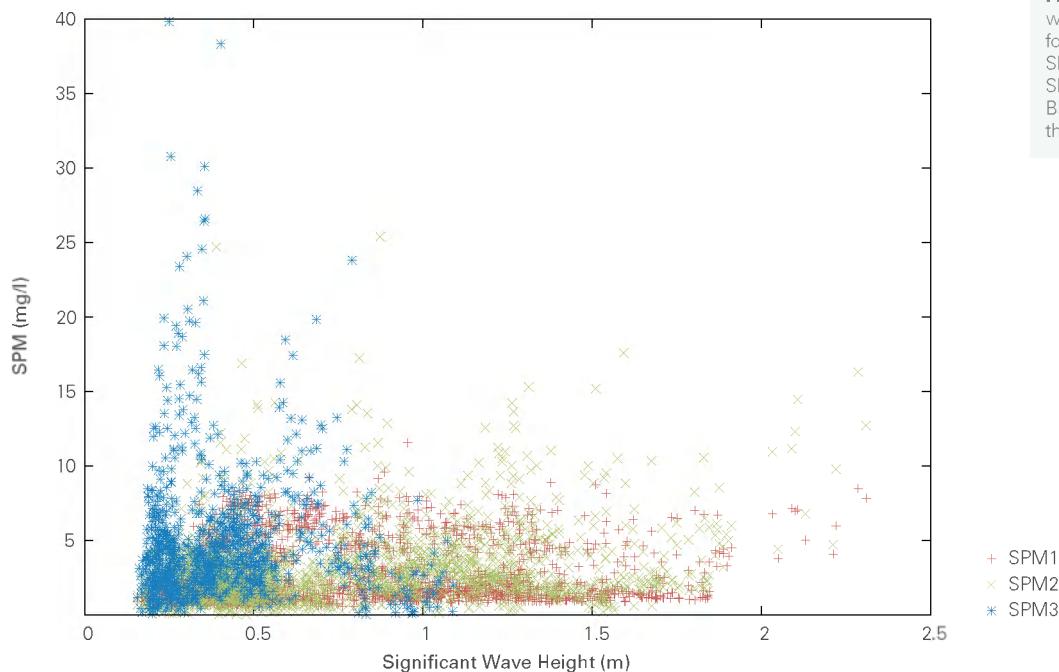
Figure 6. Scatter plot of significant wave height and SPM concentration for SPM1 (0.2 m above the bottom), SPM2 (2 m above the bottom) and SPM3 (1 m above the bottom) at the Bligh Bank (-26 m water depth), after the works.

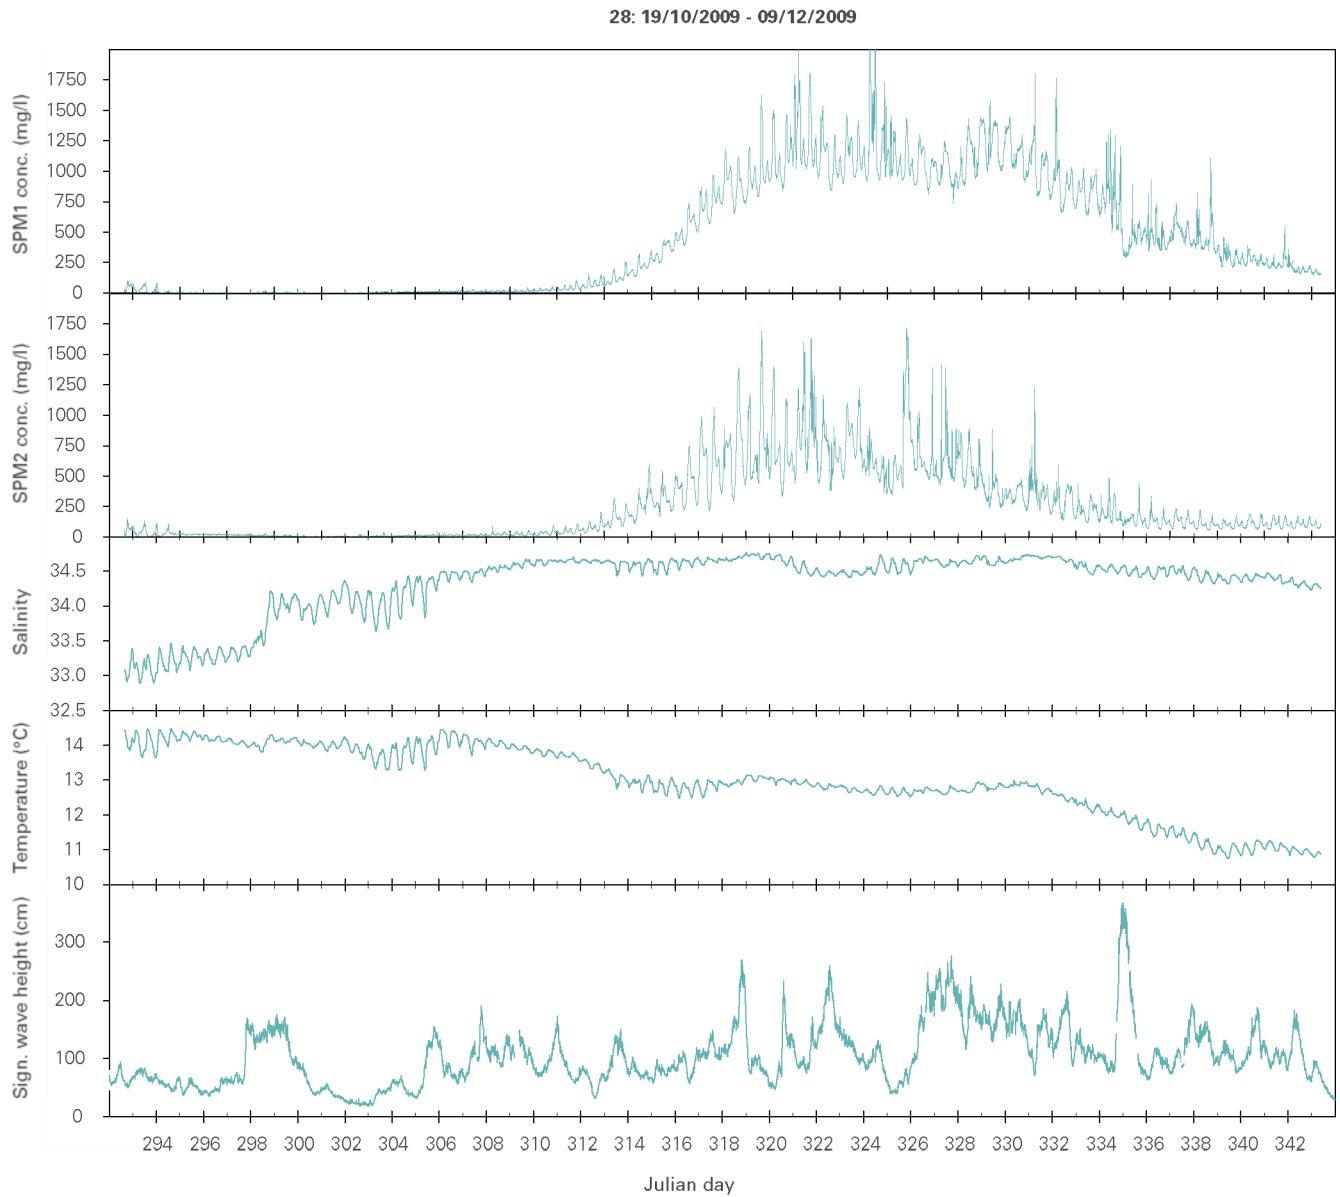
Figure 7. SPM concentration (SPM1 at 29 cm above the bottom, SPM2 at 234 cm above the bottom), temperature, salinity at the Gootebank from October 19th, 2009 to December 9th, 2009. Significant wave height at Zuidwest Akkaert (Meetnet Vlaamse Banken, Flanders Hydrography).

While the SPM concentrations remained low during most of the measuring campaigns at the Bligh Bank and the Thorntonbank, this was clearly not the case at the Gootebank (Figure 7). At the Gootebank, from November 1st, 2009 onwards, the SPM concentrations increased considerably to high values up to 2000 mg/l close to the bottom, and 1700 mg/l at 2 m above the bottom. This was a result of a long period of prevailing southerly winds (Van den Eynde et al., 2013) that can cause an offshore shift of the coastal turbidity maximum (Baeye, 2012) and the introduction of associated high concentration mud suspension layers at the measuring location as observed in the ADV altimetry time series.

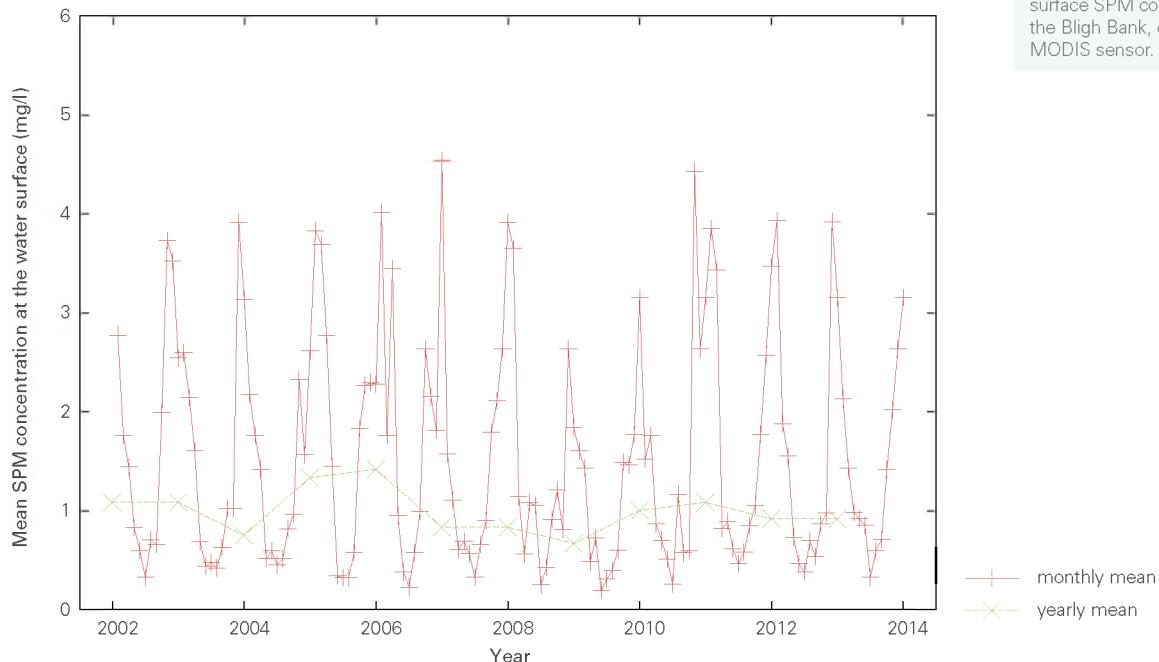
Figure 8. Monthly and yearly mean surface SPM concentration values at the Bligh Bank, calculated from the MODIS sensor.

The surface SPM showed a very clear seasonal cycle, resulting in higher surface SPM concentration values in winter months

(3-4 mg/l) and lower SPM concentration values in summer months (< 1 mg/l). Since the good values are not evenly distributed over the years and the months, the monthly values were calculated first, replacing the missing values by the climatological monthly means, before calculating the yearly mean values of the surface SPM concentrations. These monthly and yearly means from the MODIS sensor are presented in Figure 8. Student's T-test indicated that the yearly mean surface SPM concentration before the works (2002-2009) were not significantly different from the yearly mean surface SPM concentrations after the works (2010-2013). Also the monthly means did not differ significantly in most cases before and after the construction works. Only for a few months the differences were significant, but these results could be related to meteorological events, rather than to the construction and operation of the wind farms.

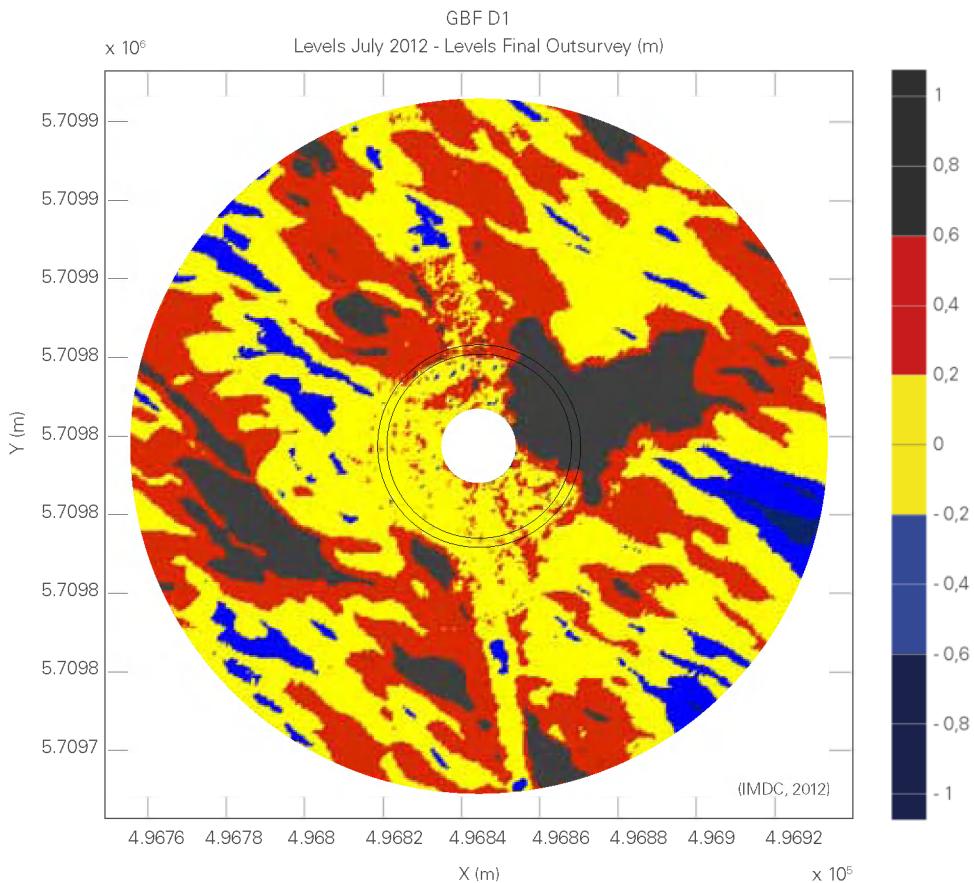
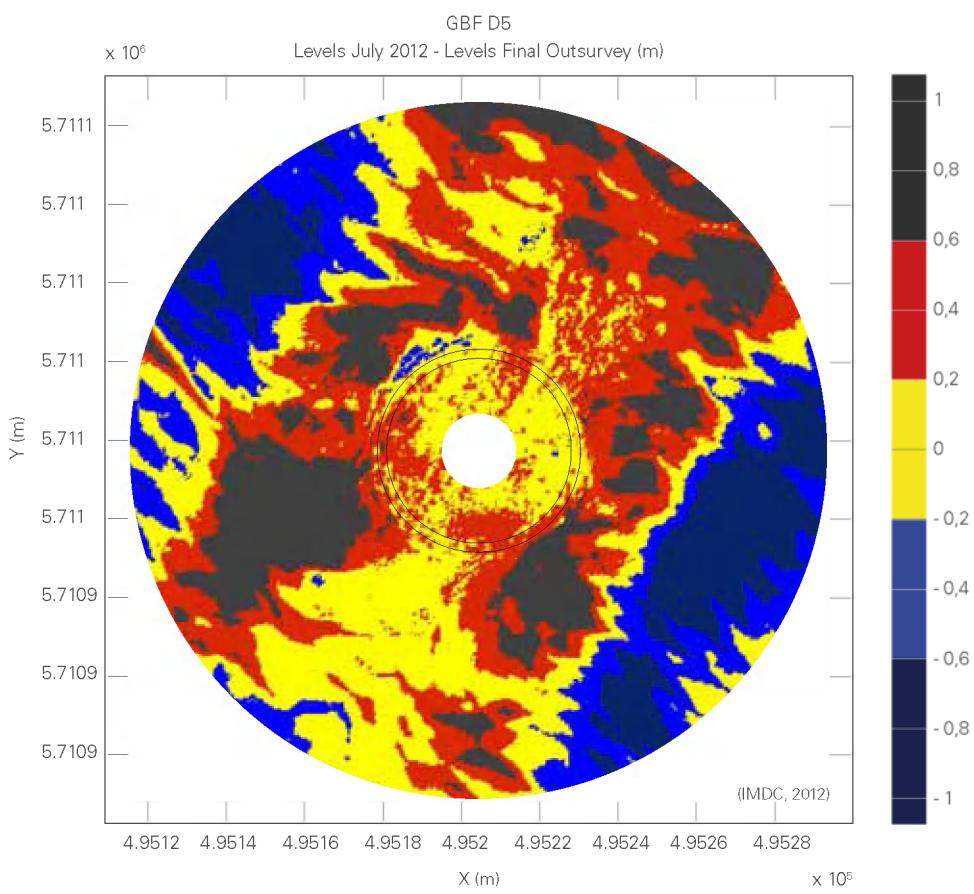
Figure 9. Difference maps of the bathymetry around GBF D1 and GBF D5, comparing the bathymetry after installation against the situation in July 2012 (C-Power, 2012a).

In some cases, small areas were found where erosion exceeded a pre-set alarm level. This was mostly levelled out by natural sedimentation, apart from one location where rocks were deposited (northeast of GBF D1, see figure 9), preventing erosion at the foundation.

Overall, sedimentation occurred in the dredged pits (e.g., GBF D5, see figure 9). Around the erosion protection, similar seabed levels occurred, though important erosion or deposition was also observed. The erosion protection functioned without any secondary erosion.

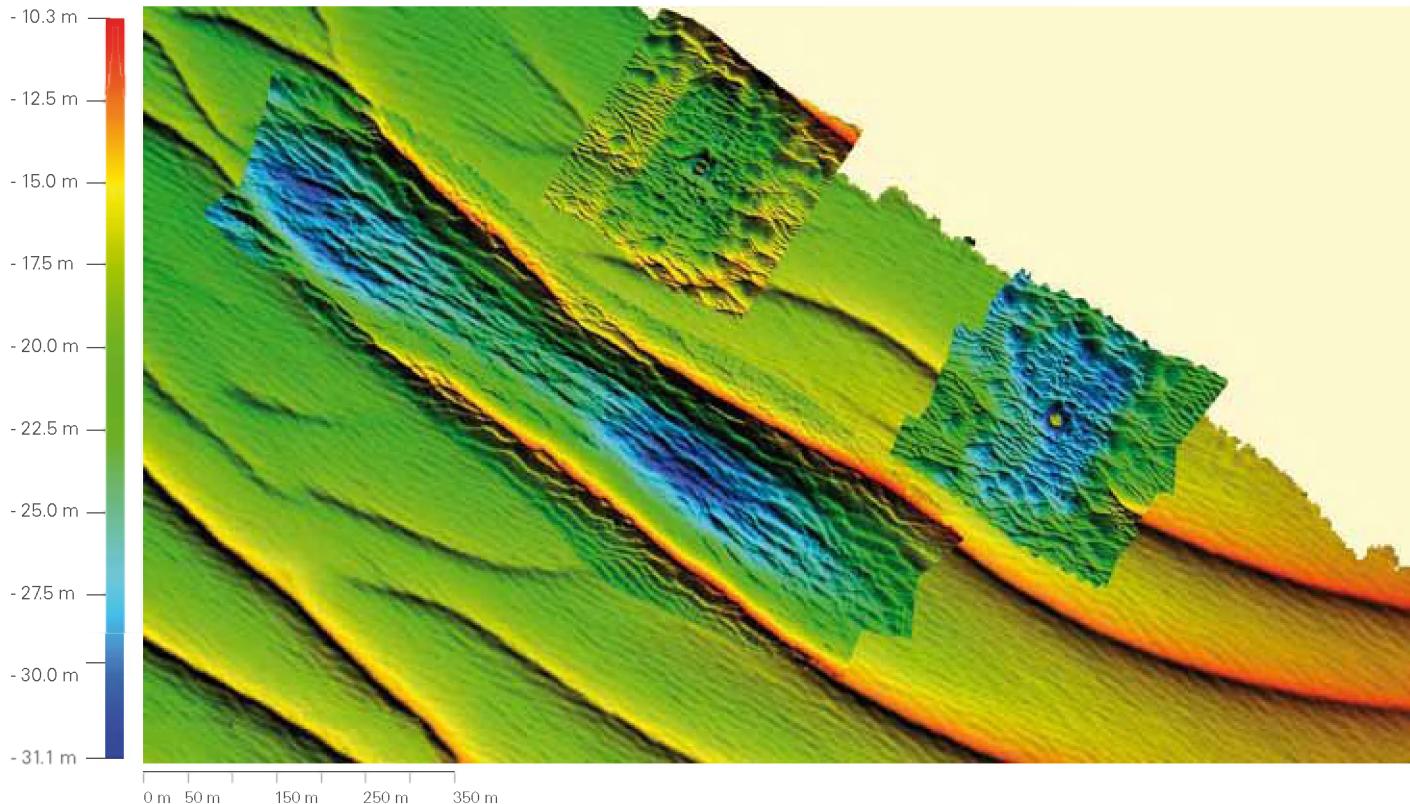
Figure 10. Depression generated in the C-Power concession area. Background bathymetry is from 2006 (FPS Economy).

sites, from which some 588,000 m³ was used effectively for the backfill and infill operations. IMDC (2009c) concluded that the sand was mostly lost during dredging (10 %) and disposal works (20-25 %). Due to these losses, no excess material was found at the disposal sites after the construction of the foundation pits and the backfill and infill operations, but instead 480,000 m³ sand was extracted. The bathymetry of one of these sand pits is shown in Figure 10.

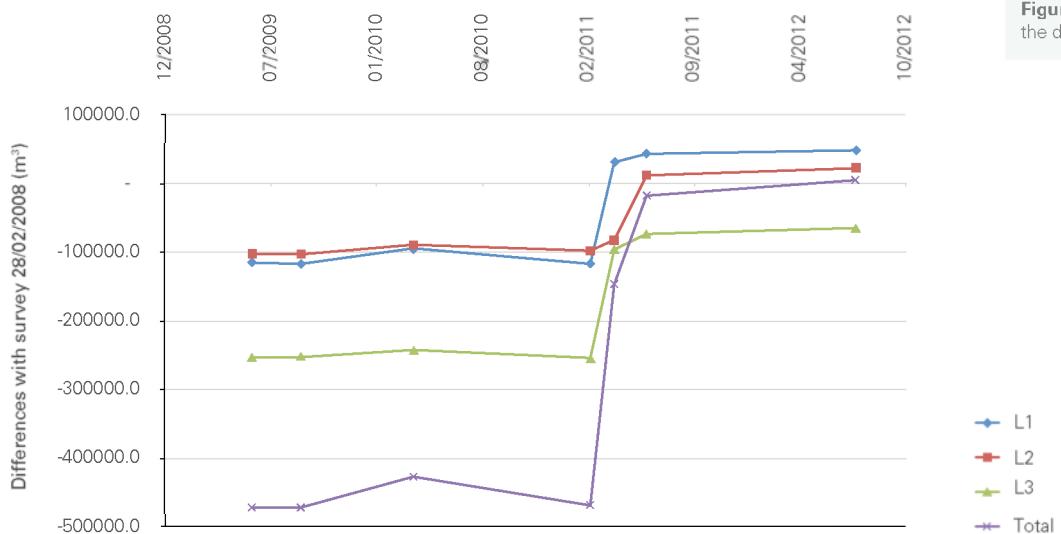
Figure 11. Evolution of the material in the disposal areas (C-Power, 2012a).

Compared to October 2008, the continued monitoring of the depressions showed that in June 2009, 471,000 m³ was still missing, indicating that over a period of 8 months only 9,000 m³ were naturally deposited in the depressions (Figure 11). Between September 2009 and April 2010, some deposition resulted in a volume increase of 45,000 m³, but due to dune migration the material almost entirely disappeared again in February 2011. In February-March 2011, the sand pits were filled again, by using material from the foundation pits that were dredged for the installation of jacket foundations (second phase of the C-Power wind farm). The difference between the original sites and June 2011 amounted -18,000 m³. The last survey of July 2012 showed some additional deposition in the area, resulting in a total difference of +5,000 m³.

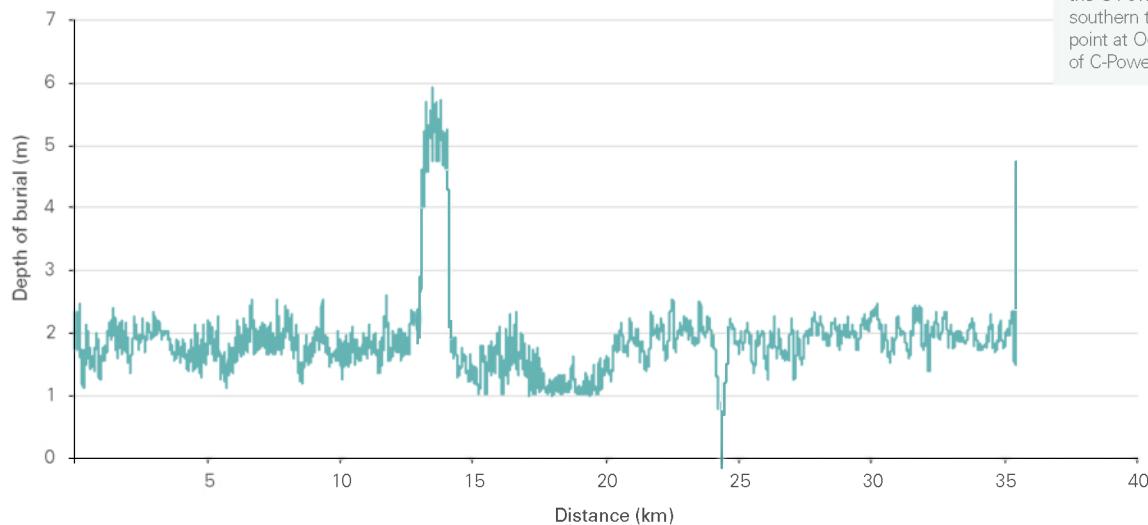
Figure 12. Original depth of burial (January 2009) of the export cable from the C-Power wind farm from the most southern turbine (km 0) to the landing point at Oostende (km 36) (From data of C-Power, 2009b).

To assure that the export cables remained buried, their coverage was verified on a regular basis. Along the entire length of the 150 kV (A) export cable from the C-Power wind farm to the cable landing at Oostende, a burial depth of 2 m was aimed for. In some areas, due to clay layers, only 1 m burial depth was reached (Figure 12) with a much deeper burial around km 14 where the cable crosses the navigation channel 'Scheur'. This was required in the environmental permit for safety reasons. At km 24, a surface communication cable was crossed and gravel was disposed to protect the cable.

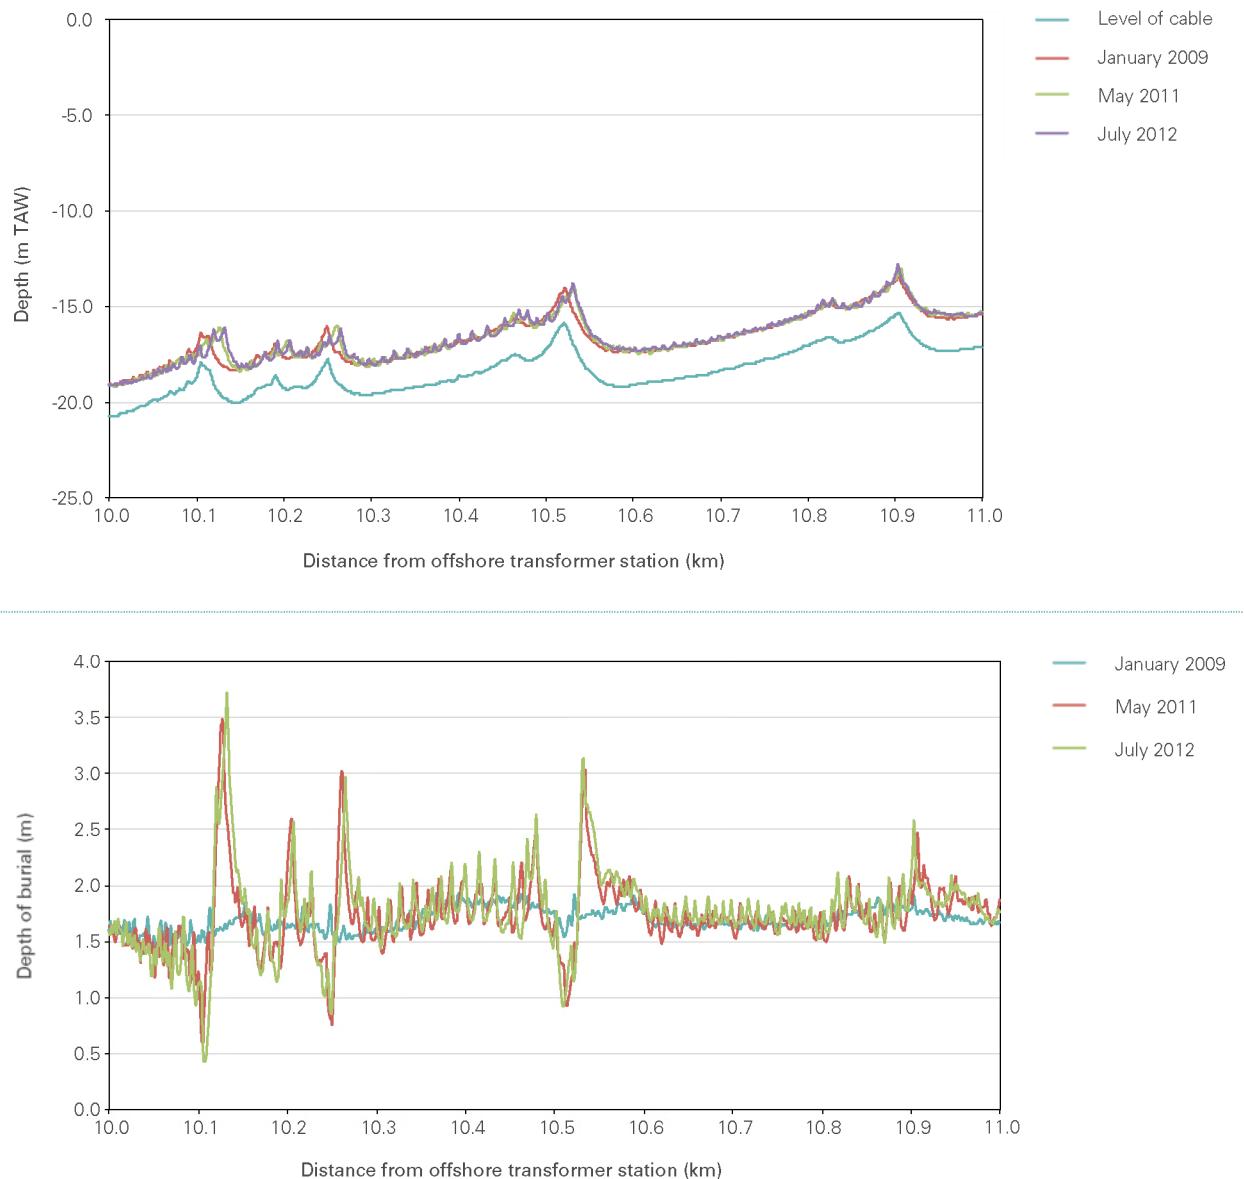
Figure 13. Bathymetry during different surveys and depth of burial of the 150 kV cable from the C-Power wind farm between km 10 and km 11 (From data of C-Power, 2012a).

that at some areas, especially near the GBF D1 and at the Scheur, the DOB was less than 1 m. At three locations, the cable was exposed at the seabed and needed re-burial. This was due to sand dune migration (Figure 13). Remediation works were executed to assure that the cable remains covered. From this, C-Power decided that the second export cable (B) would be buried 1 m below the base of those sand dunes. Similar difficulties were encountered with the export cables from the Belwind wind farm to shore. Rocks were deposited on the locations where the cable was exposed.
