INTERVENTION IN FORTE DO GUINCHO

SEA HERITAGE – CONSERVATION AND ARCHITECTURE PROJECT

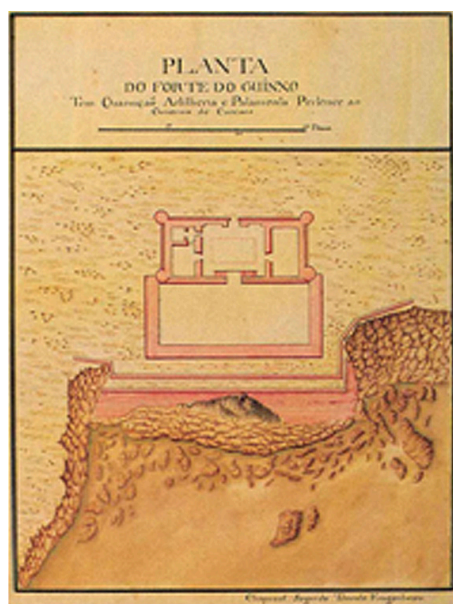
Figure 2 – Forte do Guincho, drawn by Chapuzet in 1798 (DSFOM)

In the late 18th century (Figure 2), due to the threat of collapse of the rock platform where the fort is built, major changes were made to its entire structure. A seawall in the basement rock on which the fort's battery stands was built to create an obstacle to the destructive action of the sea. The work, which began in 1793, created a new space, although the interior layout remained unchanged from the original construction. Compared to the original fortification, the major changes were to the intermediate compartment of the cantonments, in the battery and in the outside walls. The intermediate compartment was significantly enlarged and occupied an area corresponding to twice the size of each side compartment (barracks, kitchen, warehouse storage and gunpowder). In the process of restructuring, the main gate of the fort was rebuilt and the entry courtyard reorganized. The cistern was also expanded, occupying a central position. The most extensive work was carried out on the battery. The fort's foundations, which were under threat of crumbling, due to the continuous impact of the sea waves on the rocks, were rebuilt and the fort's walls thickened. In this new layout, the new foundations were added to the continuation of the exterior walls of the cantonments, which resulted in a larger rectangular enclosure.

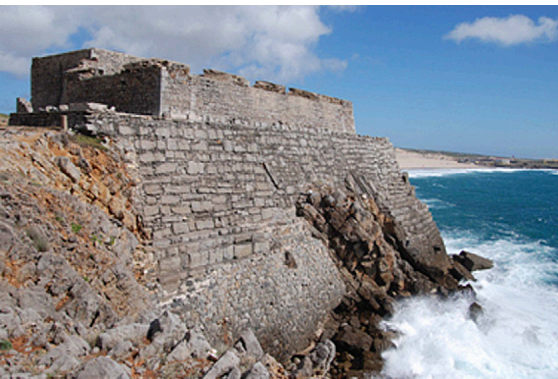
Figure 3 – Forte do Guincho: side view

Today, it stands in ruins (Figure 3).

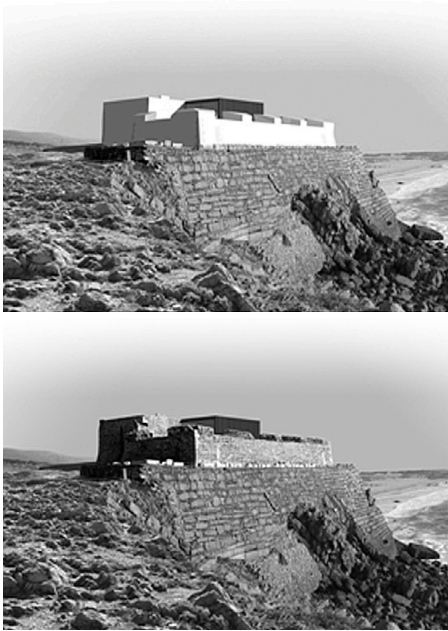
Figure 4 – Three-dimensional simulation: fort walls with and without plaster

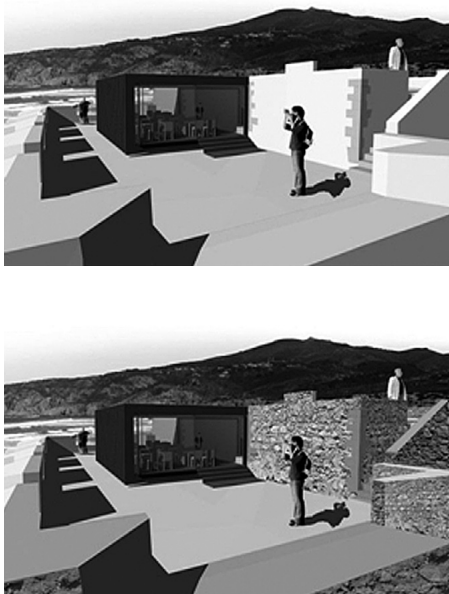
Figure 5 – Three-dimensional simulation of the tea house structure: fort walls with and without coverage

Since the existing space did not ensure the necessary customer area, it was proposed that the new piece of contemporary design (Figures 5 and 6) would allow the two existing cantonments to be interconnected, thus increasing the covered area of the fort. Although this piece would enable connections to the existing structures, it was assumed as a separate object. It keeps the idea of the existence of the lower, smaller courtyard as an exterior chamber preceding the main public covered area. It would contain a tea lounge, served by the facilities arranged in the cantonments. This intermediate space would make it possible to enforce a universal design on the project.

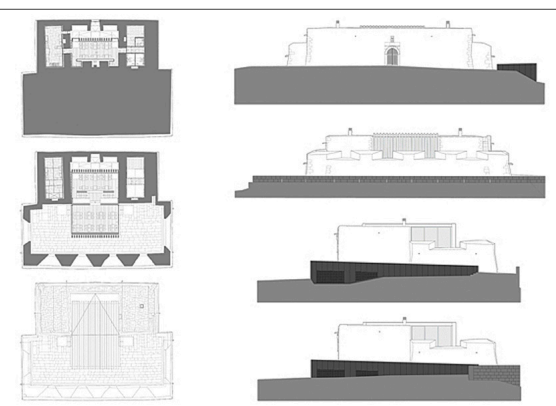
Figure 6 – Proposed plans and elevations

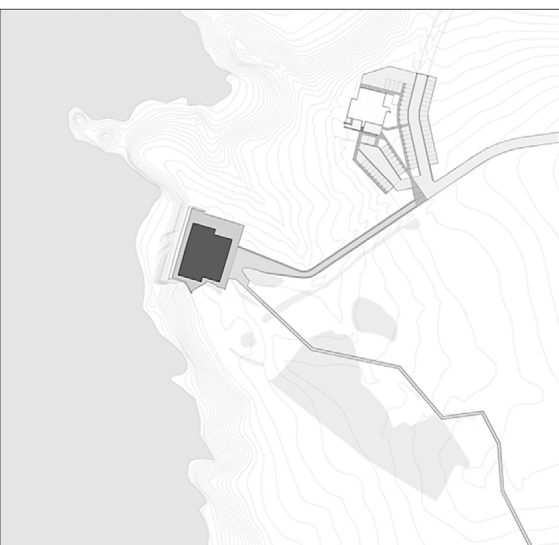
Figure 7 – Landscape architecture project

The landscape project (Figure 7) proposed by NPK⁷ ensured a minimal paved area surrounding the building and confining its access, built with a stone-paving material similar to the already existing. The limits and sizing of the pavement were adapted to the terrain, outlining the existing rocky outcrops. A linear connection between the fort and the parking area was proposed for use by pedestrians and emergency and service vehicles, in order to regulate both the flow of people and vehicles in the area surrounding the building.

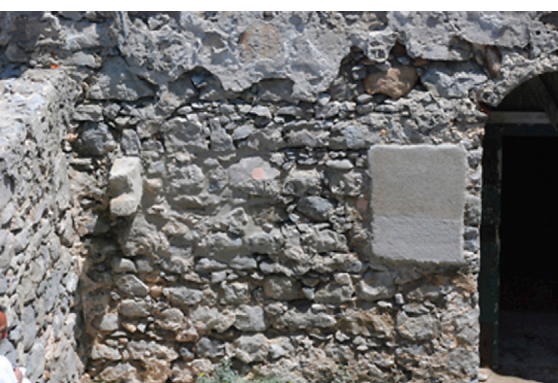
Figure 8 – Joint treatment and wall coating plaster tests

During the tests (Figure 8) conducted in 2008, it was found (under normal conditions, in strong winds) to be difficult to ensure a slow and gradual drying of the plaster executed with lime mortar. This control was easier to ensure in small areas than in large plaster areas. Thus, in treating the joints, it is also easier to guarantee proper execution.
