Description of flood defence structures for pilot sites

Report Number **T04-06-02**

Title	Description of flood defence structures for pilot sites
Lead Author	Dr.-Ing. Andreas Kortenhaus (LWI)
Contributors	HRW, CAU, IOER, UPC, UniPad, VITUKI, UFZ
Distribution	FLOODsite
Document Reference	FDS_pilotes_v2_0_p03.doc

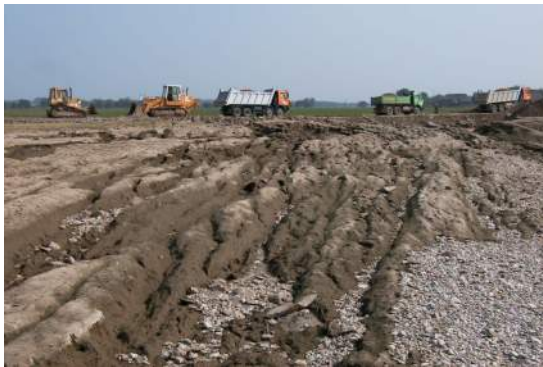
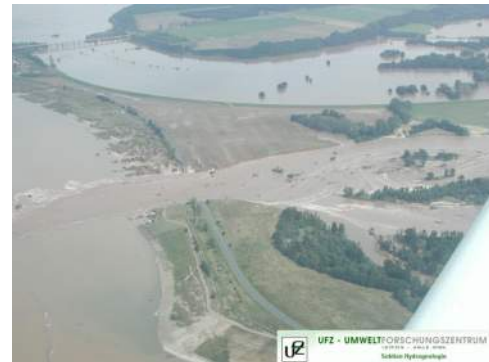
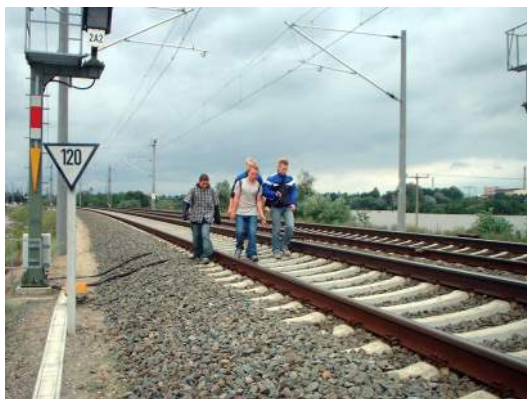
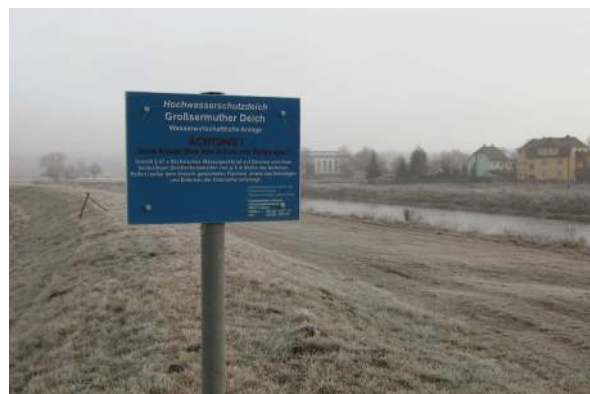
Figure 3 Examples for flood defence structures of the River Vereinigte Mulde.

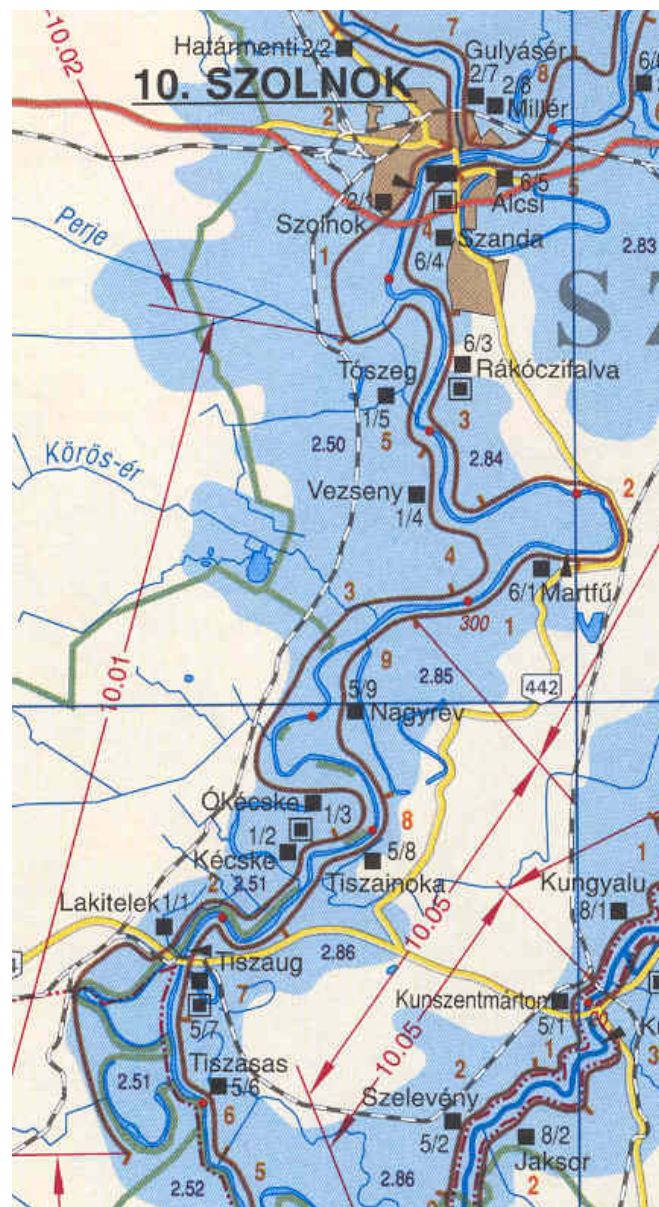
Figure 4 Overview of pilot site "River Tisza Basin"

The pilot site is situated along the right bank of the River Tisza, downstream the city of Szolnok. Extension of the floodplain cells protected by the flood defence section 10.01 covers an area of 125 km². There are 7 communities in the flood cell, namely: Lakitelek, Tizsakécske, Tiszabög, Tiszajenő, Tiszavárkony, Vezseny, Tószeg. Significant agricultural production is going on in the flood cells: vineyards, orchards and arable lands are here. Industrial activities are growing in the Tizsakécske region. Tourism is rapidly growing especially in the larger holiday resorts of Lakitelek-Tőserdő as well as Tizsakécske-Kerekdomb.

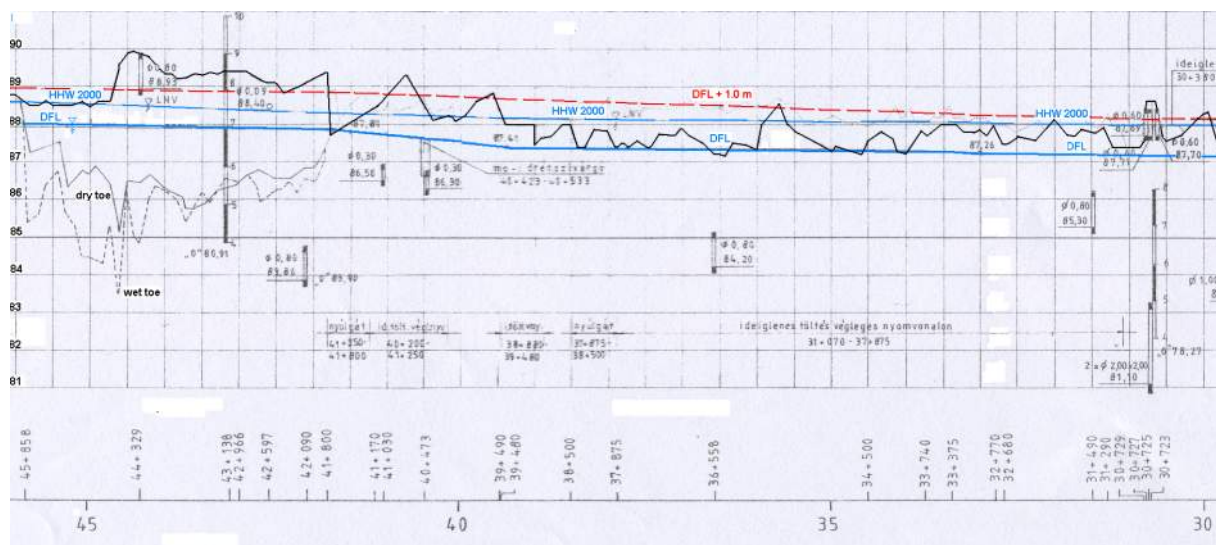
Figure 5 Longitudinal section of the River Tisza within the selected pilot site

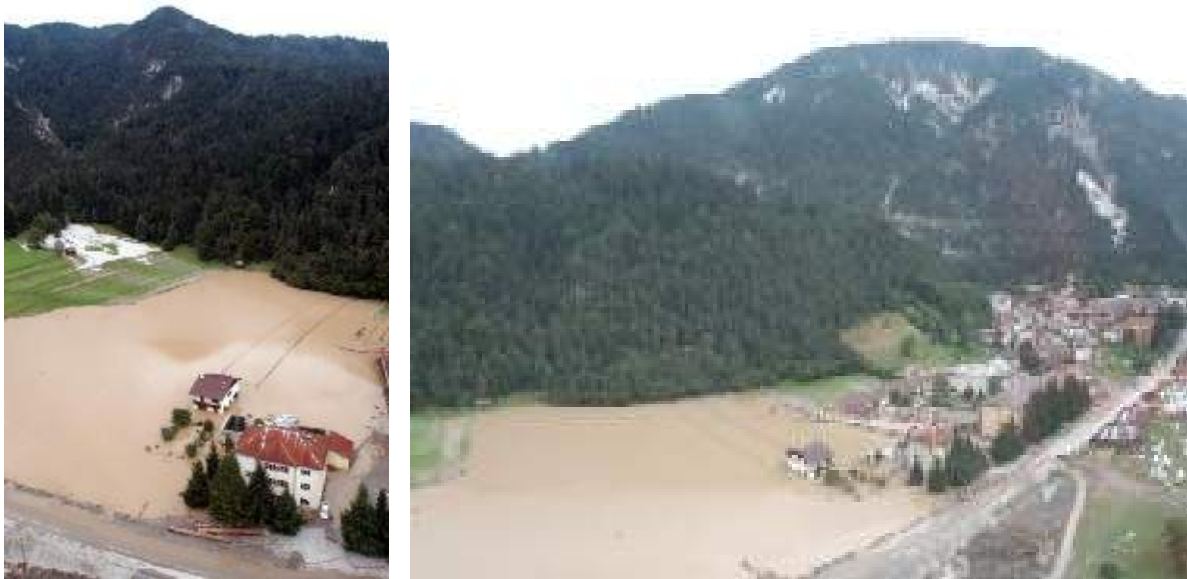
Figure 8 Pictures taken shortly after an extreme flash flood occurred on 29 August 2003 on the Upper Tagliamento river basin.

Flash floods have occurred over various regions. Extreme floods have occurred in the Adige and Tagliamento river basins during the period 1999 – 2004 which will be analysed in more detail within FLOODsite (Figure 8).

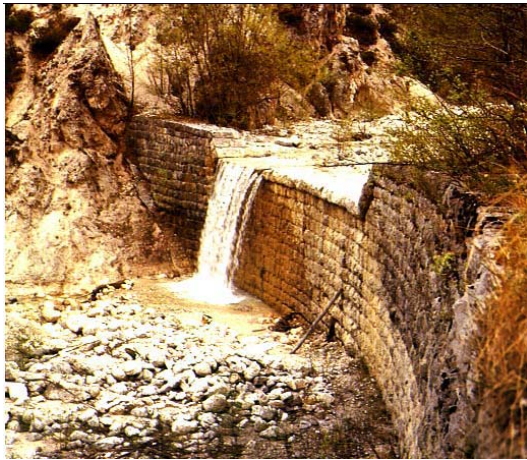
Figure 9 Cemented stone or concrete dam

These structures can be constructed along the entire watercourse length because of their adaptability to different morphological and hydrodynamic conditions of the torrent bed. Their strong rigidity enables them to have considerable dimensions. Both the building yard and the dam itself cause however a significant environmental impact.

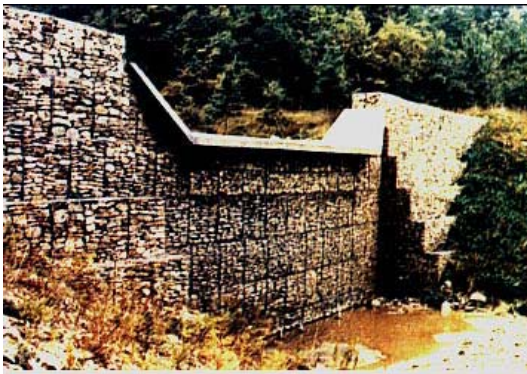
Figure 10 Gabion dams

They consist of adjacent wire baskets filled with heavy stones that can sometimes be found in the torrent bed. They can reach a height of up to 10 m and can be adapted along the entire hydrographic network. Other types are more flexible, thus adapting better to more unstable watercourse bed sites. The preparation of the building yard causes a significant environmental impact. However, the dam itself permits a rapid re-naturalising by natural plants or cuttings.

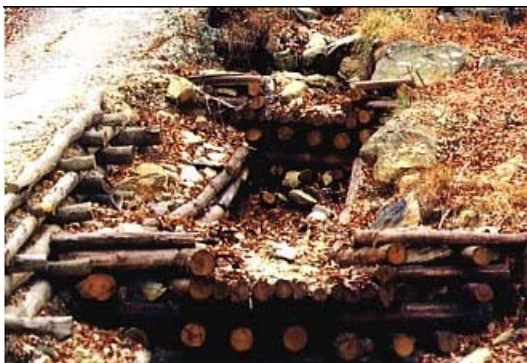
Figure 11 Wood or rocks and wood dams

They consist of a well-organised structure made of rocks and wood poles, in general any kind of wood with strong resistance to water and rocks that can be found in the area of construction. Their height does not usually exceed 2 m. For this reason they are usually built in the upper portion of the hydrographic network or along small tributaries with low or intermittent water flow. Partial re-naturalising of this type of dam is possible, thus reducing its environmental impact.

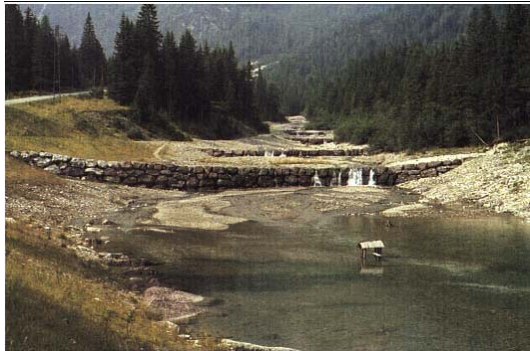
Figure 12 Dry stone/wall dams

They consist of a well-organised structure made of big stones, which might be found near the site of the structure. These dams are usually built in the upper reaches of the hydrographic network or along small tributaries where the intermittent water flow with low discharge favours their durability. Their height does not usually exceed 2 m. Their environmental impact is relatively low and has the lowest cost amongst check dams.

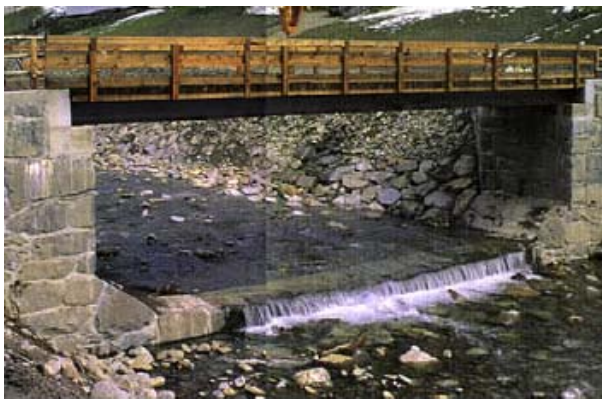
Figure 13 Concrete or stone sills

These have been the most commonly used sills so far because of ease of construction, despite having the highest cost. They can be constructed in all morphological conditions, especially in those of lower watercourse reaches.

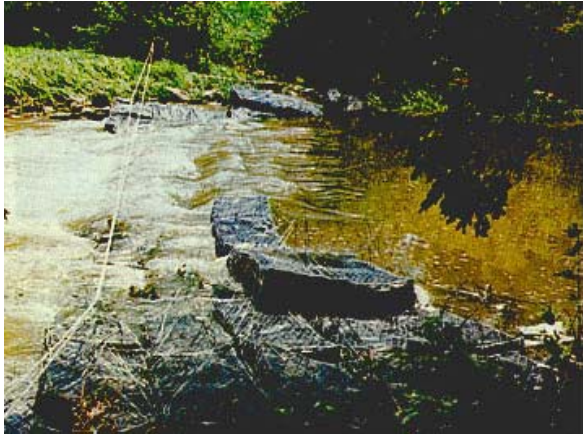
Figure 14 Gabion sills

Sills made of gabions can be applied to many different hydrodynamic conditions. Their limited height allows for a considerable width. Sometimes, building of gabions can be carried out with the rocky materials available along the torrent beds.

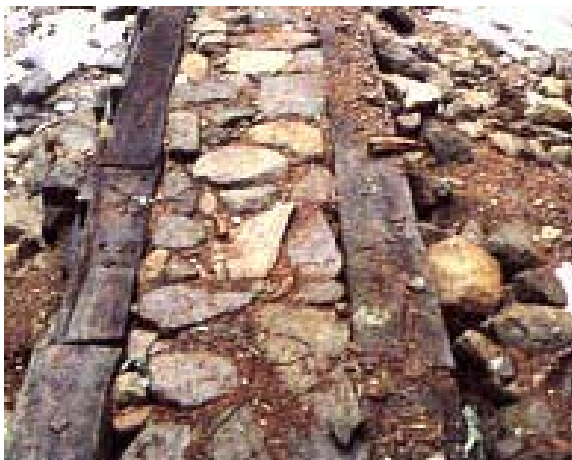
Figure 15 Sills made of blocks

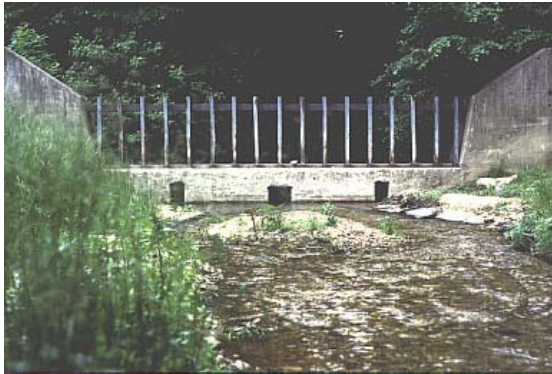
Figure 16 Screen dam with vertical bars

- **Screen dams with vertical steel or concrete bars** (Figure 16): They are used mainly for retaining vegetal materials. Screen dams can be built in different reaches of watercourses. These dams offer a high resistance against the transported materials. Alternatively, dams with bars made of wood can be built along small torrents or agricultural or forest channels.
- **Beam dams with central pylon bars** (Figure 17), vertical opening (Figure 18) and horizontal steel bars (Figure 19) - These dams are constructed with concrete and steel structures. Their main objective is to prevent mass transport that could affect urban areas.

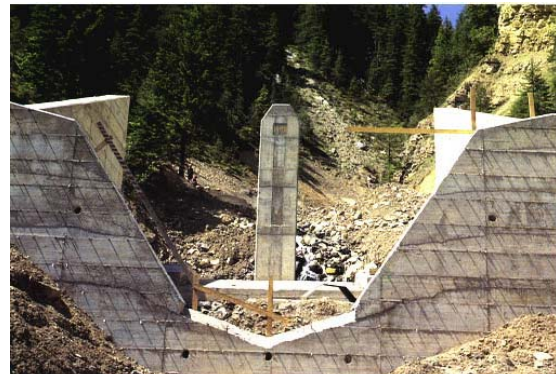
Figure 17 Beam dam with vertical pylon bar

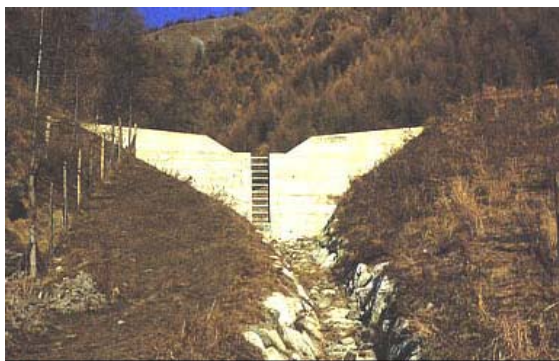
Figure 18 Beam dam with vertical opening

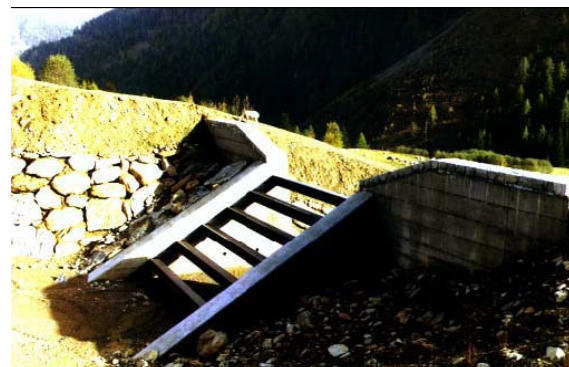
Figure 19 Beam dam with horizontal bars

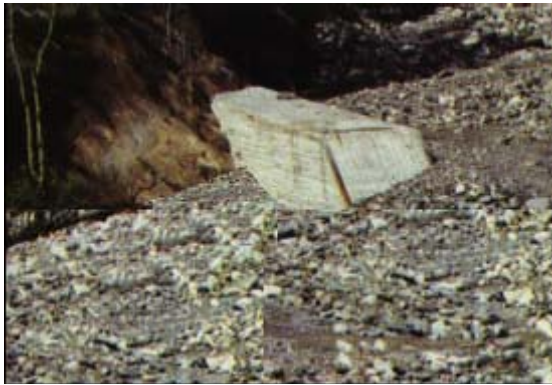
Figure 20 Groyne made of concrete or cemented stones

They are usually adopted along torrent beds subjected to strong bank erosion and are usually carried out in the lower portion of watercourses. The short transversal dimension of groynes cause limited environmental impact on watercourses. However, they cannot be re-naturalised through bioengineering works. These groynes have the highest cost.

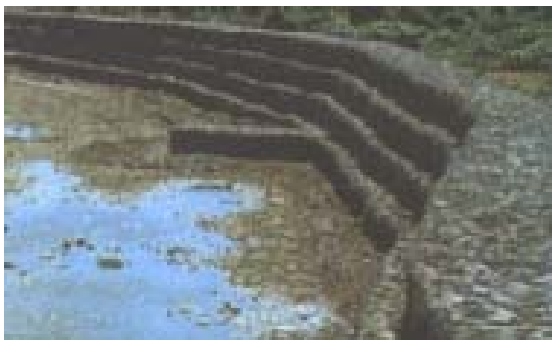
Figure 21 Groyne made of gabions

Because of their flexibility, groynes made with gabions can be easily applied along torrent beds subjected to strong bank and bed erosion. They cause a limited environmental impact. Gabion groynes have the lowest cost.

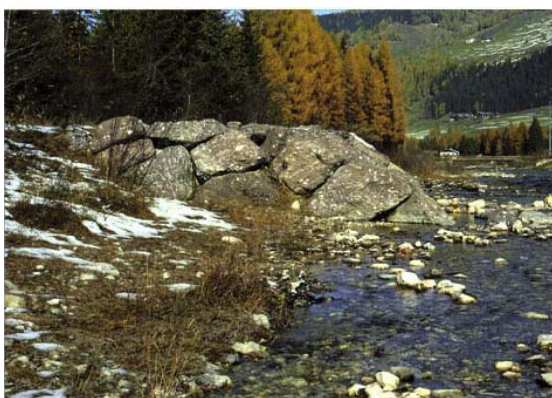
Figure 22 Groyne made of prefabricated or natural blocks

Groynes made with non-cemented prefabricated or natural rocks are usually built along the upper reach of watercourses. Natural blocks available inside the torrent bed can be used. They cause a low environmental impact, especially when using natural materials (rocks, woods, plants) by bioengineering techniques, hence allowing for revegetation.

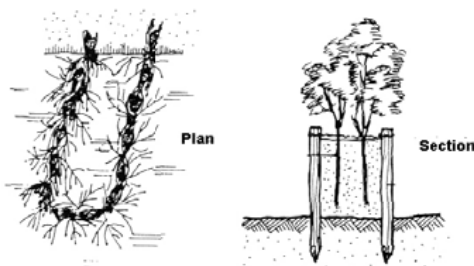
Figure 23 Groyne made of rocks and cuttings or wood and cuttings

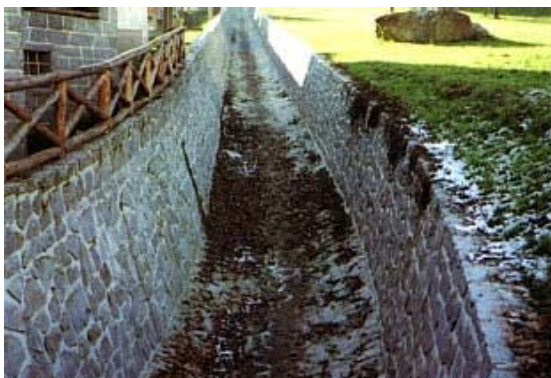
Figure 24 Channel lining made of concrete, cemented stones

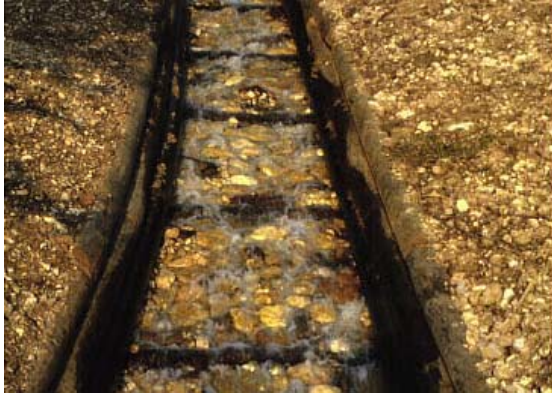
Channel lining made of wood and stones or wood

Channel lining using rocks or woods are mainly applied where ecological and environmental respect requires using natural materials. This type of lining consents limited building yard actions fitting the intervention to the natural characteristics of the watercourse. Channel lining with rocks or wood, which are generally available locally, permit to re-naturalise the watercourse. Insertion of cuttings among the structure allows for stronger channel lining. Channel lining using wood and stones implies the lowest cost.

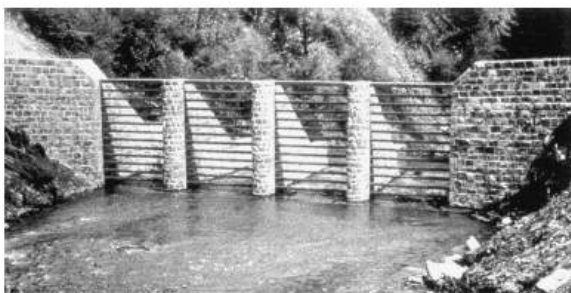
Figure 27 Example of open beam check dam

Open-check dams are usually designed according to clear-water principles, without considering the effects of sediment transport. In this respect, the slit width b is chosen in such a way that the specific energy upstream of the dam, under uniform flow conditions, H_0 is less than the minimum specific energy in the slit section

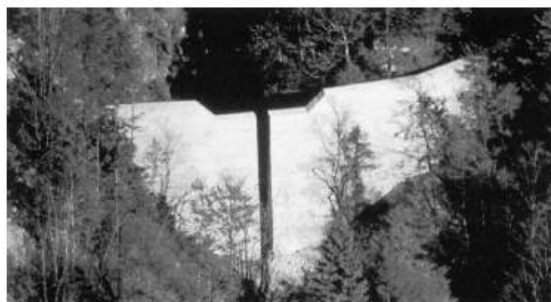
Figure 28 Example of open slit dam

- Slit dams (Figure 28) are based on a completely different criterion. This kind of check dam presents one or more narrow vertical openings, going from the dam's base up to the weir. The effect is mostly dosing the sediment transport rate and it is obtained by means of a backwater effect that allows most of the particles to deposit upstream of the dam (hydrodynamic sorting).

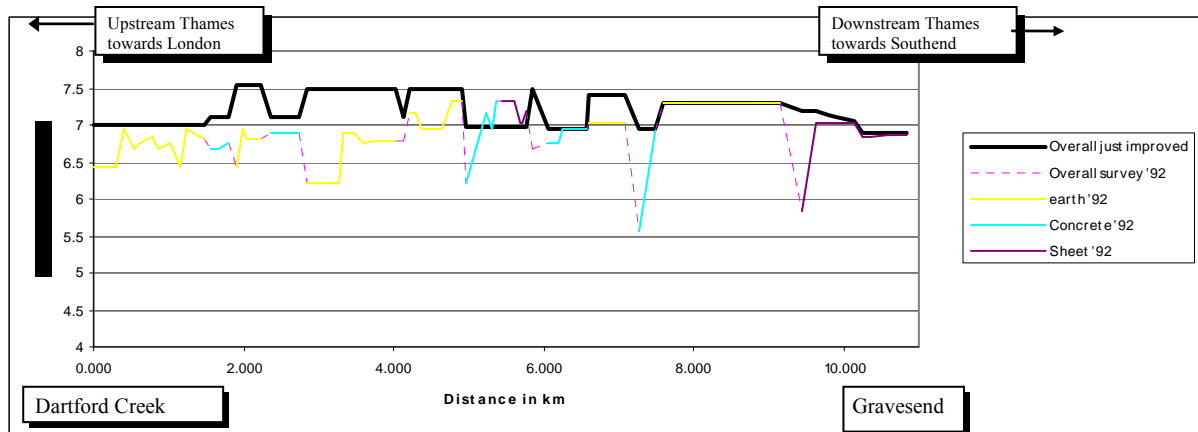
Figure 30 Elevation of the flood defence line between Dartford Creek to Gravesend. The figure includes the elevations per structure type as surveyed in '92 versus those indicated in the as designed / as constructed drawings.

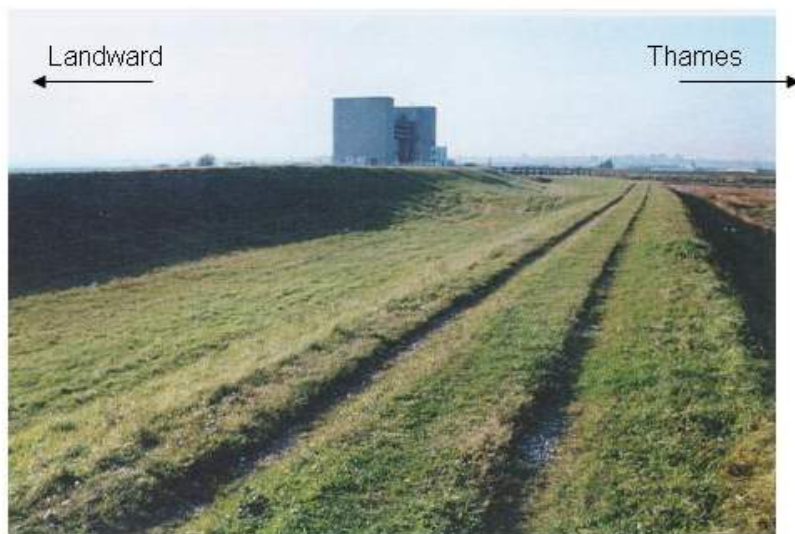
Figure 32 View along the embankment at the 'River Thames' pilot site

The earth embankments along the Dartford Creek to Gravesend defence line typically have two crests. In the late '70s and early '80s the Thames Estuary defences were improved. The lower riverward crest is the old pre-improvement defence line, the higher landward crest has been constructed as part of the improvements. The defences are founded on weak clayey and peaty soil layers with a thickness in the order of magnitude 14 to 20 m. Those impermeable layers are in turn founded on a water conductive layer formed by sandy or chalky layers. To avoid the occurrence of deep seated slip circles during and after construction, berms were applied on the inside and outside toes of the defences to provide for sufficient stabilising weight. See Figure 31 for an example cross section and Figure 32 for a recent photograph.

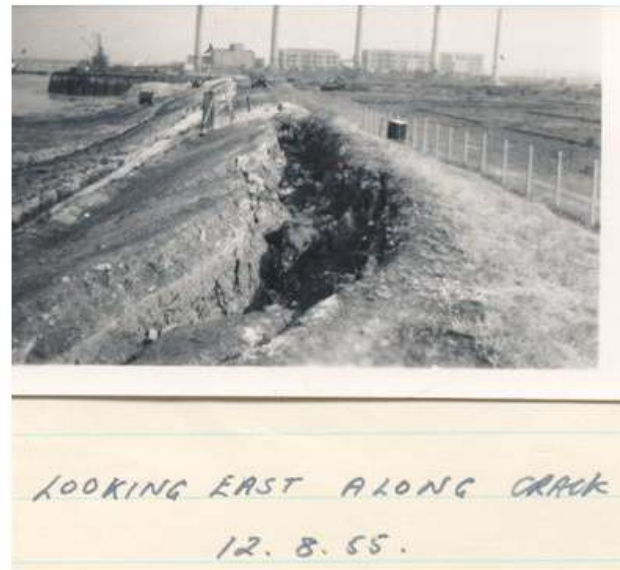
Figure 33 Example of “crack” in earth embankment crest before the landward improvements were built at the ‘River Thames’ pilot site

The potential failure modes of earth embankments are seepages into fissures and cracks. Instability of slope occurred and uplifting and piping behind the embankments have been located. Figure 33 shows a picture from 1955 of a crack in the previous earth embankment.

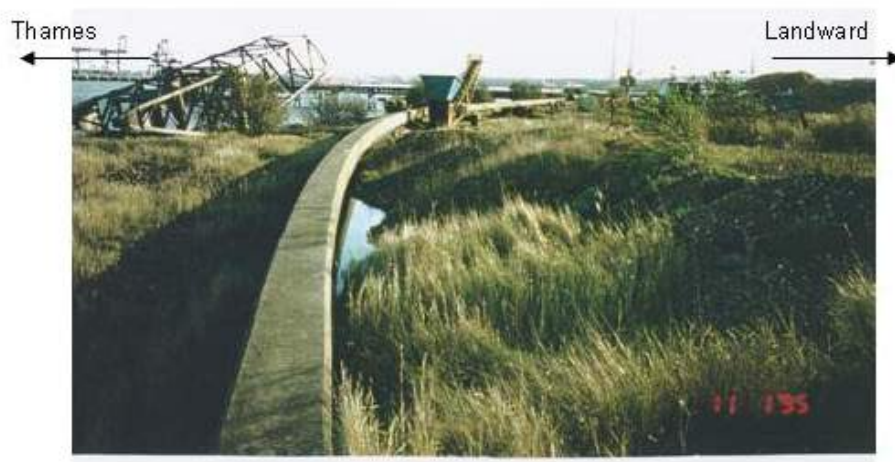
Figure 34 Concrete wall between Dartford Creek to Gravesend at the ‘River Thames’ pilot site

- Application of a single sheet pile sometimes in the form of an anchored sheet pile.
- A mirrored version of the structure is shown in Figure 35, with the vertical wall on the landward side rather than the Thames side.

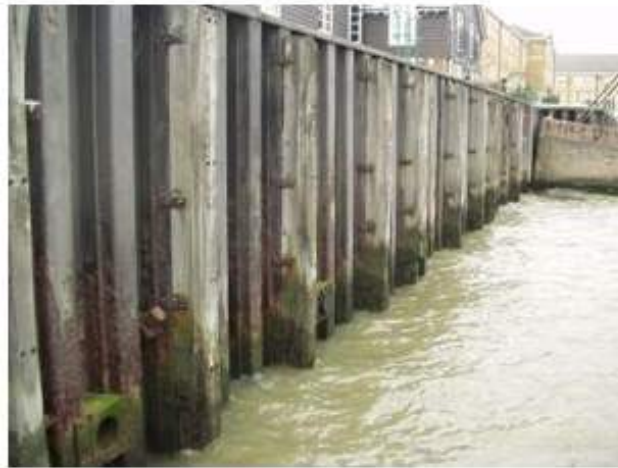
Figure 37 Examples of sheet pile walls between Dartford Creek and Gravesend at the 'River Thames' pilot site

Sheet pile walls were built/improved as part of the Thames Estuary flood defence improvements in the '70s and '80s. Figure 37 and Figure 38 show an example of a sheet pile wall applied along the Dartford Creek to Gravesend defence line. In some cases old frontages in the form of for instance masonry walls are still present in the ground behind the current sheet pile walls, the space in between the walls backfilled with concrete. In other cases, the old frontage was used to anchor the sheet pile walls in or the rubble of the old frontage was used as backfill material. At the time of the construction of the defence improvements, parts of the frontage between Dartford Creek and Gravesend were docks. Because of the function as a dock, besides the typical sheet pile wall a large variation of sheet pile wall cross sections and combinations with concrete structures occur. By now, the frontages are not in use as docks anymore. Another type of sheet pile wall occurs without anchors as part of an earth embankment. The sheet pile wall then provides an additional 0.5 to 1.0 m freeboard without demanding extra space associated with a sloped elevation.

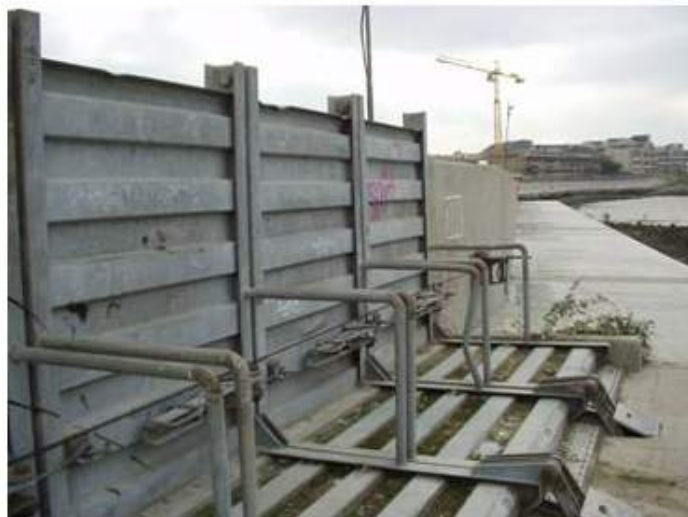
Figure 39 Example of a floodgate for pilot site 'River Thames'

As the frontages between Dartford Creek and Gravesend partly had a function as a dock during the '70s and '80s improvements, sufficient passages from the floodplain to the Thames had to be ensured. For this reason, a large number of floodgates were built into the flood defence line (Figure 39). By now, some of these floodgates are permanently in a closed position and some were replaced by a fixed defence line as part of commercial or residential developments. Others are part of a telemetry system and need to be closed to prevent flooding. The width of the opening varies from smaller gates, for instance 5 m, to larger gates of e.g. 20 m.

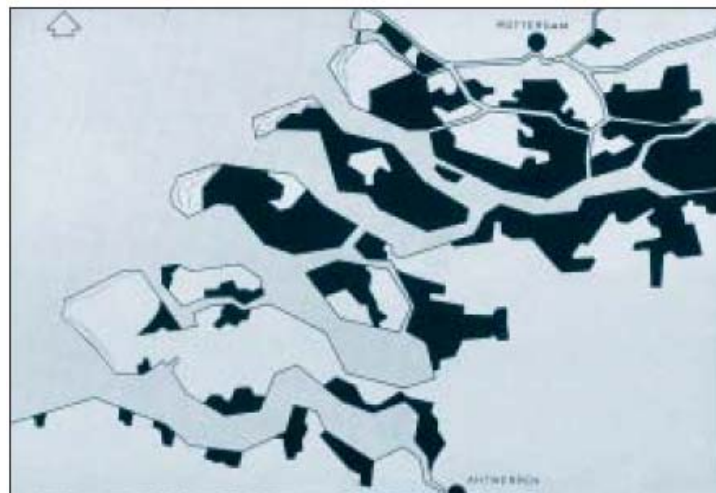
Figure 43. Overview of inundated areas after the 1953 storm surge

In 1953 a violent storm breached the dykes in many places in Zeeland and in Flanders and caused a disastrous flooding. The number of casualties was more than 1800. Approximately 72,000 inhabitants from the south-western disaster area had to be evacuated for a long period of time. More than 47,000 head of cattle and 140,000 poultry drowned. Three thousand houses and 300 farms were destroyed and more than 40,000 houses and 3000 farms were damaged. Almost 200,000 hectares of land were inundated. The total material damage is estimated to have been 1 ½ billion Dutch guilders. (eq. 3.1 billion € taken into account the inflation rate over 50 years).

In total around 100 breaches were counted after the storm. The lower and less well-maintained dikes on the south side of the polders were the first to go. The first dikes to burst were at Kruiningen, Kortgene and Oude Tonge. At Stavenisse, the force of the waves gouged out an 1800 m breach. And even in Noord-Brabant, near Willemstad, Heijningen and Fijnaart, the dikes could not withstand the

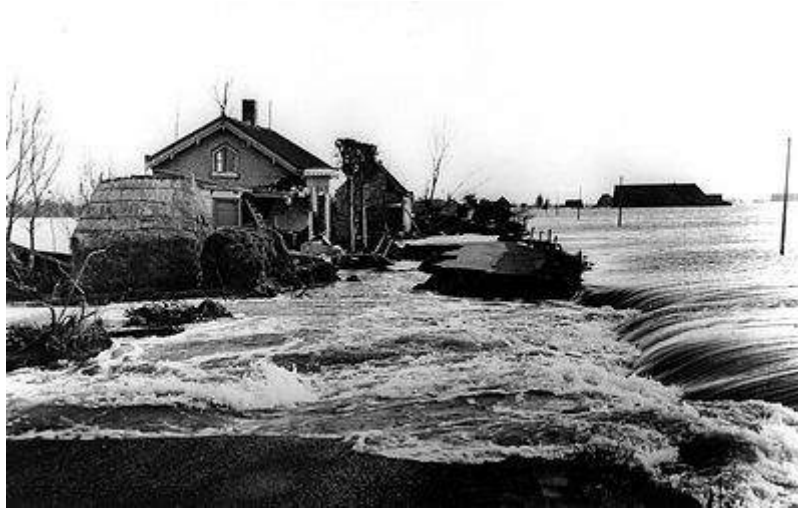
Figure 45 Dike breach during 1953 disaster

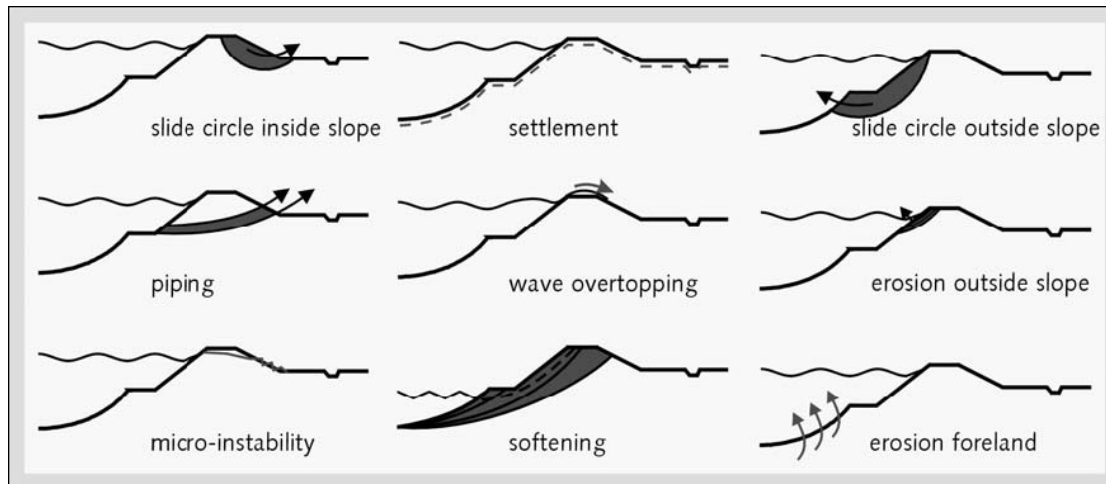
Figure 48 Failure mechanisms of a sea dike

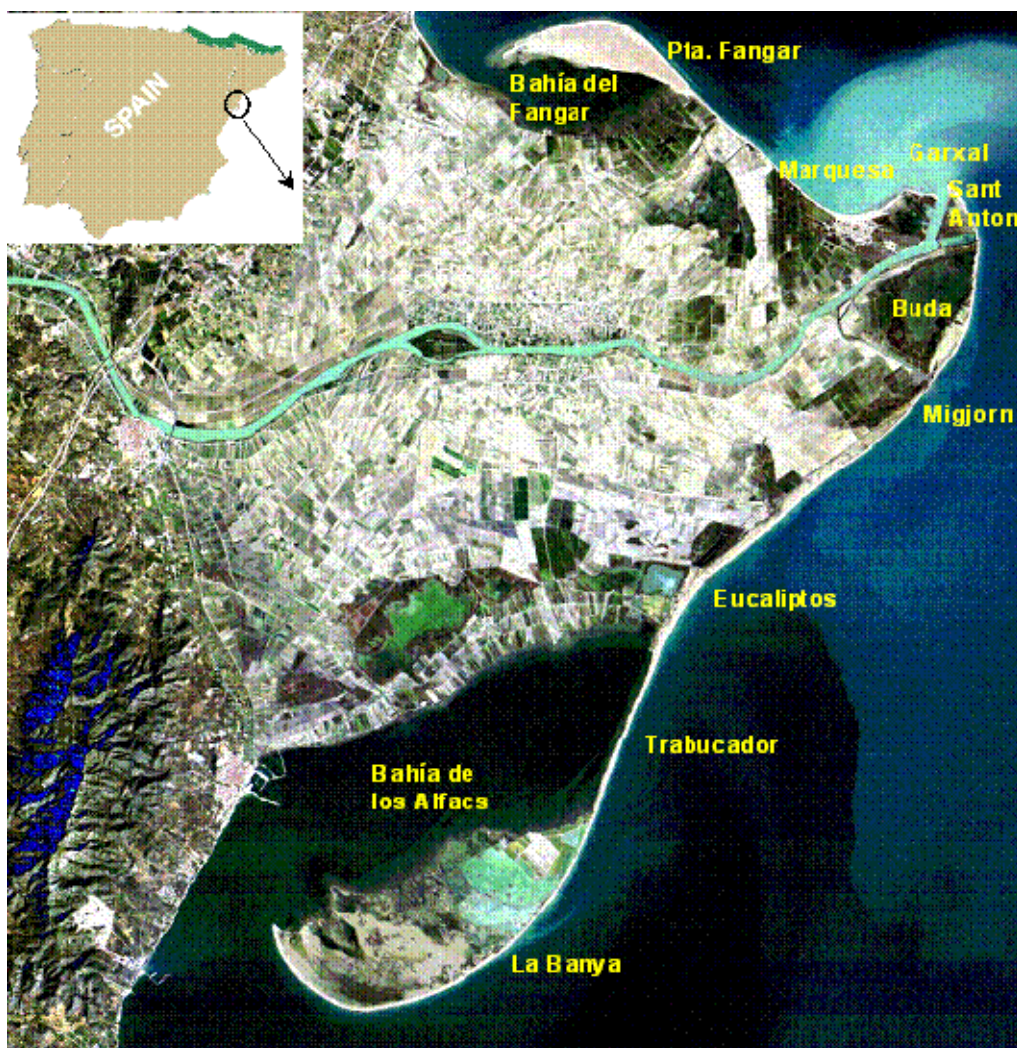
Figure 49 The Ebro delta

The Ebro delta is located on the Spanish Mediterranean coast about 200 km southward of Barcelona. It has an approximate subaerial surface of 320 km² and a coastline length of about 50 km including the inner coast in the two main lagoons (Figure 49). As many other deltas, it is an ecologically rich environment with about 311 different species of birds (60% of all the species in Europe) and about 515 different plant species (Espanya, 1997). It includes a Natural Park of 7,802 ha giving administrative protection to the areas of highest environmental value, including habitats like freshwater, brackish and saline lagoons, salt marshes and coastal and small dune sandy areas.

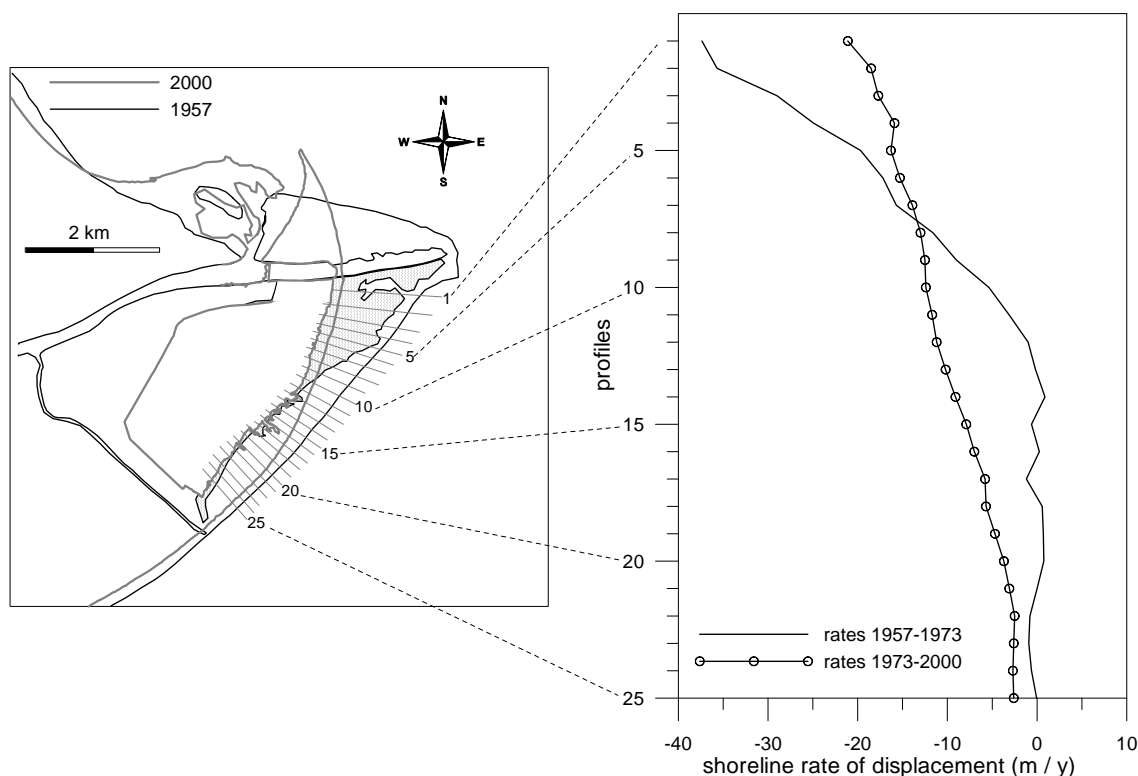
Figure 52 Decadal-scale shoreline rates of displacement along Illa de Buda (adapted from Valdemoro *et al.*, 2005).

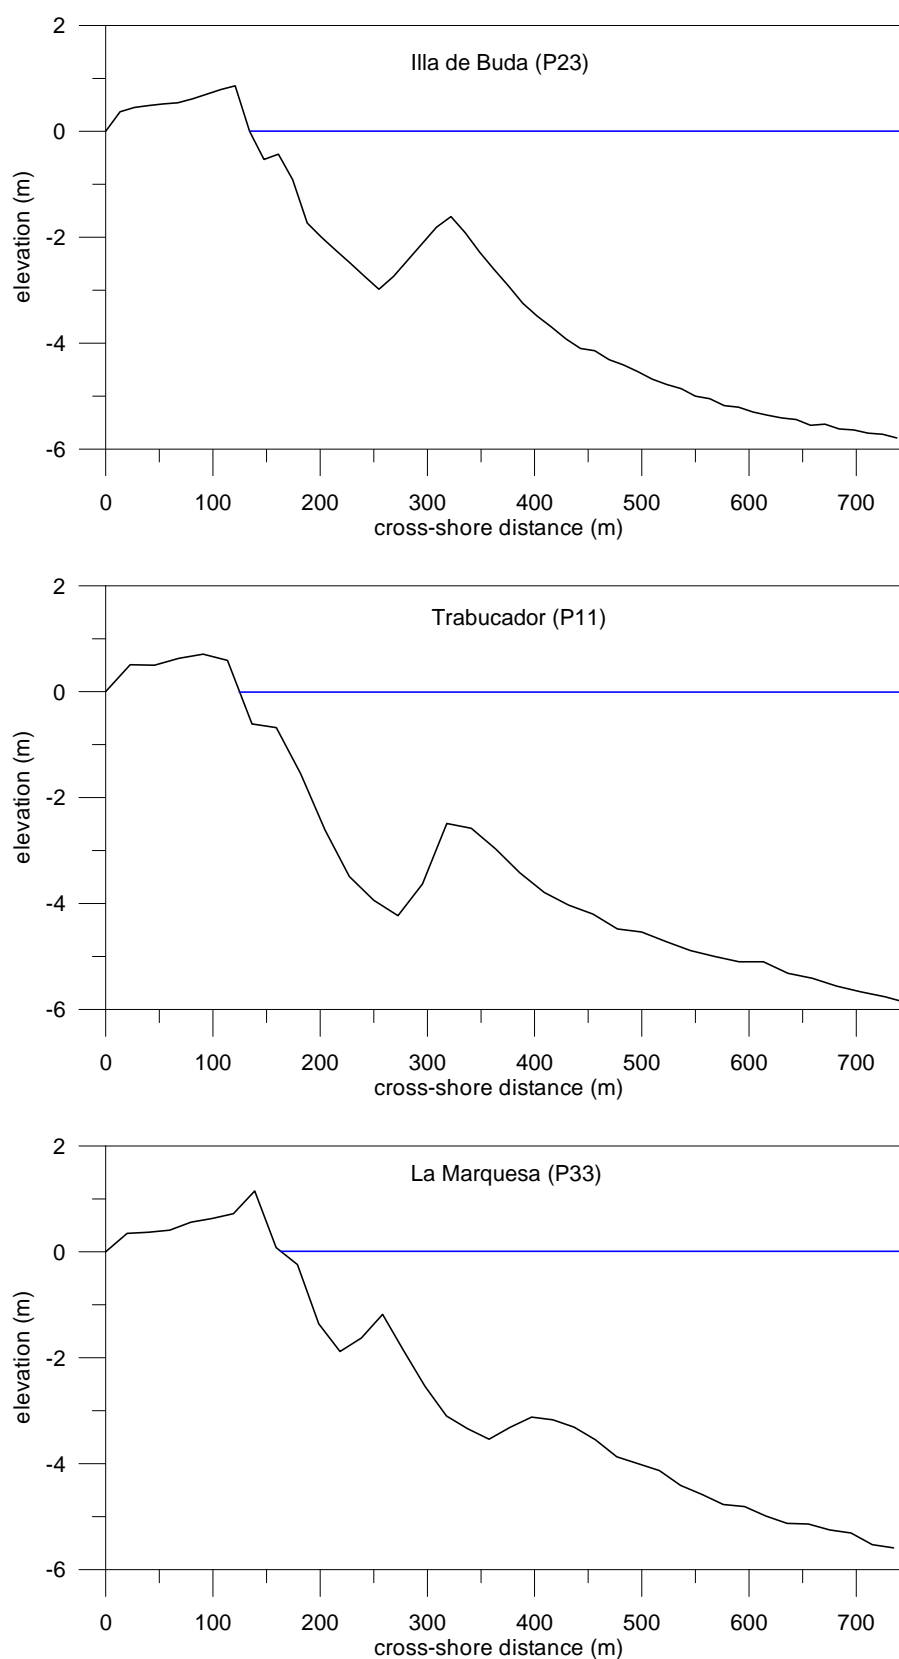
Figure 55 Representative beach profiles for each of the identified sensitive coastal stretches

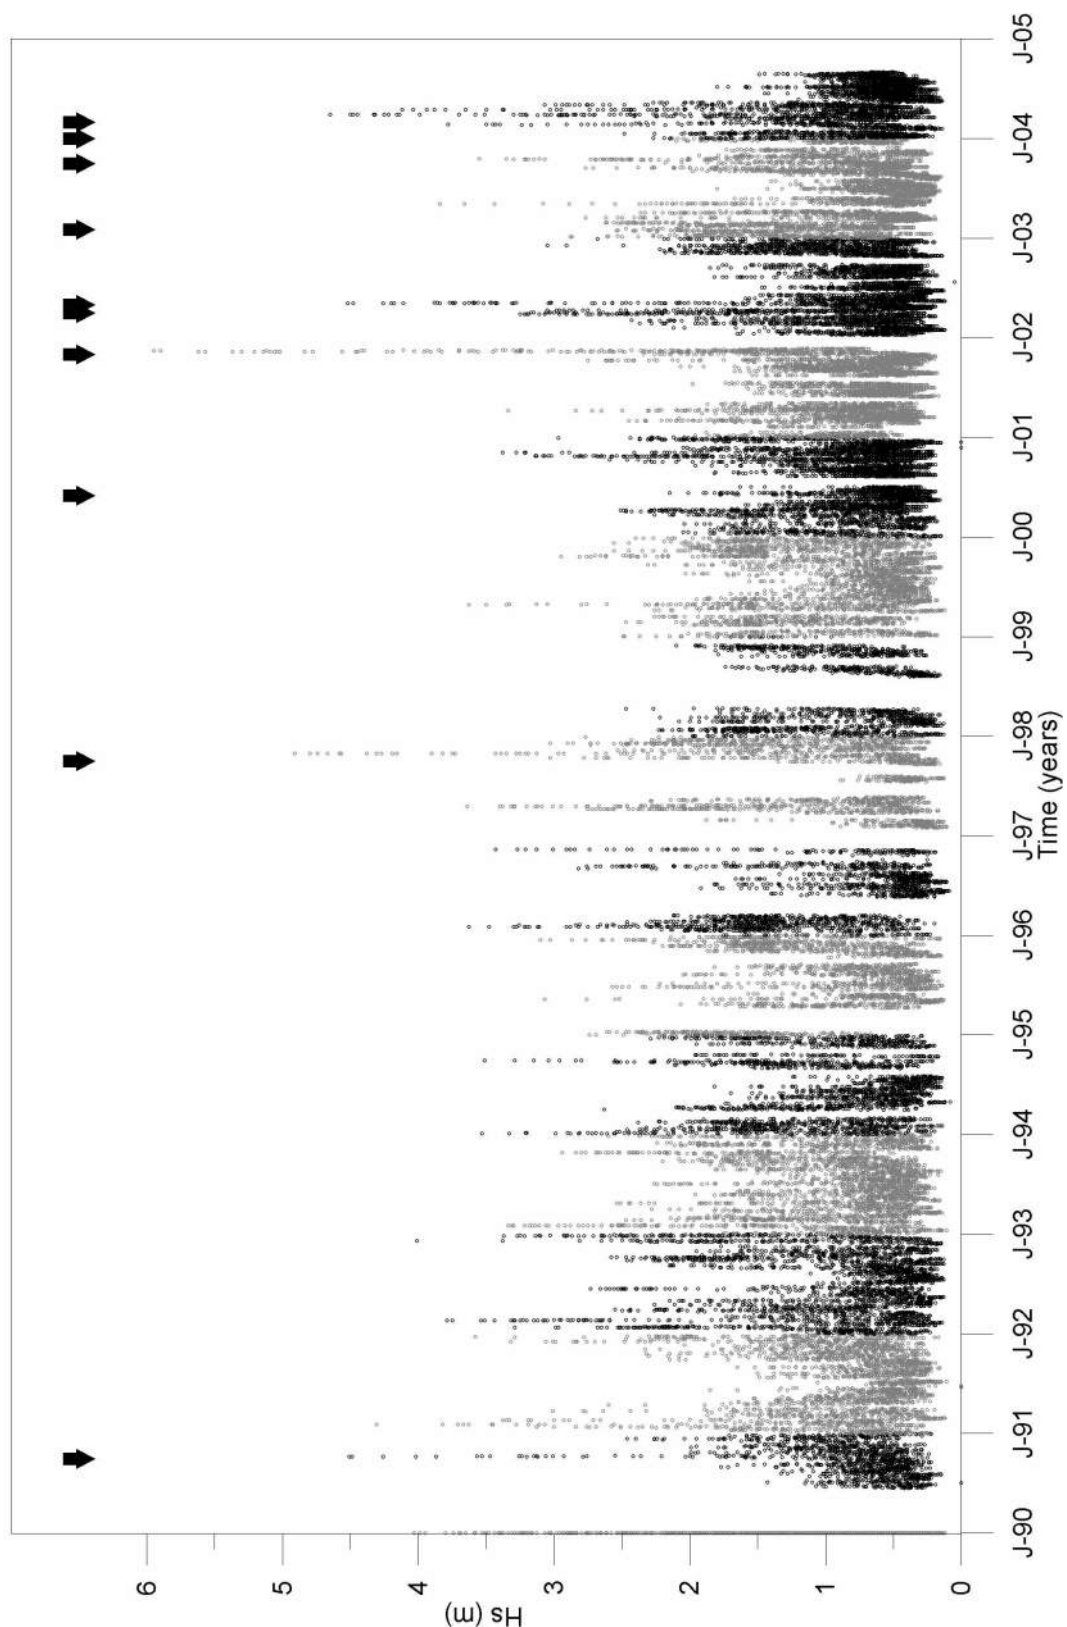
Figure 56 Significant wave height time series recorded off the Ebro delta showing storms mentioned in Table 2 (adapted from Valdemoro, 2005)

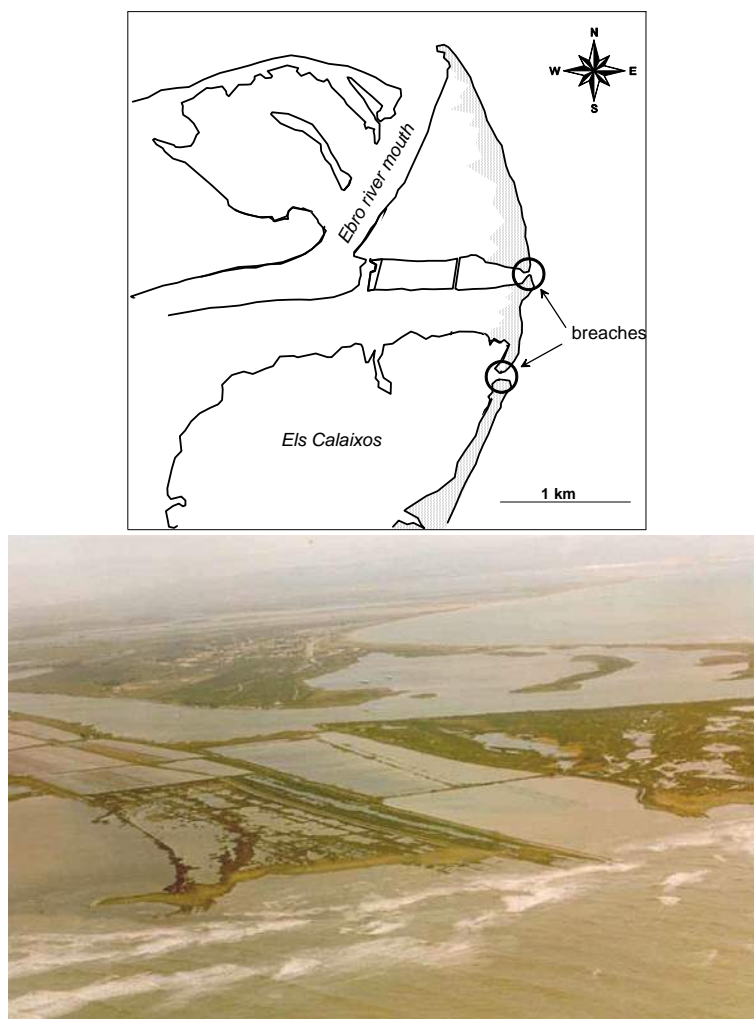
Figure 57 Examples of the impact of storms in the Illa de Buda. (Top) Breaches after the impact of the October'90 storm. (Bottom) Inundation of the beach during the October'97 storm

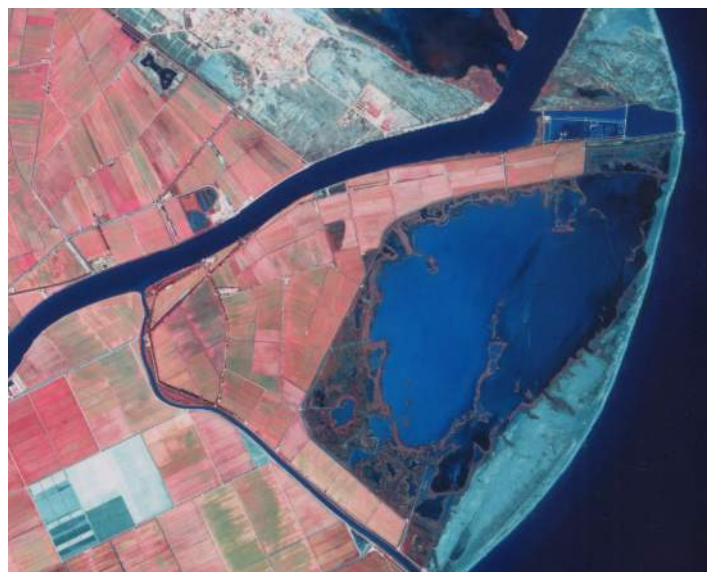
Figure 58 Aerial photograph of the Illa de Buda

In this area, consequences of storm impacts are mainly related to affectation of the natural system, since the hinterland is occupied by a lagoon of natural interest that belongs to the Natural Park (Figure 58). This lagoon, Els Calaixos, receives freshwater inputs from adjacent rice fields mainly during the period from May to October, whereas saltwater inputs mainly occur during winter when coastal storms are more frequent (see *e.g.* Valdemoro *et al.*, 2005).

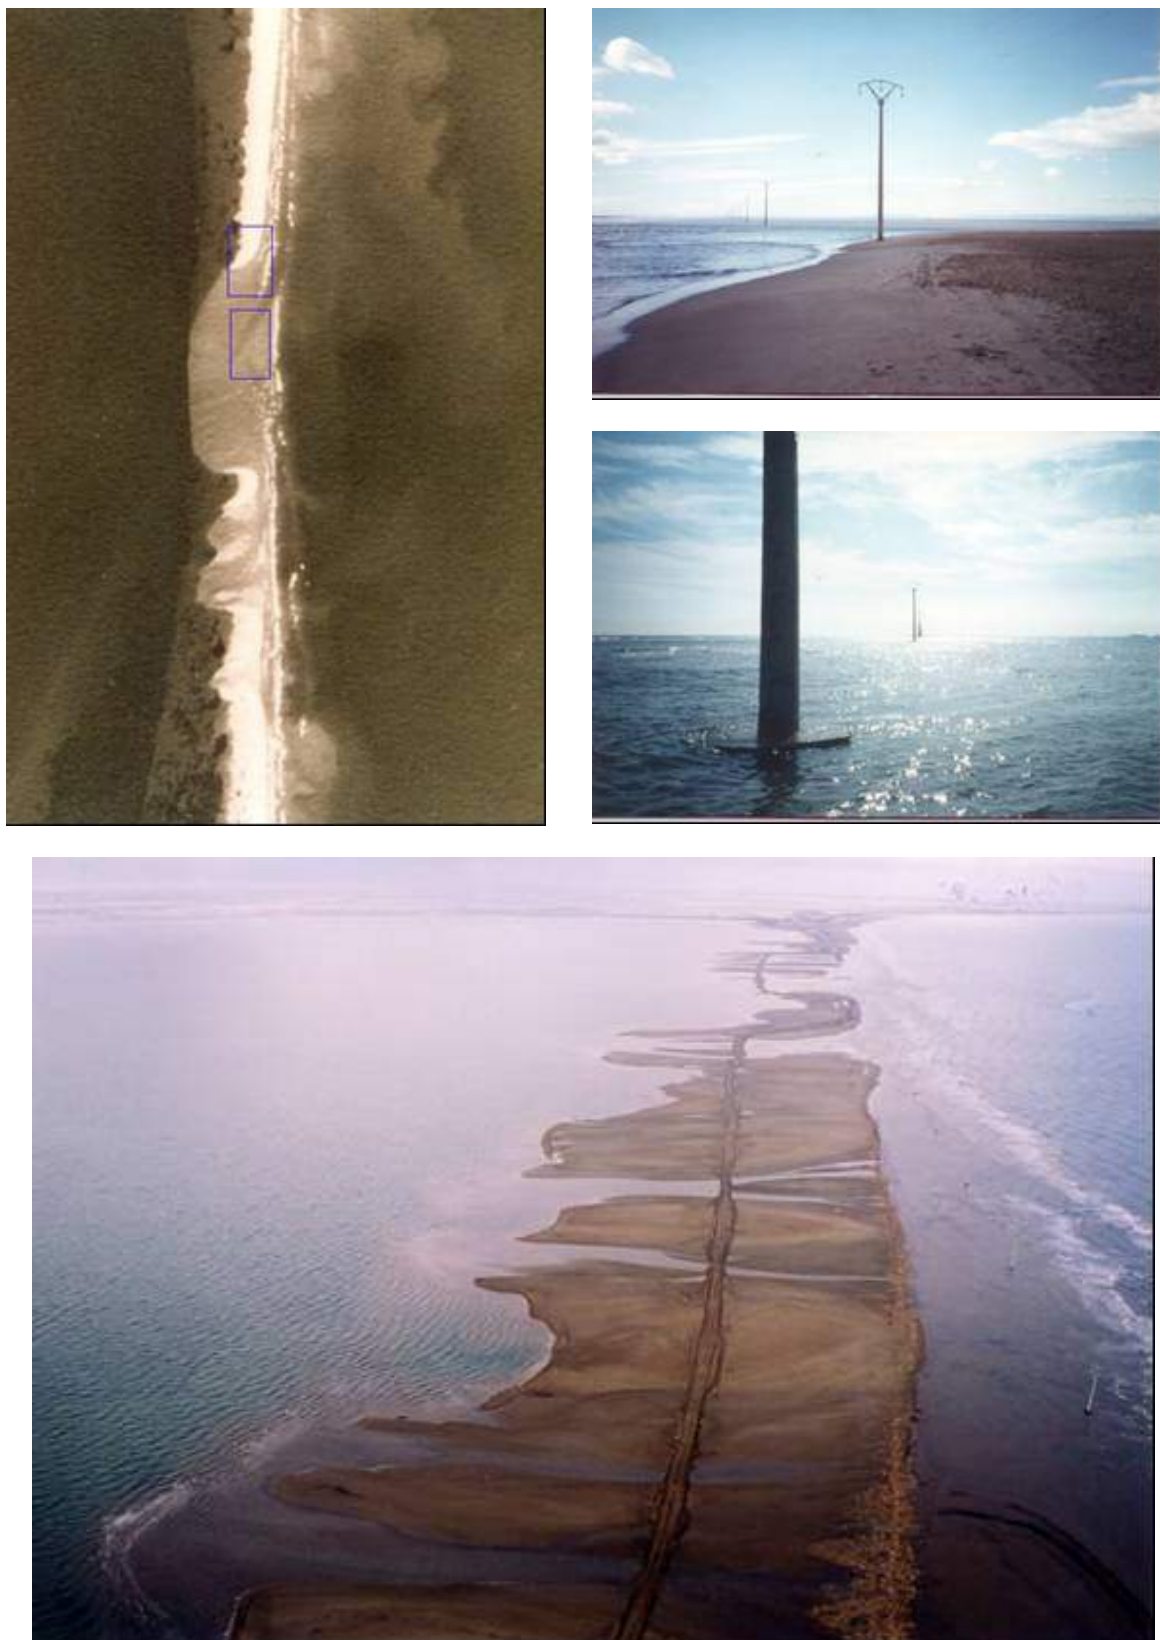
Figure 59 Examples of the impact of storms in the Trabucador beach. (Top) Breaching after the impact of the October 1990 storm. (Bottom) Breaching after the November 2001 storm.
