Description of flood defence structures for pilot sites

Report Number **T04-06-02**

Title	Description of flood defence structures for pilot sites
Lead Author	Dr.-Ing. Andreas Kortenhaus (LWI)
Contributors	HRW, CAU, IOER, UPC, UniPad, VITUKI, UFZ
Distribution	FLOODsite
Document Reference	FDS_pilotes_v2_0_p03.doc

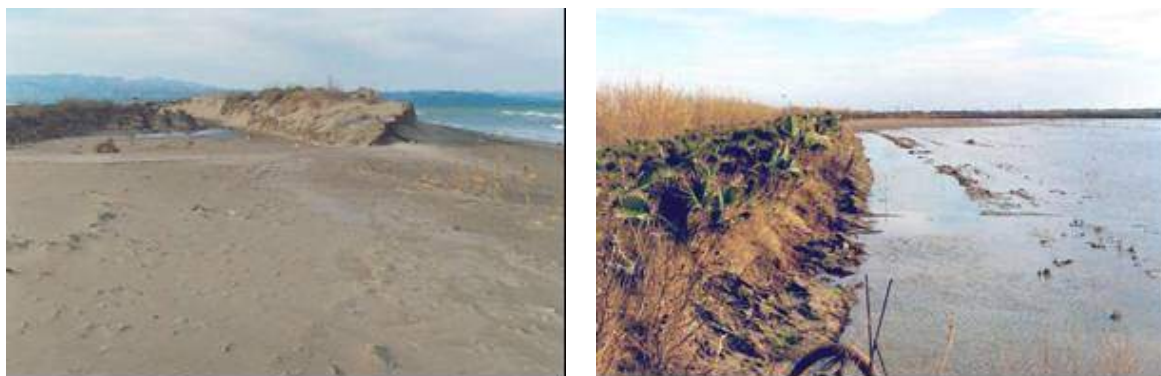
Figure 61 Breaching of the dune row in the Marquesa beach and inundation of the hinterland after the storm of October 1997

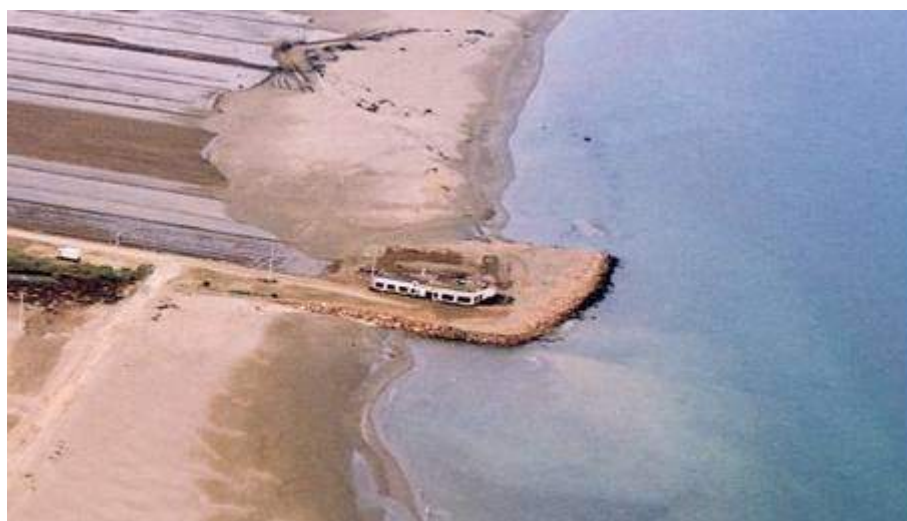
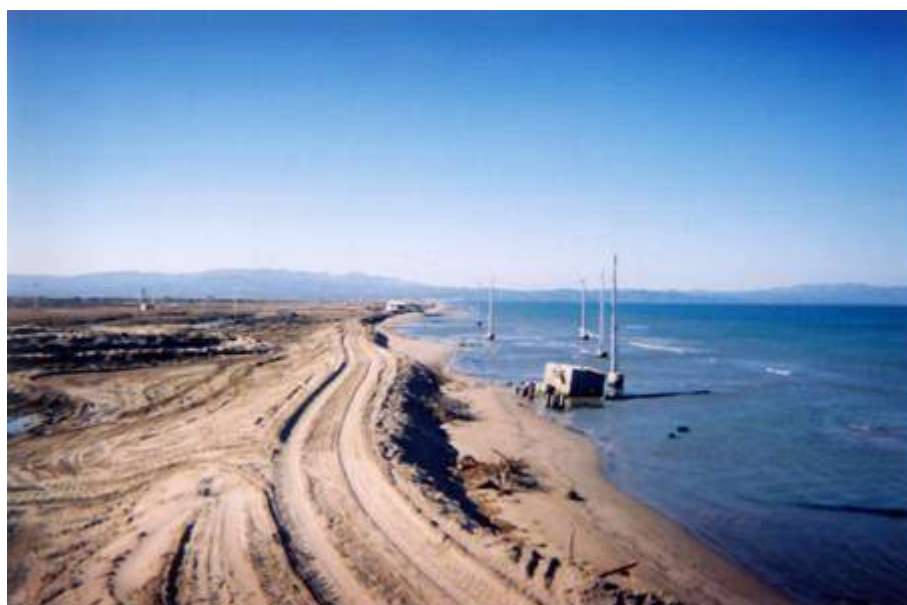
Figure 62 Large coastline retreat along the Marquesa beach after the storm of November 2001

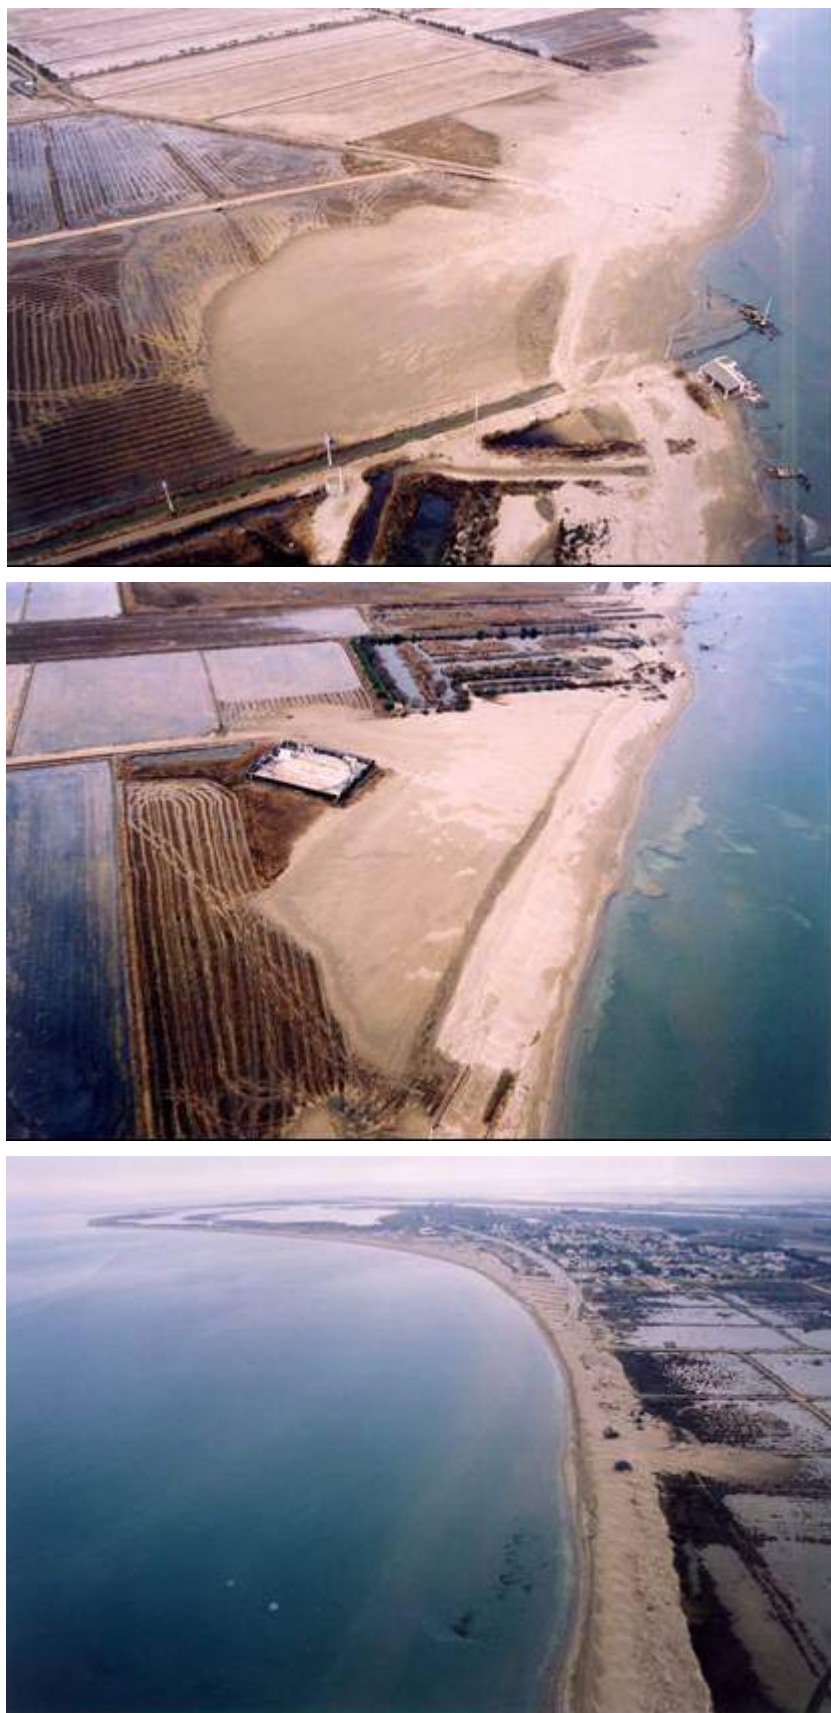
Figure 63 Massive overwash deposits along the Marquesa beach after the storm of November 2001

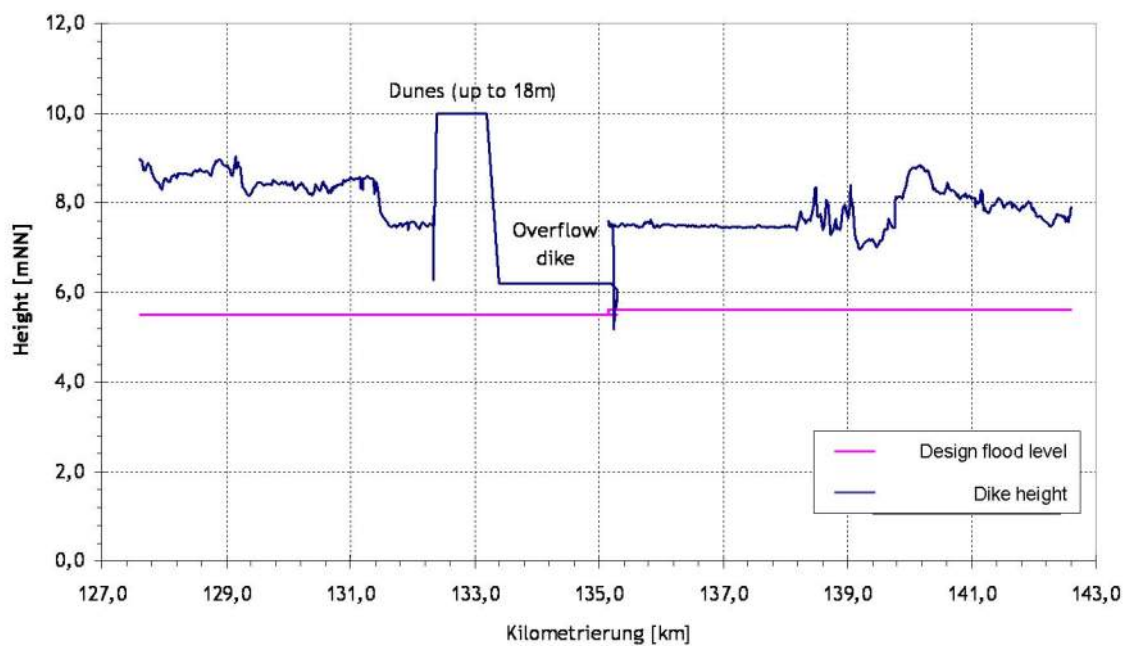
Figure 66 Height of costal defence structures at pilot site 'German Bight' (after MLR (2001))

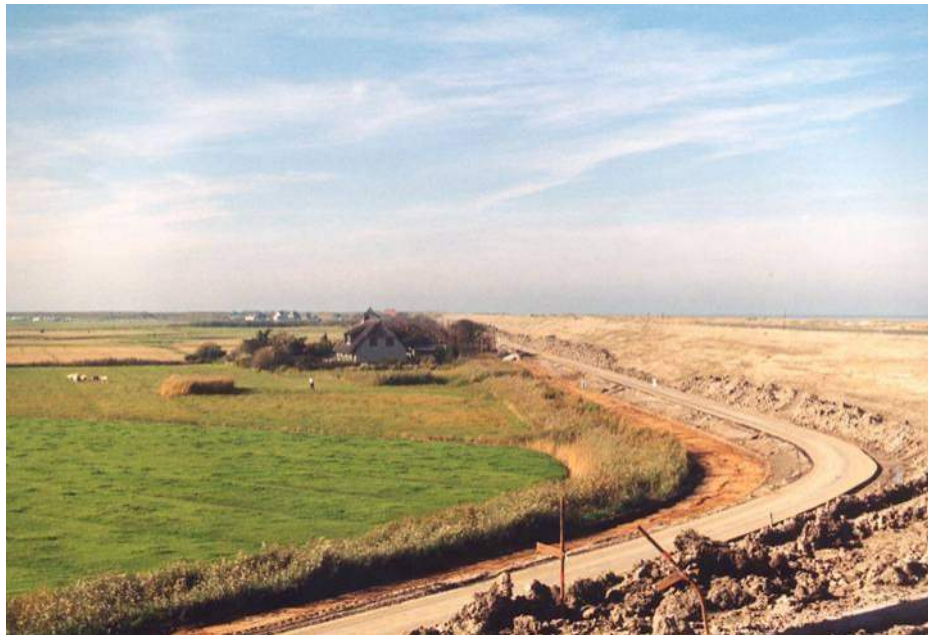
Figure 67 Main dike 'Ording Nord' at the North of the 'German Bight' pilot site

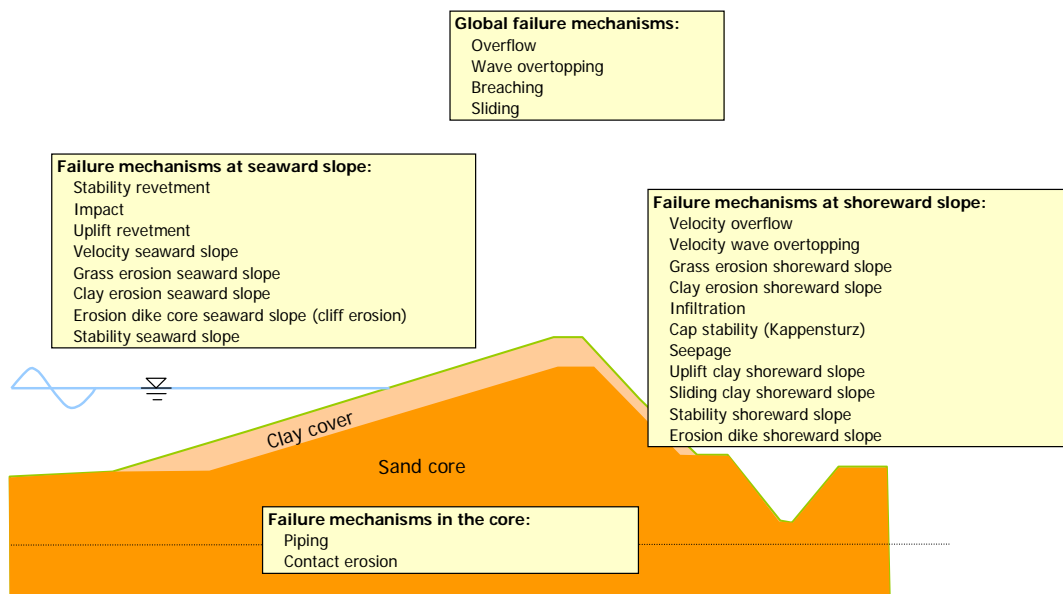
Figure 68 Key failure modes for sea dikes after Kortenhaus (2003)

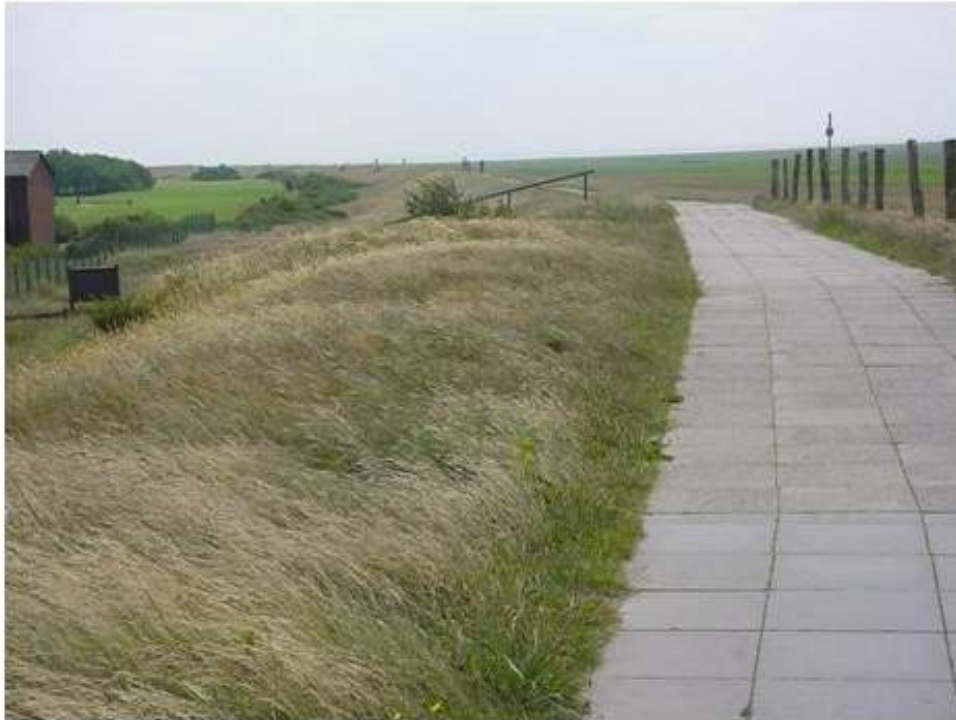
Figure 69 Section 38.3 'Boehl Süd'

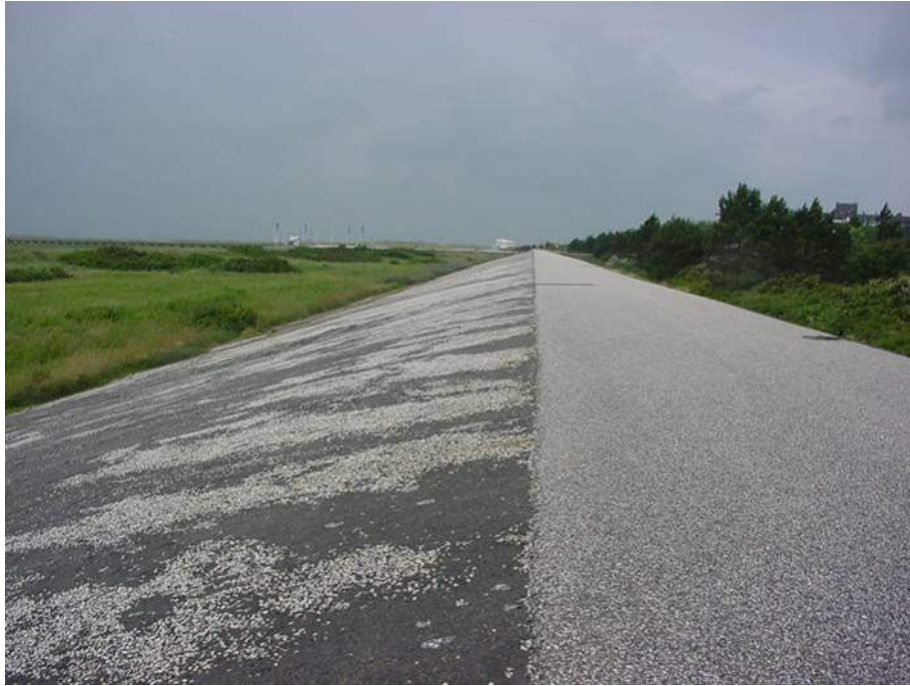
Figure 70 Overtopping dike at pilot site 'German Bight'

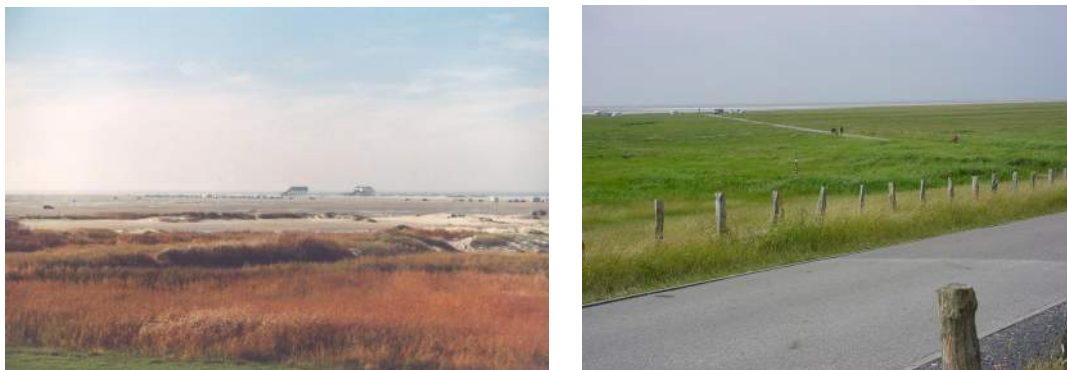
Figure 71 Different kinds of foreland in front of the coastal defence line at pilot site 'German Bight'
