# CHAPTER 131

## STATIC AND DYNAMIC LOADING TESTS ON THE HARO ARMOUR UNIT

### **1. ABSTRACT**

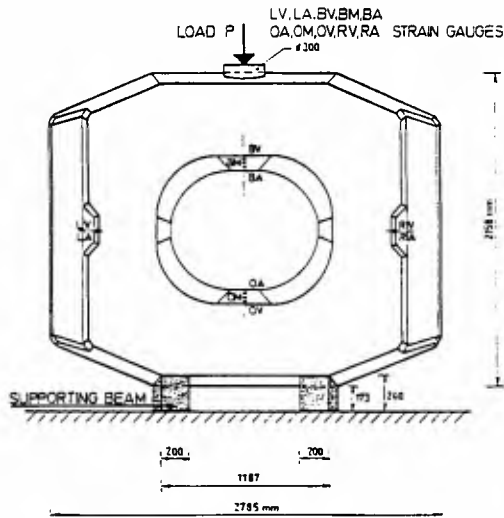
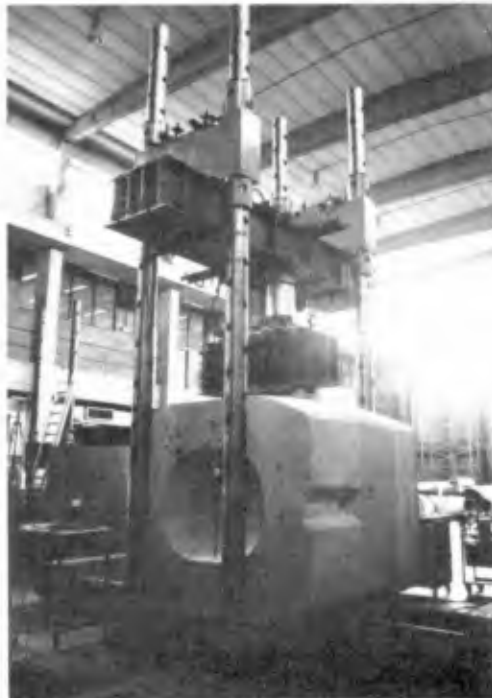
Figure 2. Test set-up for the static loading test

The test set-up for the static loading test on a 150 kN HARO is shown in fig. 2. The block was turned on its side and placed on two supporting concrete beams with variable depth. On the upper surface, a circular steel disc (300 mm  $\varnothing$ ), on which the load  $P$  was applied, was placed. This load application point is located on the axis passing through the centroid of cross-section BB (fig. 1). During the test, the total load  $P$  was

increased by increments of 200 kN. At each load level the deformation of the concrete surface was measured at 10 different points by means of strain gauges with a gauge length of 60 mm. The strain gauges were positioned parallel to the original upper and lower faces of the block. The shortening of the minor axis of the central hole was measured along three verticals.

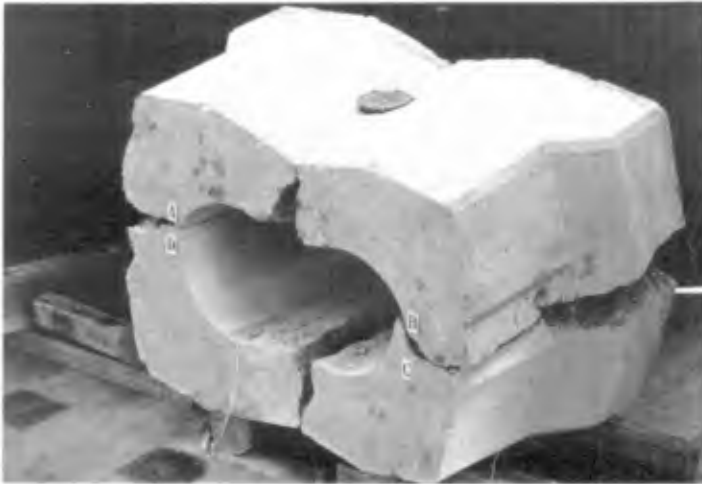
Figure 3. Block after the static loading test

Rupture of the block occurred at a load level of 2400 kN which corresponds to 16 times the weight of the block itself. Fig. 3 shows the HARO after failure.

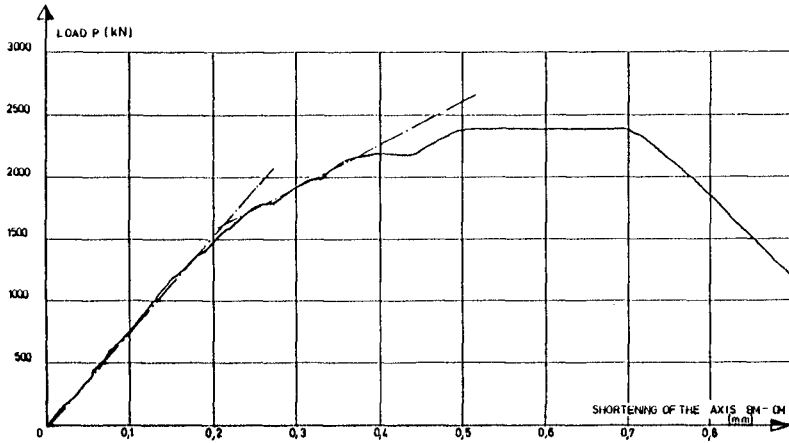
Figure 4. Shortening of the axis BM-OM as function of the load P

The shortening of the short central axis BM-OM in relation to the applied load  $P$  is shown in fig. 4. From this figure it appears that the elastic state extends to about 1600 kN. Beyond this value the shortening of the axis BM-OM increases at a higher rate. This non-linear behaviour is confirmed by the strain gauge readings. Measured strains and strains found in a supporting 3-dimensional linear elastic finite element analysis correspond reasonably well for loads up to  $P = 1600$  kN, as is shown in fig. 5 for strain gauge LA. From this load level on, the course of the measured strain signals varies rather widely depending on the location of the strain gauges. This is due to the fact that during the loading process the internal stress distribution gradually changes and that only local strains are measured. The maximum measured (tensile) strain equals  $190 \cdot 10^{-6}$  (strain gauge BV).

As the static loading test concerns, the total input energy is obtained as the surface under the load-displacement curve. Associating the decrease  $\Delta d$  of the axis BM-OM with the displacement at the point load, one can obtain from fig. 4 the energy values mentioned in table 1.

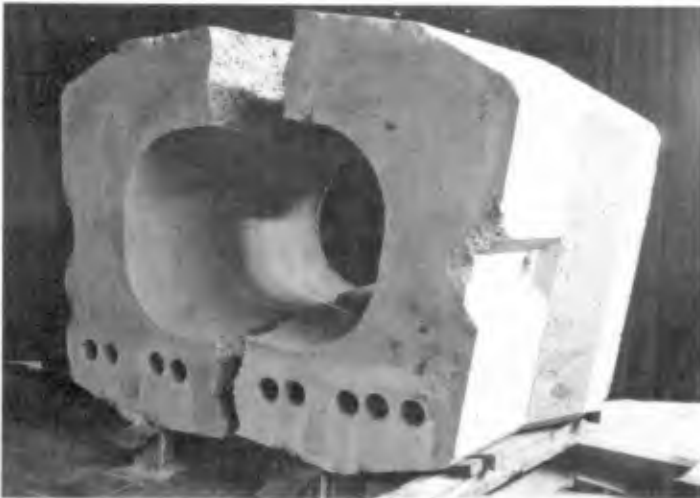
Figure 6. Block after the dynamic loading test

The height of fall, being equal to 50 mm the first time, was successively increased by 50 mm increments until complete failure of the HARO took place. The following cracking sequence could be observed by the naked eye :

- drop height of 650 mm : vertical crack at the upper inner face, extending to the front and back face.
- drop height of 700 mm : vertical crack at the lower inner face.
- drop height of 750 mm : horizontal crack at the left inner face.
- drop height of 800 mm : extension of the vertical cracks and rupture of the block into two parts (fig. 6).

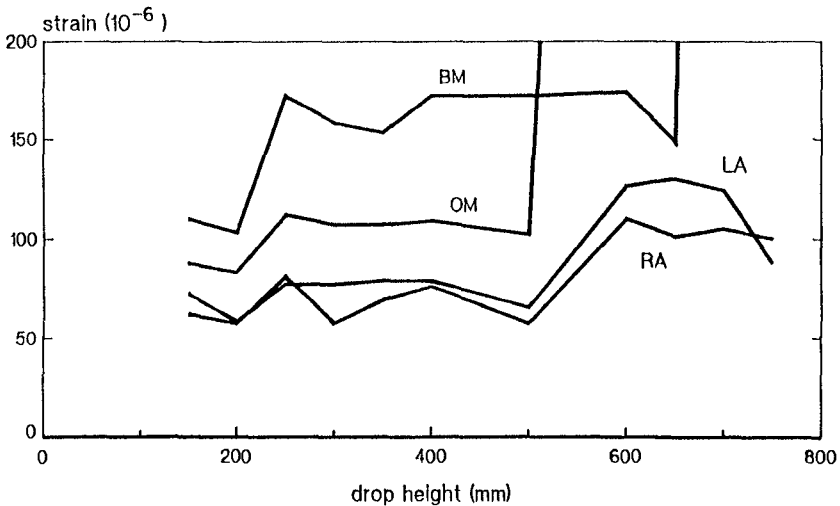
Figure 7. Measured peak strains during impact

In fig. 7, the maximum tensile strain, recorded during the impact at the locations RA, BM, LA and OM is plotted. It follows that after the impact from 550 mm height, cracking already occurred at the lower inner face (OM). The maximum strain at the upper inner face appears to remain almost constant at a value of 180 microstrain from the impact from 250 mm height on. Noteworthy is that the maximum concrete strain, again corresponds to the usual range i.e. 150-200  $10^{-6}$ , as encountered in the static loading test.
