SHIP WAVES AT VLISSINGEN BEACH

Vlissingen boulevard and beach

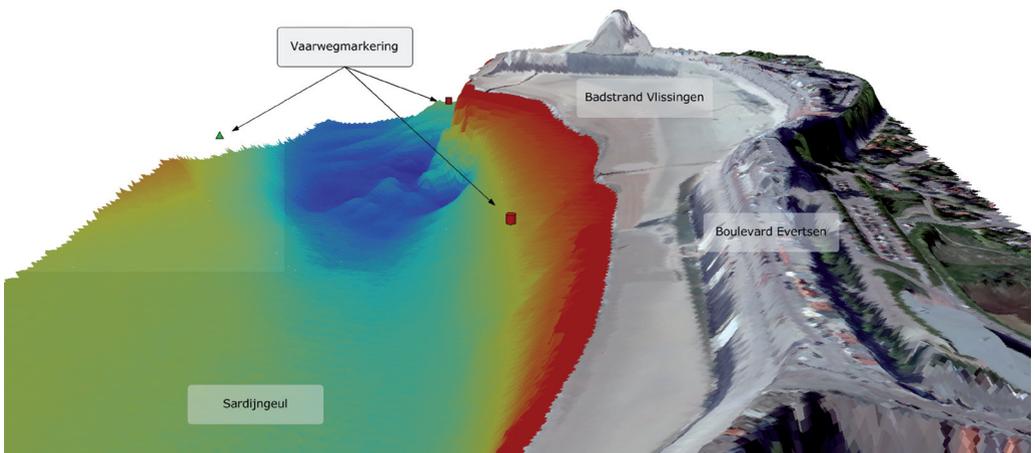
Aerial photo of recreational beach and depth recording of the passage in question

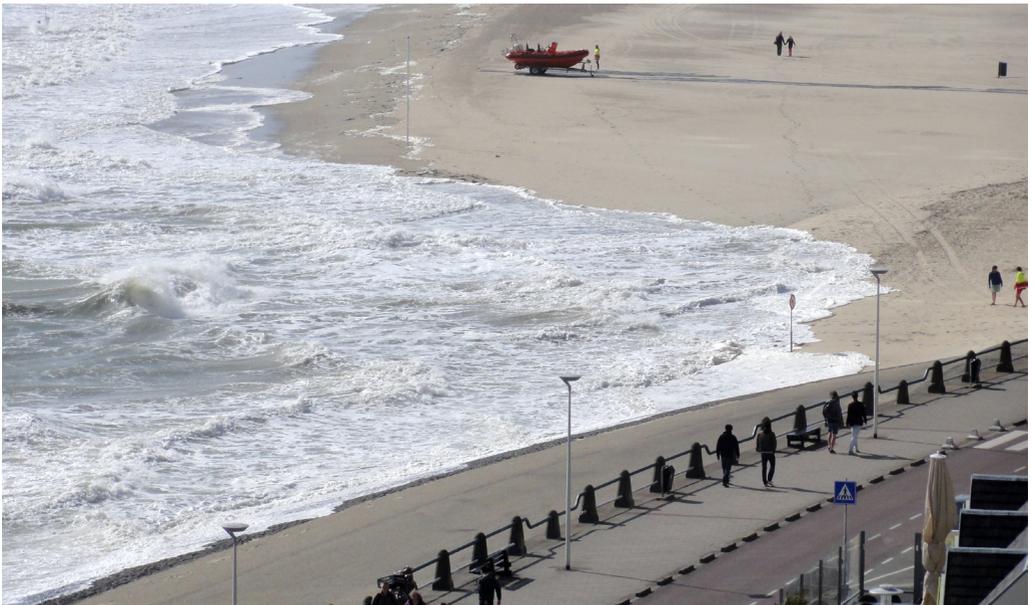
Flooding of the beach by a stern wave on May 22 2011

On the beach, we first see how the water retreats due to the distorted decline in water level beside the ship. Due to the increased resistance in shallow water, this water-level decline reaches the beach far behind a vessel. The water-level decline changes into a stern wave and a wake current. Due to the distortion, the stern wave is higher on the beach than in the fairway. The first major stern wave might be followed by several other stern waves.

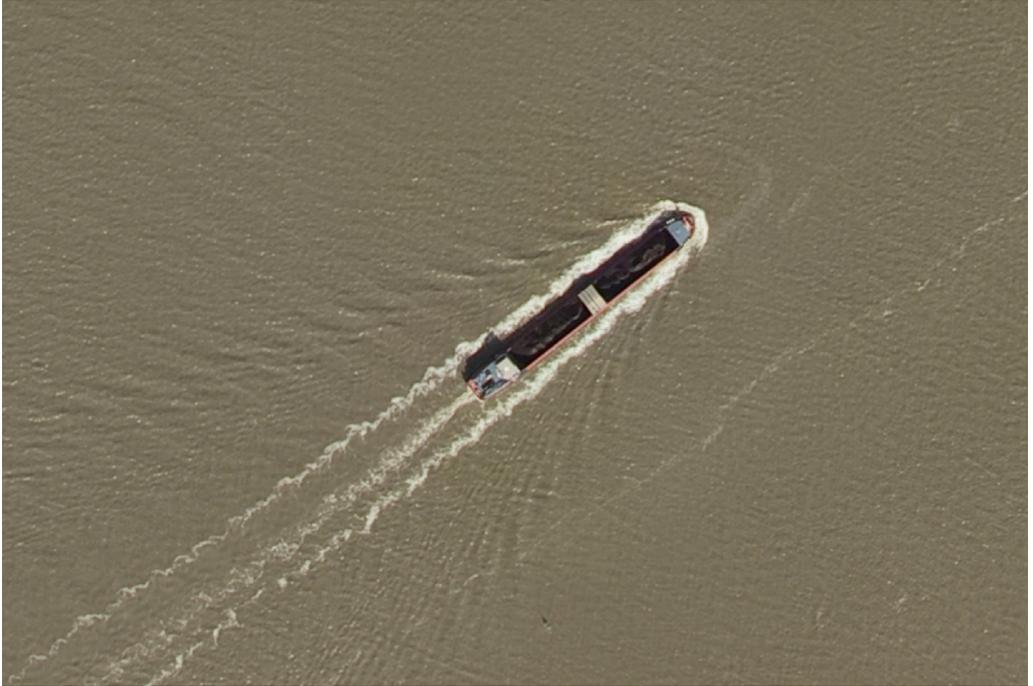
The circumfluence of a vessel and the secondary waves this produces (aerial photo courtesy of the Province of Zeeland, 2011)

When a vessel is in motion, the water, which is superseded at the bow, flows to the gate of the ship. This flow causes a backwash in front of the ship, and a return flow beside the ship, coupled with a decline in the water level. At the gate, the return flow ends with the stern wave. Circumfluence increases when the vessel starts sailing faster – this circumfluence is referred to as the ‘primary shipping wave’.

A ship in motion also triggers a secondary wave system, consisting of diverging and transversal waves. Interference peaks are created in those areas where diverging and transversal waves strengthen each other.

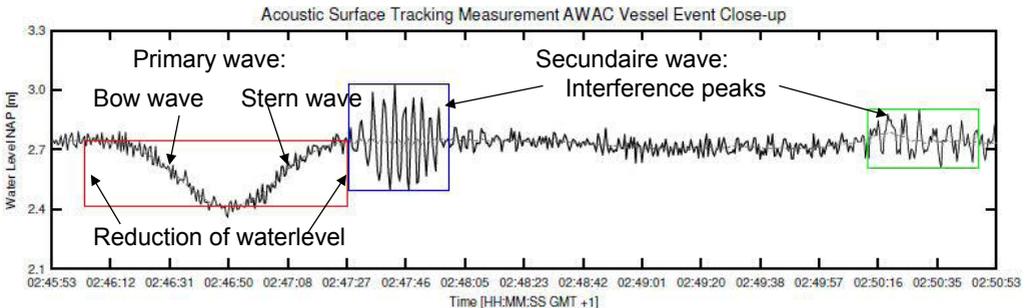
Full wave signal of vessel, including the water-level decline and secondary waves

Depending on the ship and the ship's position in the fairway, the interference peaks may coincide with the stern wave, thereby further increasing the force of this stern wave. In the Sardijnegeul passage, these effects are extra strong because the passage for vessels is narrow and shallow in that area.

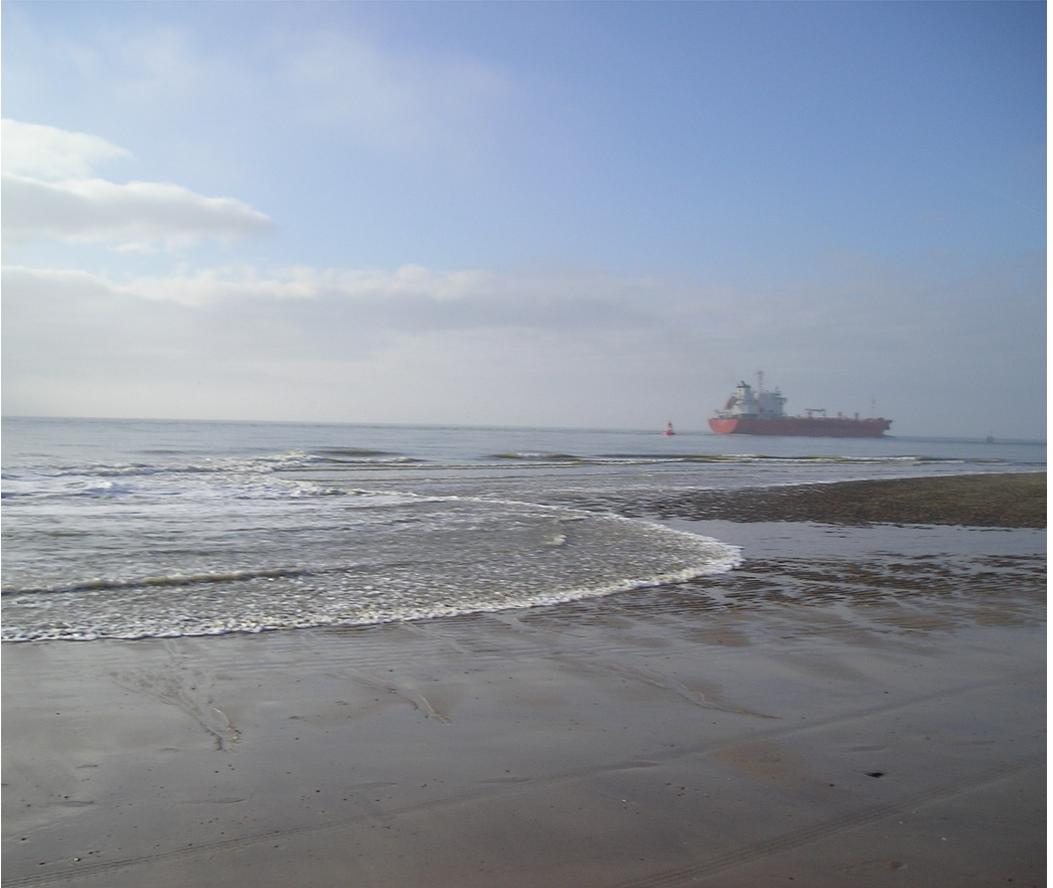
The front of the stern wave becomes distorted and fills the dried-out, shallow passage (photo by Maarten van der Wal, Deltares)

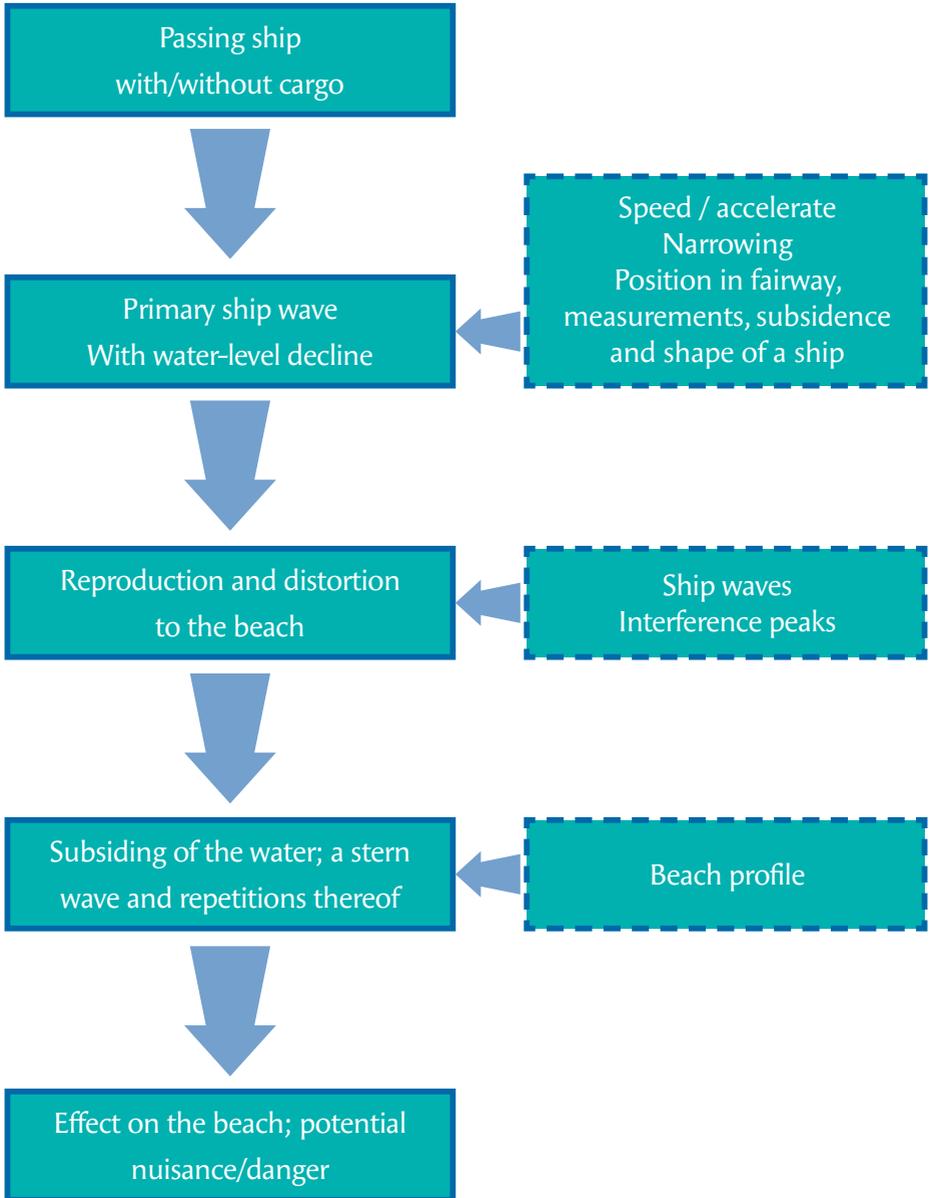
The combination of the water flowing away followed by a stern wave is the cause of the nuisance on the beach. This is because the stern wave reproduces itself along the beach with the speed of the ship. This can easily catch swimmers unawares, as shown in the flowchart below.

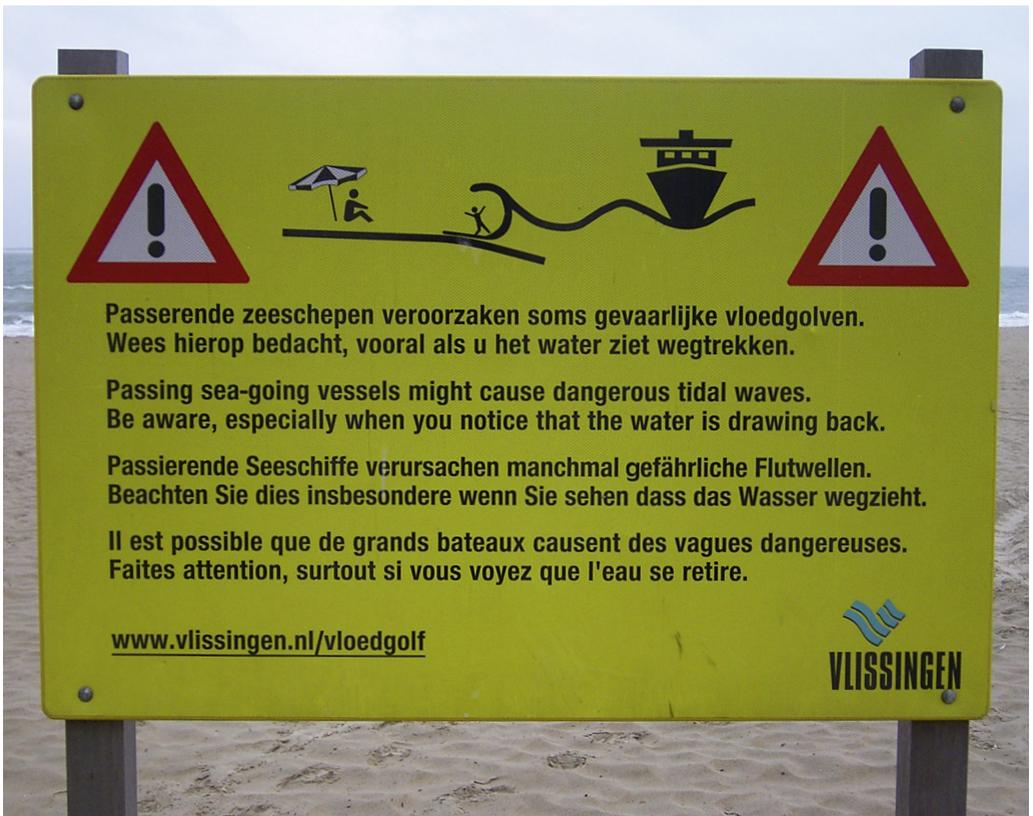
Alert sign on the beach

During beach season, the lifeguard of the municipality of Vlissingen will keep an eye on the recreational beach between 10 a.m. and 6 p.m. A great deal of practical experience has been gained over the years, so that it can be reasonably estimated when potentially dangerous situations might arise. In addition, there is a direct link to the Vessel Traffic Services (VTS) Scheldegebied . As soon as a vessel that might produce a ship wave is on the way, the Centre issues an alert in time to the beach centre at the recreational beach. This provides the lifeguards with sufficient opportunity to warn the beach users. In the event of danger, swimmers are alerted with whistle sounds. Warning signs are posted near the stairs and entrances to the recreational beach.
