The Var River in Southern France

The 1994 flood & inundation

The collapse of sills 2 & 3

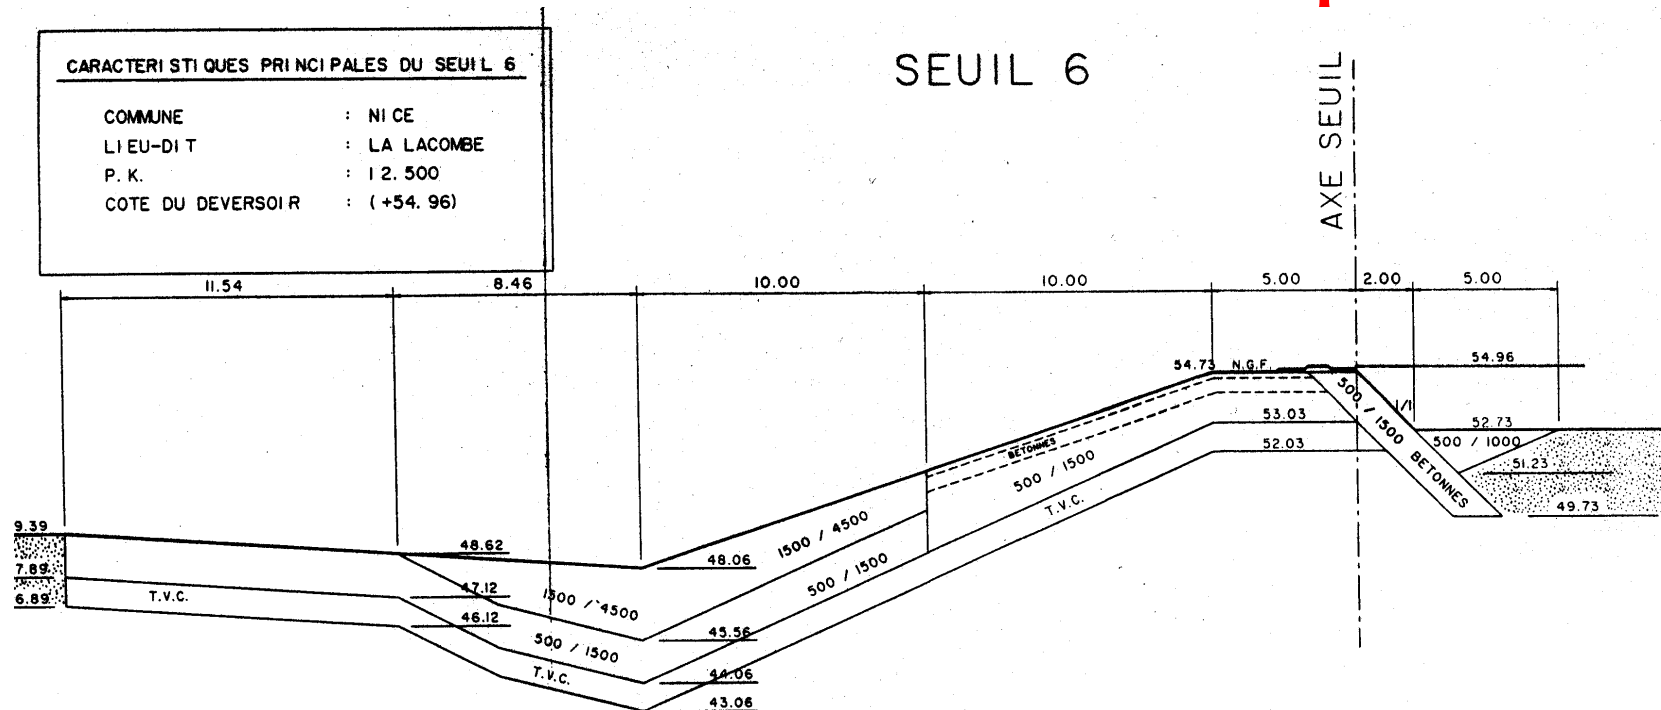
- Sills (fixed weirs) constructed for bringing the water table back to its original level
- Hidden agenda: to have hydraulic structures to demonstrate the new low-head power stations

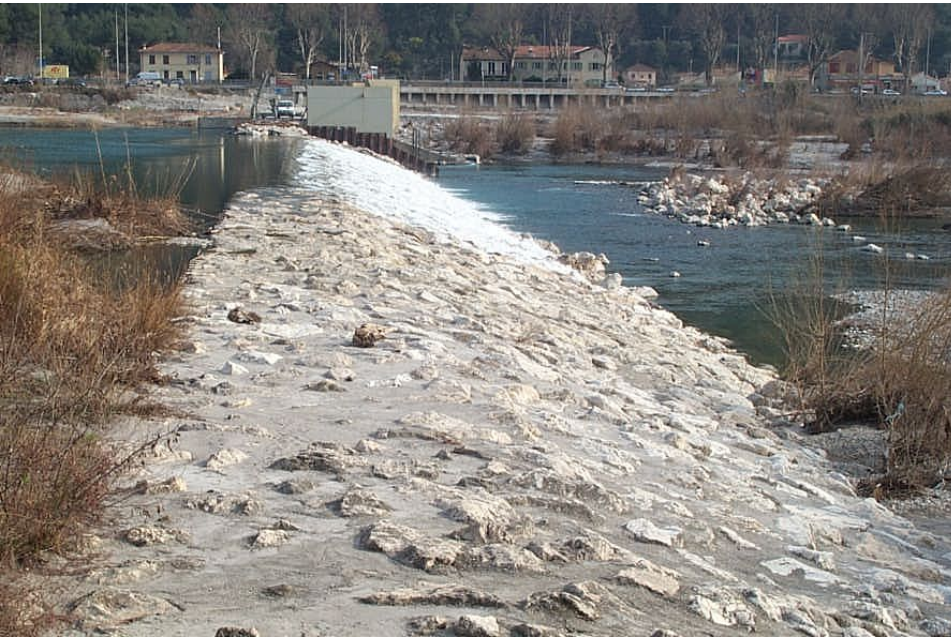
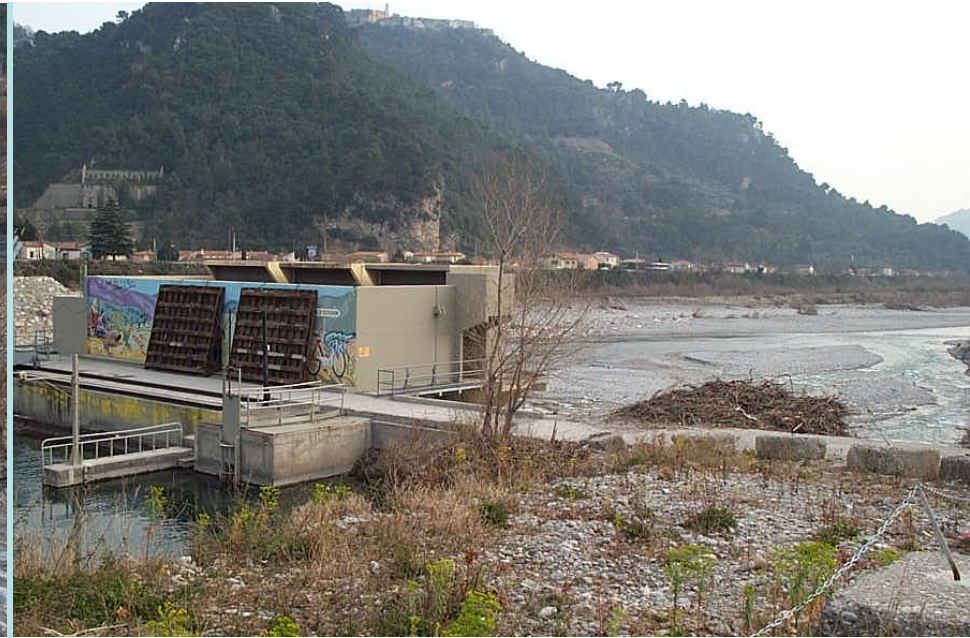
Sills / weirs, for what?

- To control the water levels.
- To generate hydropower.
- Negative impact was not anticipated.

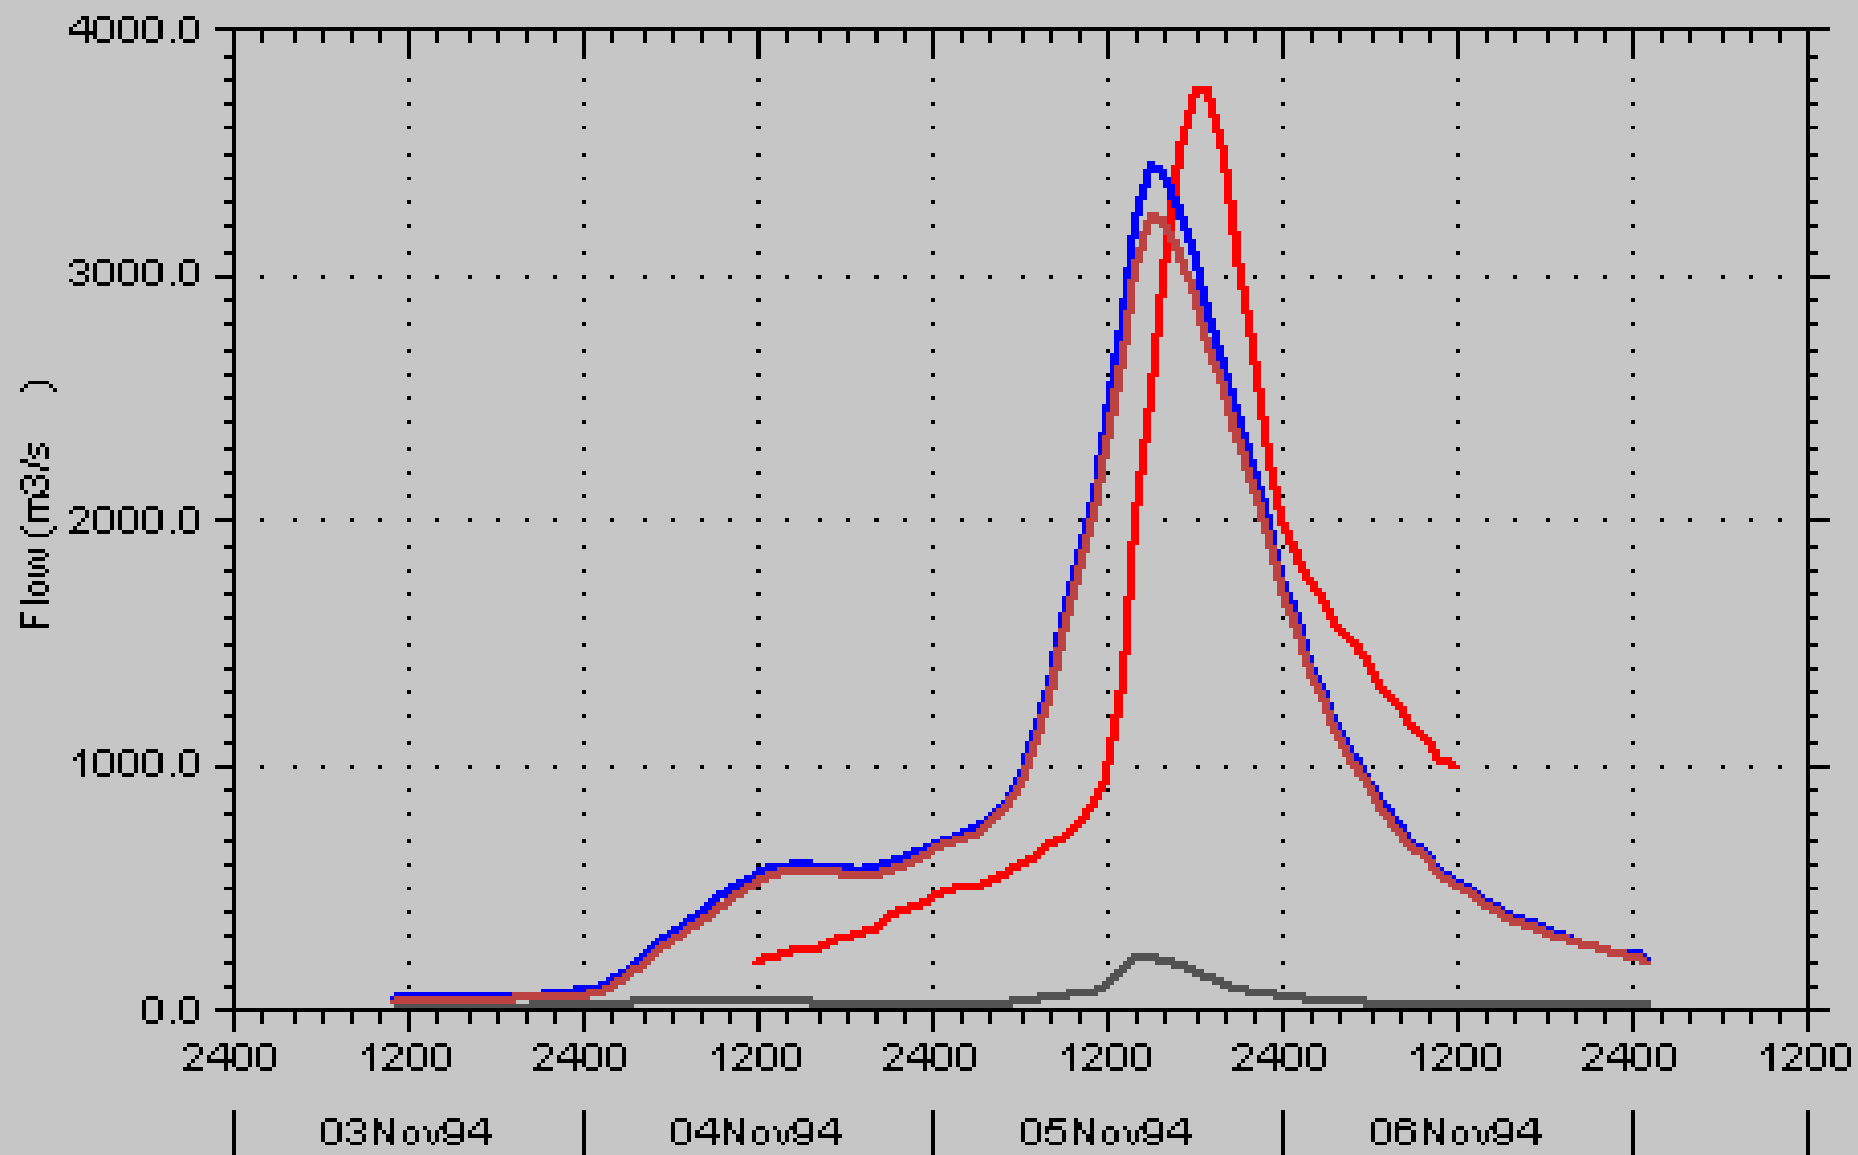
**Estimations,
Napoleon III bridge
(Nice airport)
(source: DIREN-
Cemagref)**

- The storage of coarse river sediment upstream the dams made the riverbed drop at the foot of last dam, the head passing from 6 to 12 m in 12 years
- On 5 November 1994, an extreme flood event produced the collapsing of the lowest and the second-lowest dam, the flood wave inundating Nice's international airport.

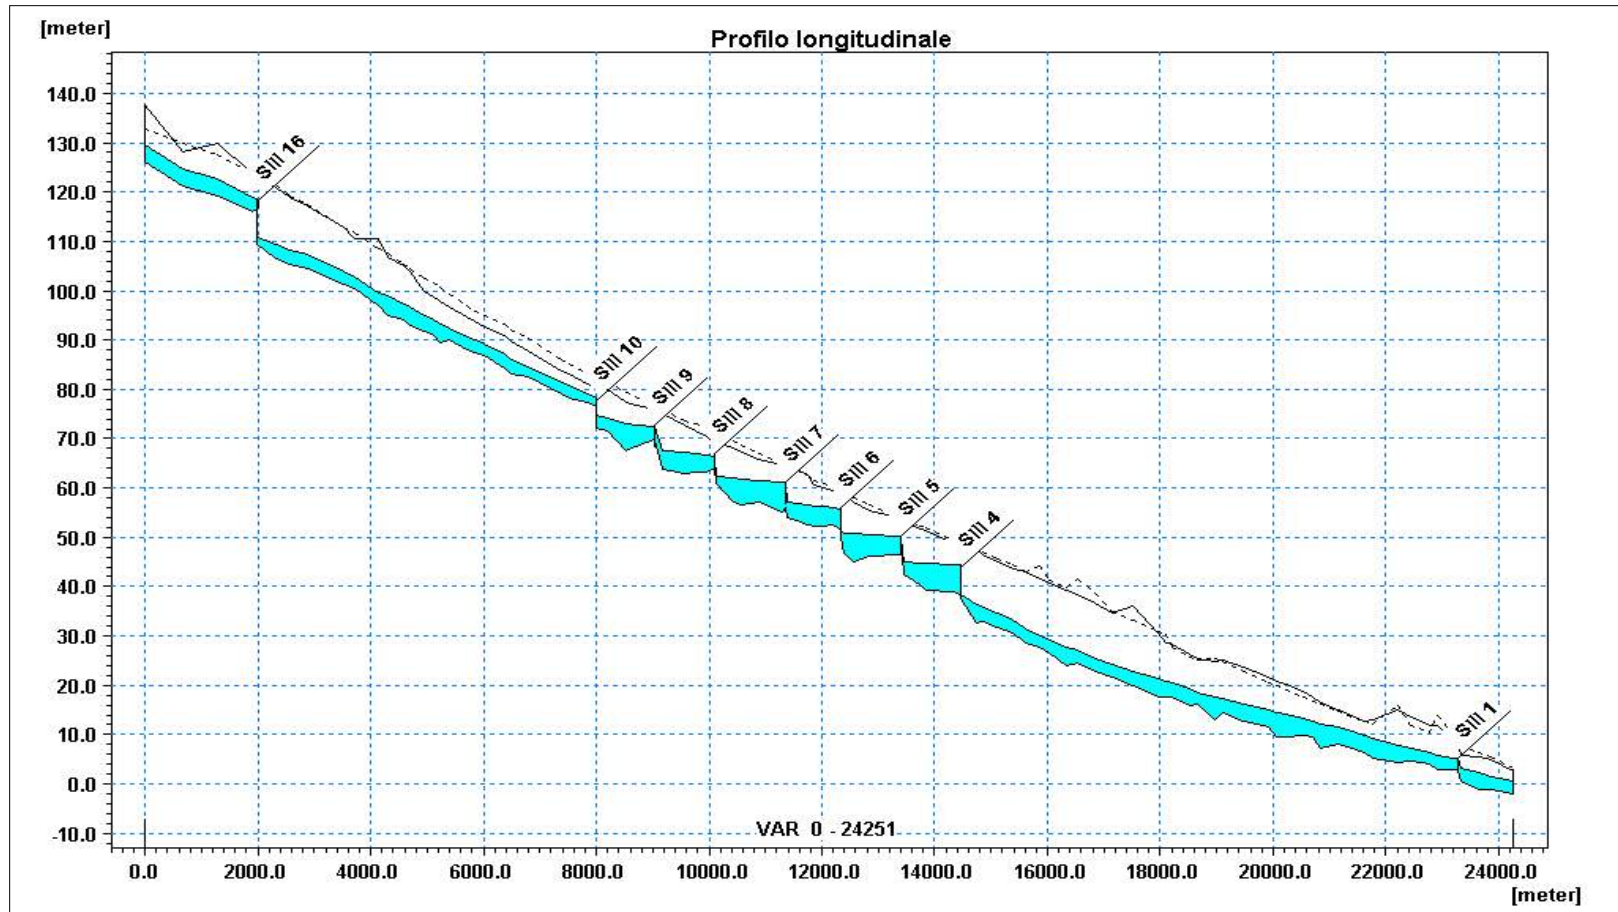
- Sills constructed to “correct” the artificial lowering of the riverbed and groundwater table
