Overflow Tests on Grass-Covered Embankments at the Living Lab Hedwige-Prosperpolder: An Overview

Citation: Koelewijn, A.R.; Rikkert, S.J.H.; Peeters, P.; Depreiter, D.; van Damme, M.; Zomer, W. Overflow Tests on Grass-Covered Embankments at the Living Lab Hedwige-Prosperpolder: An Overview. *Water* **2022**, *14*, 2859. <https://doi.org/10.3390/w14182859>

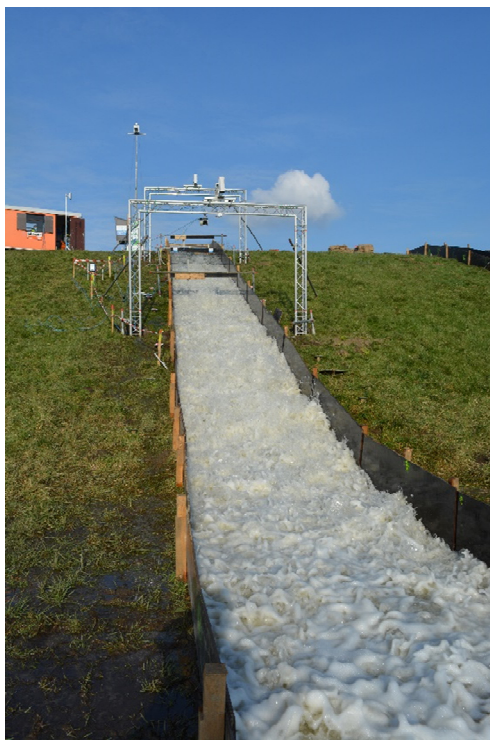
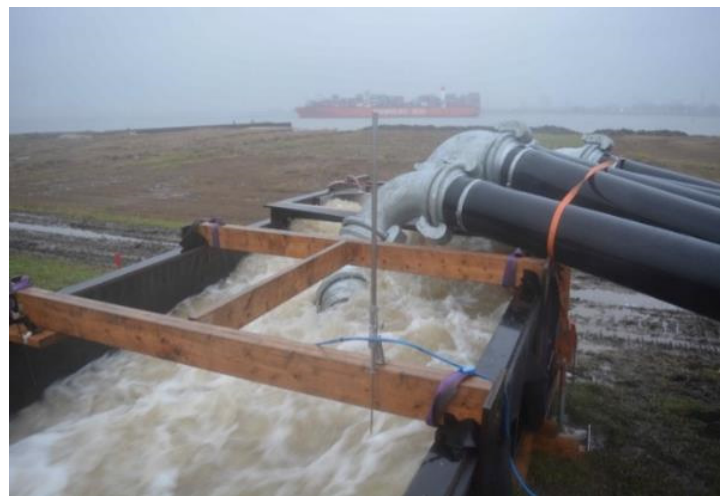
Figure 3. (a) Overflow in progress; (b) Overflow generator at maximum discharge of 1100 L/s.

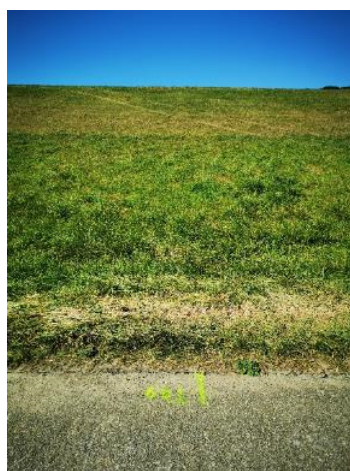
The reference tests carried out on an undamaged Dutch dike (see for an impression Figure 6) all had more or less the same proceeding: the test duration could be held for tens of hours (up to 30 h) without any critical damage occurring, despite measured flow velocities ranging from 2 to 4.5 m/s. This result is significantly better than the results collected in [4]. During the proceeding of such tests, it was observed that the density of the grass layer decreased while the grass roots were becoming slightly exhumed (centimetre scale). Due to the ‘jumping’ effect of the water over grass sods, decimetric step structures in the soil profile were observed, but this did not lead to any significant downward or headcut erosion. With increasing discharge, this effect appeared to develop faster and become more prominent.

Figure 6. Dutch reference test section (September 2020).
