Integrated assessment of the buried wreck site of the Dutch East Indiaman 't Vliegende Hart

Tine Missiaen¹, Ine Demerre² & Valentine Verrijken³

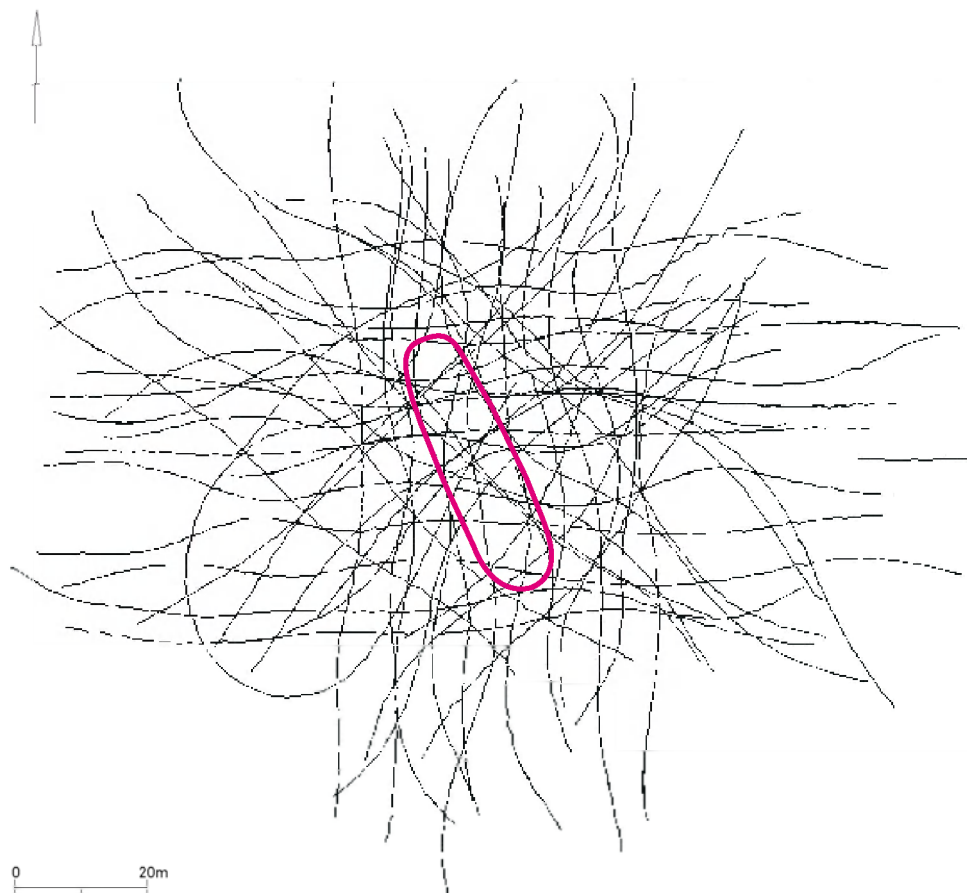
FIG. 10 Seismic network recorded over the wreck site of 't Vliegende Hart in 2010. The red ellipse marks the (supposed) location of the wreck. In total 49 profiles were recorded crossing the wreck at different angles. *Seismisch netwerk opgenomen over het wrak van 't Vliegende Hart in 2010. De rode ellips markeert de (vermeende) locatie van het wrak. In totaal werden 49 profielen opgenomen die het wrak kruisen onder verschillende hoeken.*

over the wreck site (fig. 10). Vessel speed was kept at roughly 3,5 knots, which resulted in high and regular seafloor coverage. The seismic data that are discussed in the following paragraphs were all obtained during this second survey.
