# IMPACT Project Field Tests Data Analysis

**Report Number**                      **T04-08-04**

## 2. Test 1-02 – Homogeneous Cohesive (Clay) Test - Overflow

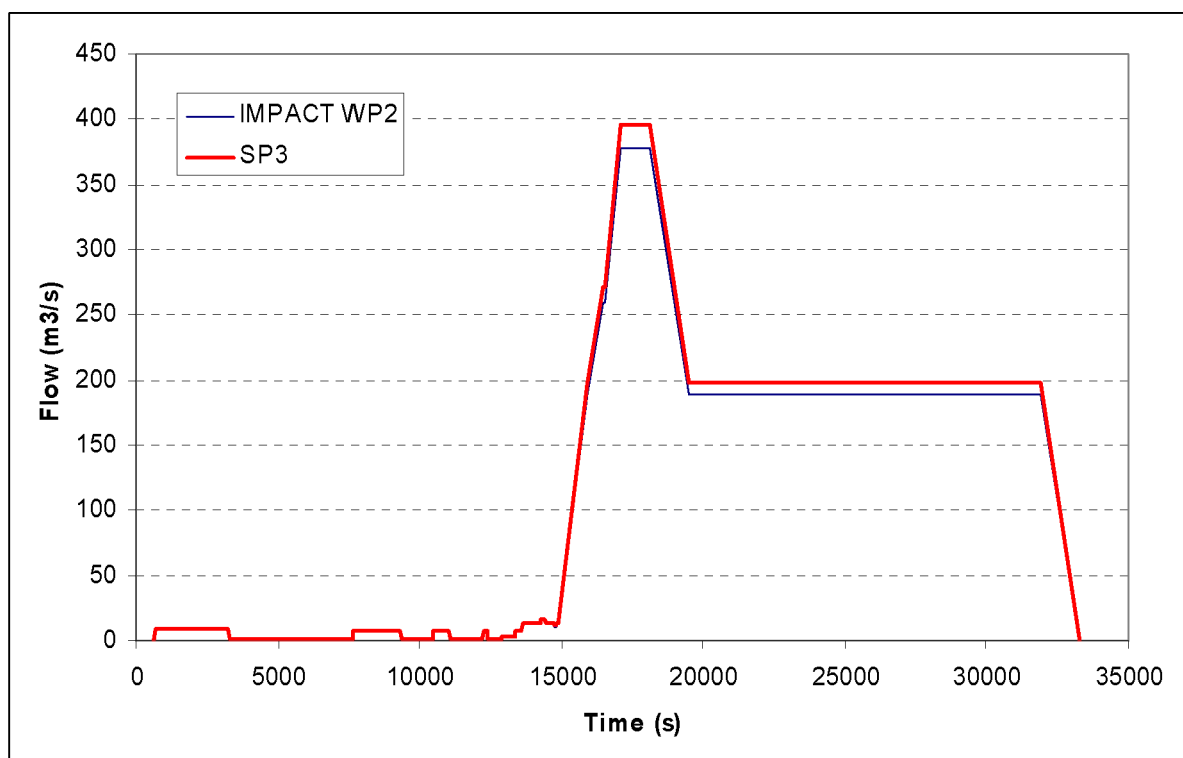
Figure 2: Inflow to the reservoir

Figure 2 shows the reservoir inflow data presented in the SP3 and the IMPACT WP2 reports. Data comparisons show a difference of an approximately 5% increase in the peak inflow value and also along the constant inflow that follows the peak. It is unclear why the inflow hydrograph has changed whilst the water levels which were used to obtain the hydrograph have not changed (See below) – no guidance has been given in response to questions on this point. Therefore, in the absence of a response from Norway, it is recommended to use the water levels data, rather than flow data, for this test case as an upstream boundary condition. Where a flow boundary condition is required modellers should undertake two runs using the two different inflow hydrographs and compare the model outflow output with the corresponding outflow hydrographs.

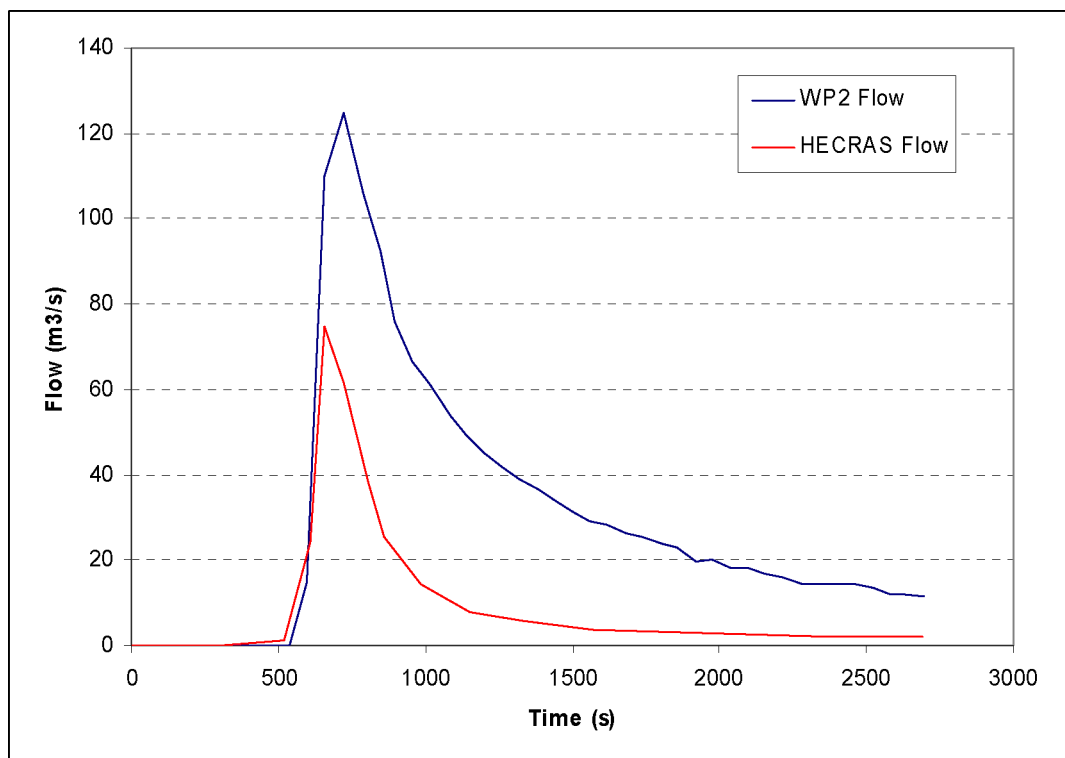
Figure 7: Test 2C-02 outflow hydrograph.

Data comparisons show a significant difference between the data reported in the SP3 and IMPACT WP2 reports (See Figure 7). SP3 shows data calculated using HECRAS. This suggests a recalculation of breach flow in some form. It is stated in the SP3 report that errors were found in the volume balance calculation for this test case which is probably due to ice build up at the location of the flow measurement downstream of the dam. However, email records show that corrections to data were made during the IMPACT project and that modified data was correct at that time. .

Recent volume calculations undertaken by HR Wallingford show that neither of the hydrographs shown in Figure 7 satisfy the volume balance equation. Based upon the hydrographs shown in Figure 7, the volume of water under the SP3 and WP2 hydrographs is 23,478 and 81,227 m<sup>3</sup> respectively starting from time T=0 to T=2690 seconds. The inflow volume for this period of time is approximately 1,100 m<sup>3</sup>. The reservoir water level at T=0 was 369.808 (m.a.s.l.) which translates to a volume equals 31,920 m<sup>3</sup>. Based upon the information presented in the SP3 report, the reservoir was empty at the end of the test. Using the above figures for both data sets does not satisfy the following volume balance equation:

This shows that there is still a problem with the two hydrographs provided by SWECO and Norconsult and that the correct hydrograph probably lies between the two curves, but likely closer to the SP3 curve. No further comment on this has been received from Norway.

It is therefore recommended that modellers use the two hydrographs for purpose of comparison, knowing that their outflow results should lie between the two given outflow hydrographs (Figure 7) and probably closer to the one calculated by HECRAS.
