# **TOWARDS AN INTEGRATED MANAGEMENT OF THE LOWER GRIJALVA RIVER (MEXICO)**

**First phase:**

**Controlling the flow and sediment discharge  
distribution at the bifurcation between the  
Samaria and Carrizal rivers**

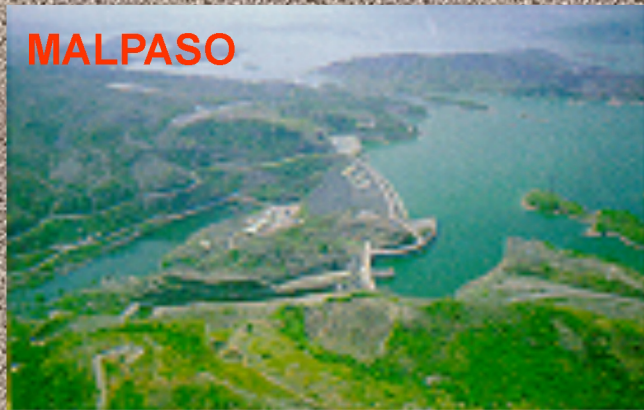
MALPASO (1964)

Discharges reduced with regulation by the reservoir, nonetheless, operation of spillway was needed in 1969, 1970 y 1973, before construction of Angostura.

\*Maximum extraordinary flood level (NAME)

\*\* Maximum operation flood level (NAMO)

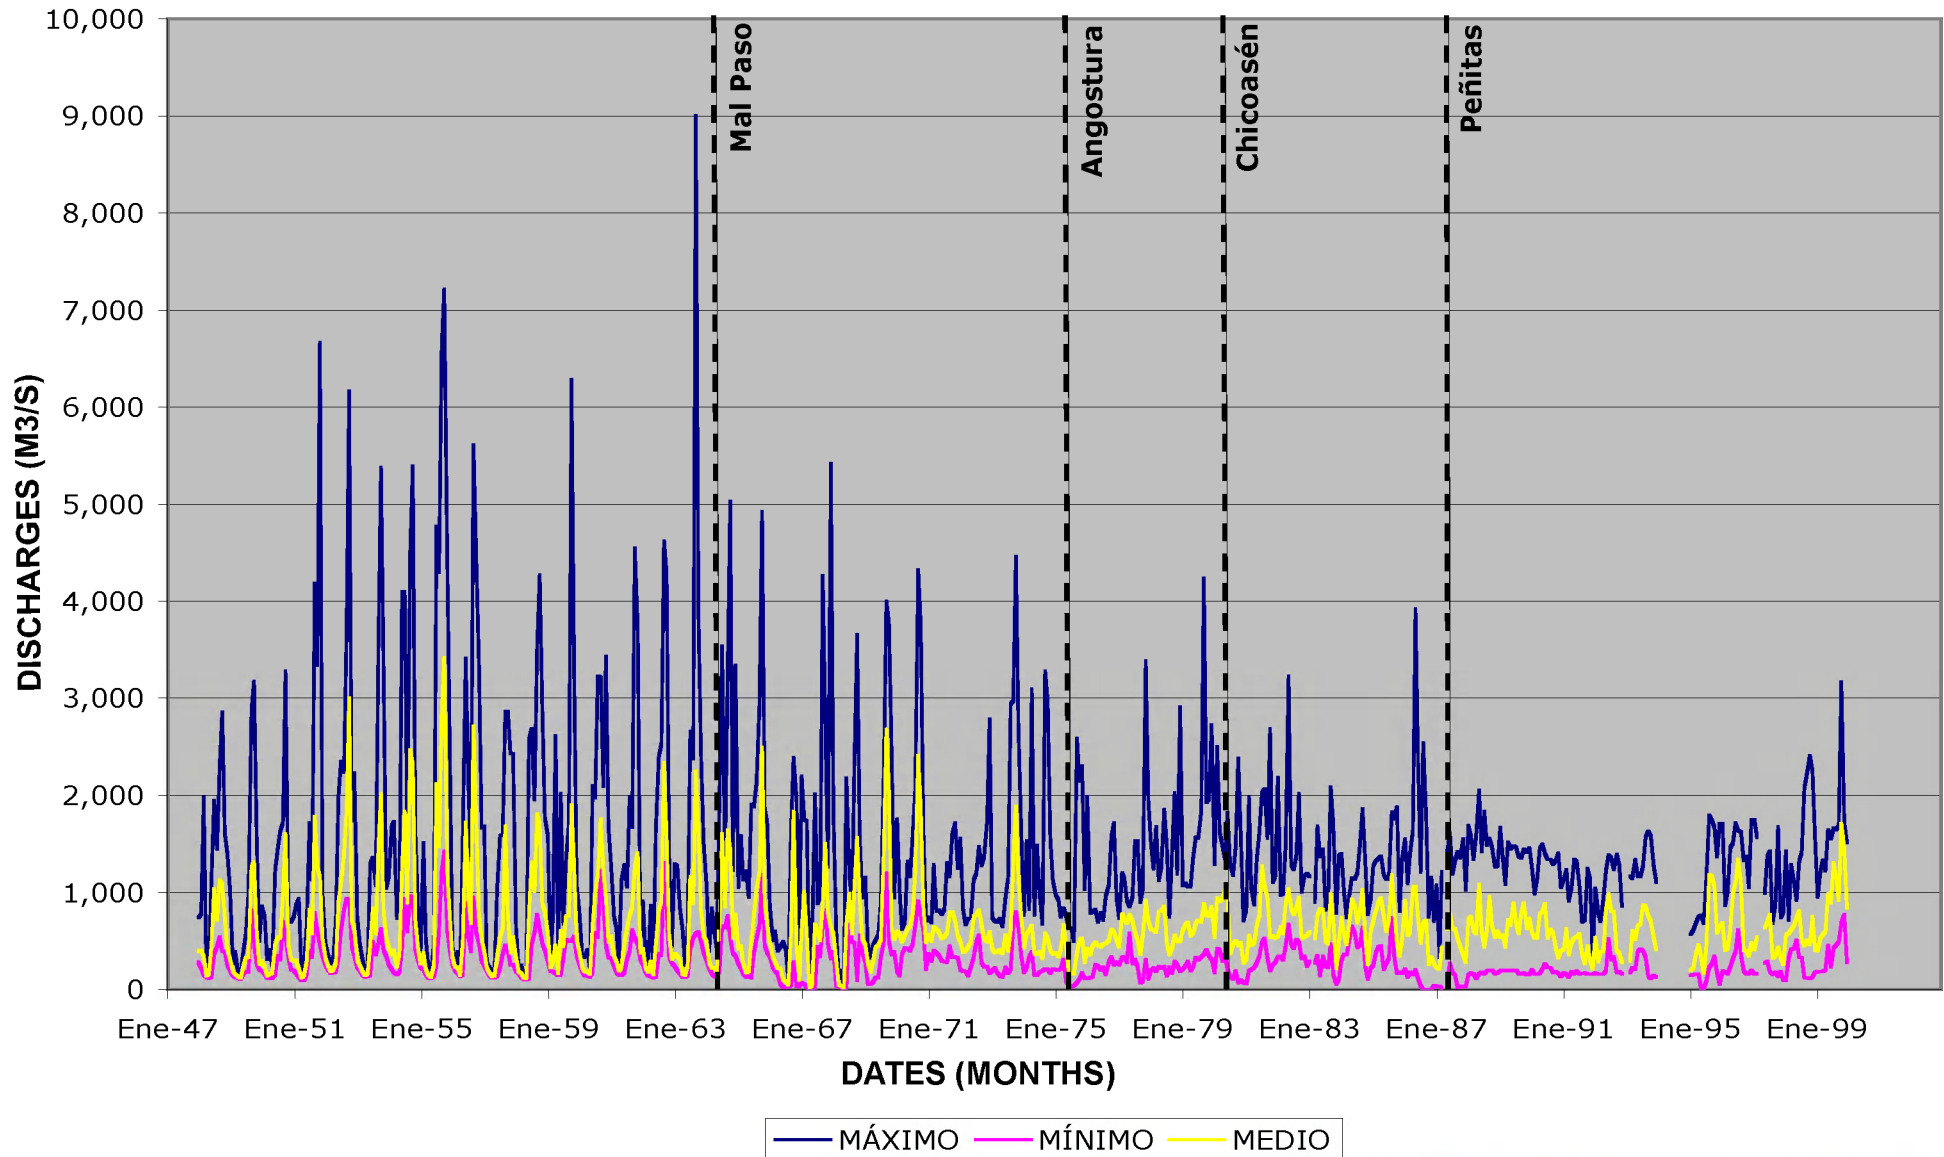
# MONTHLY DISCHARGES IN PENITAS 1948 - 1999

- Change in hydrological regimen, dry and flood seasons in *quite constant monthly discharges*, except in flood event periods
- Between 1987 and 1999, operation of Peñitas dam produced discharge fluctuations during the day between a very low and a very high value (depending on the electricity demand)

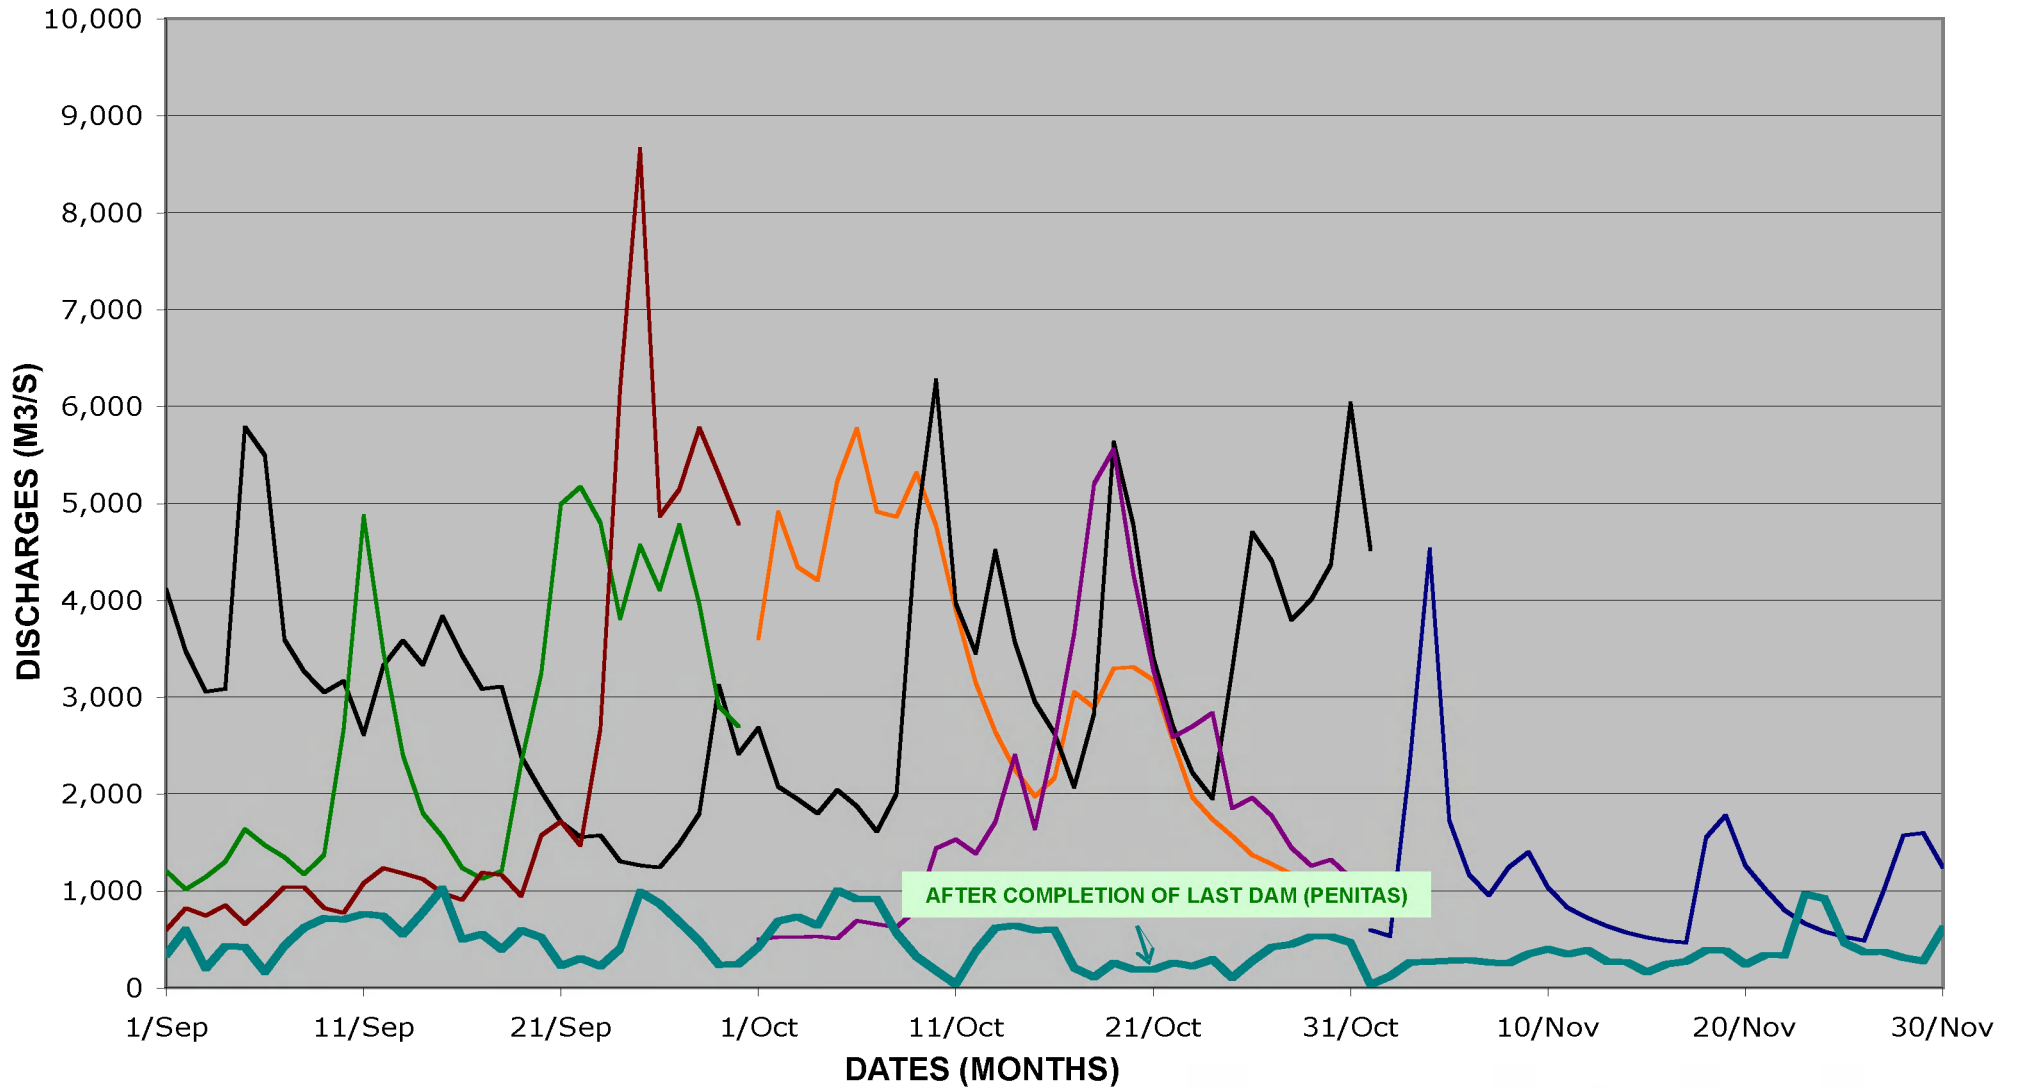
# GRIJALVA FLOOD EVENTS BEFORE AND AFTER CONSTRUCTION OF PENITAS DAM

— 1951 — 1952 — 1955 — 1956 — 1959 — 1963 — 1987

- The 4 dams constructed between 1964 and 1987 had a significant impact on the hydrological regimen of the Mezcalapa river (Grijalva downstream of Peñitas)
- Natural flood events disappeared and the operation of Peñitas dam determines the discharges (little contribution of Platanar river)
- A compensation dam foreseen to avoid rapid discharge fluctuation during the day has not yet been constructed

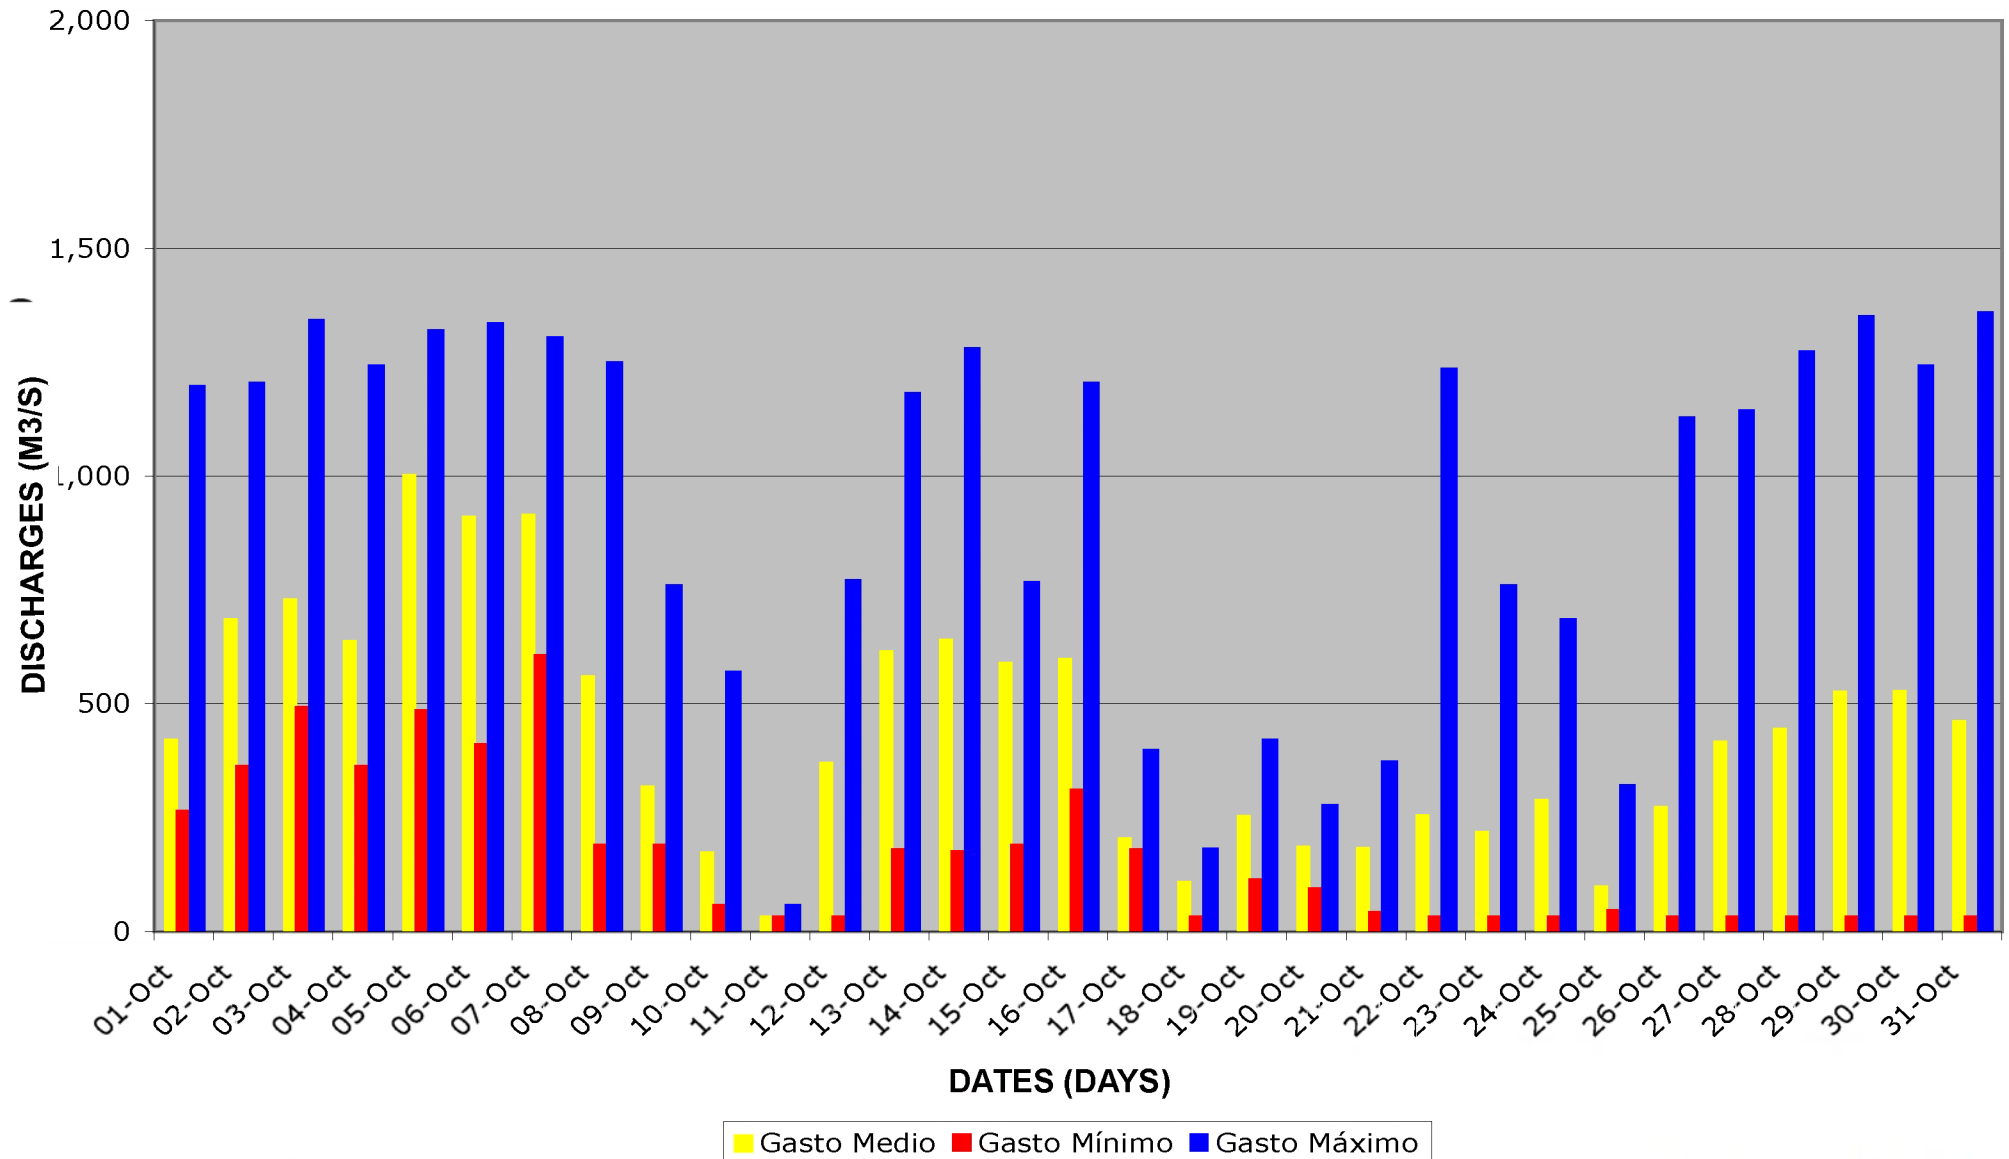
## HYDROGRAM IN OCTOBER 1987, THE YEAR AFTER CONSTRUCTION OF PENITAS DAM

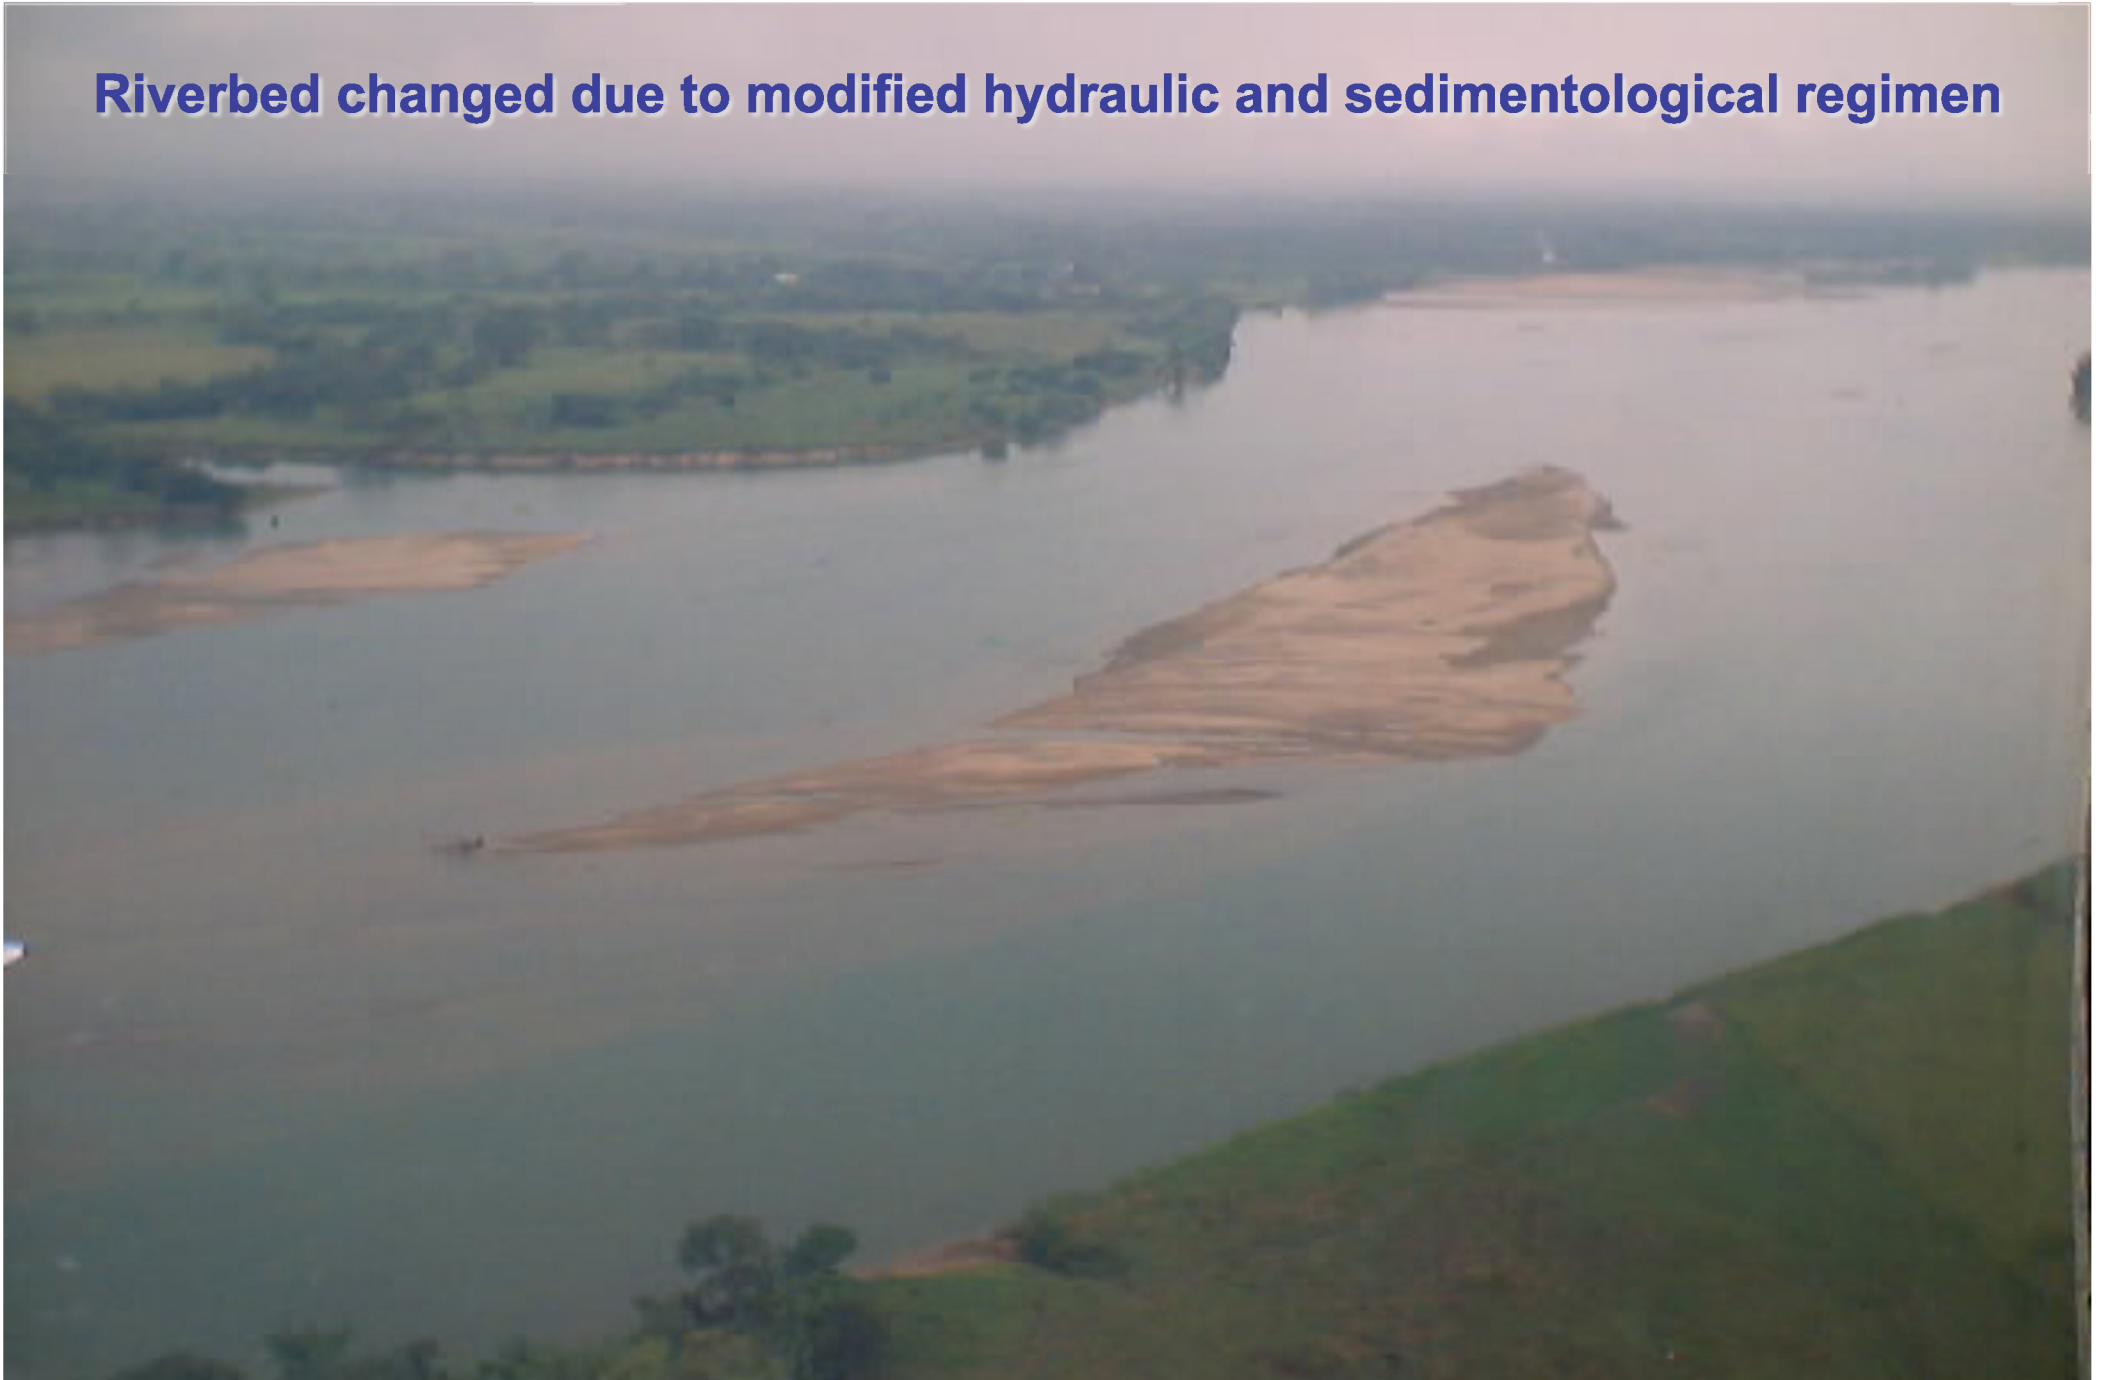
## Riverbed changed due to modified hydraulic and sedimentological regimen

- By **sediment deficit**, clear water has the tendency to erode the riverbed downstream of Peñitas dam (impact controlled by the nature of the riverbed: rocs)
- The water level gauging station just downstream of the dam hangs today above the waterlevel (was already replaced twice to follow the descent of the riverbed, degradation explained by Lane Balance)
- Products of this erosion move in downstream direction to deposit further, creating many and large sand- and gravel bars in the Mezcalapa

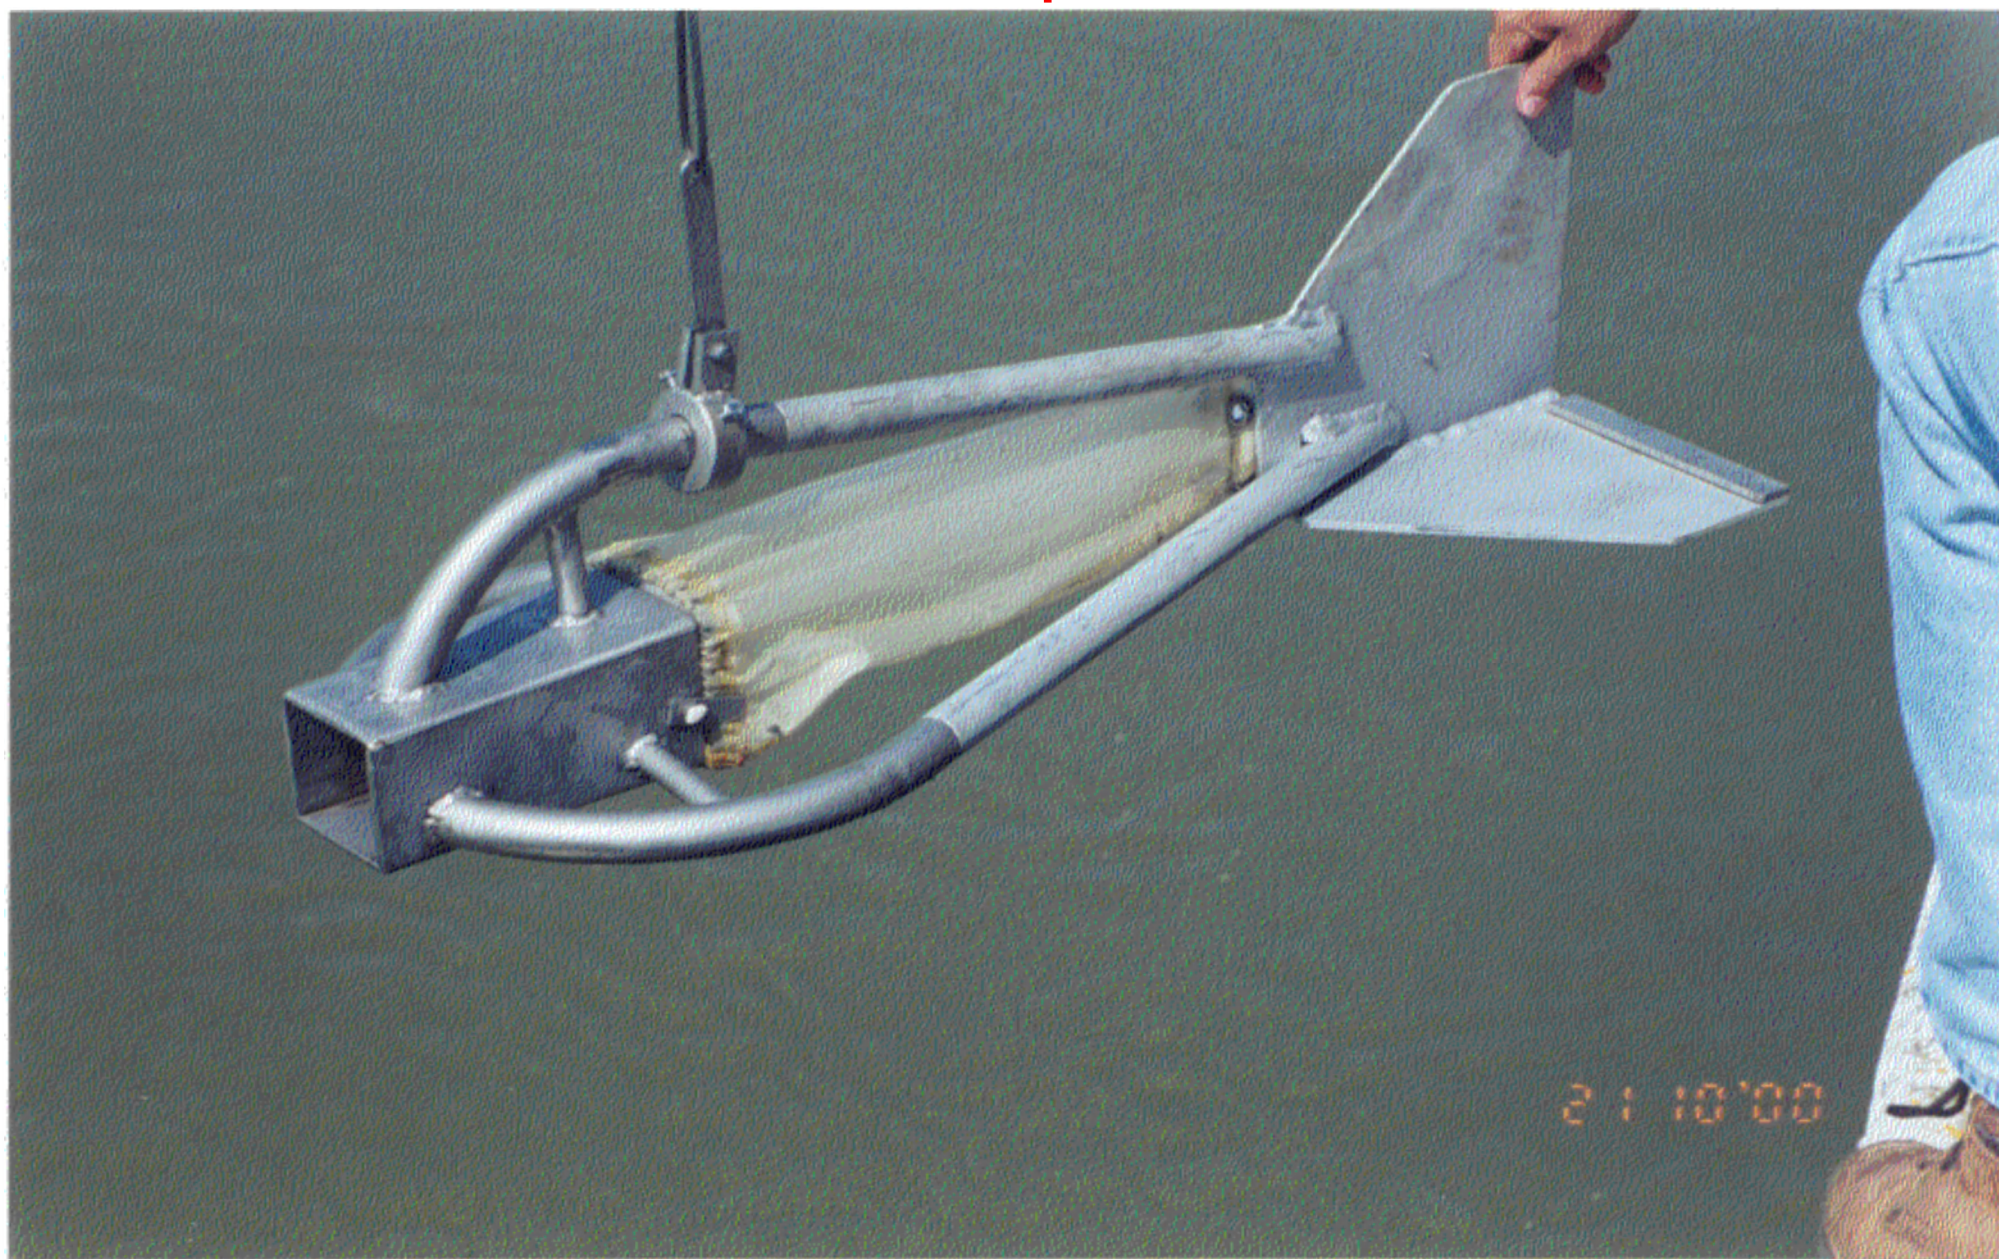
# US BL-84 for bedload transport

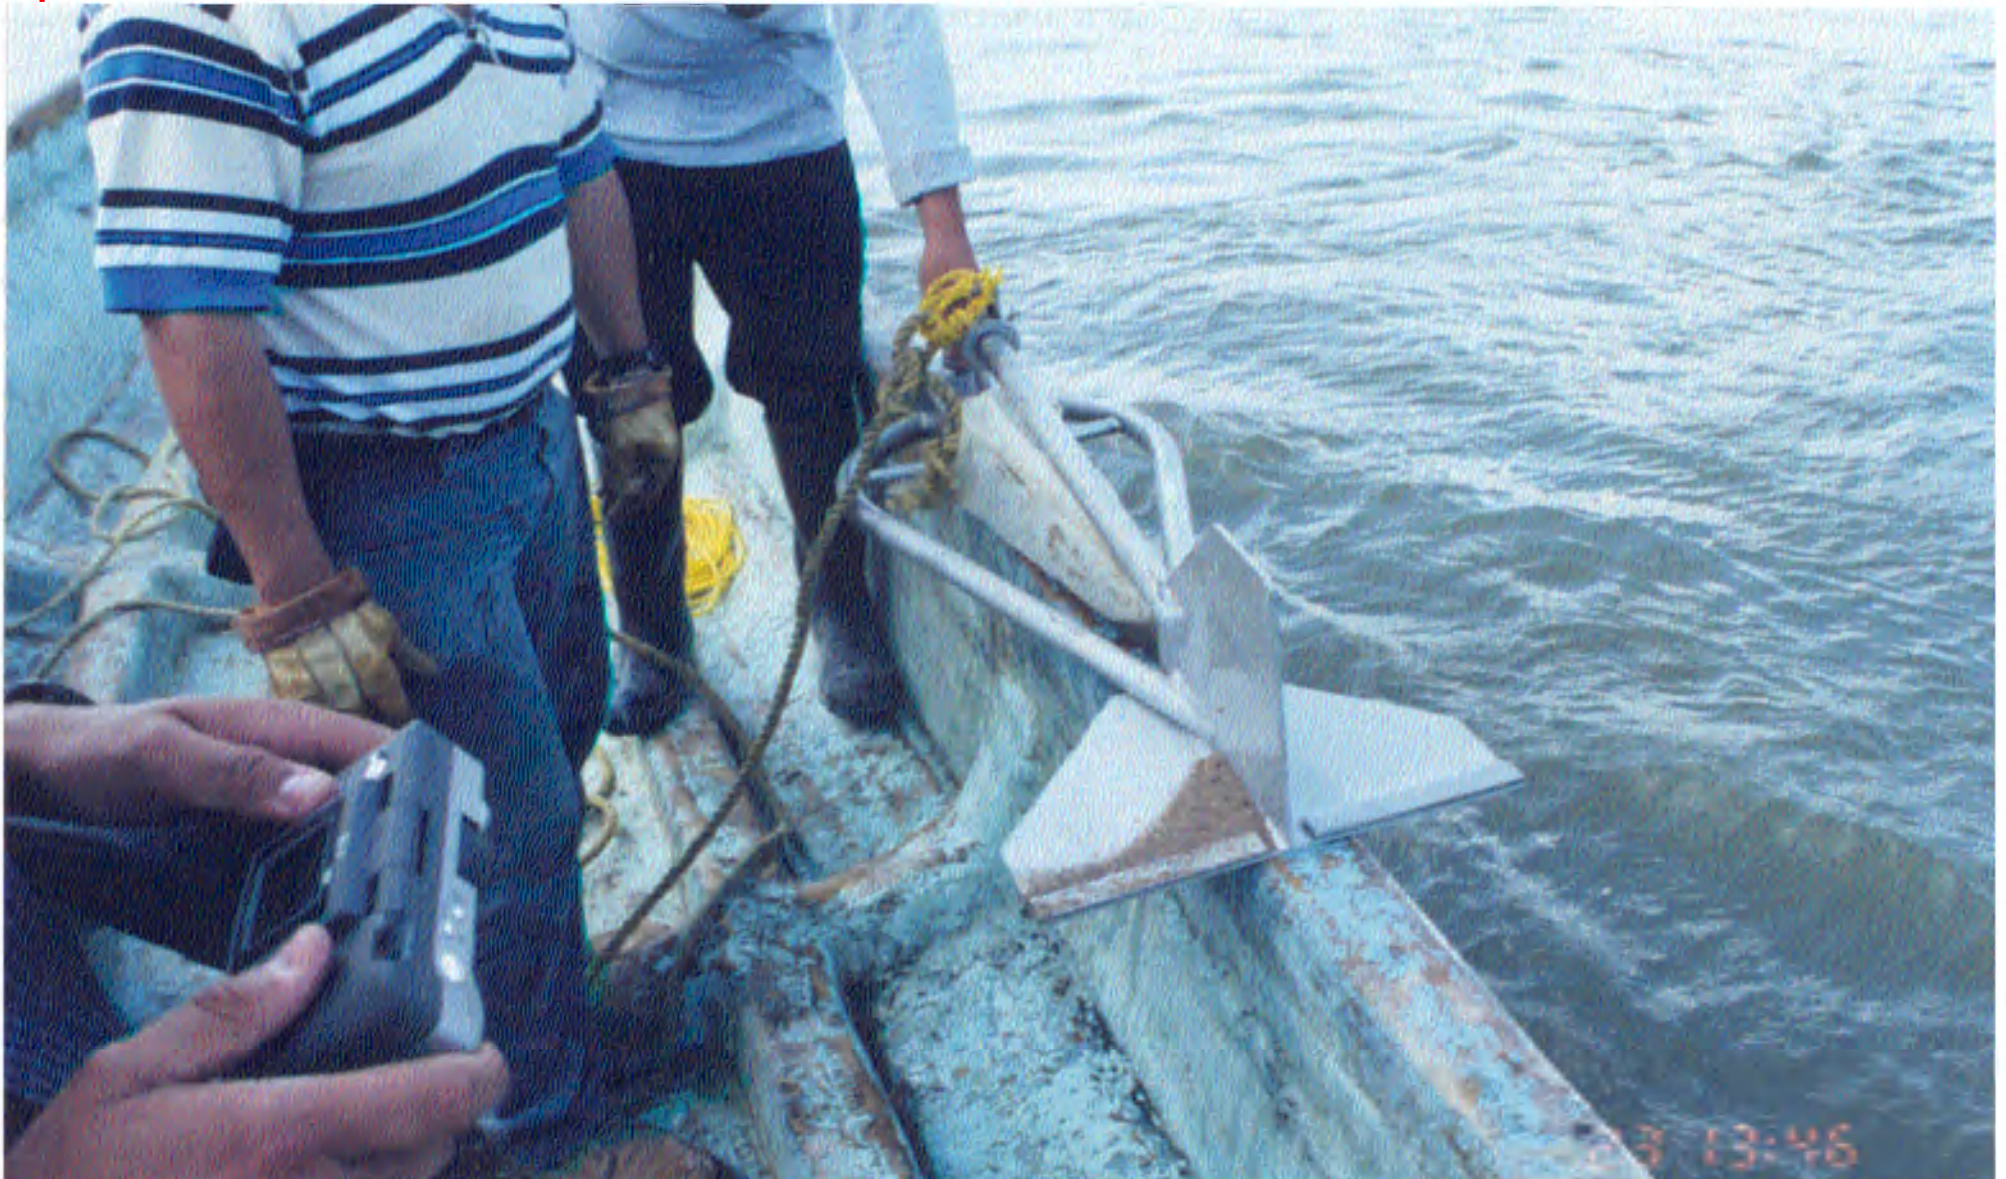
# US BL-84 for bedload transport

Operated from a small unit

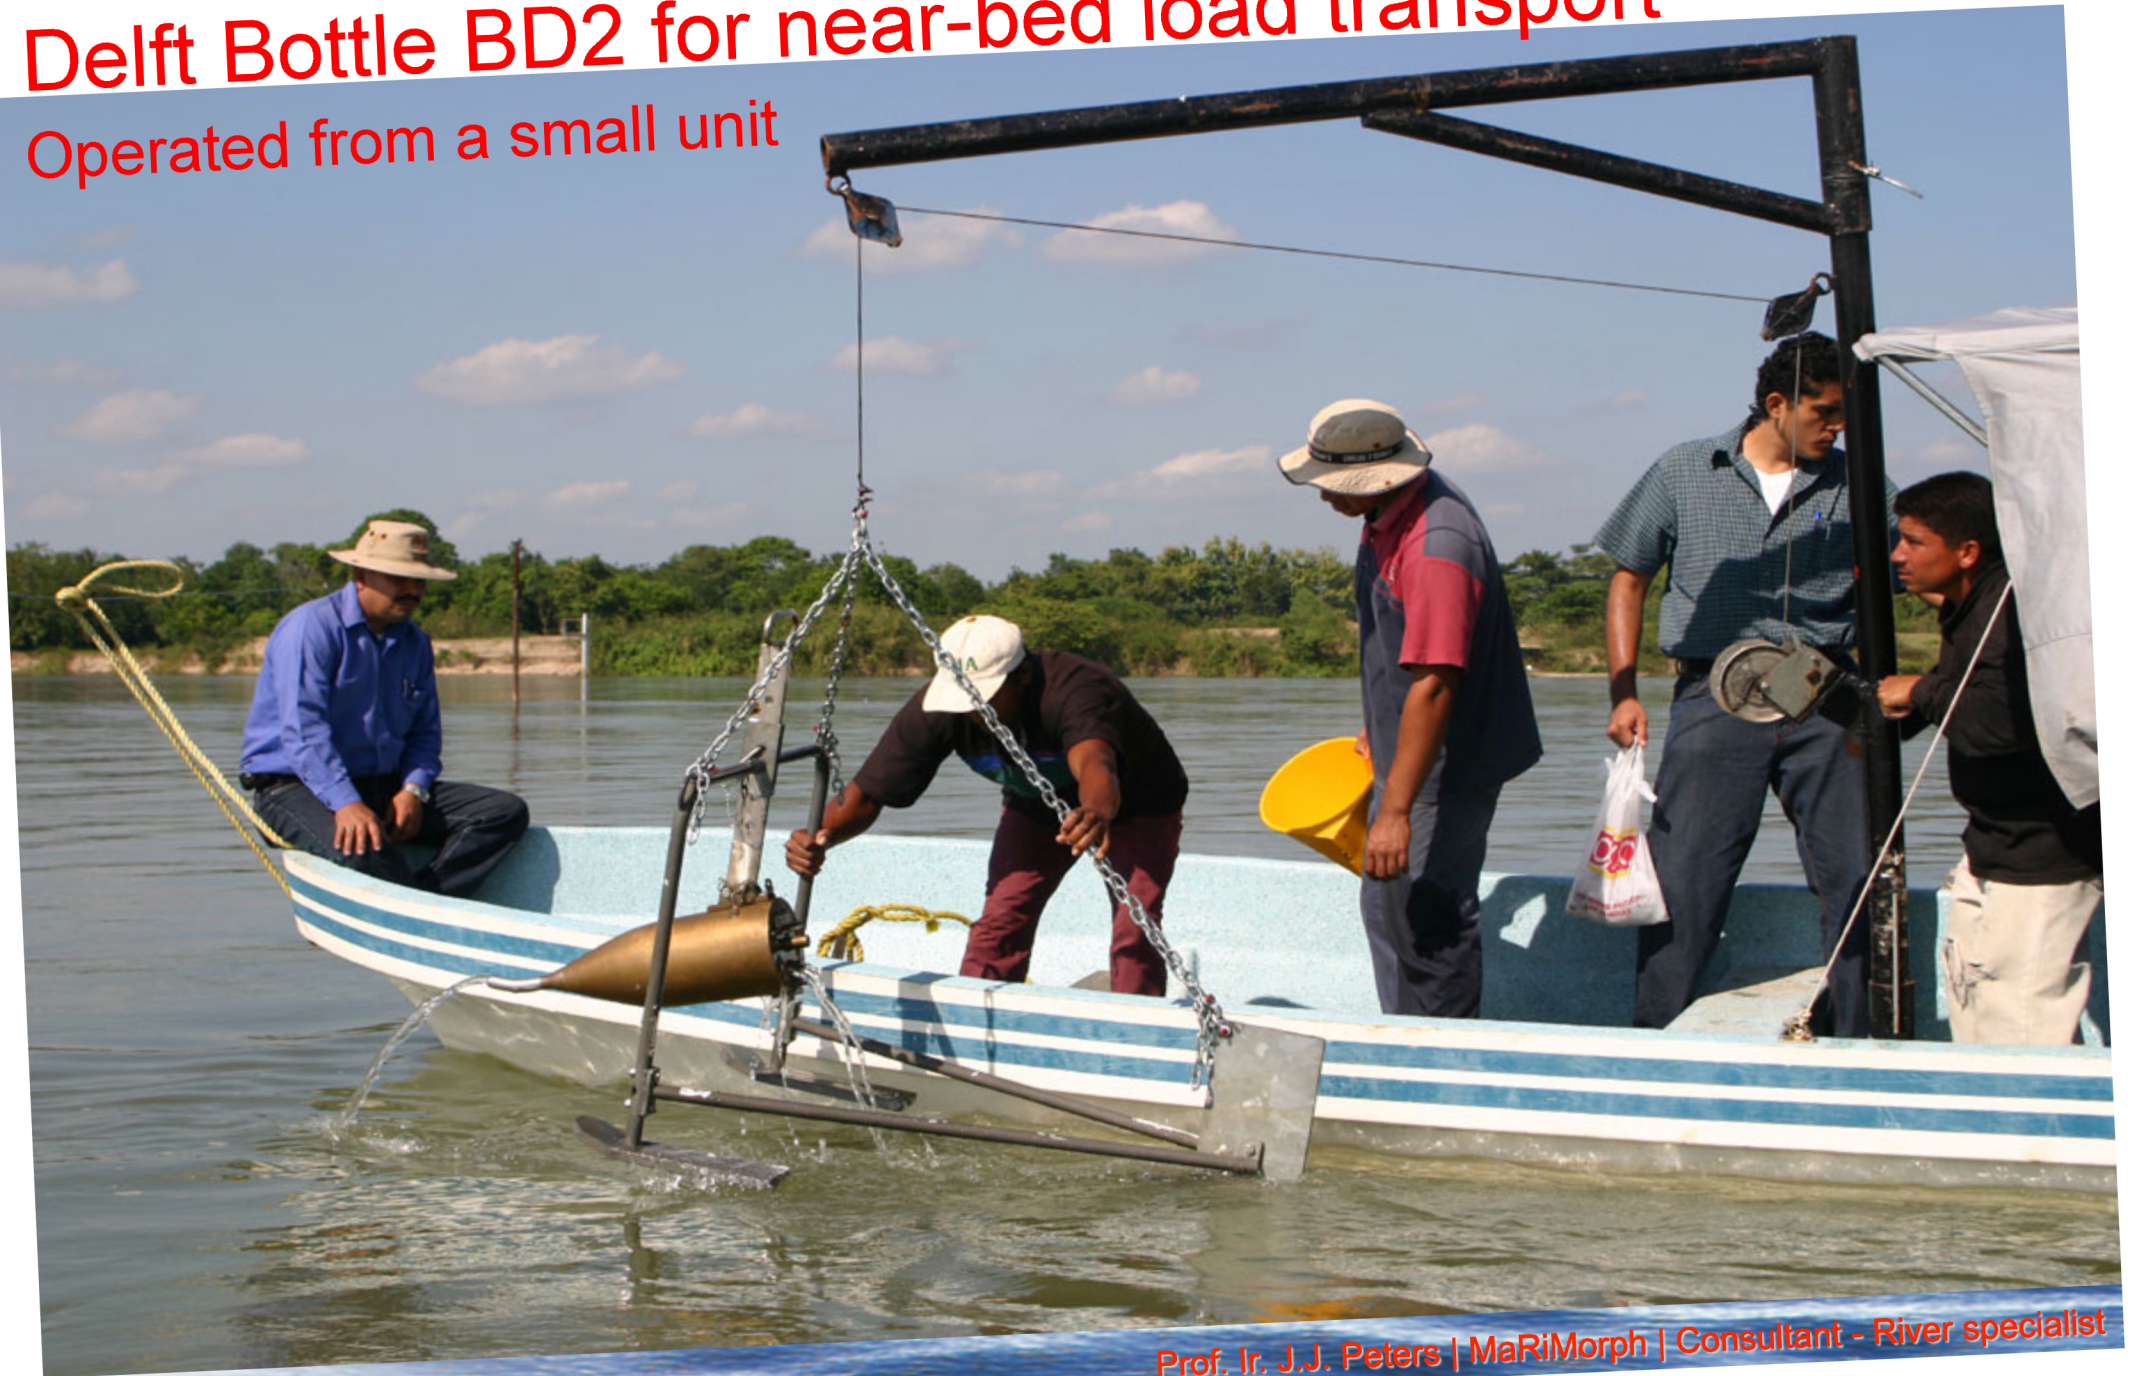
# Delft Bottle BD2 for near-bed load transport

Operated from a small unit

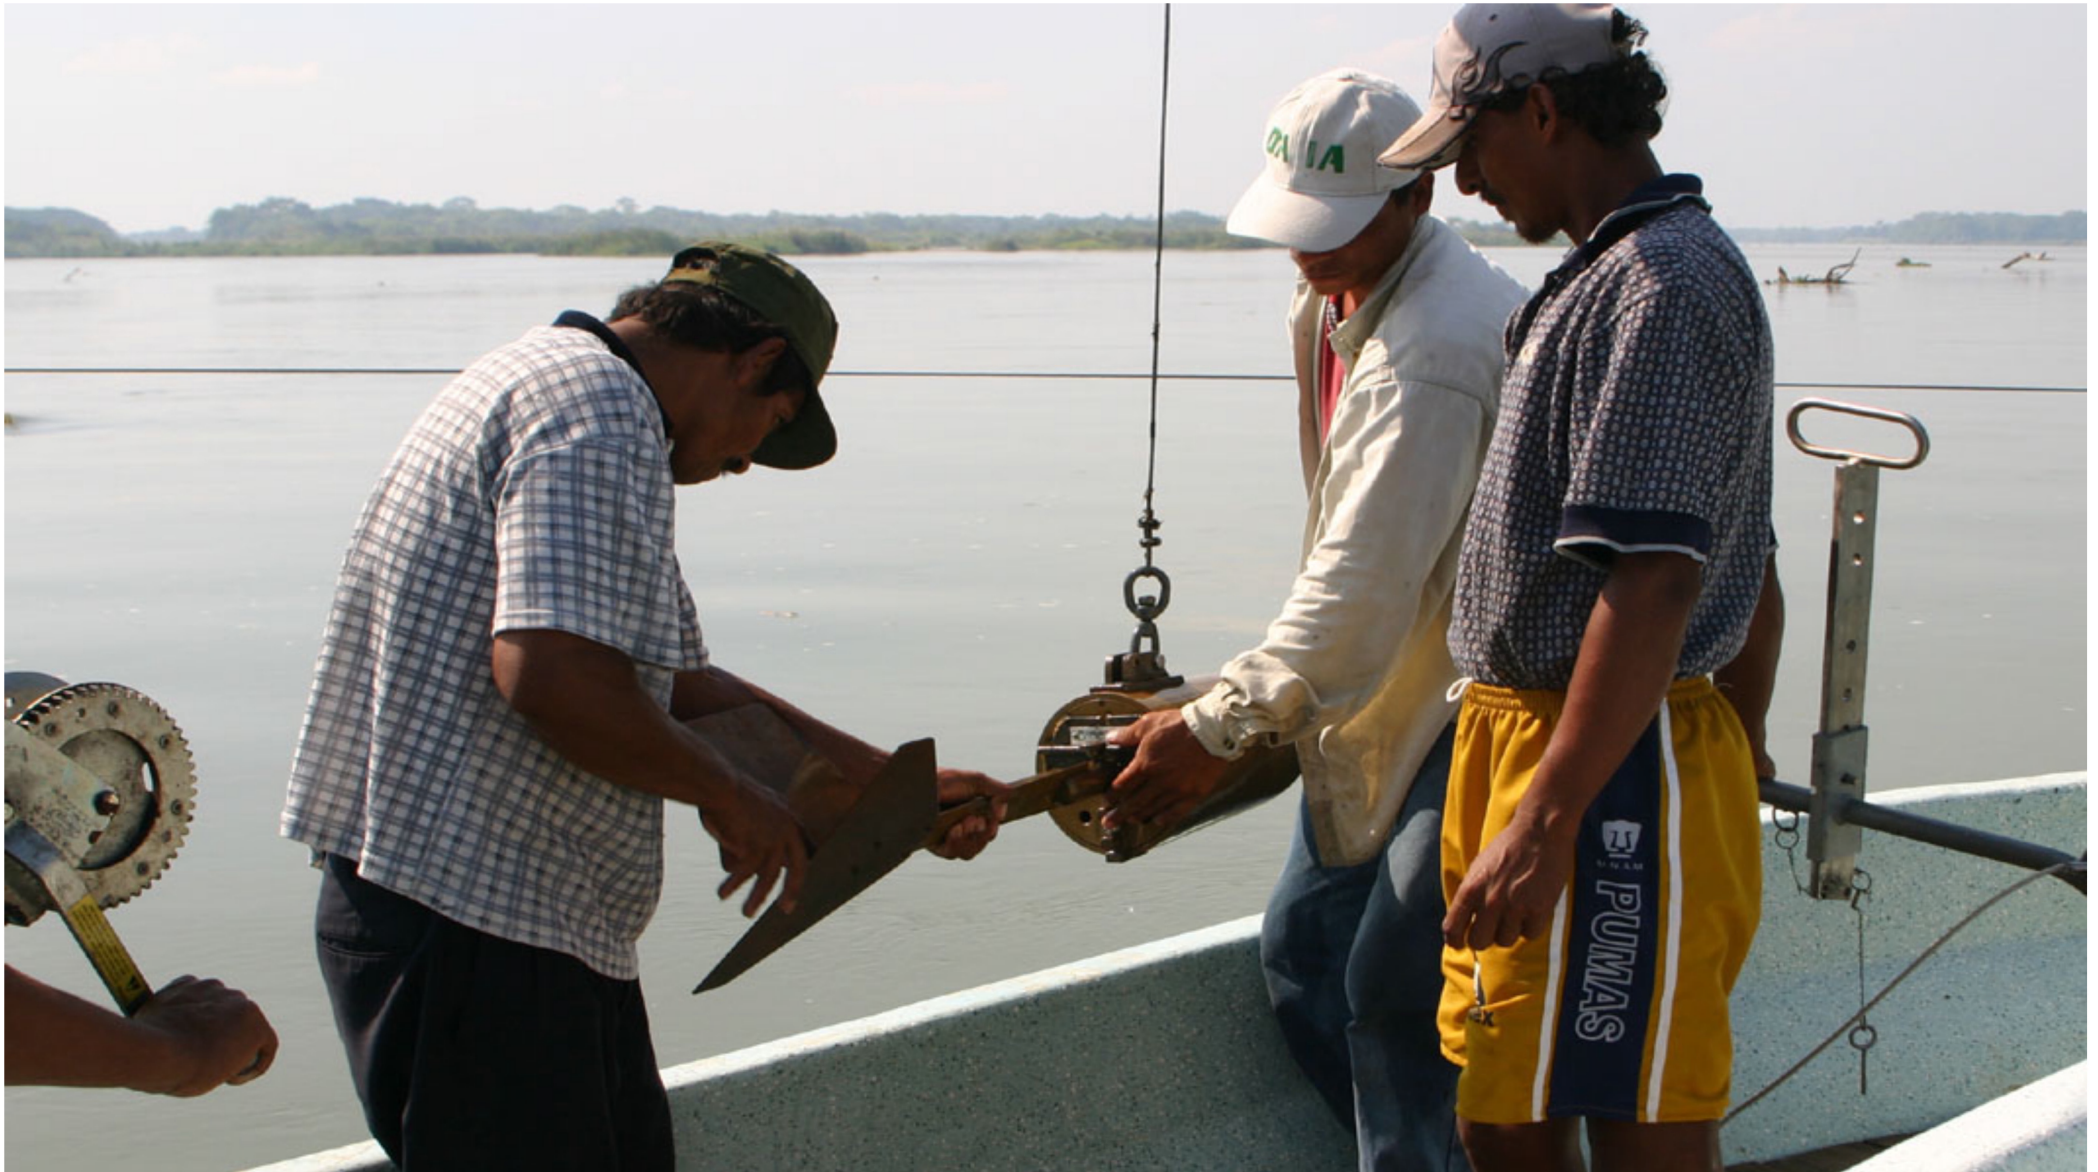
# Delft Bottle BD1 for suspended load transport

Fitting the tail; operated from a small unit

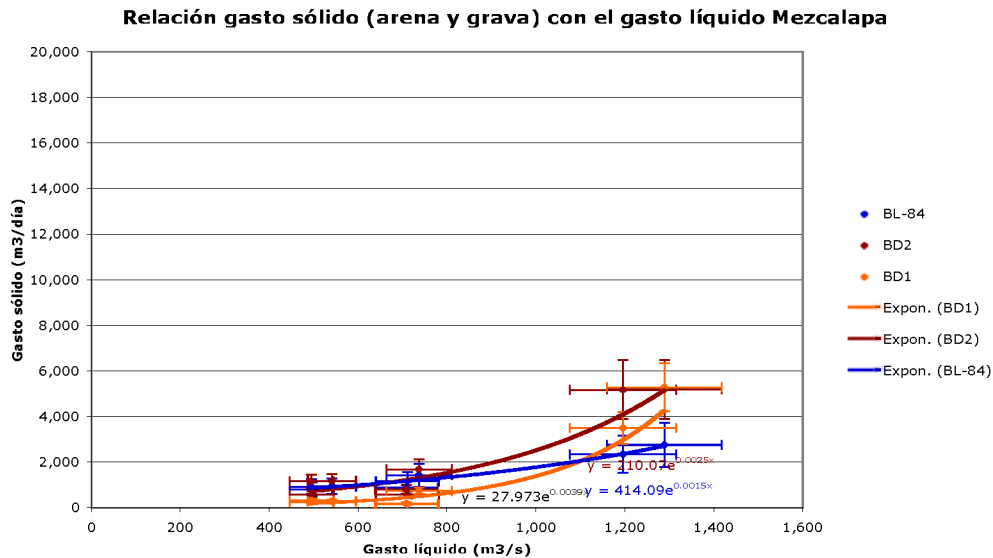
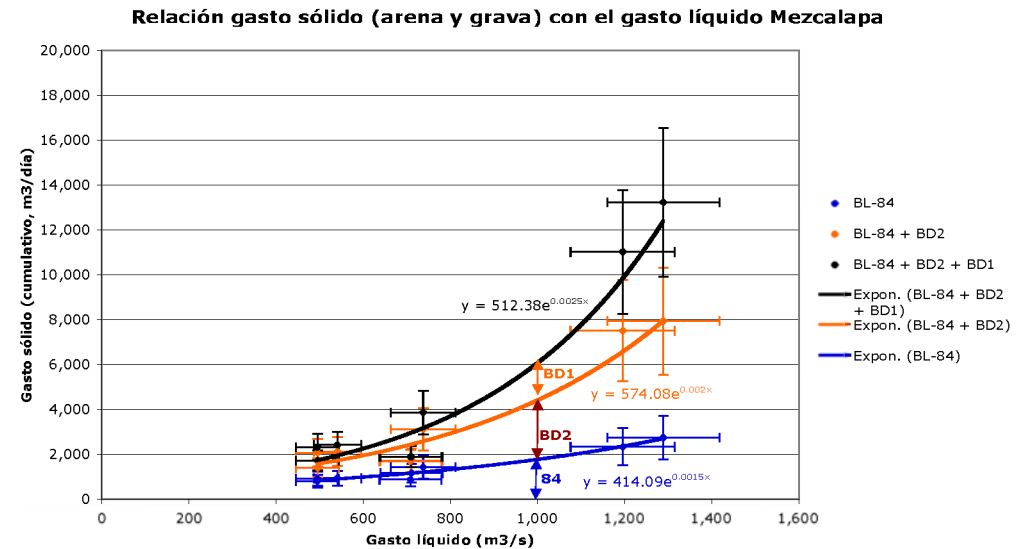
# Flow - sediment transport relationship

- At low discharges, bottom transport is significant but increases slowly with discharge
- Transport close to the bottom increases more rapidly, because of the increase in turbulence
- Transport in suspension, very low at mild discharges, augments more rapidly with discharges than transport close to the bottom

Sediment transport: BL-84 = bed-load; Delft bottle BD2= near-bed; Delft bottle BD1= suspension
