# **TOWARDS AN INTEGRATED MANAGEMENT OF THE LOWER GRIJALVA RIVER (MEXICO)**

**First phase:**

**Controlling the flow and sediment discharge  
distribution at the bifurcation between the  
Samaria and Carrizal rivers**

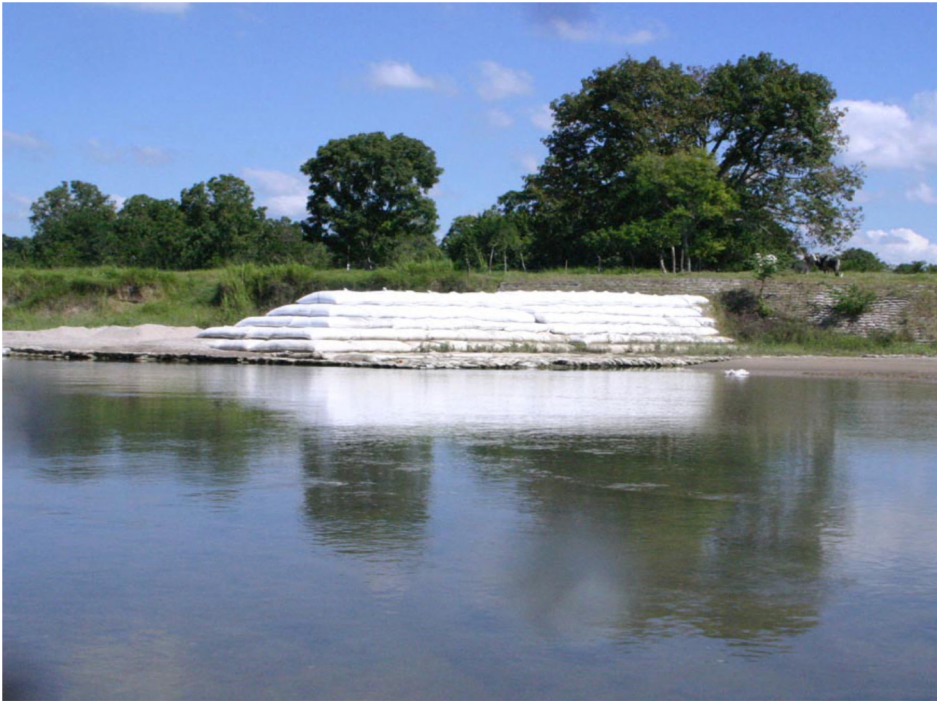
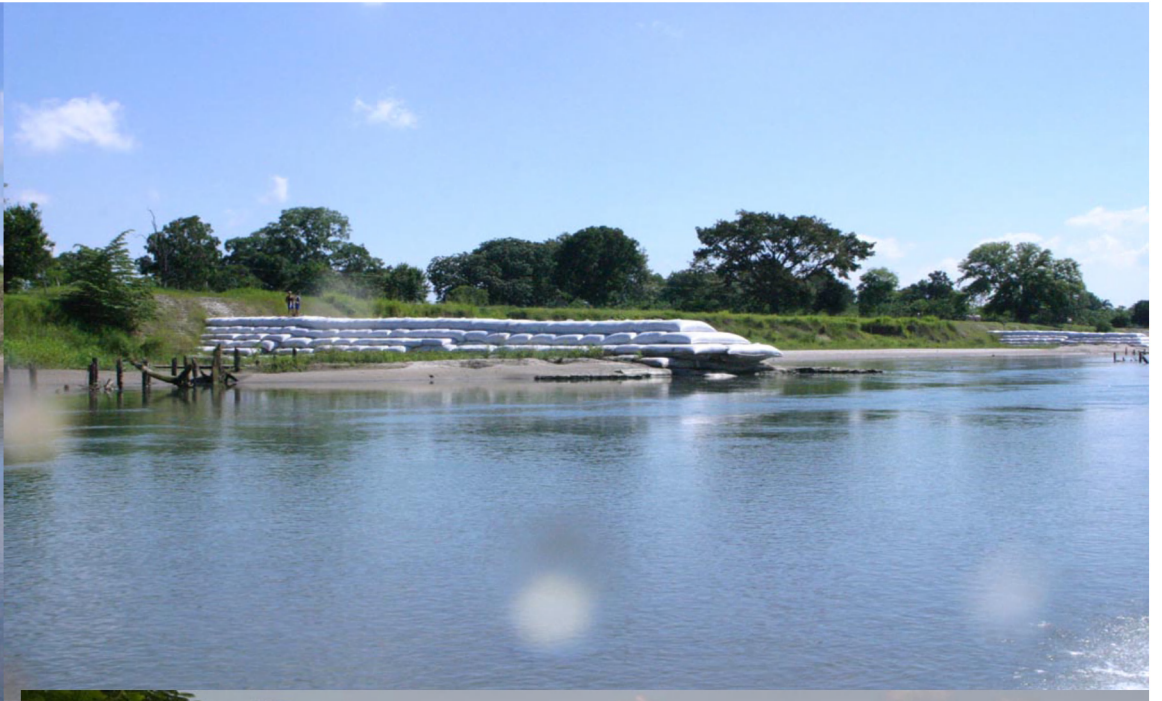
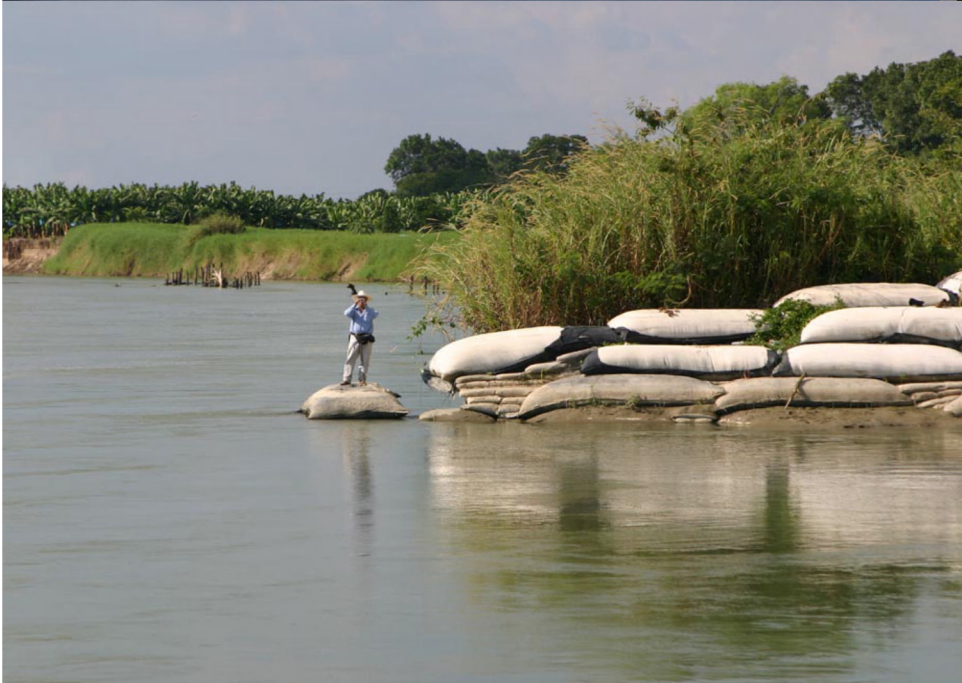
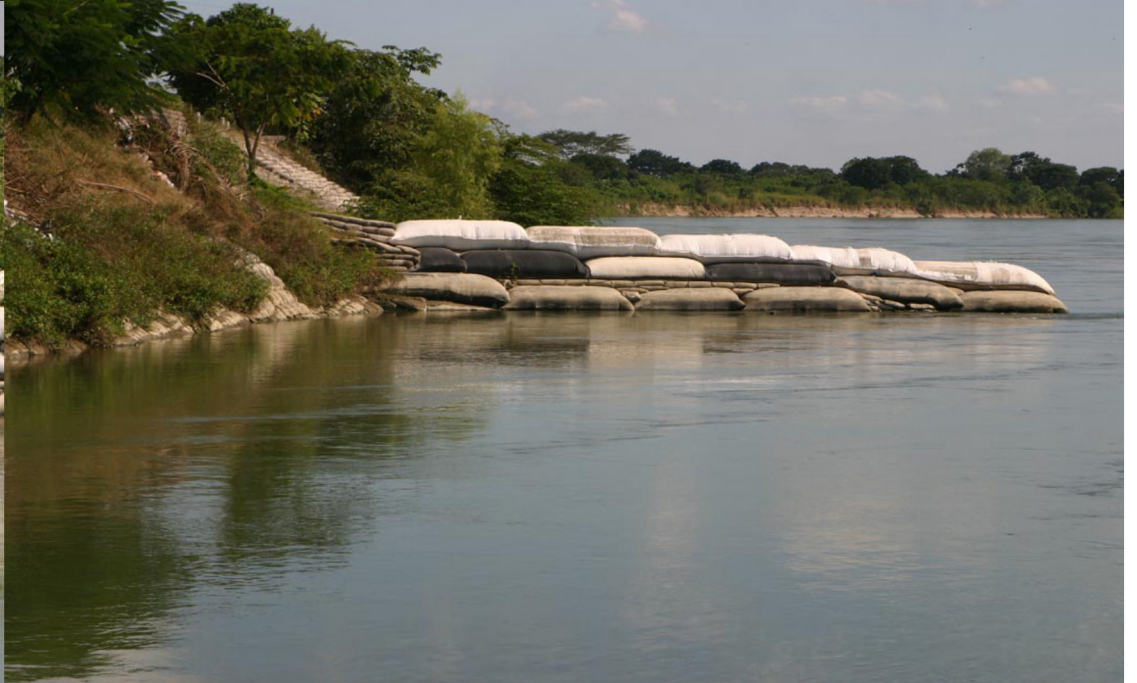
# Impact of the Samaria bridges

- The Samaria bridges have a long-lasting effect on sediment retention of sediments, riverbed aggradation and formation of bars and canals (remember the case discussed by Jean Cunge, although only about flow)
- These bars deflect the flow towards the banks, creating an ever more complex riverbed morphology
- This riverbed morphology causes always more bank erosion, resulting as usual with ever more protection (at least, contractors are happy to build the bank protections ...)

- A groyne field has been constructed to protect the right bank of the Samaria upstream of the bridges
- However, these protection works are not very effective, as the river flow attacks the bank with an oblique orientation
