## Construction Features of Doel 1, a 14th-Century Cog found in Flanders

Jeroen Vermeersch and Kristof Haneca

In 2000, a well-preserved, *c.*21 m-long shipwreck, Doel 1, was found upside-down in a silted-up creek near the river Scheldt (Belgium). An interdisciplinary research project was initiated, including 3D registration of all timbers, wood species identification, dendrochronology and archaeobotanical analysis of the caulking material. Doel 1, of which 70% is preserved, displays the construction features of a cog. Unseasoned wood was used and dated by dendrochronology to AD 1325/26. Remarkable features include the symmetrical layout of the bottom planks, the atypical arrangement of the frames to the fore, and evidence of partial disassembly of the ship after intensive use.

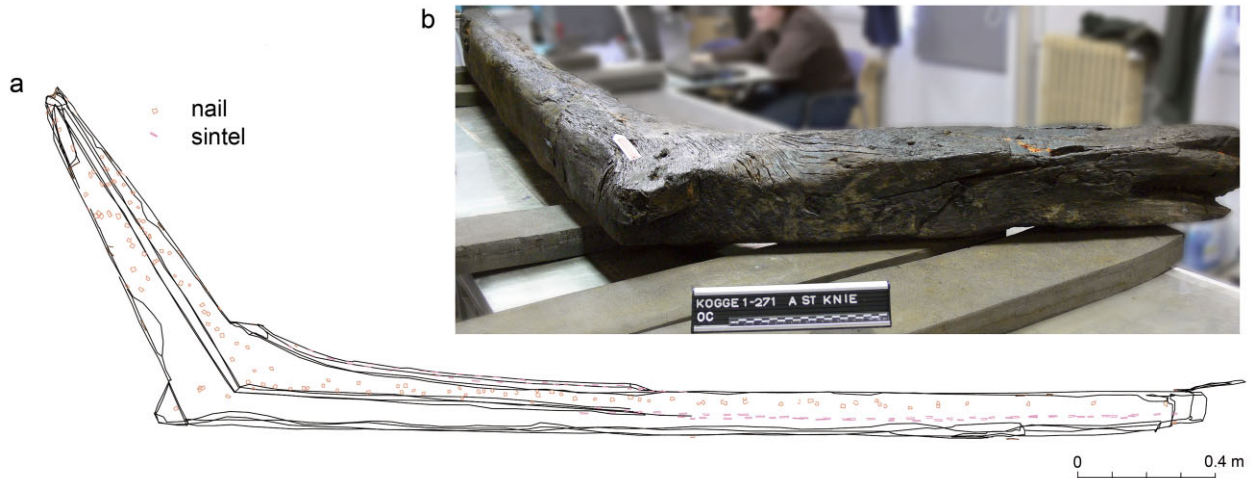
Figure 5. a) Simplified 3D-drawing of the starboard side of the stern-hook (Drawing: Johan Van Laecke), b) the aft and port side of the stern-hook showing the projecting skeg. (FHA)

The stern-hook was shaped from the trunk of an oak tree with a substantial, naturally curved side branch (Fig. 5 and Table 1). On both sides of the horizontal part of the stern-hook, a row of sintel holes indicates the position of the garboard. On the fore end of the hook, the horizontal scarf connecting the keel was damaged by the mechanical excavator and is incomplete, measuring only 0.24 m. Similarly to the keel, the bottom part of the hook is slightly convex in section. At the stern, it ends in a projecting skeg which protected the bottom corner of the rudder and the lower part of the outer sternpost. The upper arm is rebated on both sides to fit the hood-ends of the two lowest strakes. That part of the hook runs upwards into a scarf, where both the fragmentary remains of the inner sternpost and the missing outer sternpost had been

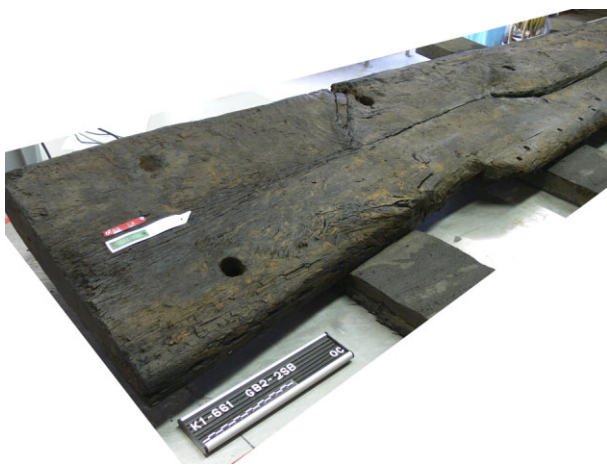
Figure 7. The outboard face of starboard hull plank GB2-2SB. The transition from carvel to lapstrake construction is clearly visible in the widening of the plank where adjoining garboard strake GA-SB becomes lapstrake. (FHA)

The transition from carvel to lapstrake construction is clearly visible on plank GB2-2SB (Fig. 7). At this tab-and-rabbit arrangement an offset in the width was cut so that the plank becomes 0.09 m wider. This land serves as the overlap with which the upper strake is connected to the lower strake. The tab-and-rabbit arrangement between GA and GB occurs 3 m from the stem (Fig. 3a). During construction, this transition was strengthened with additional clamps, as can be seen by

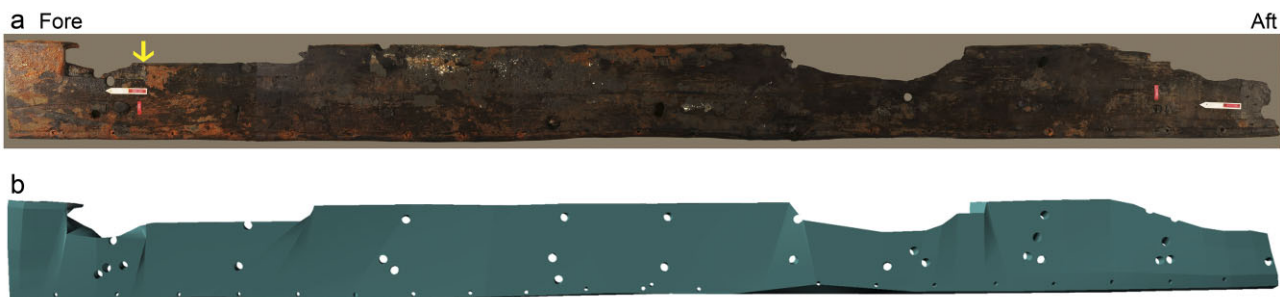
Figure 8. a) The outboard face of GR1-1BB, rebate for repair plank marked with arrow (FHA); b) the outboard face of the modelled plank. (Drawing: Johan Van Laecke)

Three fragments of the sheer-strake are preserved on the port side. The largest, GR1-1BB, runs from frame S18 to S26 (Figs 3b and 8). On the upper, forward edge, are two rebates for repair planks (which are missing) situated on both the inner and outer faces. A curved cut of underdetermined function is situated in the same plank edge. Both of these features might relate either to the rigging or additional structures. Each frame was connected by three or four treenails to this plank, the majority situated in the lower half of the plank, indicating that extra strength in the construc-

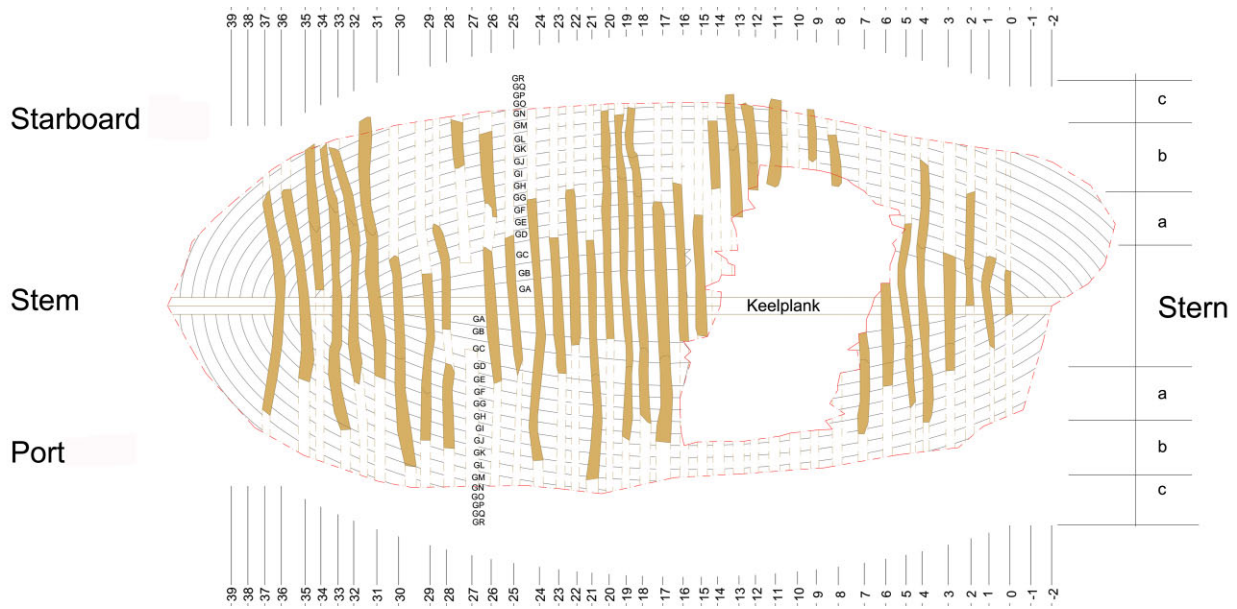
Figure 9. Schematic overview of the frames recovered from Doel 1. (Drawing: Johan Van Laecke)

The ship's frames were labelled S0 to S39 from aft forward (Figs 9 and 10). Three additional stations evidenced by treenails aft of label S1 on plank GF1-SB were noted (S0, S-1 and S-2), giving a total of 42 frames. Based on the number of frames in the forward section of the ship, and through comparison with the Bremen cog, an additional seven frames can be estimated for the missing part of the stern.

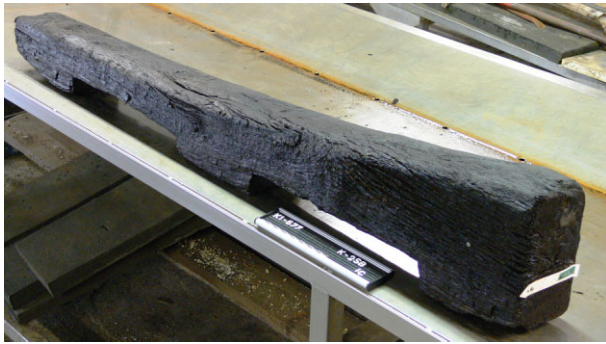
Figure 13. View of chock 2SB. (FHA)

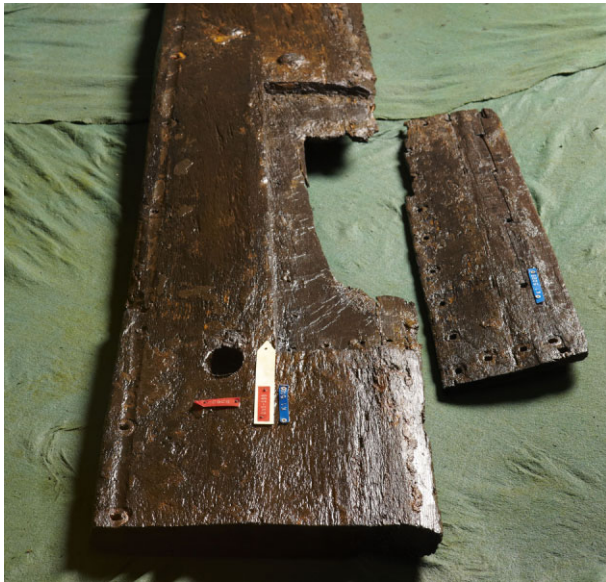
Figure 16. The outboard face of GN3-BB with a rebate for countersunk nails to left and a rebate and repair plank to right. (FHA)

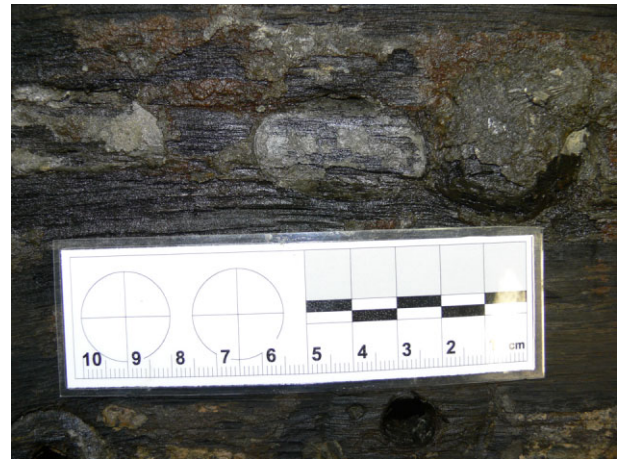
Figure 17. An impression of two sintels used in a repaired crack of plank GN1-SB. Their length is about 0.045 m and the width measured on the lath about 0.025 m. (FHA)

The ship's caulking was covered with wooden laths held in place with sintels which measured 0.04 m long and c.0.025 m wide, evidenced only by holes left along the seams and some impressions left on the laths (Fig. 17). The few impressions recorded on the laths appear to indicate that the sintels did not overlap each other, but were separated by 5–15 mm. According to Vlierman's typology, the sintels found on Doel 1 correspond to type E (Vlierman, 1996: table II).

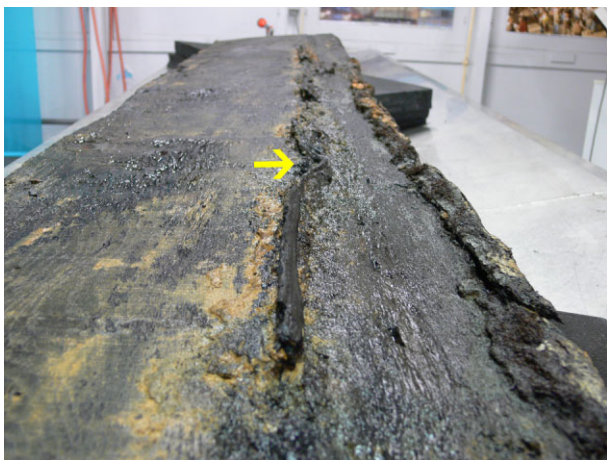
Figure 19. The inboard face of plank GQ1-BB with the c.0.09 m wide land on the right. Both strings of caulking material are still present. Note the curve in the lath (marked with arrow), where it is pushed aside by a treenail which was inserted after the caulking of the planks. (FHA)

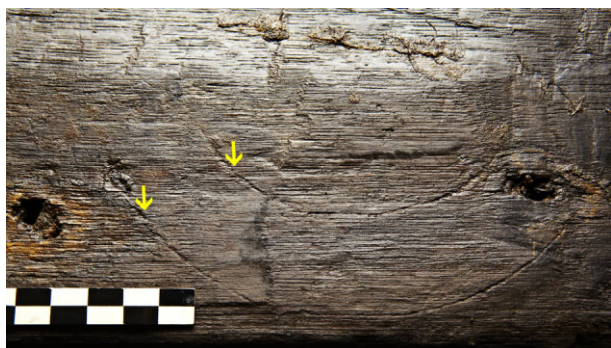
Figure 21. Two concentric circular arcs on the inboard face of the repair plank used on GN3-BB. (FHA)

Other marks noted include two concentric circular arcs, with diameters of c.0.095 m and 0.14 m, inscribed on the inside of a wainscot used as a repair of a hole in strake GN3-BB (Figs 16 and 21). Its meaning is unclear, but based on the dendrochronological research the plank has a Southern Baltic provenance and is likely to have been a later repair. Due to the hole in the original plank, the arcs must have been visible on the inside of the ship, therefore they could have been drawn by a shipwright, someone working on the wharf, or by a sailor during the later use of the ship.
