## WESTERN SCHELDT ESTUARY (THE NETHERLANDS)

## 1. GENERAL DESCRIPTION OF THE AREA

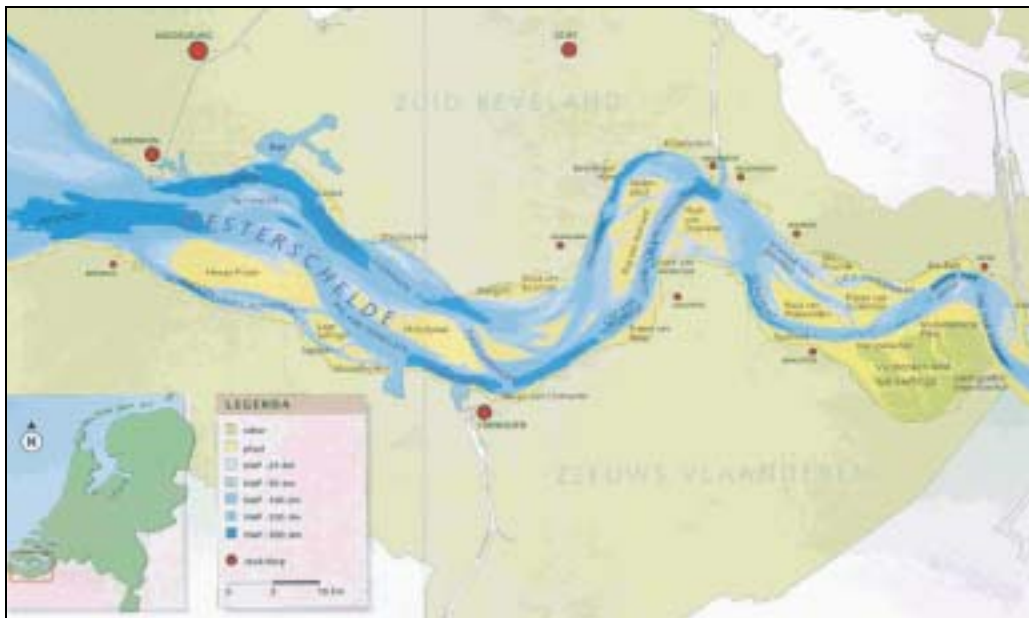
Fig. 2: Overview of the Western Scheldt.

The Western Scheldt exhibits a well-developed system of channels and shoals (see Figure 2). It has a funnel-shaped geometry and covers an area of about 370 km<sup>2</sup>. Its cross-sectional area decreases exponentially from the estuary mouth at Vlissingen to the estuary head near Gent. The width averaged depth decreases from about 15 m at Vlissingen to only

3 m near Gent. The width of the estuary reduces from 6 km via about 2-3 km near Bath to less than 100 m near Gent.

The estuary can be characterized as a multiple channel system, separated by elongated tidal flats. The large channels form a more or less continuous meandering channel, constrained by fixed points along the estuary (dikes, harbour moles). Due to the meandering of the channels shallow areas are formed (so-called sills, positioned at transitions between channel bends). Regular dredging at these sills is required in order to secure safe navigation to the port of Antwerp. Presently, ships with a draught of about 14 m can reach the port of Antwerp from Vlissingen within one tidal cycle.

Both natural and human factors have determined the present configuration of the Western Scheldt. In general, the surface area of the estuary has decreased, mainly by land reclamation. Since 1800 about 15.000 ha. of intertidal area has been reclaimed (RIKZ, 1996). Between 1960 and 1990 the area of shallow water zones and intertidal salt marshes and mud flats has decreased with about 3200 ha, partly due to land reclamation and dike reinforcement, but also due to erosion caused by sea level rise, climate change and tidal cycles. Another type of human interference that is of great importance in the Scheldt estuary is dredging. In the beginning of the 1970's and also in the end of the 1990's, the Flemish government deepened and widened the navigation channel to Antwerp. As a result, the yearly amount of maintenance dredging has increased from 4 Mm<sup>3</sup> (1970) via 8-10 Mm<sup>3</sup> (1995) to an expected amount of 14 Mm<sup>3</sup> in 2002. Most of the dredging was done in the eastern part of the estuary (east of Hansweert, see Figure 2).

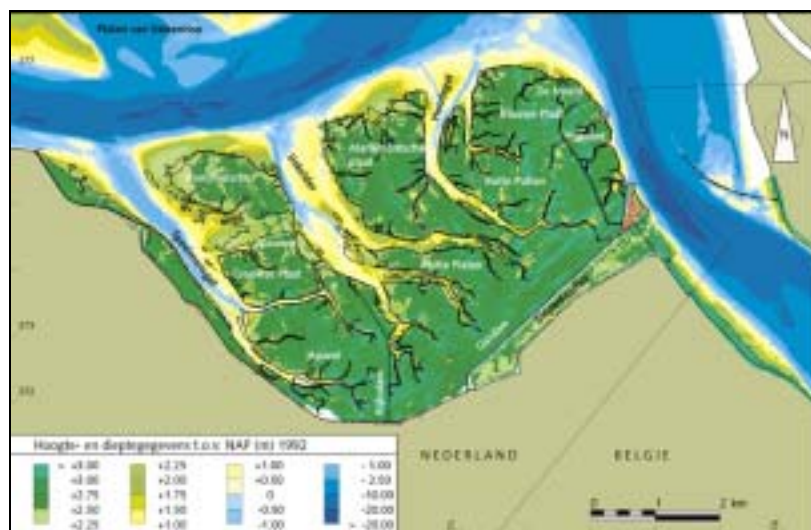
Fig. 4: The 'Verdrongen Land van Saeftinghe', near the Belgian border. Depths are given with respect to N.A.P. (Dutch Ordnance Level, approximately equal to the mean water level).

- **Nature conservation:** The Western Scheldt comprises a number of internationally recognized nature reserves, which are important for birds. One of them is the 'Verdrongen Land van Saeftinghe', near the Belgian border (see Figure 4), one of the largest brackish water salt marshes in Europe (about 3500 ha.), which has been a Ramsar-site since 1995 ([www.ramsar.org](http://www.ramsar.org)). Yearly, about 400-500 seals are counted.

Along the main land, salt marshes are present at several locations. The 'Verdronken Land van Saeftinghe', near the Belgian border, is one of the largest brackish water salt marshes in Europe (about 3500 ha.).

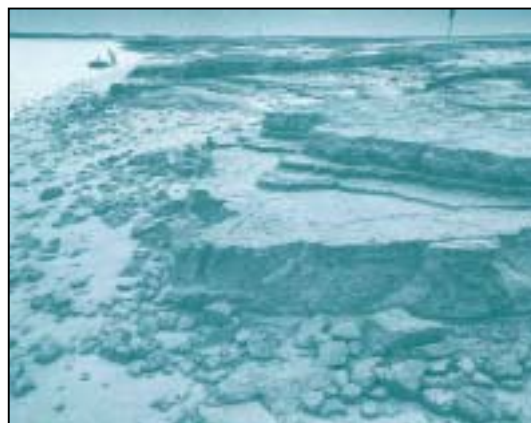
Fig. 6: Local erosion in intertidal area.

The 'Zuidgors' salt marsh eroded with a rate of about 5.4 m per year due to wave attack. The increased wave attack was the result of channel migration, having a shallower foreshore as a result.

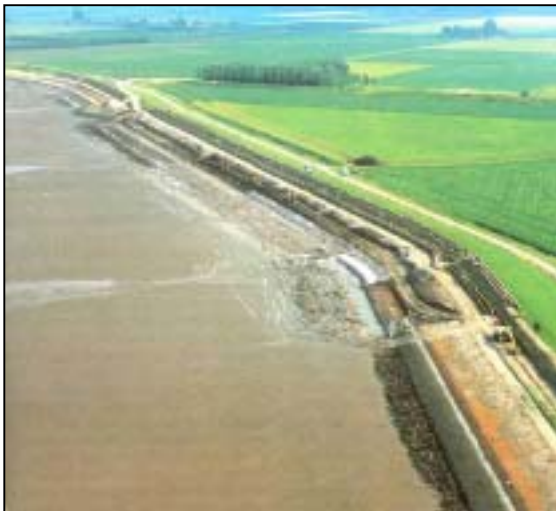
*Fig. 7: dike at Western Scheldt*

At other locations, an attempt is made for the rehabilitation of intertidal salt marshes. Here, plans have been developed for the construction of small piers, with the purpose of creating protected areas where sedimentation of fine sediment is stimulated. Here, a 'move seaward' strategy is adopted (see Figure 7).

At locations, where a further migration of the channels may cause undesired effects, such as erosion of dike toes or intertidal salt marshes, revetments are constructed. Since migrating channels are characteristic for the natural dynamical behaviour of an estuary, it can be argued that these revetments cause a less 'natural' behaviour of the estuary.

The increased propagation of the tidal wave has led to increased high water levels. The dikes are raised to ensure the safety of the hinterland.

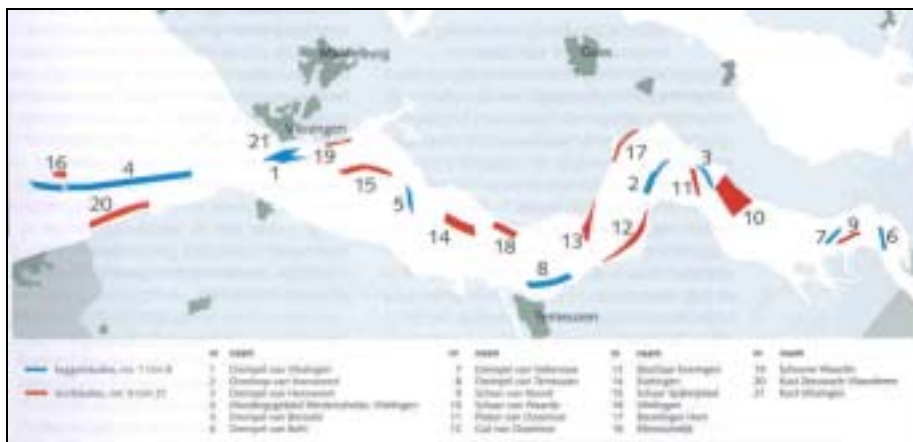
Fig. 8: Dredging (1-8) and dumping (9-21) locations in Western Scheldt.

The quantities of dredged material before and after the deepening of the navigation channel are given in Table 2.

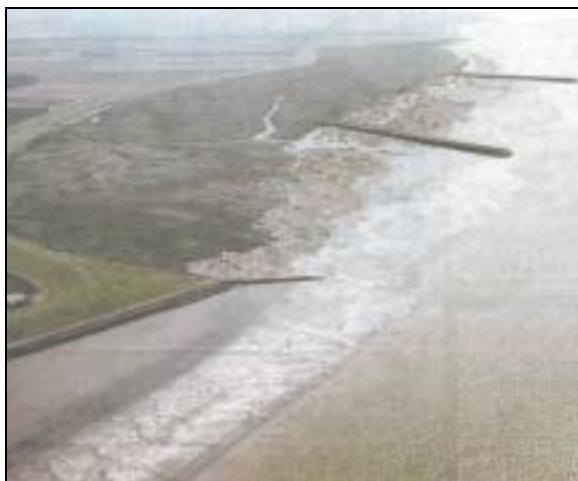
*Fig. 9: Protection of eroding salt marsh near Waarde.*

3. Thirdly, intertidal salt marshes are rehabilitated by constructing small piers (pile rows or stones) with the purpose of creating protected areas where sedimentation of fine sediment is stimulated (see Figure 9).

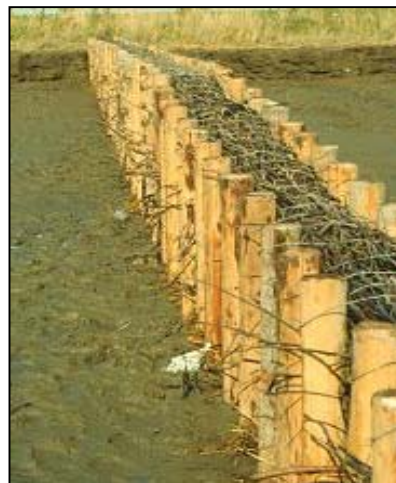
*Fig. 10: Pier protection of tidal area.*

Recently, a project was defined for the protection of the intertidal salt marsh (about 100 ha.) near Waarde (see Figure 10).

The costs of these protection works are estimated at € 2 M (NRC Handelsblad, 02.01.2003).
