Disused Shrimp Ponds and Mangrove Rehabilitation

N.J. Stevenson¹, R.R. Lewis², and P.R. Burbridge³

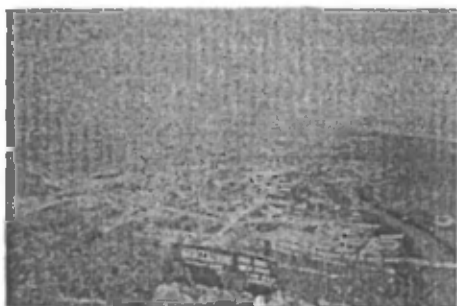
Figure 1. "Disused shrimp pond" or "pond in between production periods?" The paddle wheel at the side of the pond indicates that production may recommence. However, the overgrown grass indicates that the paddle wheel has not been used for some time. Sathing Phra, Thailand. Photographed by Nathalie Stevenson, January 1998.

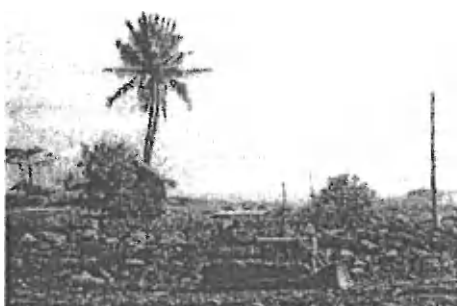
Figure 2. Disused shrimp ponds in Kuiburi and Pranburi Province, Thailand. Many of these ponds are in the area of Khao Sam Roi Yot Marine National Park with some occupying land within park boundaries. Photographed by Nathalie Stevenson, January 1998.

South of this region, Enright (J. Enright, Personal Communication) estimated that in late 1996 70-80% of ponds were "abandoned" in Kuiburi and Pranburi districts in Prachuap Khiri Khan Province, in the Gulf of Thailand. The authors conducted a brief survey of this area in January 1998, and at that time approximately 95% of ponds remained disused (Figure 2). The ponds at Kuiburi and Pranburi (some of which are within the boundaries of Khao Sam Roi Yot Marine National Park) exist in areas that were previously salt pan and only under water for 2 months of the year, during the monsoon months. A small number of ponds in this area were built in mangrove. The mangrove that existed along natural "khlongs" and in a narrow coastal strip is almost all gone, whether directly due to pond construction or due to alterations in the tidal flow. Ponds were reported to have been operational for 3-7 years before disease caused widespread crop failures and all culture operations ceased. The park is an important bird wintering area and a critical stop-over for migratory

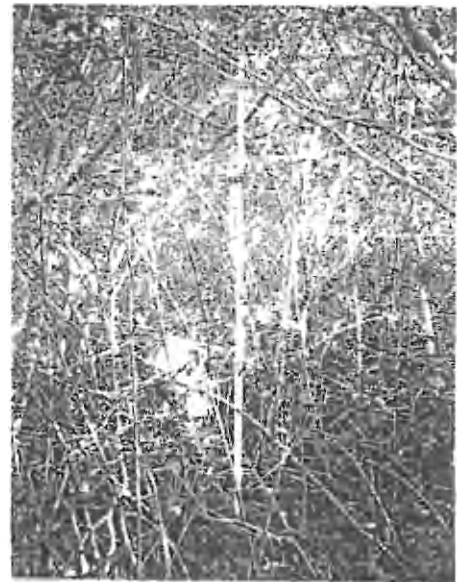
Figure 5. Aerial photograph showing pond number 1, a constructed shrimp aquaculture pond allowed to revegetate naturally with mangroves after the outer dike breached in 1987. 'A' is the location of the natural breach, 'B' is the location of the first sampling plot, 'C' is the location of the second sampling plot, and 'D' is the location of the third and fourth sampling plots. Photographed by Robin Lewis, September 1996.

The forests adjacent to the facility contain six species of mangroves: *Rhizophora mangle*, *R. racemosa*, *Avicennia bicolor*, *A. germinans*, *Pellicera rhizophora*, and *Laguncularia racemosa*. Two sites were chosen for quantitative sampling with two 5-m by 5-m plots established at each (four plots total). The first site (shown in Figure 4) was a 4-ha disused pond where the outboard dike had breached soon after the facility was purchased by the present owners in 1987. That breach is visible as location "A" in Figure 5. The owners decided not to repair the breach and to allow the pond to revegetate on its own in order to provide additional erosion protection from storm waves for the remainder of the ponds. The two plots were established at locations "B" and "C" in Figure 5. Location "c" is shown at ground level in Figure 7.

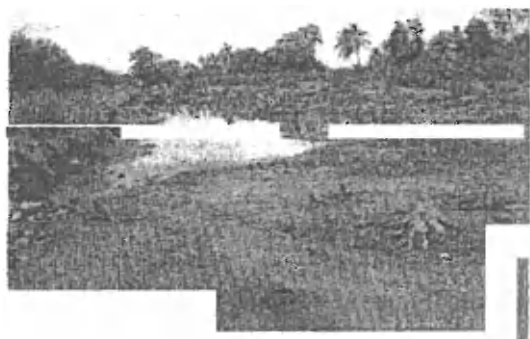
Figure 7. Ground level photograph of the mangroves in second sampling plot (naturally revegetated) inside pond number 1. The reference rod is 8 m long. The dominant species of mangrove are *Rhizophora mangle* and *Rhizophora racemosa*. Photographed by Robin Lewis, September 1996.

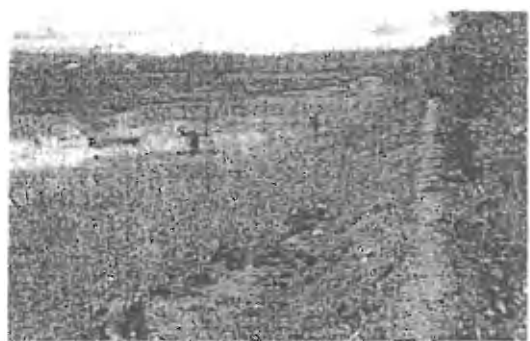
Figure 8. Disused shrimp pond in Bohol, Philippines, that has no tidal reconnection (pond walls remain intact). After 15 years there has been no recolonization. Photograph by Robin Lewis, December 1997.

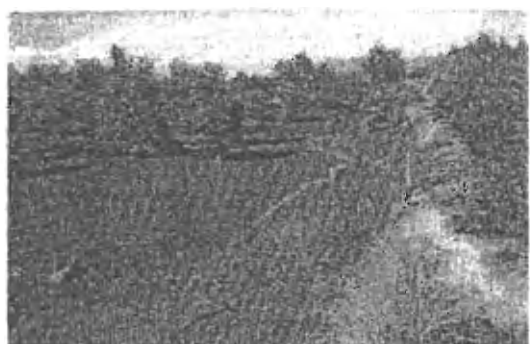
Figure 9. Breached disused shrimp pond in Bohol, Philippines, showing good recolonization of *Avicennia marina* after 5 years. Photographed by Robin Lewis, December 1997.
