Beach nourishment projects, practices, and objectives—a European overview

H. Hanson^{a,*}, A. Brampton^b, M. Capobianco^c, H.H. Dette^d, L. Hamm^e,
C. Laustrup^f, A. Lechuga^g, R. Spanhoff^{g,h}

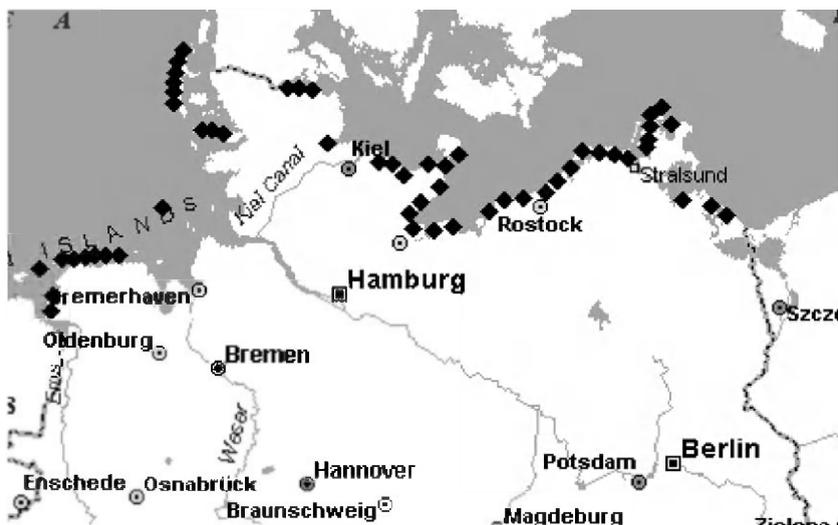
Fig. 1. Documented beach nourishment sites in Germany.

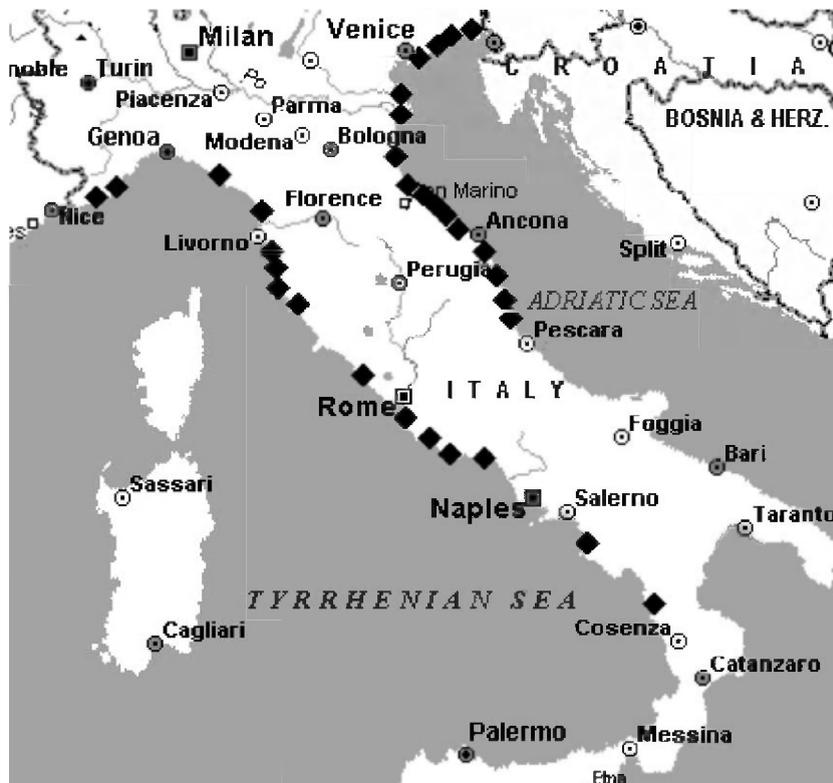
Fig. 2. Documented beach nourishment sites in Italy.

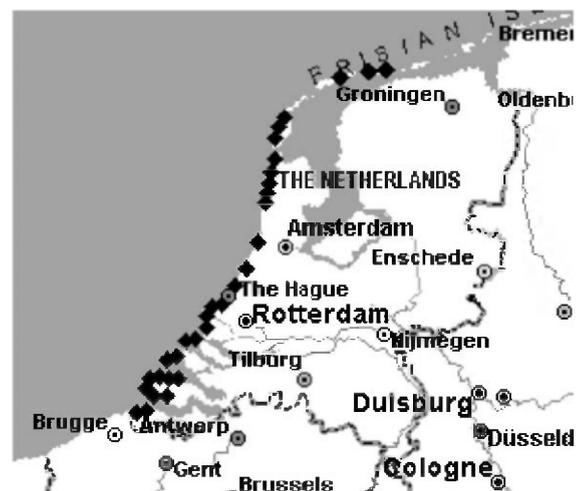
Fig. 3. Documented beach nourishment sites in the Netherlands.

fills and refills have been performed in about 35 sites adding up to a total fill volume of about 110M m³ (Fig. 3). Since 1991, the average fill volume amounts to about 6M m³ per year.

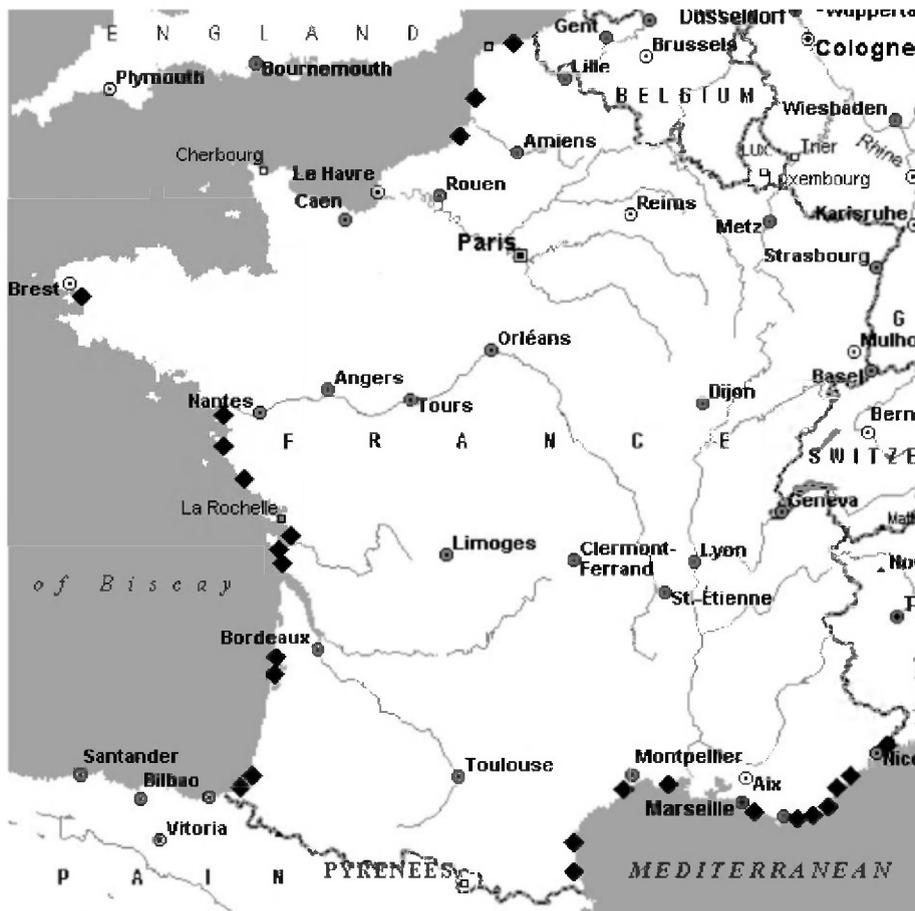
Fig. 4. Documented beach nourishment sites in France.

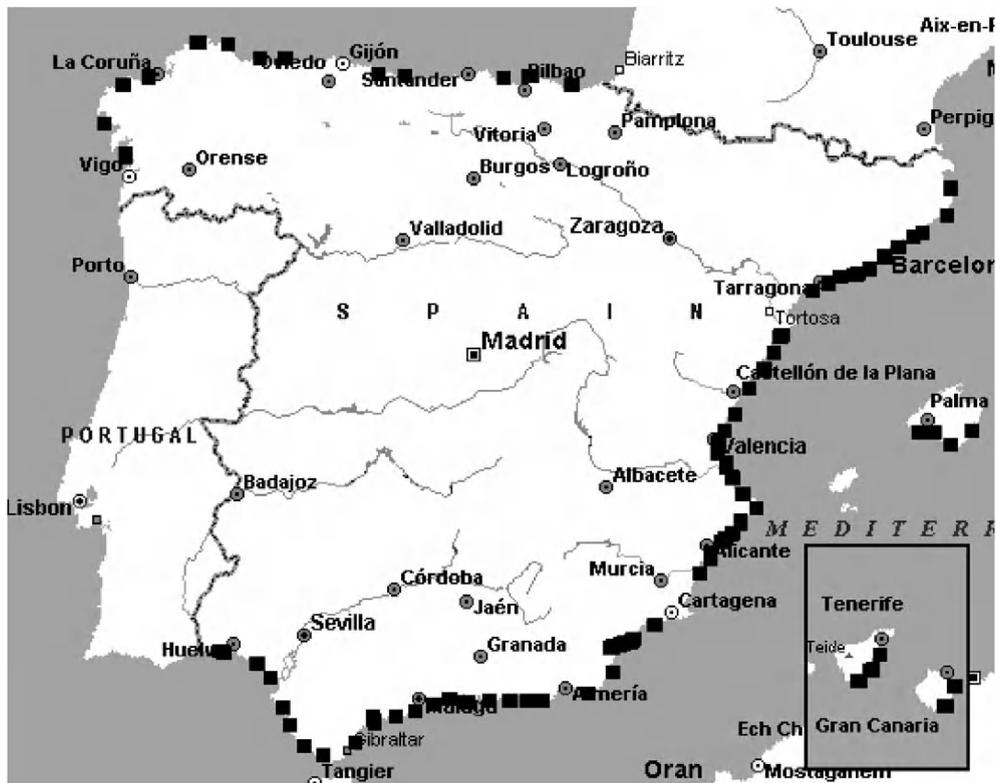
Fig. 5. Documented beach nourishment sites in Spain.

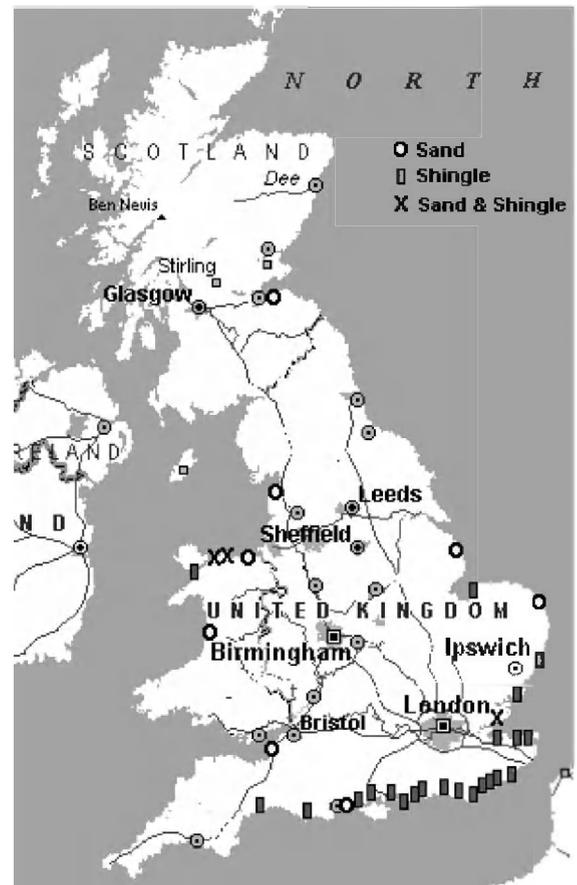
Fig. 6. Documented beach nourishment sites in the United Kingdom.

In the United Kingdom, the use of beach nourishment to complement traditional forms of coastal defence began in the 1950s. Regional flood protection authorities along eastern English Channel nourished shingle beaches in front of seawalls, using shingle (sand, gravel, and pebbles) collected from accreting beaches further down-drift. This form of “recycling” of beach sediments has been successful in extending the life of seawalls for over 40 years (Fig. 6).

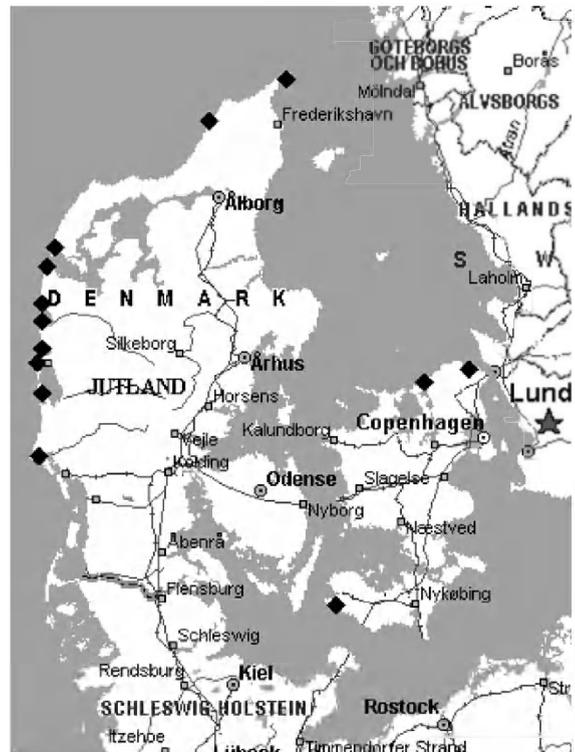
Fig. 7. Documented beach nourishment sites in Denmark.
