**AFTER
THE TSUNAMI**
Rapid Environmental
Assessment

United Nations Environment Programme

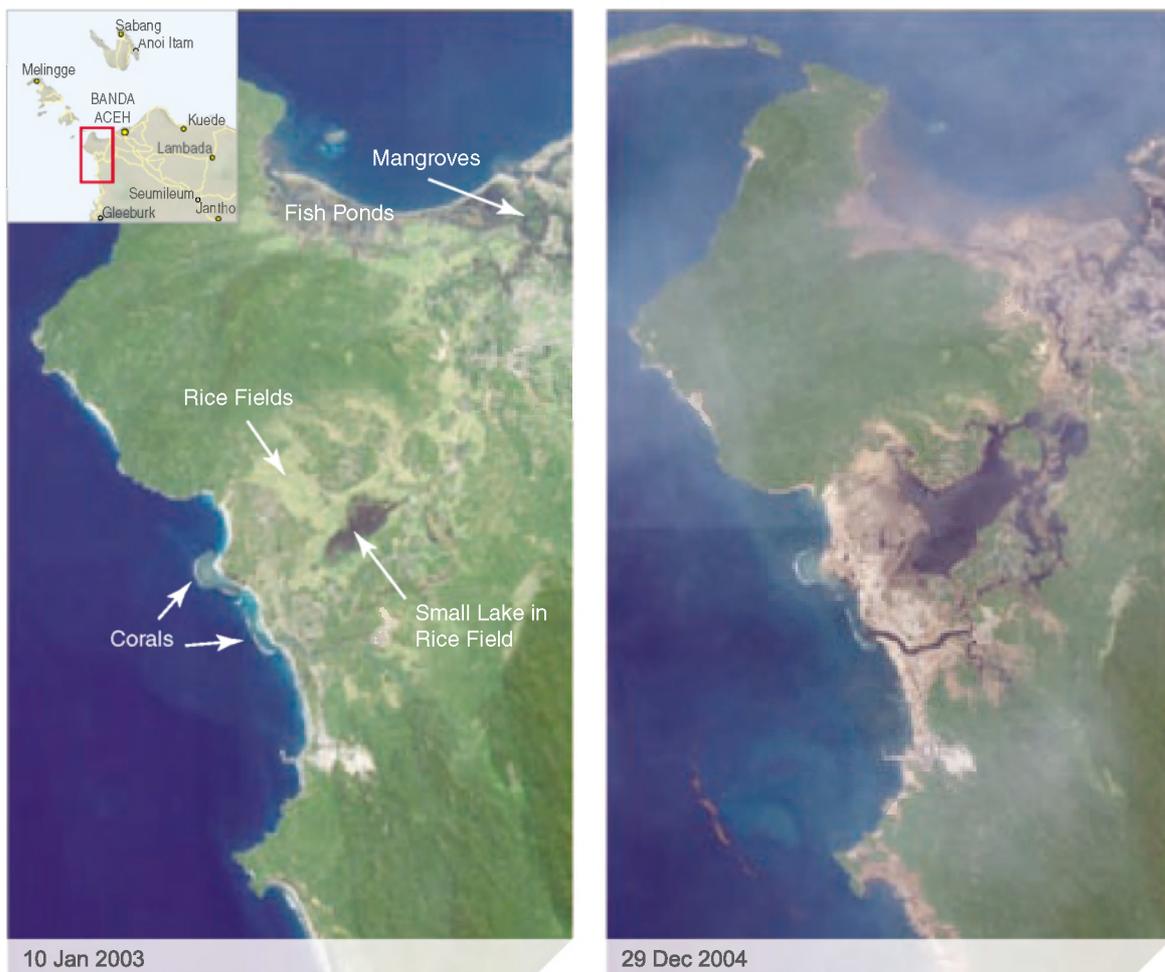
Case study: Overall damage to ecosystems in Sumatra

These images show a combination of a rocky, hilly headland along with a small river delta and swampy coastal strip. A low-lying wetland area connects the northern and western ocean fronts. An integration of natural and agricultural ecosystems operating prior to the tsunami combined rice cultivation, and fish/shrimp ponds (tambak), alongside natural delta mangrove forests and wetlands. Coastal forests and onshore reefs are also present. The effect of the tsunami is clearly evident. It scoured out the low lying delta land, destroyed fish ponds and removed mangrove cover. Volumes of soil and silt have evidently been carried out to sea expanding the area of the small lake by a factor of approximately 10. There has been removal of the sandy beaches (important in some locations for turtle nesting) and deposition of silt or mud on the reef. Apparently minor effects on the integrity of the rocky vegetated shoreline surrounding the headland are likely due to the resilient nature of the substrata, as well as dense natural vegetation cover and the sloping nature of the shore.

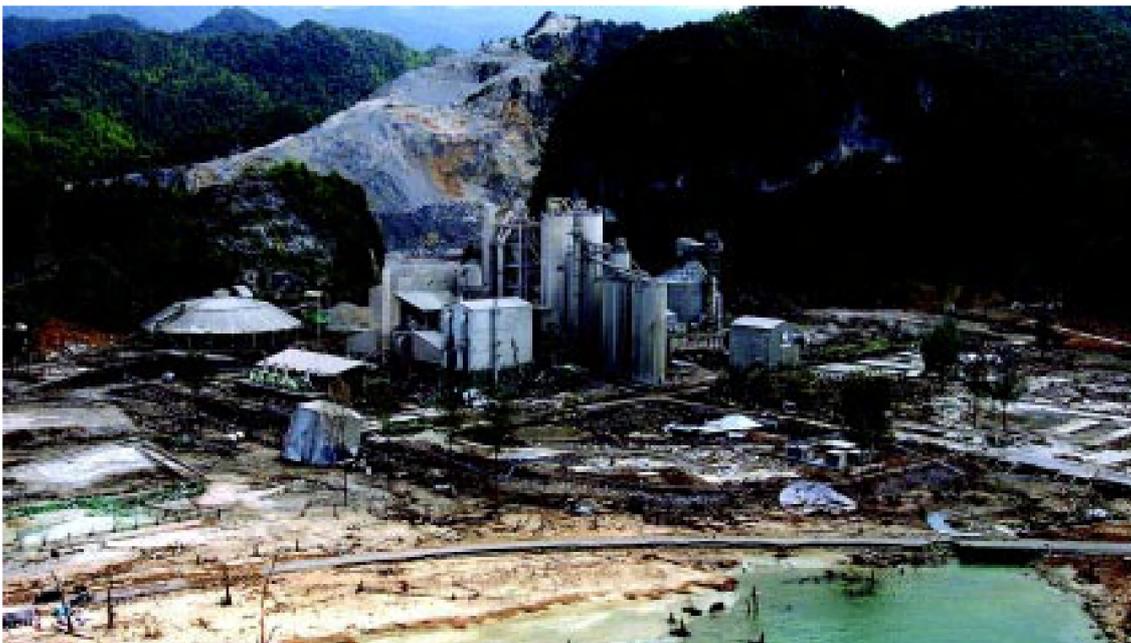
Lhok Nga, Indonesia (5 January 2005). Aerial view of a cement factory at Lhok Nga, south of Banda Aceh, Indonesia. The plant employed more than 600 people before the earthquake. The tsunami damaged an estimated 80 per cent of the facility and killed one-third of the workers. © Reuters/Choo Youn-Kong

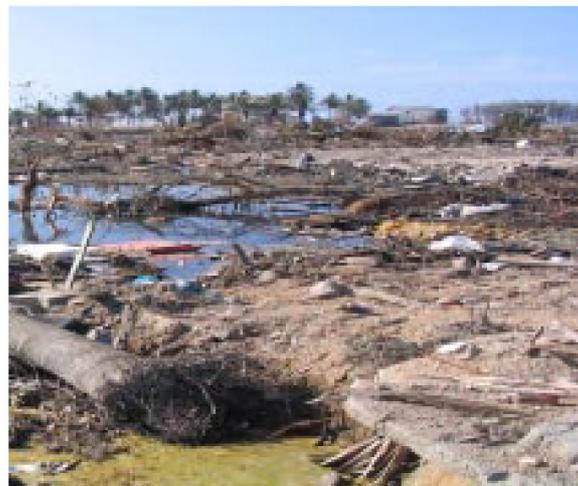
Phang Nga Province, Thailand (January 2005). Coastal area not protected by mangrove forests and severely impacted by the tsunami (location "1" on the map).

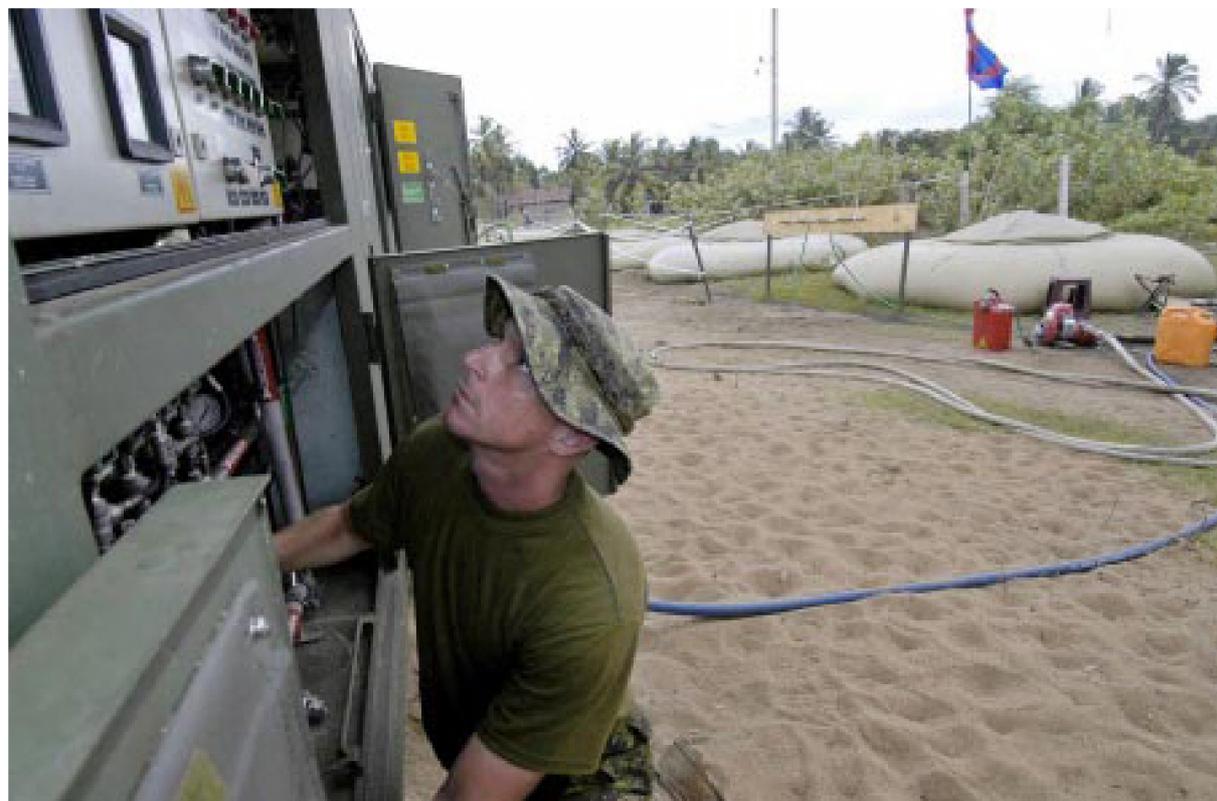
Kalmunai, Sri Lanka (3 February 2005). Checking the water purification machine in Sri Lanka's eastern town of Kalmunai. A 200-member Canadian military contingent is conducting relief operations on the east coast, providing clean drinking water for 80,000 tsunami survivors. © Prakash Singh/AFP/Getty Images

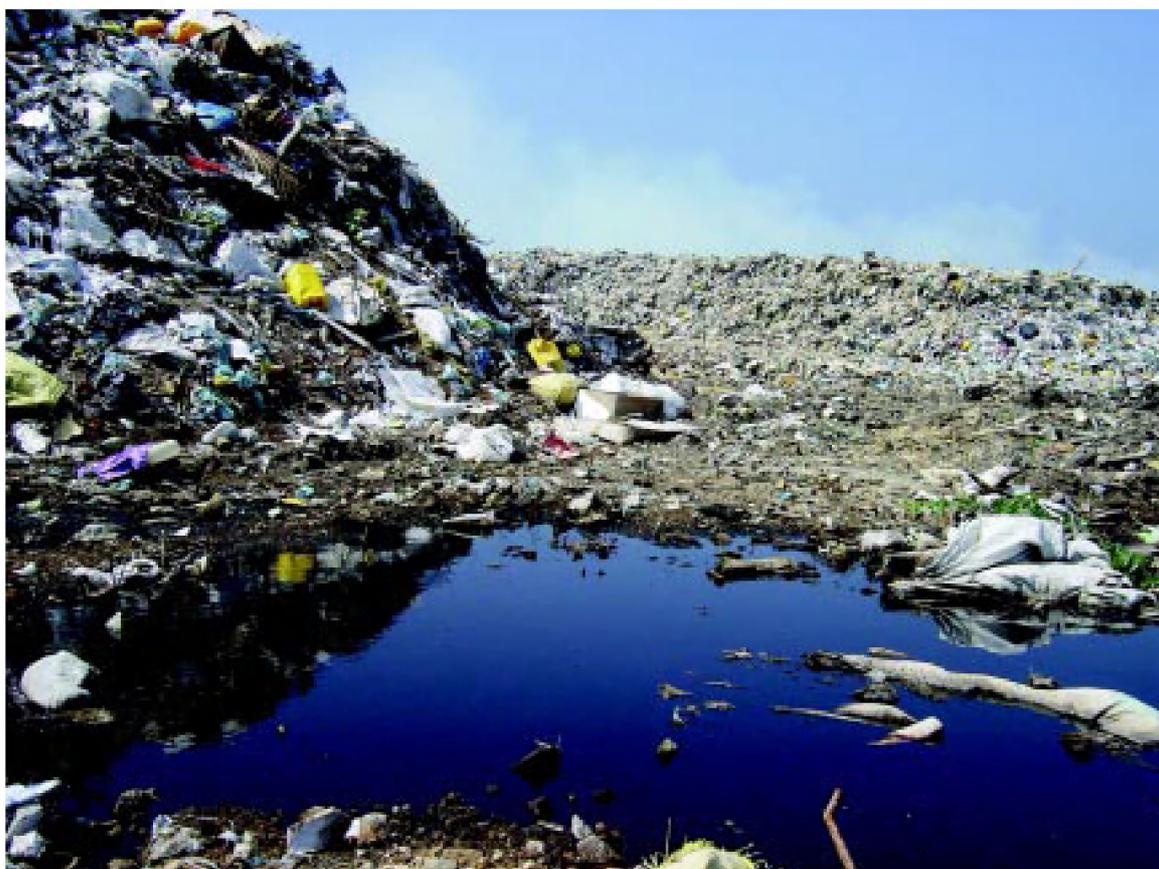
UNEP investigations of tsunami-affected islands consistently found solid waste dispersed over entire islands. Tsunami-related debris contains a mixture of demolition waste, household waste from former dumpsites, vegetation, metals, animal remains and hazardous compounds. Of particular concern is the presence of asbestos from roof sheeting. Initial clean-up operations have frequently worsened conditions by piling debris on the beaches, where it either washes off or threatens groundwater. UNEP has worked with the Maldives MEC to provide disaster waste guidance and waste management workshops and to commence an emergency asbestos management programme.

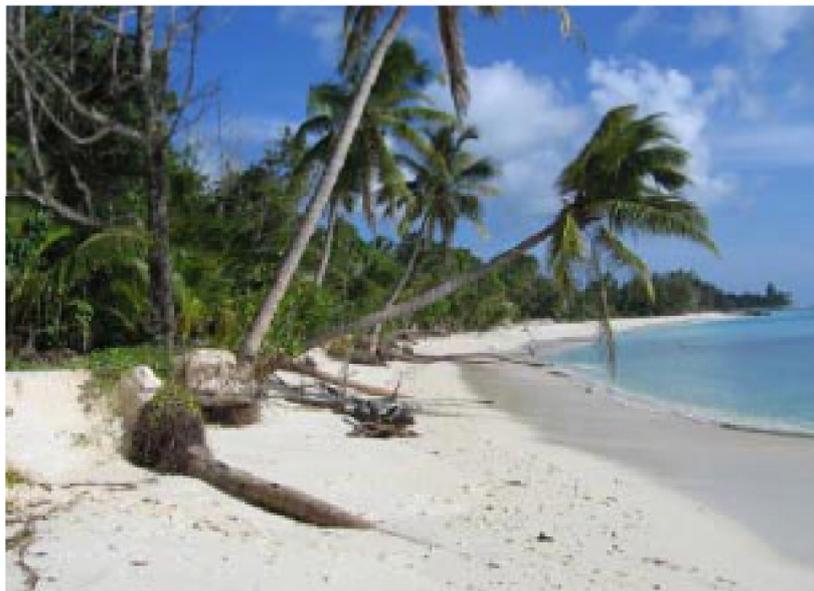
Anse Kerlan, Seychelles (5 February 2005). Eroded turtle nesting beach.
© Mark Collins/UNEP

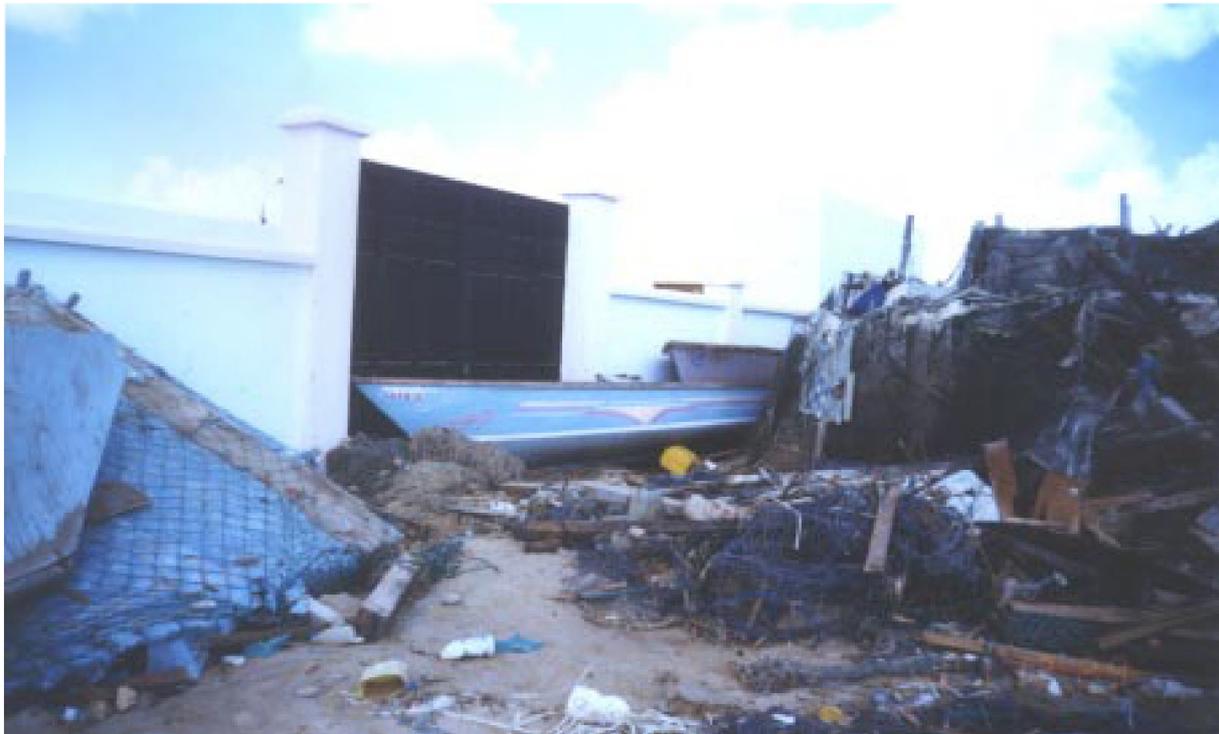
Muhayfif, Yemen (28 December 2004). Tsunami debris outside the offices of the Al Mahra Fisheries Association.
© Al Mahra Rural Development Project
