Bath construction at the Spanish Mediterranean seaside: maritime heritage for the coast environment

Abstract

This paper shows the study of different architectural, structural and constructive solutions implanted in each one of these typologies characterized by the use of fixed and removable lightweight structures and the evolution of piling systems.

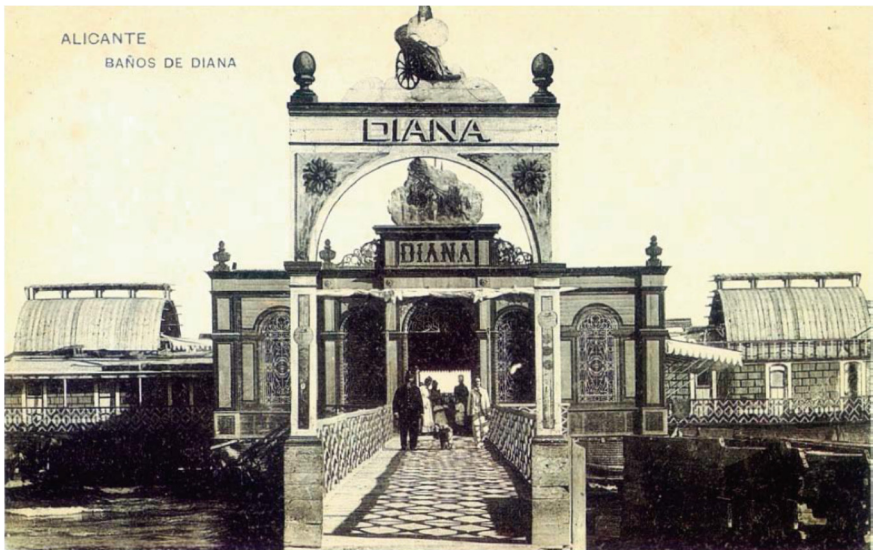
The door to the walkway had the common feature of providing extensive protection. It protruded from the width of the corridor, establishing itself more as a formal emphasis as an effective functionality, and conformed a 'front' hiding behind what happened. The walkway always appears with a handrail on both sides showing different degrees of complexity, presenting sometimes a kind of pergola covering till the halfway, before reaching the platform where the booths were settled. All these elements were combined obeying to very simple schemes, with tendency to symmetry. Their finishes used to materialize with wood painted in highly decorated and bright colors, offering the typical picture of these facilities (Figure 7).

Figure 7: Entrance to the Diana resort: early 20th century.
