Geotechnical characterisation of faulted Paleogene clays

B. Stuyts*, C. Devriendt
OWI-Lab (VUB / UGent), Brussels, Belgium

ABSTRACT: Paleogene clays constitute the substrate for the foundation of several offshore wind farms which are built or planned in the North Sea. In some of these clay layers, intense faulting and other deformations (often referred to as Clay Tectonics) were reported in several studies since the 1980s. Several hypotheses were put forward to explain the occurrence of these deformations. However, high-resolution geophysical surveys in the Princess Elisabeth Zone (Belgian Part of the North Sea) shed a new light on the genesis of these large-scale faults in the Paleogene clays of the Kortrijk Formation. It is put forward that the presence of these faults may influence the installation and operational response of foundations. An investigation into the mechanical properties of these deformations in the Kortrijk Formation is reported in this contribution.

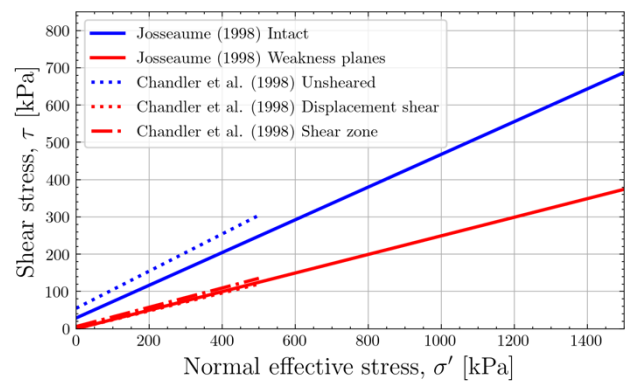
Figure 2 shows the drained shearing criteria for intact material and on pre-existing weakness planes.

Figure 2. Drained shear resistance properties for *Argile de Flandre* and London Clay (adapted from Josseume, 1998 and Chandler et al., 1998)

Josseume (1998) reported the results from extensive consolidated drained and undrained (CD/CU) triaxial testing on samples from Calais and Dunkerque. The orientation of the failure planes was also observed from the tests. If a sample failed at an angle which was significantly different from 45°, failure on a pre-existing weakness plane was likely. Mohr's circle was then used to infer the normal stress and shear stress on a plane with this orientation. By combining all measurements where a pre-existing weakness plane was activated, a drained shear strength criterion for the weakness planes was identified.

The drained shear box tests performed on samples from the intact material and the shear zones respectively, were used to derive drained shear strength criteria. When plotted in the same chart as the drained strength criteria proposed by Josseume (1998), very good agreement between the proposed strength criteria on the weakness planes is observed. Chandler et al. make a distinction between the strength of the displacement shears and the strength in the shear zone but the difference is limited. The intact criterion proposed by Josseume (1998) is more conservative than that proposed by Chandler et al. This could be due to the larger sample size in the triaxial tests which could lead to a lower mass strength.

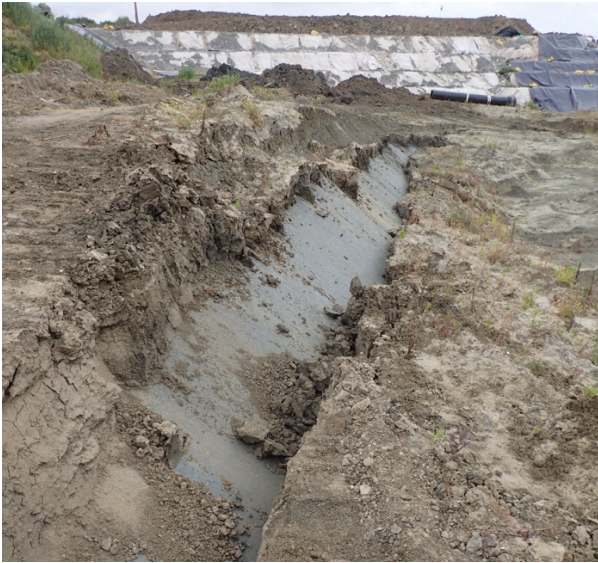
While the sampling of a fault plane in the offshore zone was not possible, shearing on pre-existing weakness was observed in onshore clay quarries in West-Flanders. Figure 4 shows a picture of an observed slope failure in the clay quarry of Rumbeke. The failure plane looked very similar to the slickensides reported from the offshore surveys.

Figure 4. Observed shear failure on a pre-existing failure plane in the clay pit at Rumbeke (image credit: Jan Maertens)

Unfortunately, the failed slope at Rumbeke was no longer accessible for sampling. However, a continuous sampling borehole with 100mm diameter thin-walled push samples was executed next to the clay pit. The borehole was positioned to intersect with the anticipated position of the pre-existing failure plane.

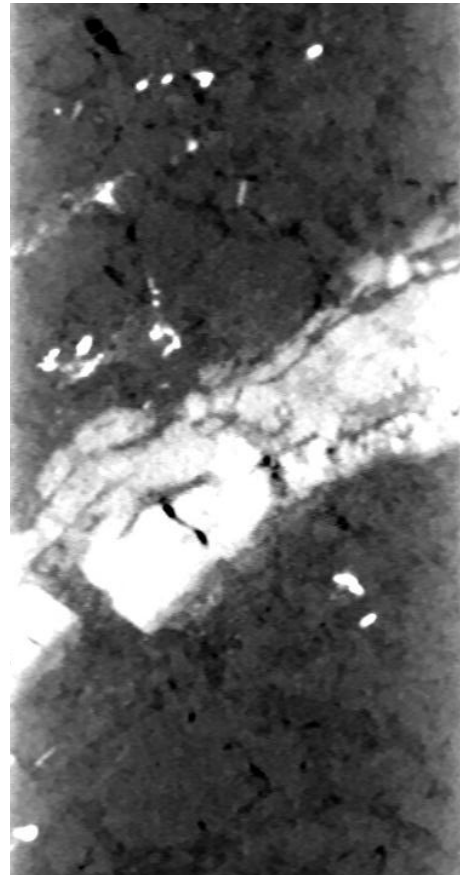
The scanning revealed a zoner of higher density material in the sample between 6.5m and 7.0m below ground surface (Figure 5). This higher density zone was relatively thin and thus only index testing was performed on this material. After index testing, the material subject to further mineralogical testing using X-Ray Diffraction (XRD). This revealed similar mineralogy to that of nodules found in the Kortrijk Formation (Reyniers, 2020).

The clay surrounding the high density zone also showed extensive brecciation as revealed by the dark features in the sample. The exact location and thickness of the shear zone could not be reliably inferred from the CT scan images. Hence, it remains speculative whether the higher-density zone in the

Figure 5. Higher density zone (lighter coloured) and brecciation observed in a sample taken in the vicinity of a shear zone

sediment can be linked with the observed failure plane in the quarry. This material was a mineralogy consisting of 23% Quartz, 2.9% K-spar, 1.3% Plagioclase, 63.5% 2:1 layer silicates, 1.6% Chlorite and 5.4% Kaolinite. Other minerals have an occurrence of less than 1% by weight.

(*) Sample from the high density zone in Figure 5

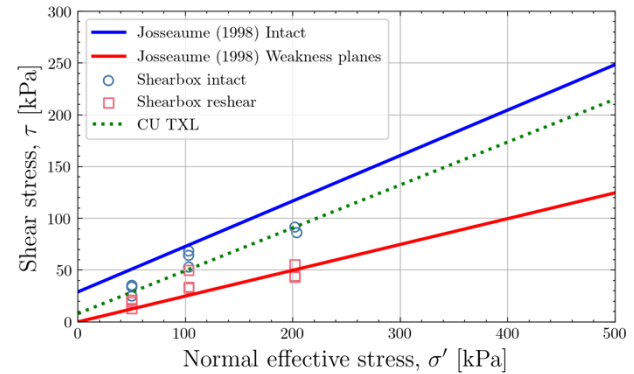
A comparison of the measured drained shearing resistance to the criterion proposed by (Josseume, 1998) in Figure 6 shows that the shear box

measurements plot below the intact shear criterion for the Argile de Flandre. This could be explained by the brecciation observed in the CT scans of the samples.

The drained shearing resistance measured in the reshear test did show reasonable agreement with the criterion by Josseume for the weakness planes. This suggests that the reshear tests can provide representative properties for drained shearing on pre-existing weakness planes.

A CU triaxial test with pore pressure measurement was carried out on three subsamples of the clays from the geotechnical borehole drilled at Rumbeke. Drained shearing properties were derived from the CU triaxial test and the resulting drained shear strength envelope was plotted in Figure 6. The drained envelope shows correspondence with the intact shear box test results but shows lower strength than the Josseume (1998) intact criterion. This could be due to the brecciation of the samples from the borehole at Rumbeke.

Figure 6. Comparison of drained shearing properties from direct shear and CU triaxial testing to criteria proposed by Josseume (1998)

While the drained shearing properties for a pre-existing weakness plane are nearly identical in all studies, the drained shearing resistance for the intact material shows a noticeably lower strength for the borehole in Rumbeke. This could be due to the brecciation of the sample and the effect of the smaller-scale fissures on the mass strength and stiffness will be investigated further in a follow-up project. The amount of small-scale fissures in the samples and their orientation relative to the failure plane will influence the results (Lo, 1970)
