COMRISK

Flanders/Zeeuws-Vlaanderen Case Study

Title:	Flood Risk Flanders/Zeeuws-Vlaanderen
Project:	COMRISK
Principal:	Coastal Waterways Department
Reference number:	I/RA/11226/04.059/KTR

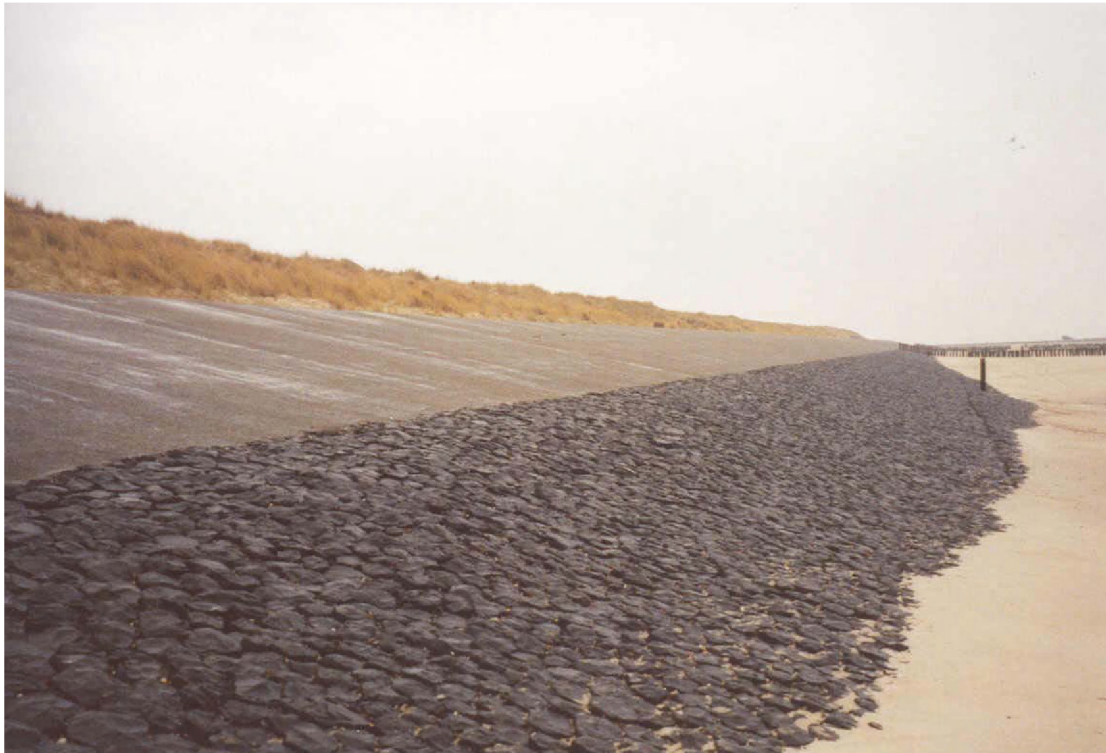
Stone pitching, asphalt revetment on the seaward side of the dike.

Zeeuws-Vlaanderen has both dikes and dunes. On the seaside the dikes typically have a revetment mainly consisting of stone pitching below a (flatter) berm and an asphalt revetment from just below the berm level to a few metres above this berm.

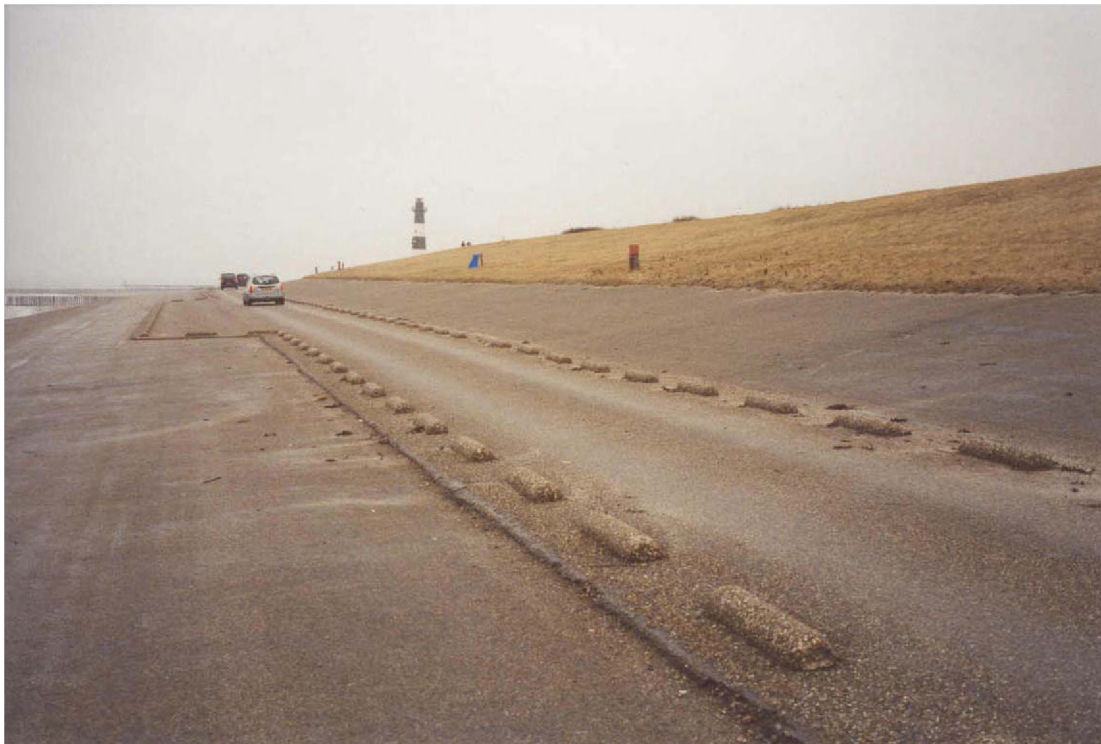
Asphalt revetment on the seaward side of the dike.

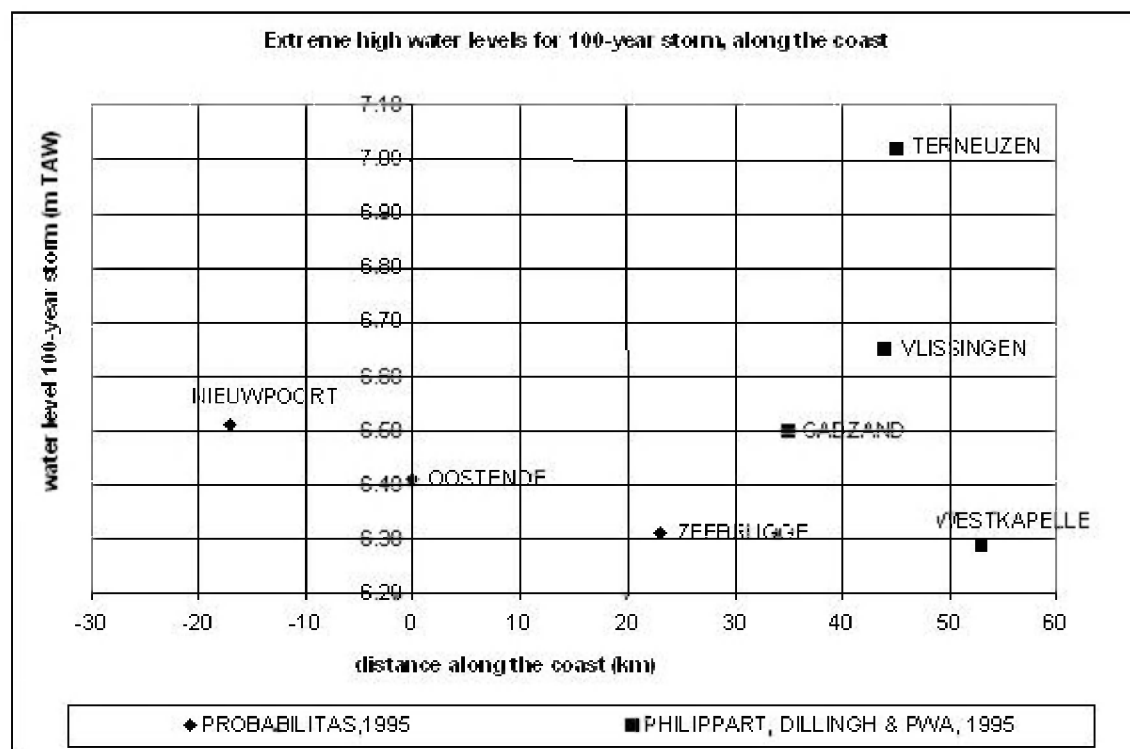
Figure 2 Evolution of extreme high water levels, for the 100-year storm along the coast.

The extreme value distributions of the water level above are deduced for the tide meter in Ostend. For other locations it is corrected by means of the high-water spring. It is assumed that the storm surge during the 1000-year storm is uniform over the entire coastline, and that only the tide causes variations. An analysis of the 100-year water levels (Verwaest, 2000), however, shows that the difference between the 100-year water level and the level of an average spring tide is higher in Vlissingen (1.88m) than in Zeebrugge/Ostend/Nieuwpoort (1.7m). This may be explained by the Scheldt mouth actually being formed by the Zeebrugge – Westkapelle line, as the water levels gradually increase from the estuary to the upstream river (e.g. Vlissingen-Terneuzen difference is 25 cm at spring tide, 45 cm during a storm). This extra increase will be taken into account linearly between Zeebrugge and Vlissingen.

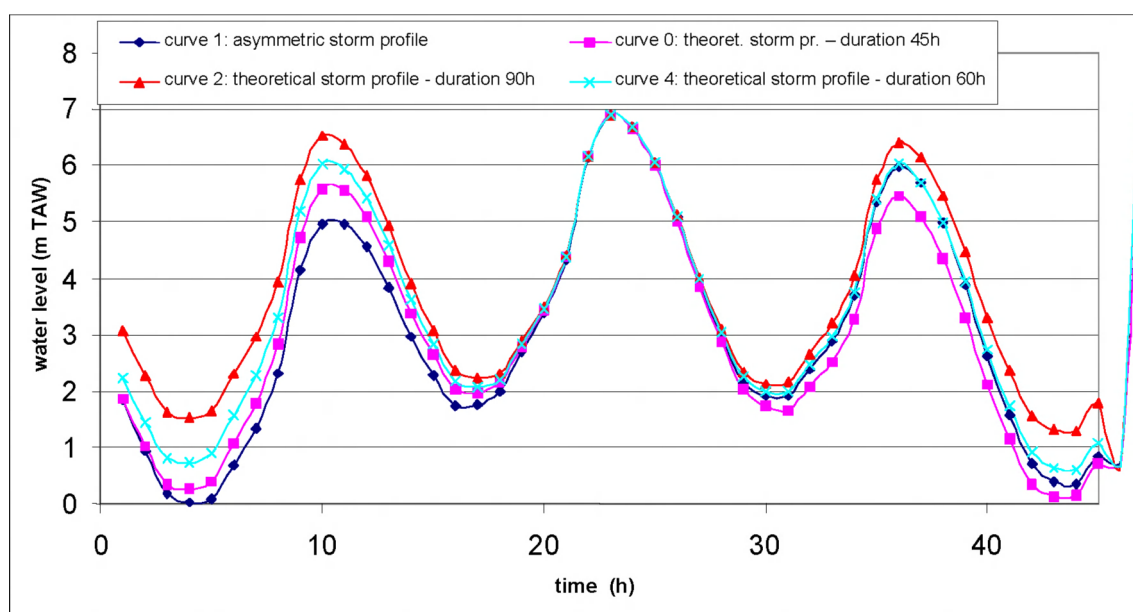
Figure 13 Evolution of a number of storm profiles during 45 hours.

A comparison between the theoretical profile (graph0) and the asymmetric profile (graph1) shows that this has little to no effect.

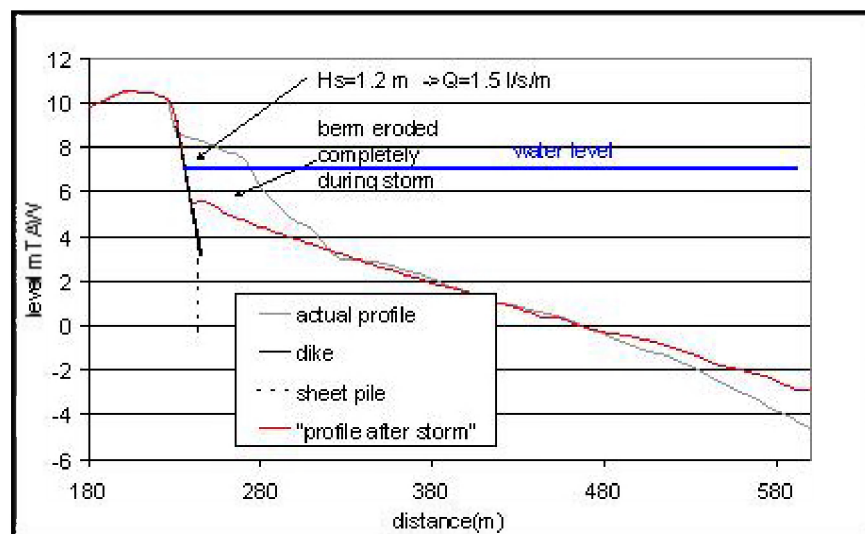
Figure 18 Evolution of the beach during a storm and consequences for the wave height at the toe of the dike.

Figure 18 shows an example of the beach evolution during a storm. Without erosion, the waves cannot reach the toe of the dike, but the berm before the dike erodes fully, resulting in waves of 1.2m at the toe of the dike.

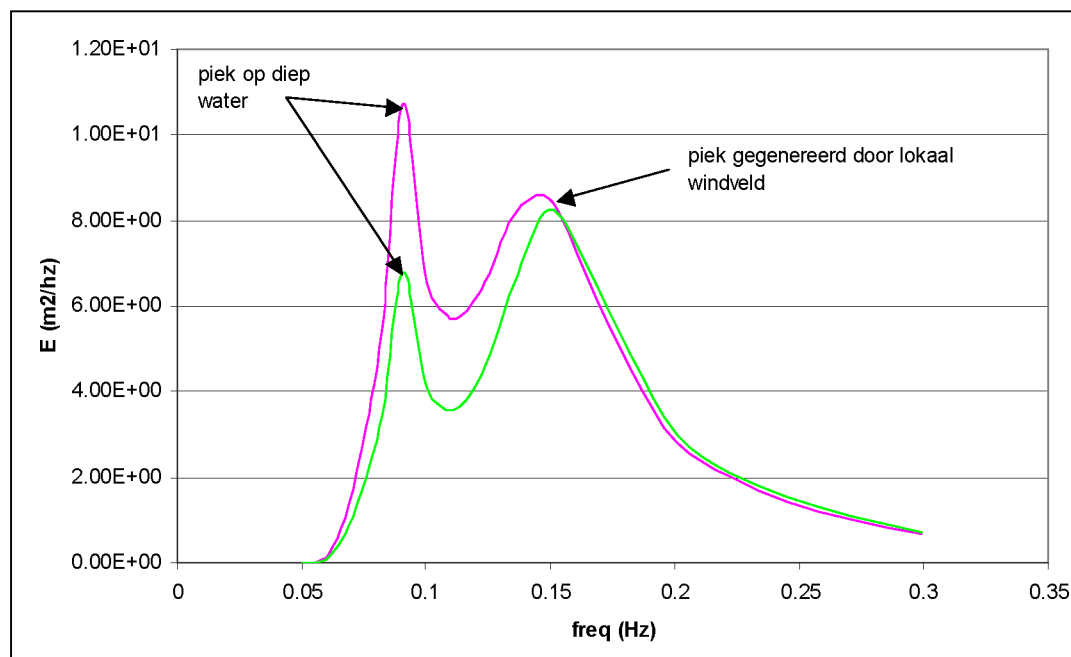
Figure 19 Spectrums to the east of Zeebrugge.

Isn't the second peak of the spectrum overly taken into account, and is this safe when using overtopping discharges?

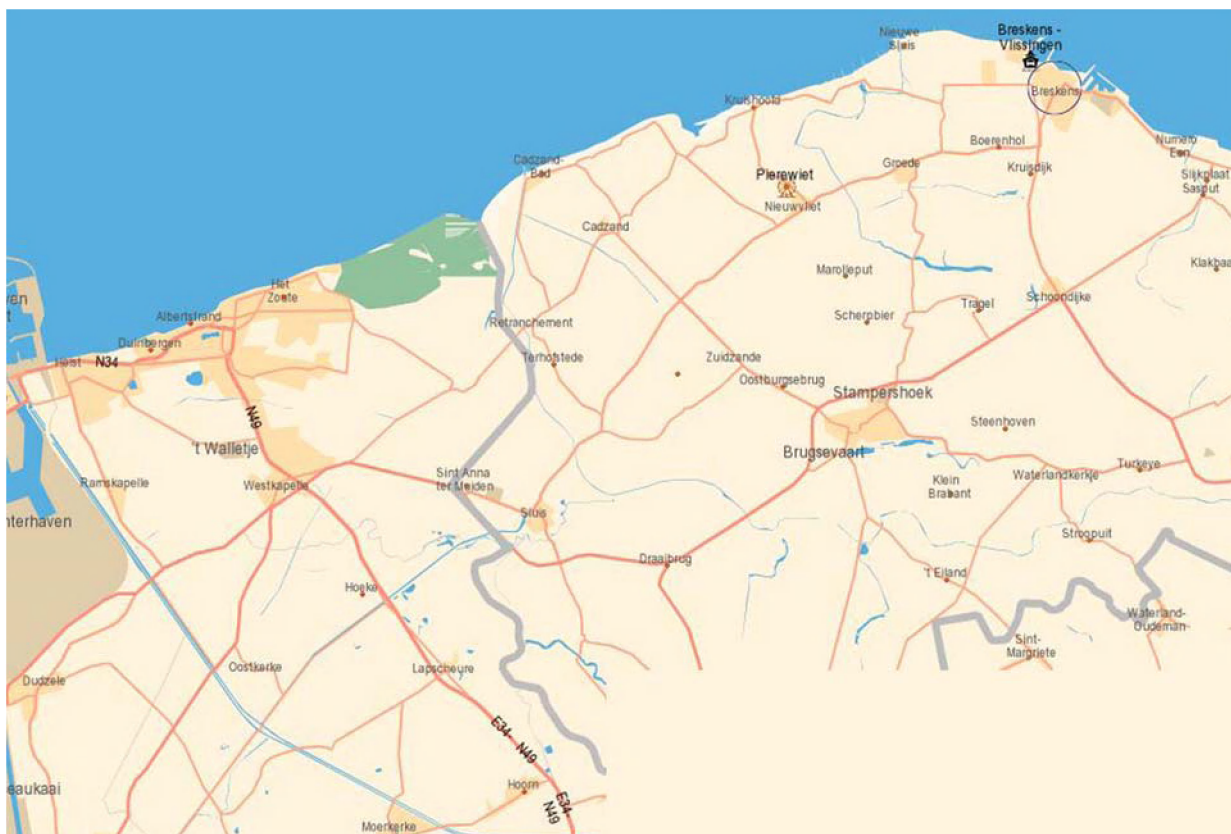
Figure 115: Situation of the study area¹

The study area included in the hydrodynamic 2D model comprises a limited part of the North Sea, including the coast between the port of Zeebrugge and Breskens on Dutch soil. The hinterland extends about 15 km inland.

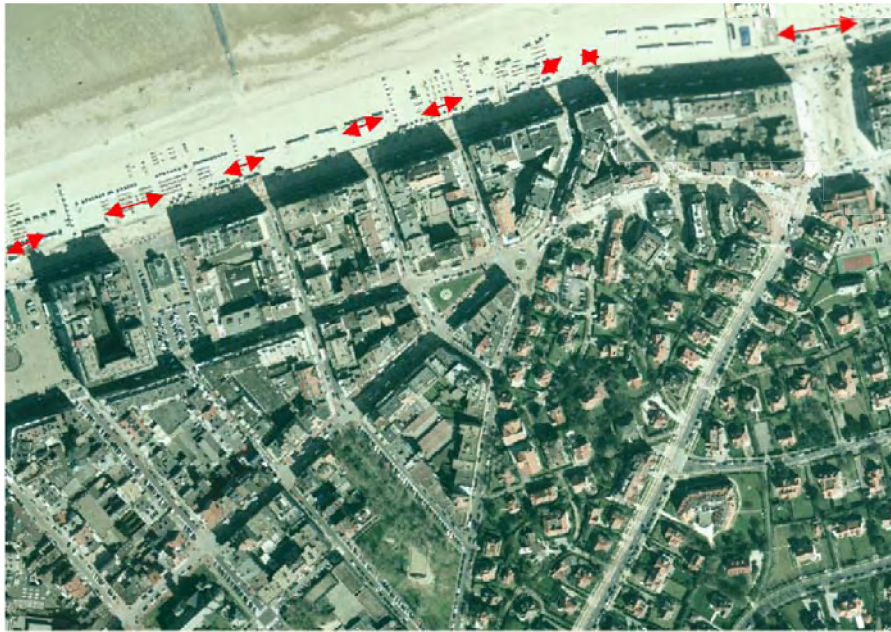
Figure 122: locations of breaches (red arrows)(situation in Flanders)

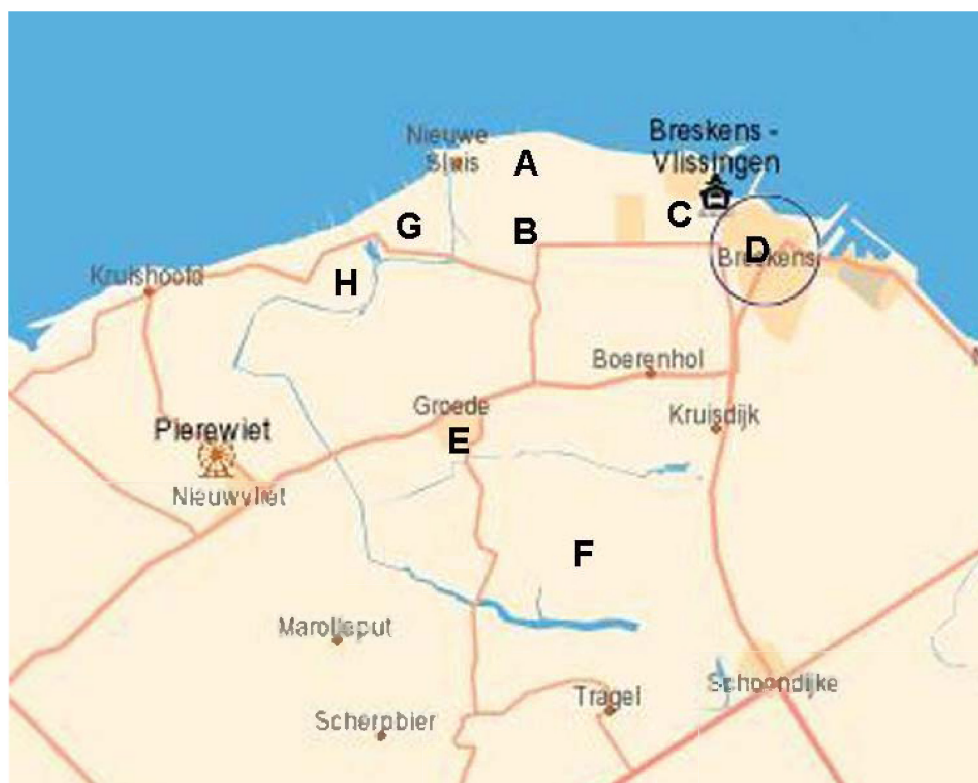
Figure 123: Locations of flood depths in Zeeland Flanders

Point	Location	Altitude mTAW
A	Nieuwe Sluis	2.92
B	Nieuwe Sluis below Walendike	3.22
C	Het Heem	3.35
D	Breskens	3.57
E	Groede	3.46
F	Agricultural area between Baarzandsche Kreek – Nieuwkerksche Kreek	3.00
G	Puijen dike	3.31
H	Zeeweg (Zwarte Gat)	3.23

These locations are given in Figure 123 and Figure 124. The altitudes of the corresponding grid cells are given in Table 50 and Table 49. It is not the average soil height of the area.

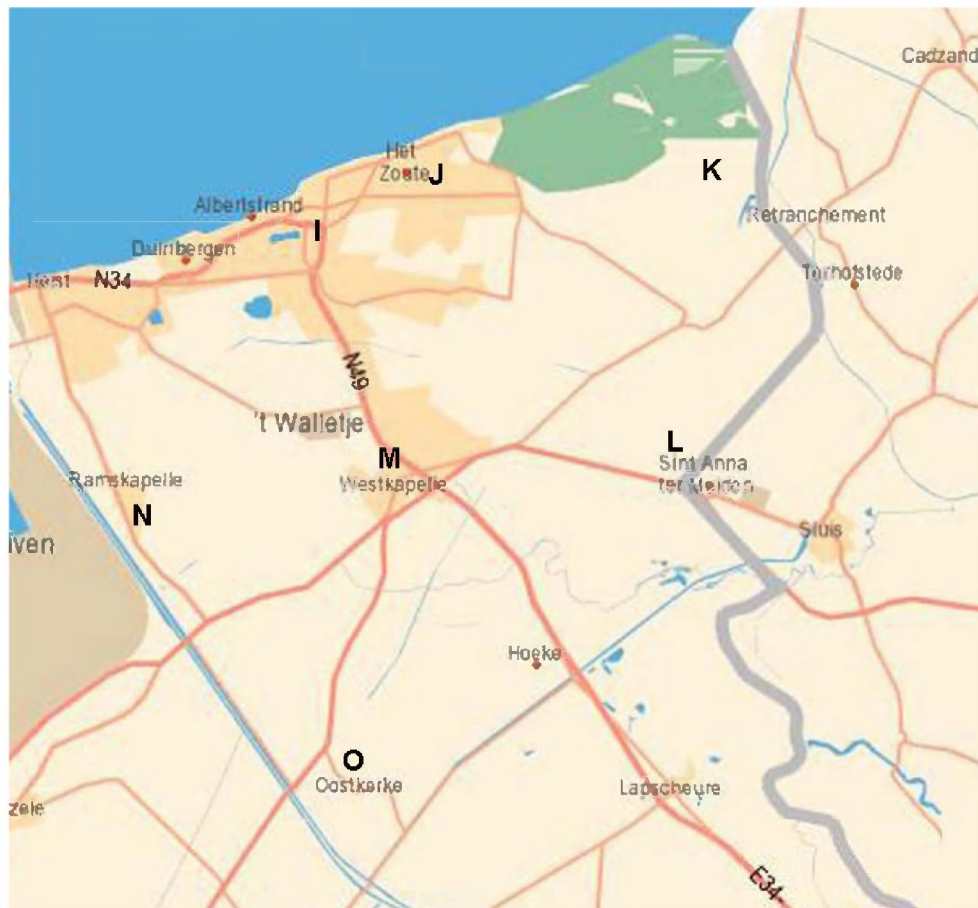
Figure 124: Locations for the results of flood depths in Flanders

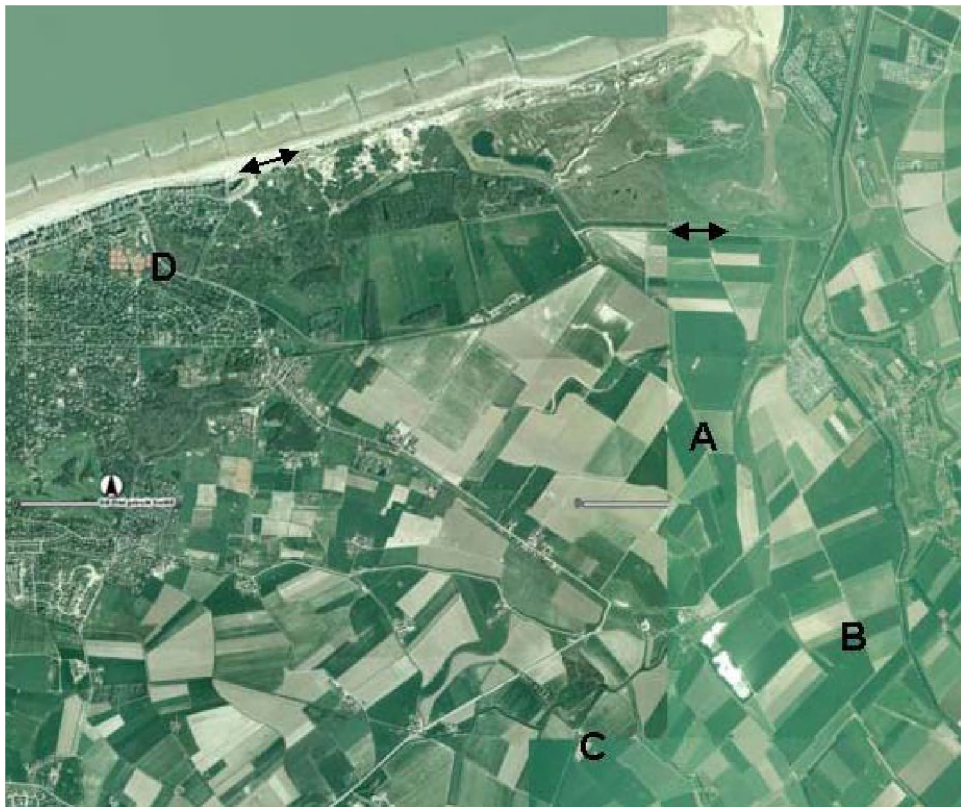
Figure 163: Locations for analysis of the influence of flood depth resistance.

Figure 163 shows the location where the influence of the roughness on the flood depth was analysed. Figure 164 to Figure 167 show the water depth calculated for the various locations.

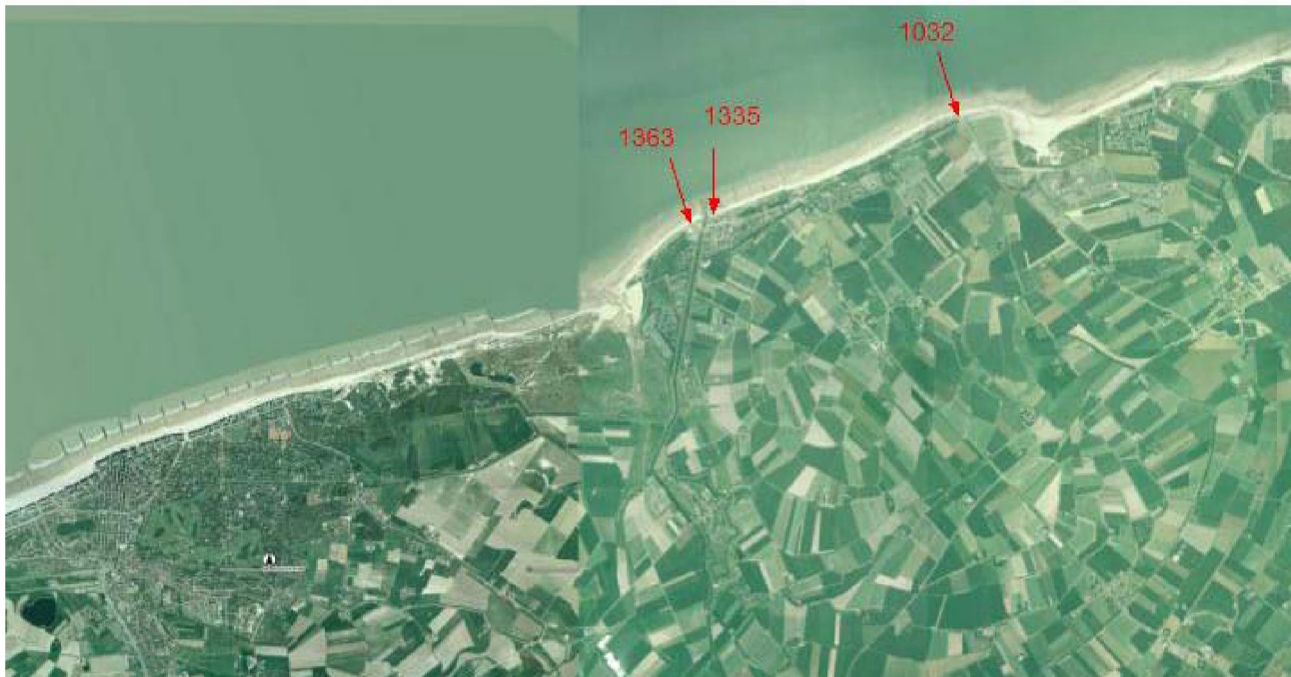
Figure 179: Locations of additional dike breaches at Cadzand

The dike breach at Zwarte Polderweg (dike profile 1032) causes additional flooding in the Tienhonderd polder reaching to the Strijder dike.

An overview of the parameters used for the dike breaches at the 3 locations is included in the table below. The locations of the additional dike breaches are given in Figure 179.
