German U-boat development during World War I

Tomas Termote

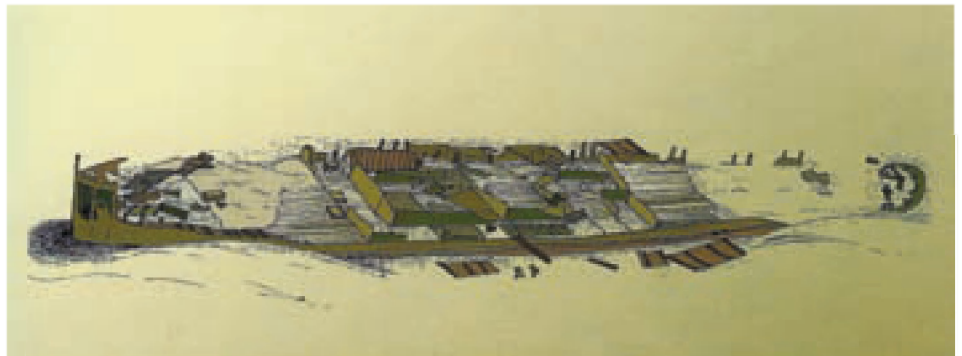
■ Sketch of the wreck of cross-channel ferry *MV Queen of the Channel* (Tomas Termote)

wrecks on the Flemish Banks. The wreck of cross-channel ferry *MV Queen of the Channel*, sunk at Middelkerkebank in 1940, was relatively intact when it was discovered in 1987. The bow was in an upright position, with secured anchors, winch and mast foot as identifiable parts. The author can confirm that nearly 20 years later, the sides of the bow of *MV Queen of the Channel* had collapsed and the winch, anchors and superstructure lay scattered and buried.

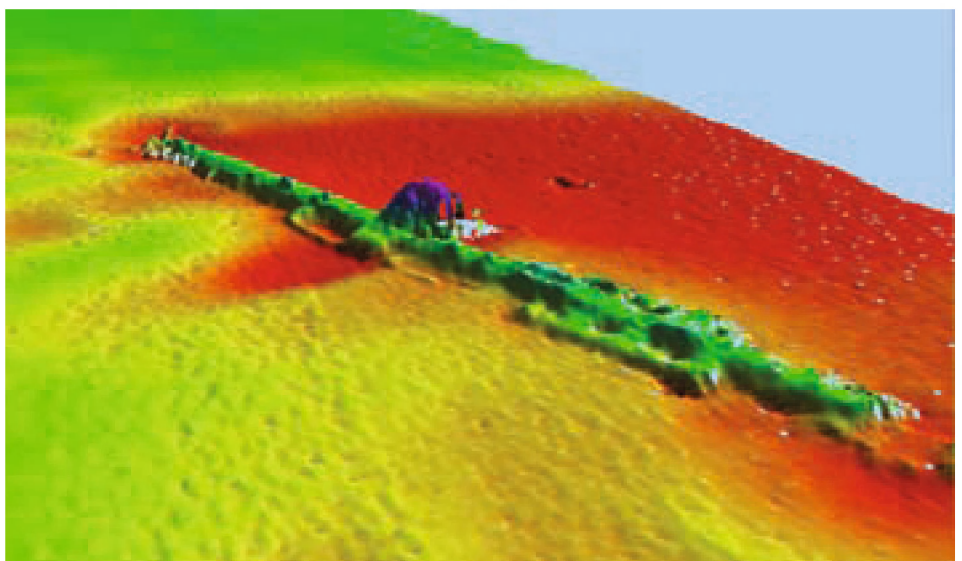
■ The typical 'cigar shape' and the central conning tower make a submarine wreck easily recognisable. This is the wreck of UB-59 near Zeebrugge, visualised by means of acoustic (multibeam) techniques (MDK – Coastal Division)

wrecks are among the most resistant to natural and human impacts. These wrecks can have a lifespan of 100 years or more. They are easily recognisable too. Even on acoustic images created by means of a side-scan sonar or multibeam echosounder, the prominent 'cigar shape' and the central conning tower are very striking (see below).

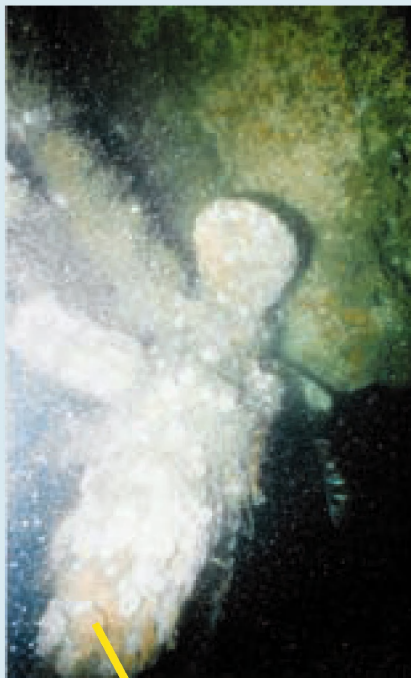
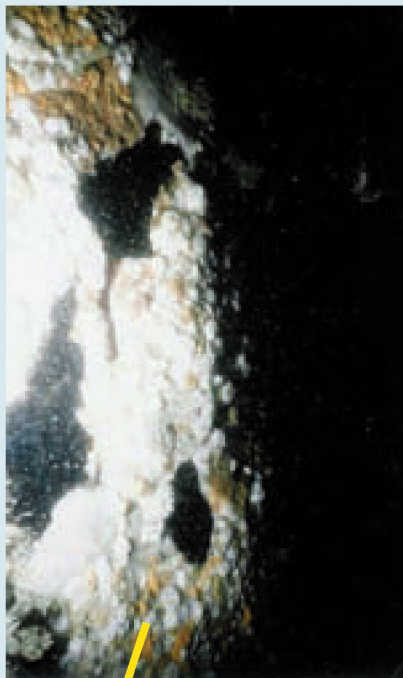
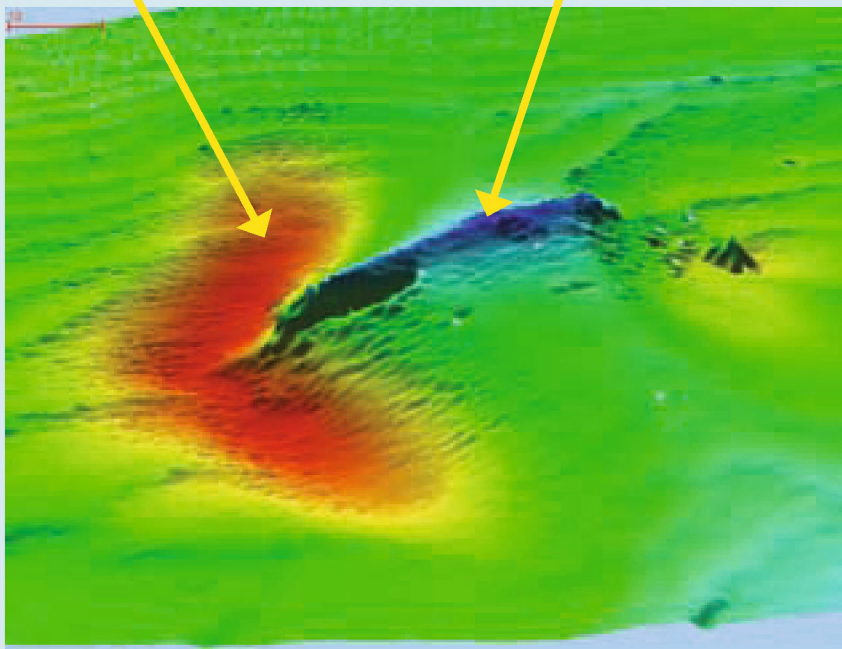
■ A multibeam image of the location of UC-62 (below). The red area indicates scouring as well as the deepest point of the wreck (below the stern). This is the location of the port propeller featuring the U-boat number.

The elevated blue area in the middle is the remains of the conning tower. The picture (top right) clearly shows the three holes in the conning tower hull which indicate shell bursts. The fragment (top left) is the broken bow of UC-62

The case of the wreck of UC-62 on Thornton Bank proves that fieldwork can confirm but also refute the historical facts. In 1993 the remnants of a large mine-laying submarine were found in deeper waters north of Thornton Bank, approximately 1 mile from Dutch territorial waters. The wreck showed heavy damage at the mine chutes; the bow had been ripped off and was lying some distance away. It was clear that the damage had been caused by a torpedo impact. The most intriguing aspect was the presence of three irregular holes in the pressure hull of the conning tower. When the hubs of the three-bladed propellers were cleared, the U-boat number turned out to be UC-62. Both German and British historical sources state that UC-62 disappeared around Portland – St Albans Head during her ninth mission in mid-October 1917. The U-boat was supposedly sunk by an enemy mine. During the time of the disappearance of UC-62, British submarine HMS E-45 was able to hit a surface-running enemy U-boat near Thornton Bank. In the log of HMS E-45, the captain mentioned firing two torpedoes from a distance of 400 m and hitting the U-boat in front of the conning tower, after which she sank immediately. The three irregular holes in the conning tower hull were probably caused by gunfire impacts incurred earlier on. As a result, UC-62 was unable to submerge and fell victim to HMS E-45.

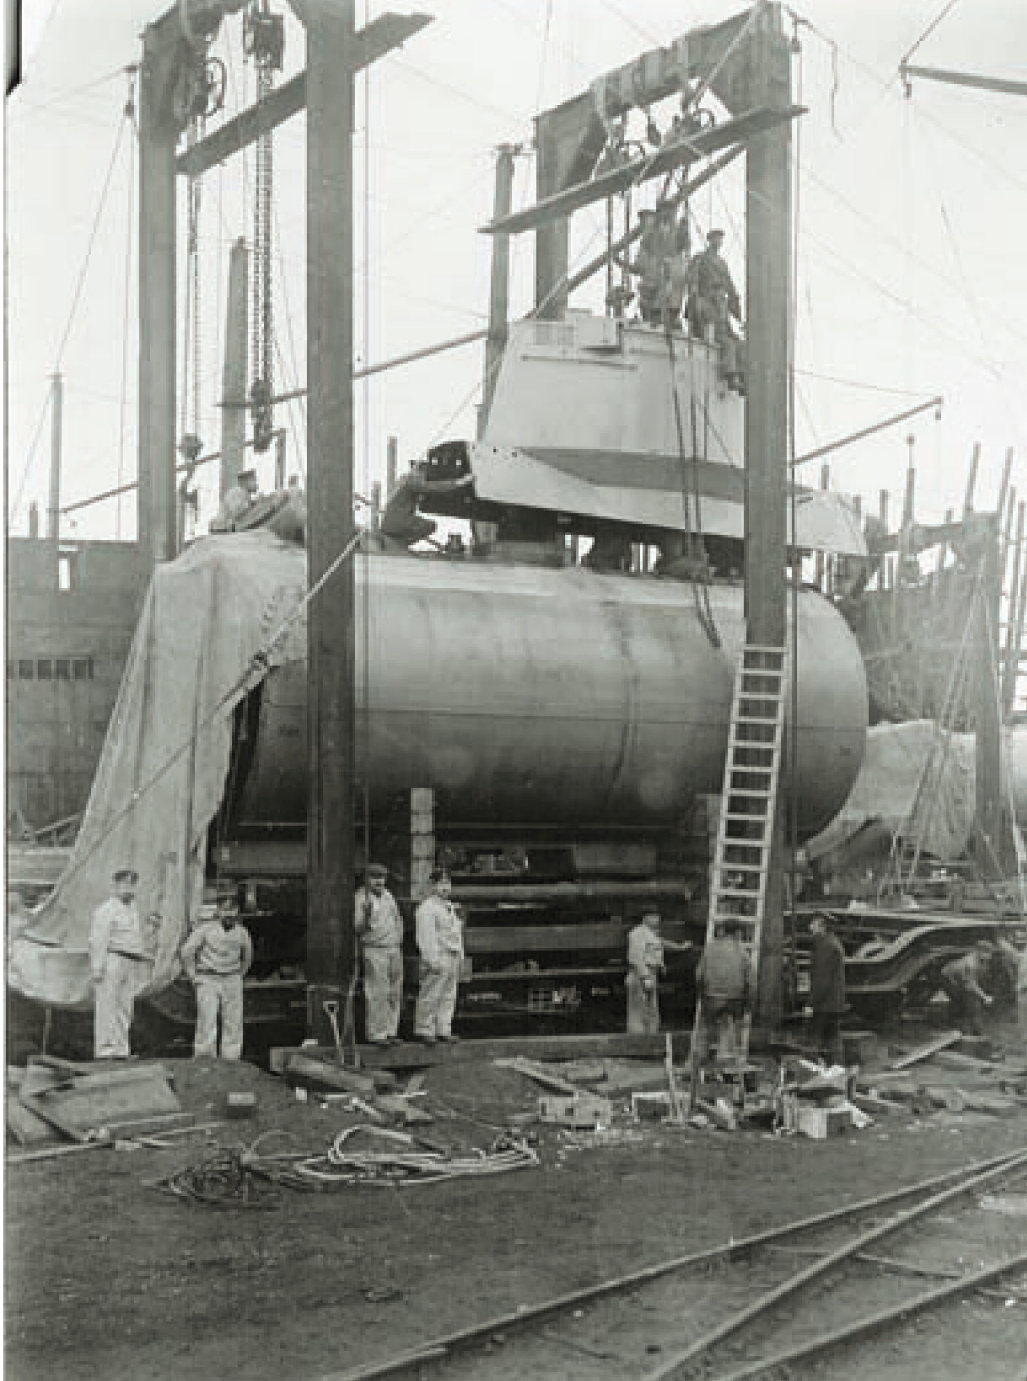
■ A UB-I type submarine at the Hoboken naval dockyard in 1915 (Dirk Termote)

and their fifteen components were loaded onto different flat wagons. The four biggest components were the bow section, the mid section, the conning tower and the stern section. After a five-day journey they arrived at the Hoboken naval dockyard, where they were reassembled.

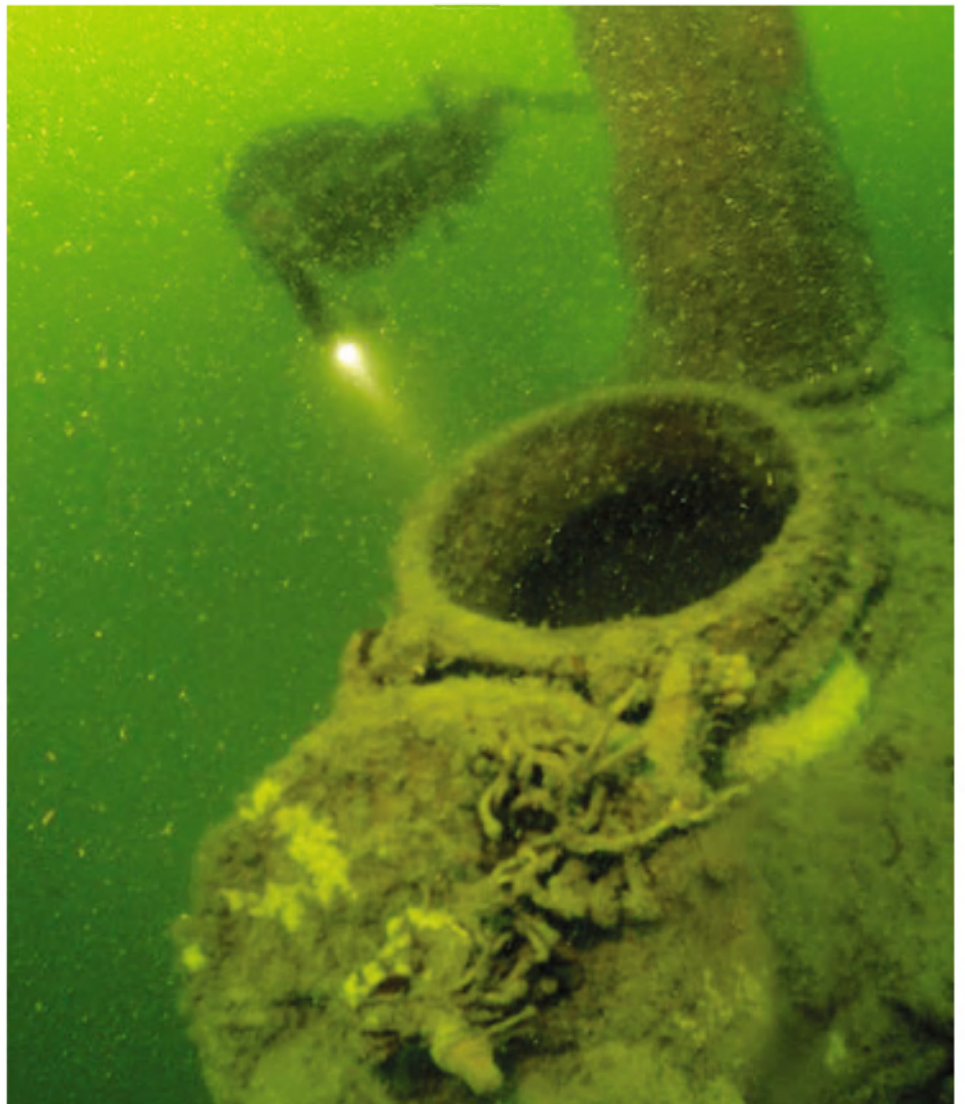
■ A diver explores the conning tower of a UB-III type U-boat on Fairy Bank (Harry Klerks)

One of the most remarkable wrecks is located on top of Fairy Bank. The site itself is limited to a large conning tower protruding from the seabed and part of the upper hull as well as a few stowed bottles of compressed air. On top of the conning tower there are periscope standards with retracted periscopes and an open hatch. The site is remarkable because it contains a large UB-III type submarine, 90% of which has been covered by sand. The U-boat has not yet been identified with certainty, but possible candidates are *UB-54*, *UB-56* or *UB-58*.

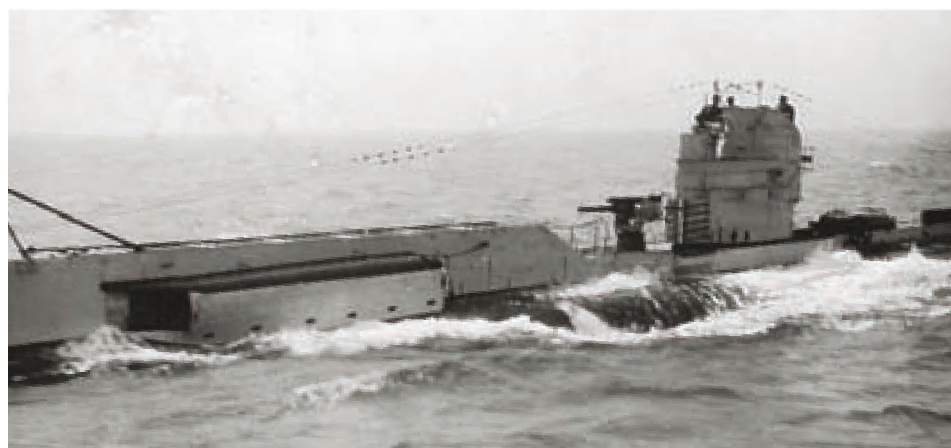
■ A UC-II type submarine at sea. This type of U-boat carried 18 mines in 6 internal chutes as well as a gun in front of the conning tower (Tomas Termote)

featured an elevation fitted with six vertical mine chutes with a total carrying capacity of 18 mines. This had the advantage that the mines were stored dry, contrary to the UC-I type submarines, where mines were located outside the pressure hull. The UC-I type required the depth to be set in the harbour prior to departure and this setting could not be adjusted afterwards. In case of the UC-II type, it was possible to adjust the depth setting during the voyage so as to determine where and at what depth a minefield should be laid on site. UC-II type submarines were also equipped with three torpedo tubes and

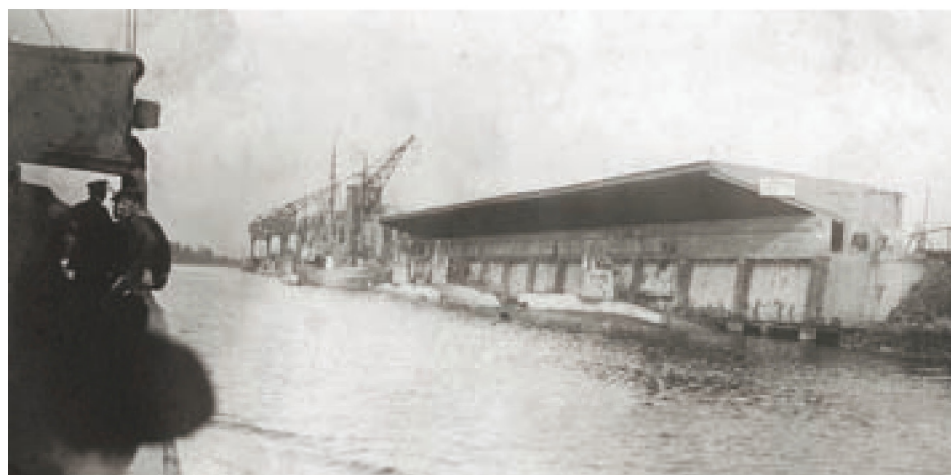
■ A torpedo boat passes a few moored UB-I type submarines in the Bruges inner harbour. They were somewhat protected against possible air raids by means of concrete and wooden lean-to constructions (Tomas Termote)
