Article

Quantification of the Service Life Extension and Environmental Benefit of Chloride Exposed Self-Healing Concrete

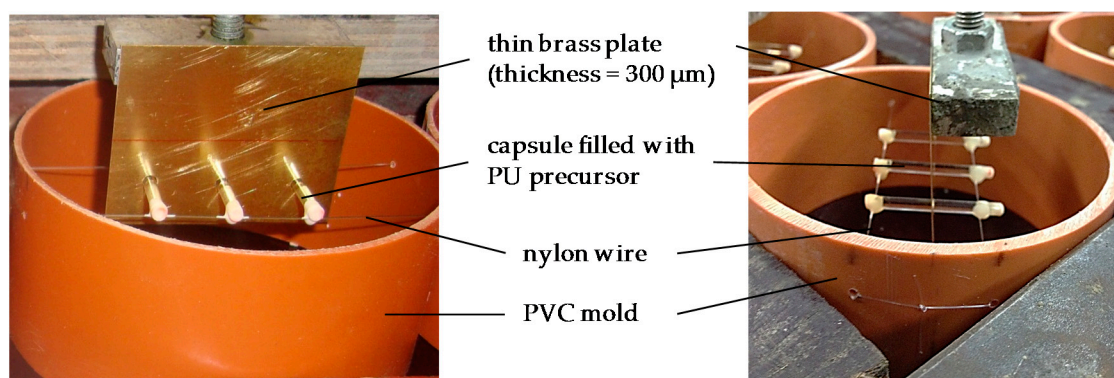
Figure 1. Preparation of self-healing concrete samples.

After the preparation of the molds, the concrete was cast and the specimens were stored in an air-conditioned room at a temperature of 20 °C and a relative humidity of more than 95% for 24 h. Subsequently, the specimens were demolded and stored in the same environment to cure until the age of 28 days. After the curing period, the plates were removed from all samples creating standardized cracks with a predefined width, depth and length of 0.3 mm, 25 mm and 60 mm, respectively. For the specimens with the self-healing properties the capsules broke due to the removal of the plates. In this way, the healing mechanism was triggered and the healing agent was released in the crack.

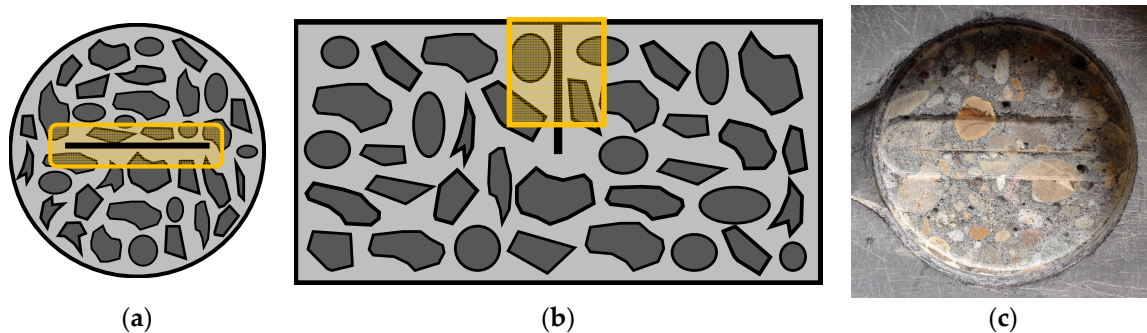
Figure 2. (a) Schematic top view of the 16 mm × 78 mm zone around the crack that was ground off; (b) schematic side view of the material ground away around the crack; and (c) top view of a specimen where a 2 mm thick layer of concrete was ground away around the crack.

profiles of the specimens at the respective exposure times were determined by grinding off material in layers of 2 mm parallel to the exposed surface. A diamond coated drilling head with a diameter of 16 mm was used to grind away the material in a zone of 16 mm × 78 mm around the crack (Figure 2), similar to Maes et al. [33].

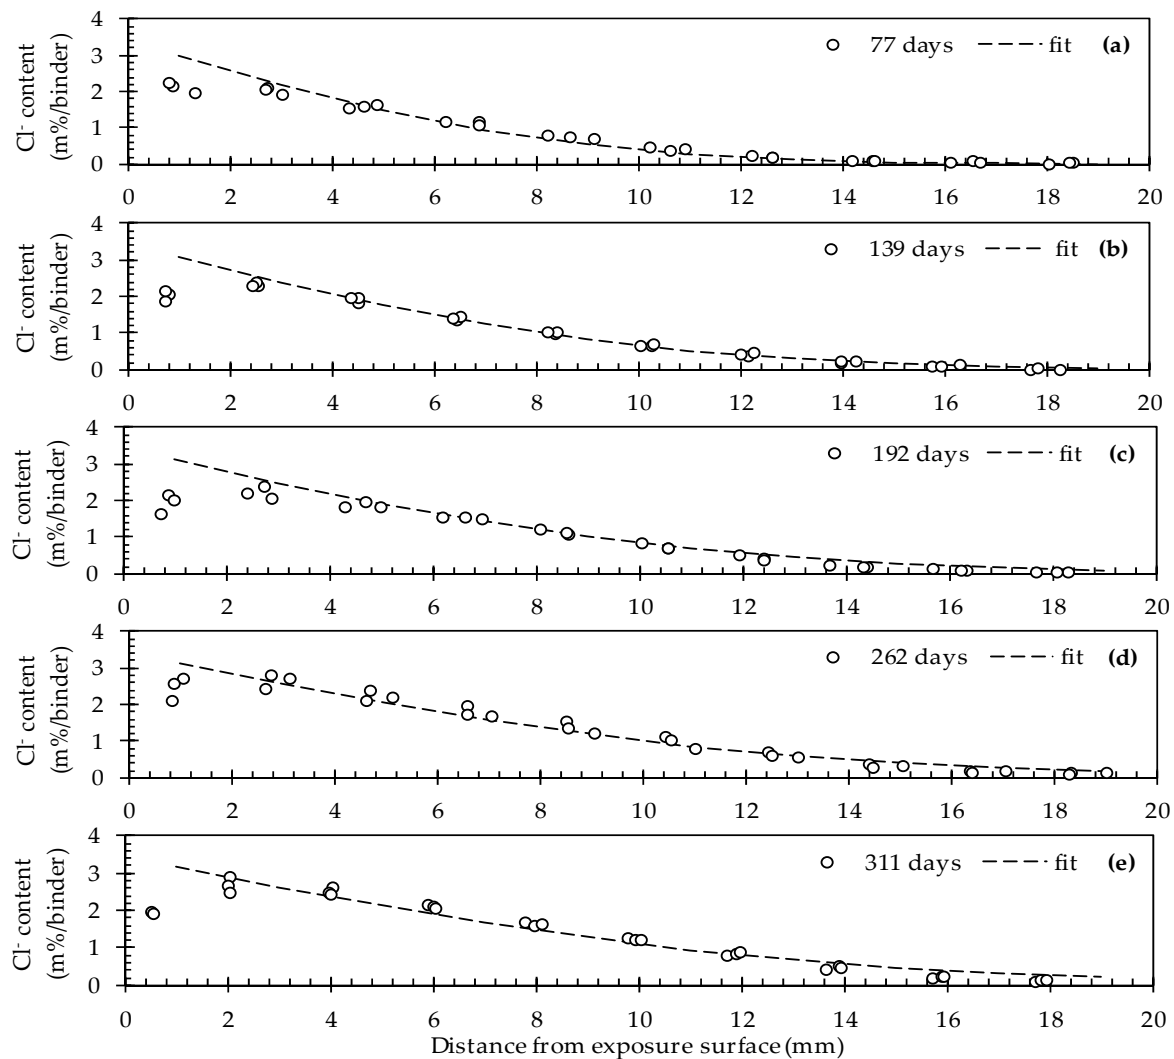
Figure 3. Experimental and fitted chloride profiles for uncracked concrete after (a) 77; (b) 139; (c) 192; (d) 262 and (e) 311 days of exposure in an aqueous 33 g/L NaCl solution.

The simultaneous fitting of C_s , D_0 and n cf. Visser et al. [56] resulted in theoretical chloride profiles that correspond rather well with the experimental data (Figure 3).

This seems to be the case for all five exposure times (77, 139, 192, 262 and 311 days). As such, the values for C_s , D_0 and n amount to 3.42 ± 0.05 m%/binder, 89 ± 3 mm²/years and 0.33 ± 0.04 , respectively (Table 3). For this fit an R^2 value of 0.978 was recorded. When looking at the evolution of the chloride profiles as a function of the exposure time it is clear that the chlorides move inwards. In other words, for a given distance from the exposure surface, the chloride concentration is gradually increasing. While for the first exposure time (77 d) the chloride profile reaches a stable value at a depth of around 14 mm. For the last exposure time (311 d) this event is only observed at a depth of around 18 mm onwards. Based on these results, it is quite evident that at a certain moment, the zone in direct contact with an embedded rebar will reach the critical chloride concentration that causes breakdown of the protective passivation layer on top of the rebar.

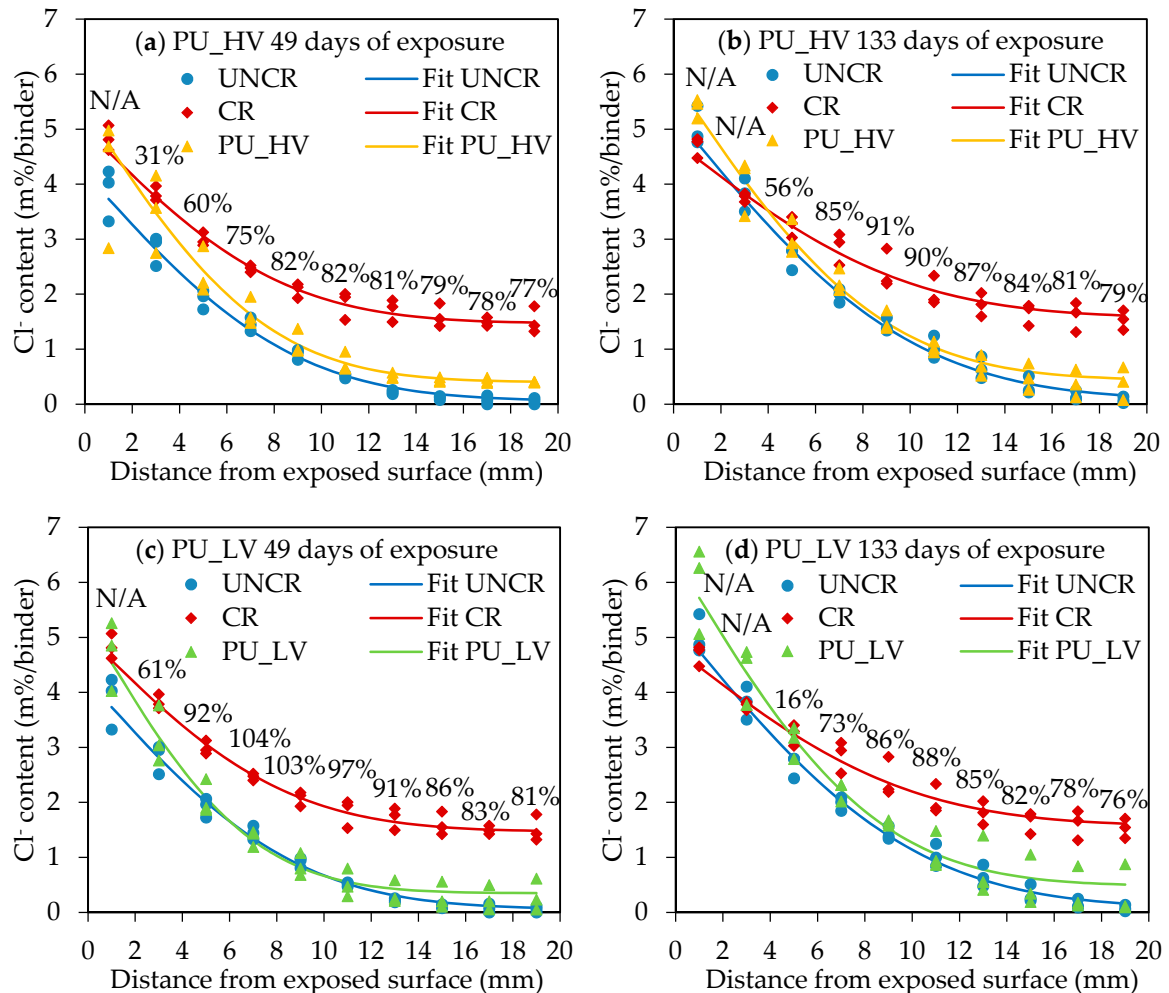
Figure 4. Experimental and fitted chloride profiles for (un)cracked and healed concrete with PU_HV after (a) 49 and (b) 133 days; and healed concrete with PU_LV after (c) 49 and (d) 133 days of exposure in 165 g/L NaCl solution. The self-healing efficiency (SHE) of each layer is denoted above the curves.

The experimentally obtained chloride profiles and corresponding profile fittings according to Equation (1) for all (un)cracked and healed specimens at the two exposure periods are shown in Figure 4.

The graphs in Figure 4 show clearly that cracks of 300 μm have a huge influence on the penetration of chlorides in concrete. After 49 days of exposure an increase of chloride content at every depth in the concrete is found due to the presence of the crack. The influence of the crack is rather limited close to the exposed surface, but increases nearly exponentially when going deeper in the concrete (Figure 5). Based on the fitted profiles in Figure 4, the chloride content at a depth of 18–20 mm was almost 18 times higher in cracked concrete compared to uncracked samples. The high increase in chloride content due to the presence of a crack from a depth below the surface of 10 mm onwards can be attributed mainly to the fact that the chloride ingress in cracked concrete in an early stage is dominated by the capillary absorption of the exposure solution in the crack.

Figure 4a,b gives the chloride profiles and fittings for the specimens healed with the high viscosity polyurethane (PU_HV) at 49 and 133 days of exposure, respectively. Figure 4c,d shows the chloride profiles and fittings for the specimens healed with the low viscosity polyurethane (PU_LV) at 49 and 133 days of exposure, respectively. The fitted chloride profiles of the healed specimens are almost completely in between the profile of the uncracked and the cracked specimens, except for the first layer (0–2 mm) in the case of 49 days of exposure and the first two layers (0–4 mm) in the case of 133 days of exposure. A possible reason for the high chloride content in the first layers of the specimens with a healed crack could be the fact that the crack healing was not perfect. At the surface of the healed cracks it could be seen that some very small parts of the crack were not well sealed. It is thus possible that the exposure solution entered into the top part of the crack through these small imperfections in the crack healing. The imperfections might be caused due to the mechanical removal of the top layer of the specimens to obtain a flat test surface. However, deeper inside the crack (and thus closer to the capsules) there might be a more complete crack filling which prevents the chlorides from penetrating deeper into the crack. As a result, there is an accumulation of chlorides in the top layers of the specimens with a healed crack. However, the main deterioration mechanism caused by the ingress of chlorides is chloride induced reinforcement corrosion. Since the reinforcement in a concrete element is usually located at a depth much higher than 4 mm, a high chloride concentration in the top layers (0–4 mm) does not directly have a negative impact on the durability of the element.

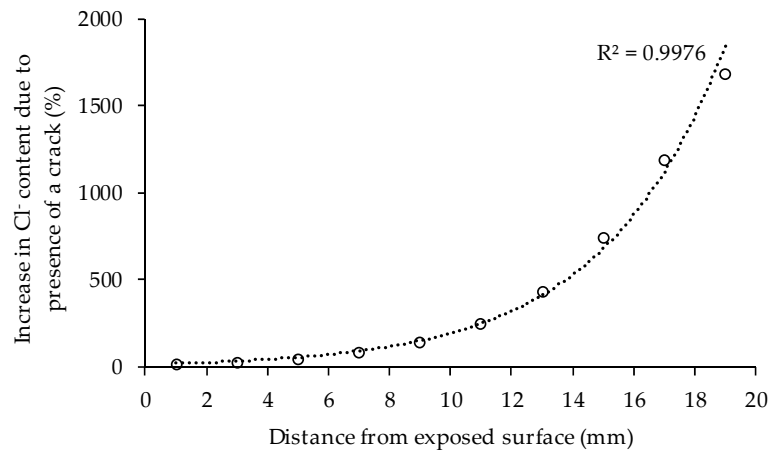
Figure 5. Increase of chloride concentration in function of the distance from the exposed surface due to the presence of a crack (exposure period of 49 days). The dotted line represents an exponential fit. The corresponding coefficient of determination (R^2) is denoted in the graph.

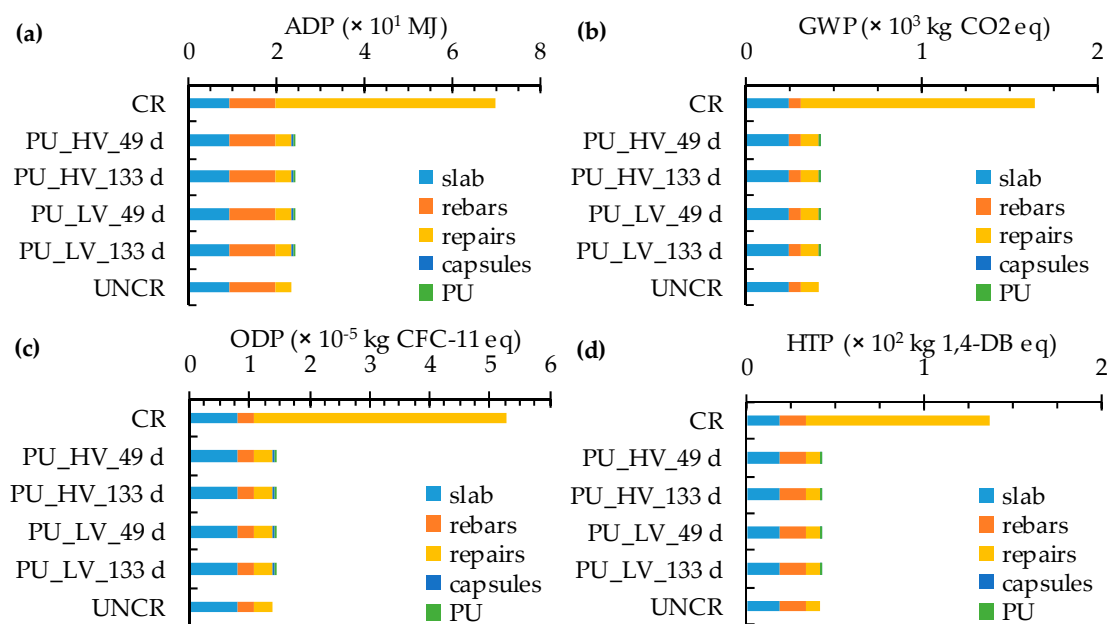
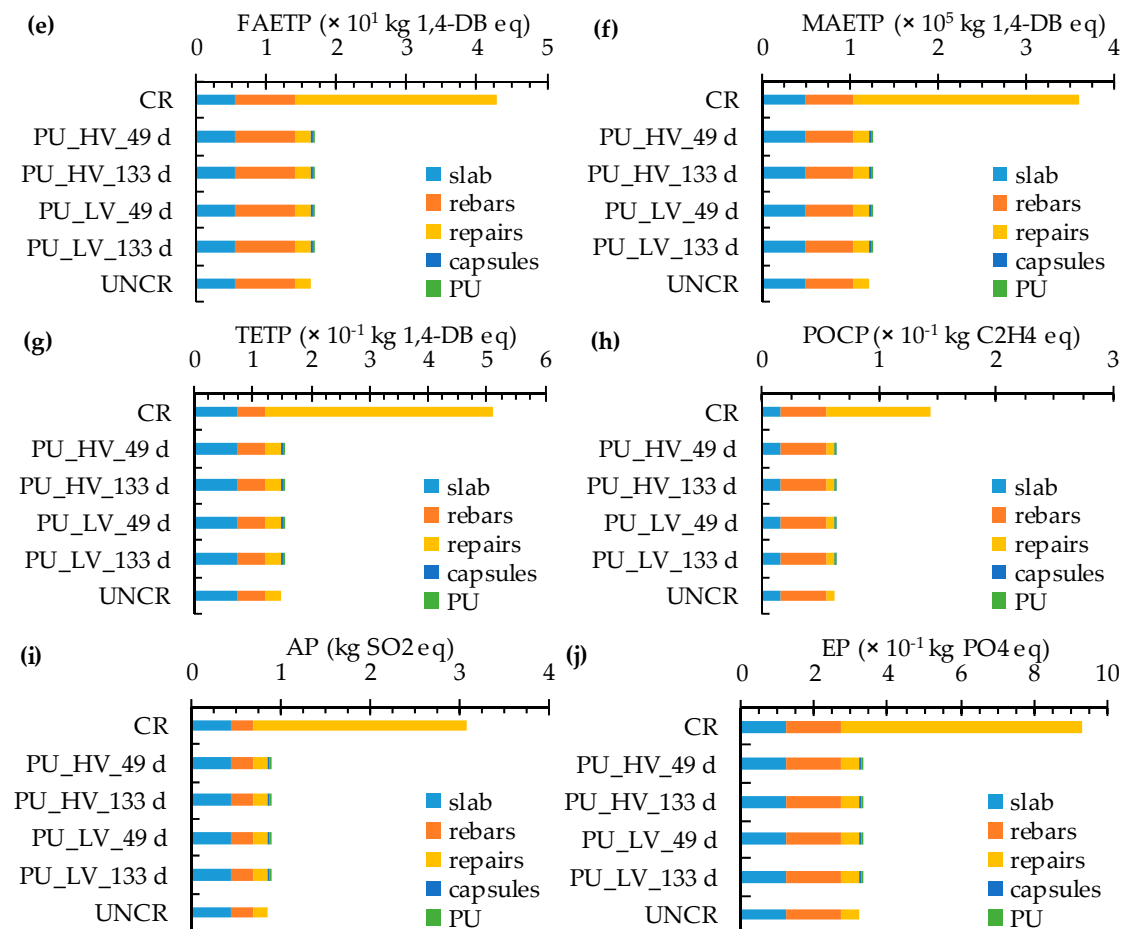
Figure 6. The ten CML-IA baseline impact category indicators for steel reinforced concrete slabs (variable load: 5 kN/m², design service life: 100 years, including repairs) made with (un)cracked and self-healing concrete with encapsulated PU_HV and PU_LV: (a) ADP; (b) GWP; (c) ODP; (d) HTP; (e) FAETP; (f) MAETP; (g) TETP; (h) POCP; (i) AP; and (j) EP.

When assessing the ten CML-IA baseline impact indicators for the considered functional unit (i.e., steel reinforced concrete slab with a given load and service life in exposure class XS2), a high sustainability potential seems to be present for the self-healing concrete with encapsulated PU precursor in comparison with ordinary (cracked) concrete (Figure 6). ADP (−66%), GWP (−74%), ODP (−73%), HTP (−69%), FAETP (−61%), MAETP (−65%), TETP (−70%), POCP (−56%), AP (−71%) and EP (−64%) values that have been recorded for the self-healing concrete are all substantially lower. This can mainly be explained by the fact that the regular time dependent replacement of the cover for the cracked concrete imposes a huge environmental burden onto the slab. On the other hand, the presence of the encapsulated PU precursor to reduce the repair frequency to only one time has a negligible impact on all ten baseline impact categories (1%–4% of the impact of one steel reinforced slab including one repair). The encapsulated PU precursor was found to contribute the most (3%–4%) to the HTP, FAETP, TETP, POCP, AP and EP.
